## **PROPERTY CONDITION ASSESSMENT**

Los Altos Woods Office Building

5050 El Camino Real

This Property Condition Report (Assessment) was completed by Global Realty Services Group, GRS Group, for Woodmen of the World (Client). Site reconnaissance was conducted on September 19, 2011 by Mark S. Prock.

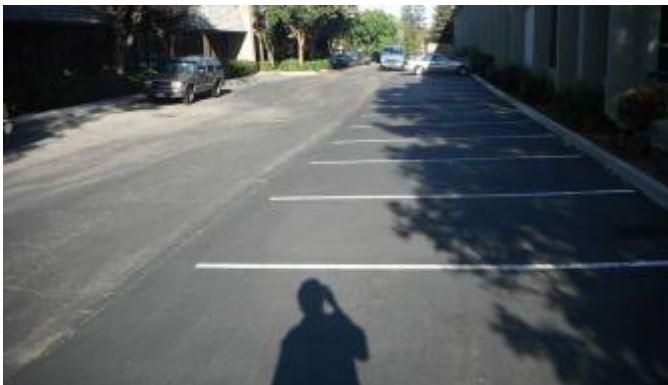
5. Overview of parking lot.

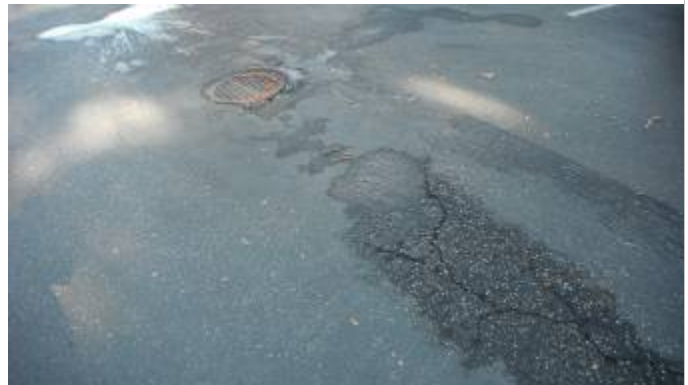
Asphalt Pavement      *Replacement Reserves* – Asphalt pavement along the perimeter of the building is generally in good condition, with some areas having minor cracks with deterioration observed at the driveways within the parking lot. Asphalt repairs with periodic sealing and re-striping is required during the reserve term. Funds have been included in the replacement reserve table for this work during the reserve term.

6. Parking lot asphalt damage.

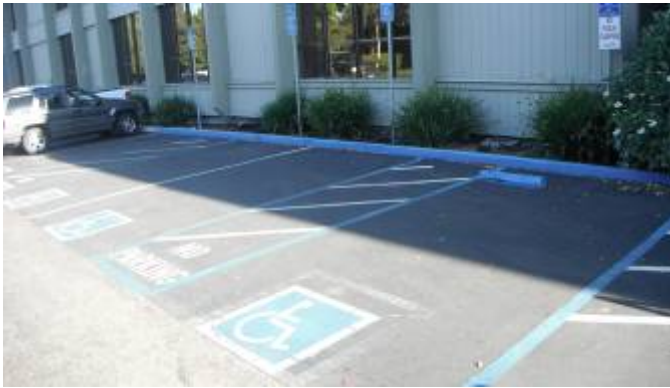
7. Handicap parking stalls.

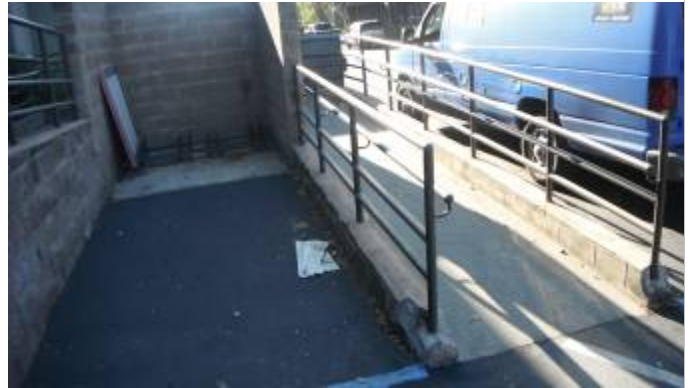
8. Handicap access ramp at rear parking lot.

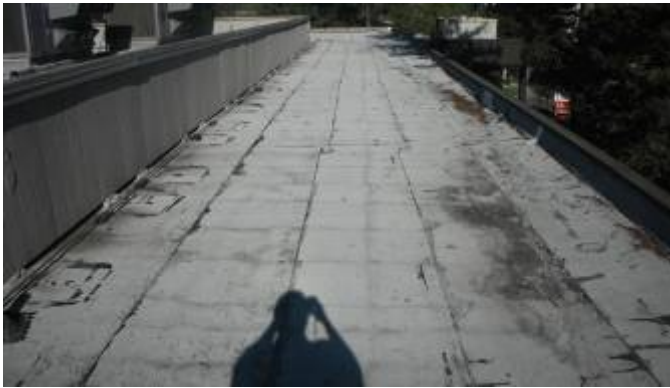
19. Overview of flat roof covering.

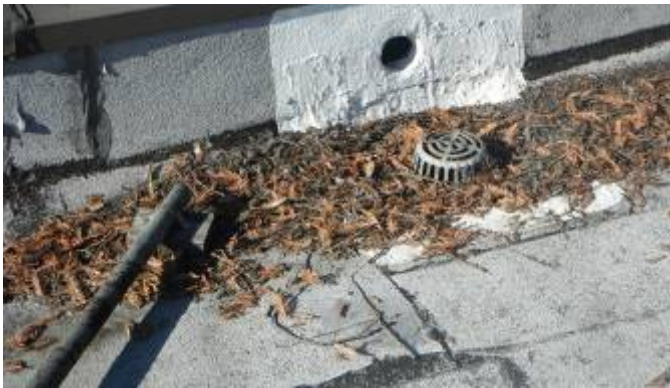
21. Roof drainage showing debris.

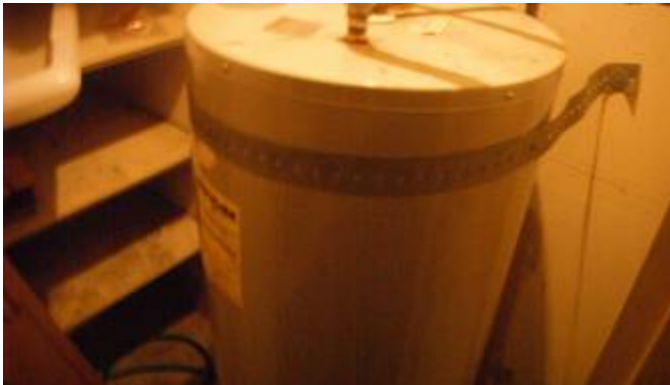
Hot Water Heater      *Routine Maintenance Only* - Replacement of the building domestic water heater for this building is considered to be part of routine maintenance.

25. Gas-fired water heater at semi-subterranean parking garage.

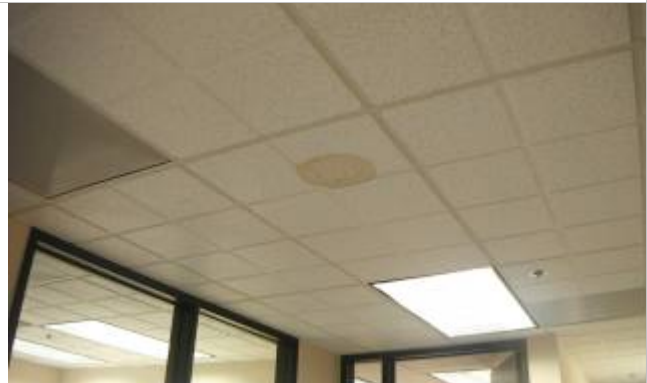
40. Second floor office space ceiling tiles with moisture stain.
