REPORT OF INVESTIGATION

**Surface Metal Mine
(Alumina)**

**Fatal Falling Material Accident
November 18, 2014**

**Turner Industries Group LLC
Contractor ID No. HPQ
at
Alcoa World Alumina LLC
Bayer Alumina Plant
Point Comfort, Calhoun County, Texas
Mine ID No. 41-00320**

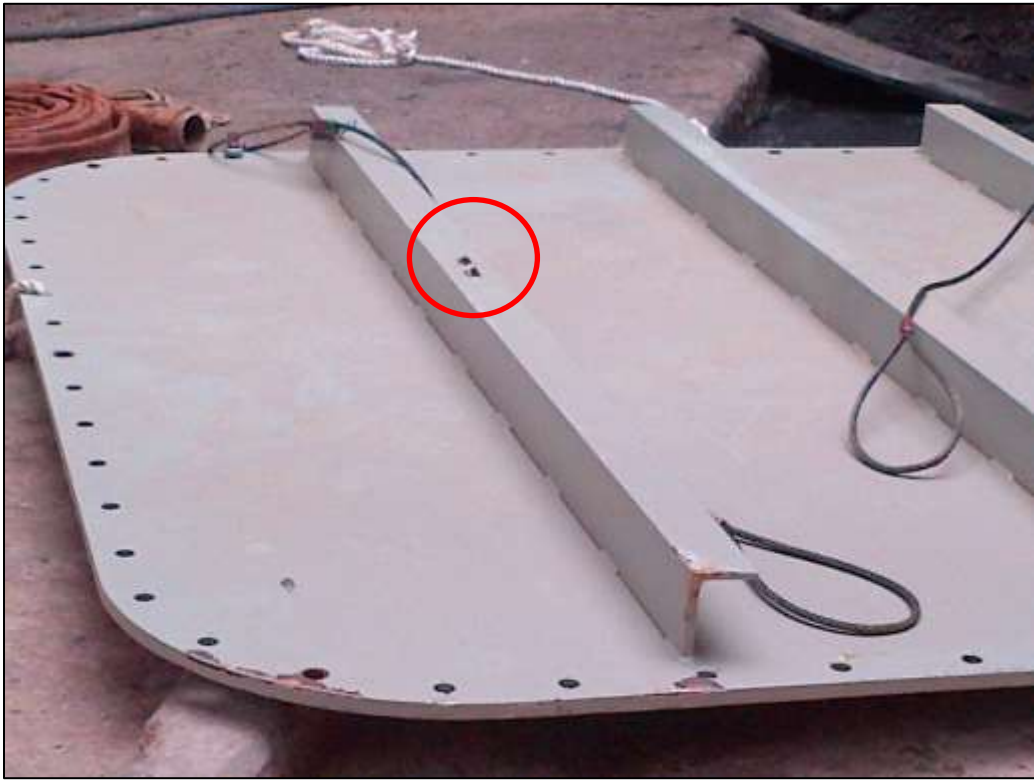
Two U-shaped lifting lugs had been fillet welded to the door. One lug was on the top stiffening angle and the other was on the bottom stiffening angle. At the time of the failure, only the top lug was being used to lift the door, as it was ready to be bolted into position against the tank flange. Reportedly, the lugs were made in batches of 14 from a sheet of A36 steel. A computerized plasma cutting machine was used to cut and size the lugs. The machine cut results in a slight slant across the ½-inch thickness of the cut faces. The lugs were 4-¾ inches tall, 4 inches wide and ½-inch thick (photo 3). Each leg of the U-shape lug was 1-½ inches wide. The lugs were welded around the perimeter of each leg with two passes of weld metal. The initial pass was made with P5 6010 rod and the cover pass was made with a 7018 rod. Reportedly, between the passes the welder used a wire brush to clean off the flux. With two passes, the base of the weld was to have an ultimate tensile strength of 60 ksi¹ and the top of the weld was to have an ultimate tensile strength of 70 ksi. The lug was mounted on a slight skew with the left leg 3/16 inches higher (i.e., toward the top or the door) than the right leg of the lug. Both the door and weld were then painted.

Photo 1 – Tank door with stiffeners and bolt holes around the perimeter. Circled location is where the top lifting lug was attached prior to failure.

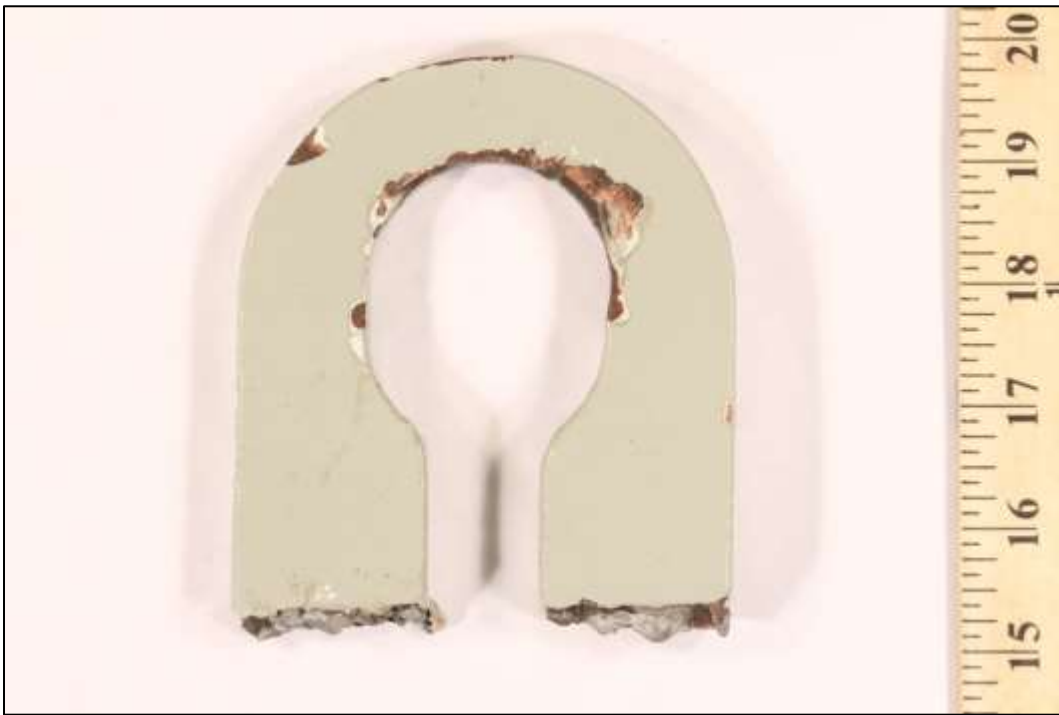
The fractured lug involved in the accident was 4-7/16 inches tall on the face that would have been closest to the bottom of the door and it was 4-1/2 inches tall on the top face. In comparison, this was shorter than the intact lug, which was 4-3/4 inches tall. The fractured lug fillet welds were 1/8 to 5/16 inches wide along the bottom face of the lug and 1/8 to 1/4 inches wide along the top face. In comparison, the intact lug welds were wider and therefore stronger varying from 1/4 to 3/8 inches wide on the bottom and top faces.

Photo 2 – MATCO photo of the bottom face of the failed lifting lug.

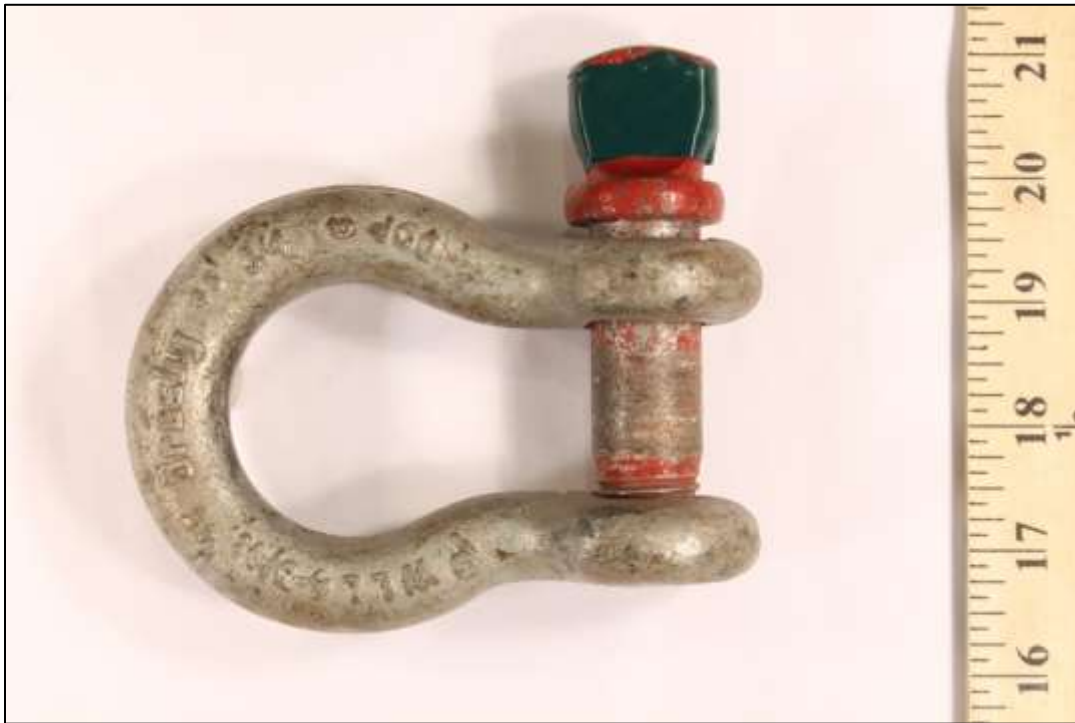
Photo 3 – MATCO photo of Crosby $\frac{3}{4}$ -inch screw pin shackle. Rated working load limit of 4- $\frac{3}{4}$ tons.

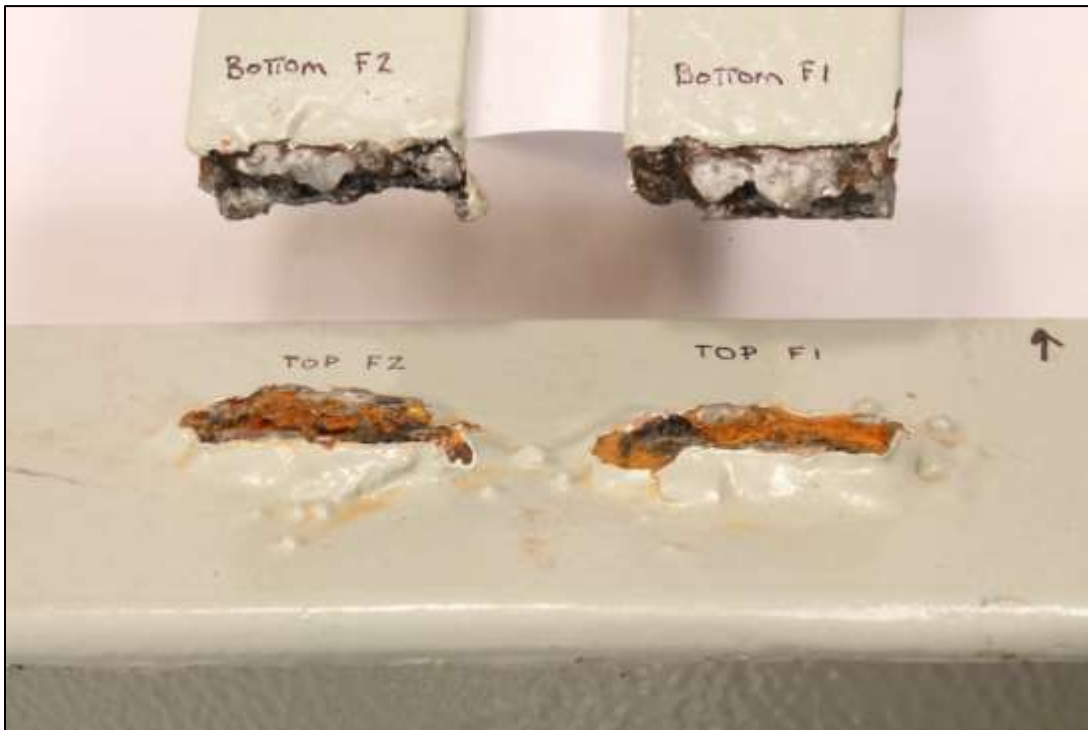
At the time of the failure, the lug was being side loaded in a bending manner. As such, the bottom welds were being loaded in tension and the top welds were being loaded in compression. The bottom side welds failed through the first pass of the weld (i.e., the weaker pass) and the failure occurred within the footprint of the lug. The fractures occurred solely within the weld metal on the bottom side of the lug. Although the lug had a lower ultimate tensile strength than the weld metal, the weld was the weakest component because of its smaller effective resisting area. This smaller area was a result of the irregular weld size and a lack of continuous fusion to the base metal of the angle.

Photo 4 – MATCO photo of fractures at the bottom of the left and right legs of the lug and the mating fractures on the top of the stiffening angle. Note light gray (shiny) fracture areas on the lug were the only portions of the bottom weld that adequately fused to the angle. The bottom face lug welds were subjected to tension loading.

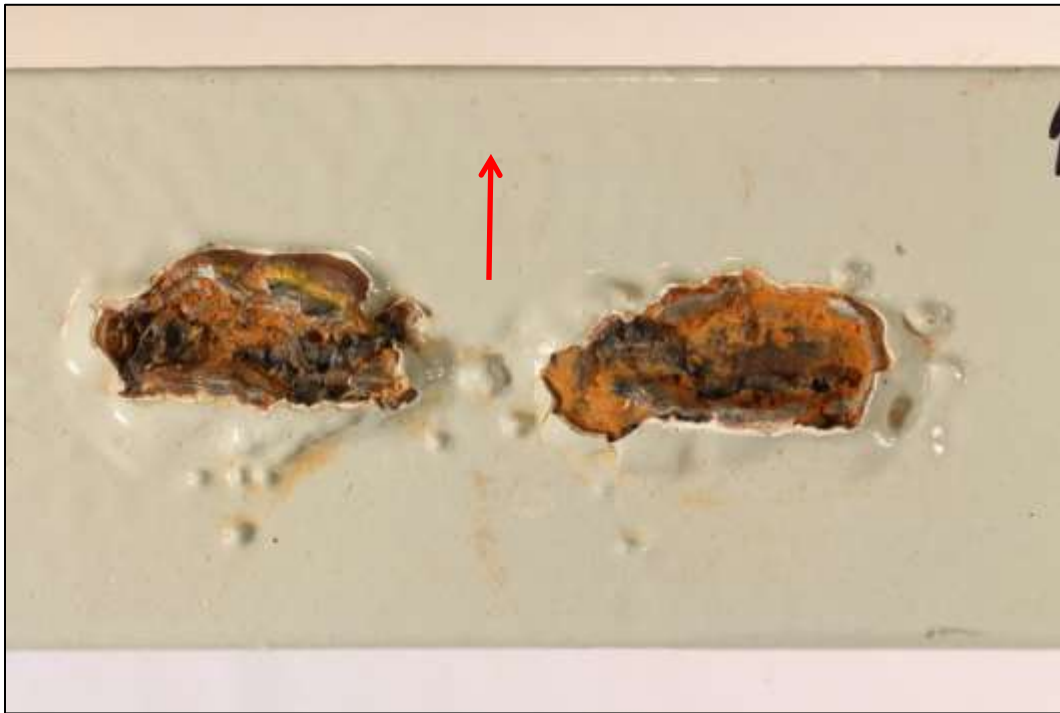
The door fell because the welds attaching the lug to the door stiffener were undersized for the encountered stresses. Further, the welds were irregular in shape and contained defects, such as lack of fusion, porosity, and undercutting, which adversely affected the weld's capacity.

Photo 5 – MATCO photo of fractured welds on tank door stiffening angle. Arrow points to the top of the door.

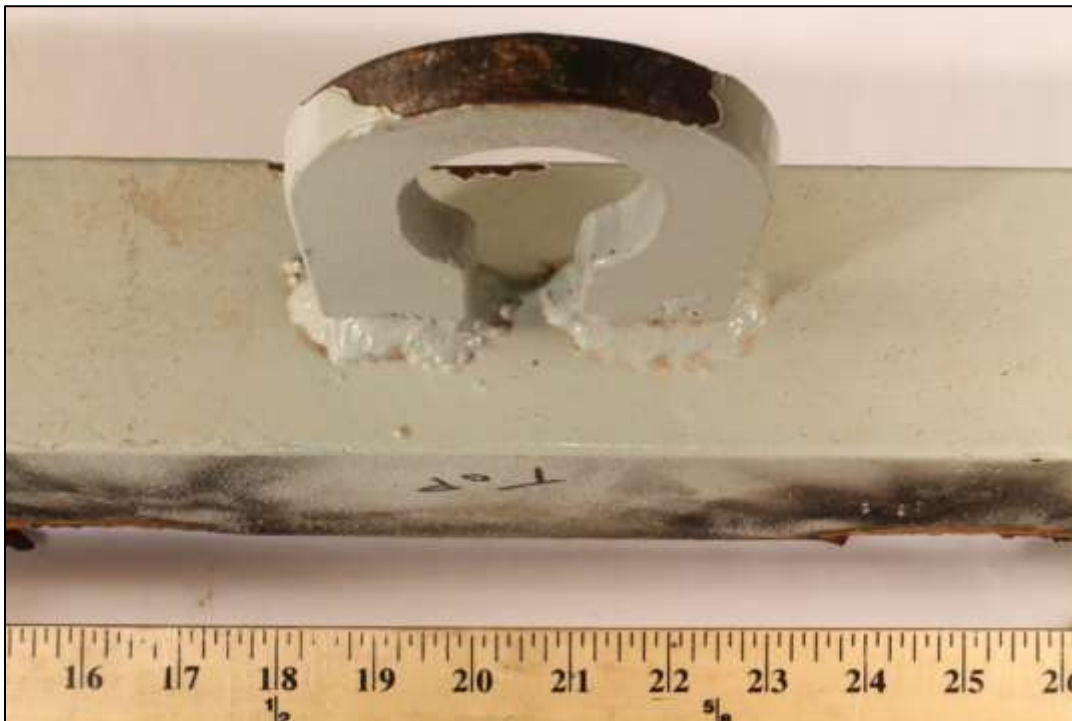
Photo 6 – MATCO photo of removed intact lug showing fillet weld connection to the stiffening angle. This lug was near the bottom of the door and was not being used when the accident occurred. Arrow points in the direction of the top of the door.

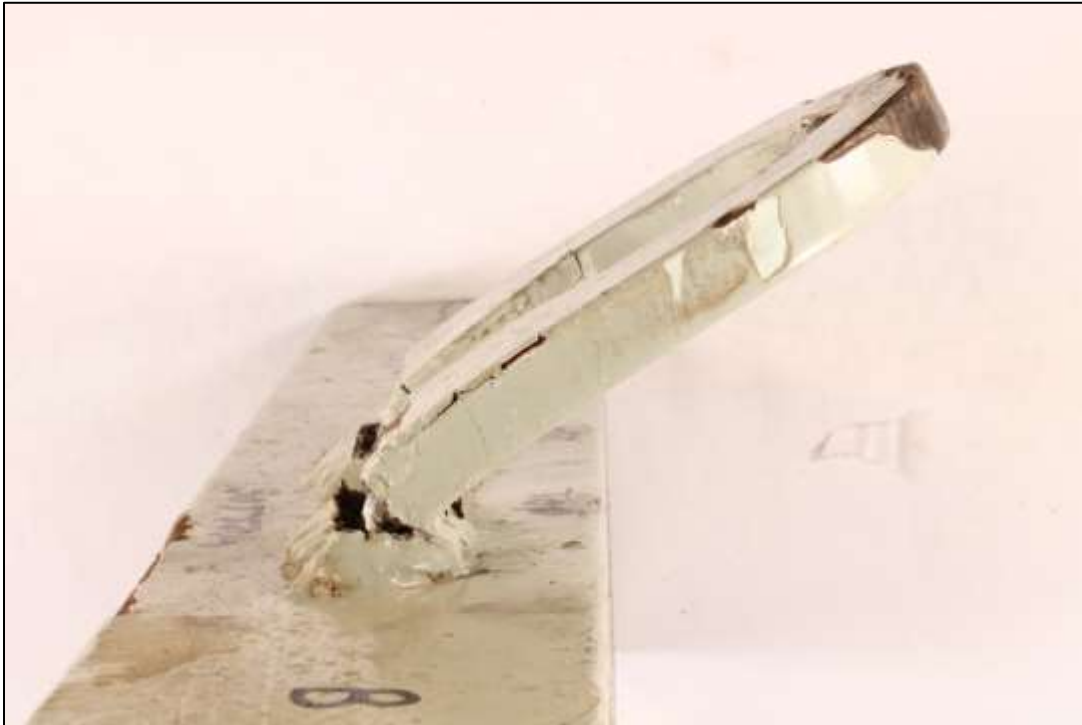
The intact lug from the bottom of the door and a section of the bottom stiffening angle were cut off and tested at TUV Rhineland (photo 7). The testing replicated the loading type and direction of the failed assembly in service. During the testing, the lug deformed and the bottom welds cracked, but the lug did not separate (photo 8). The maximum load sustained was 3,330 pounds when the welds fractured. The surfaces of the weld fractures were similar to the surfaces of the welds that failed when the accident occurred. However, MATCO noted that the area of the weld failures appeared greater than that of the lug involved in the accident. This likely explains why the tested connection was able to sustain a larger load.

Photo 7 – MATCO photo of deformed shape and fractures after the intact lug was tested at TUV Rheinland. The arrow points in the direction of the top of the door
