Report on the investigation of the
fatal man overboard from fishing vessel

North Star

16nm north of Cape Wrath, Scotland

5 February 2018

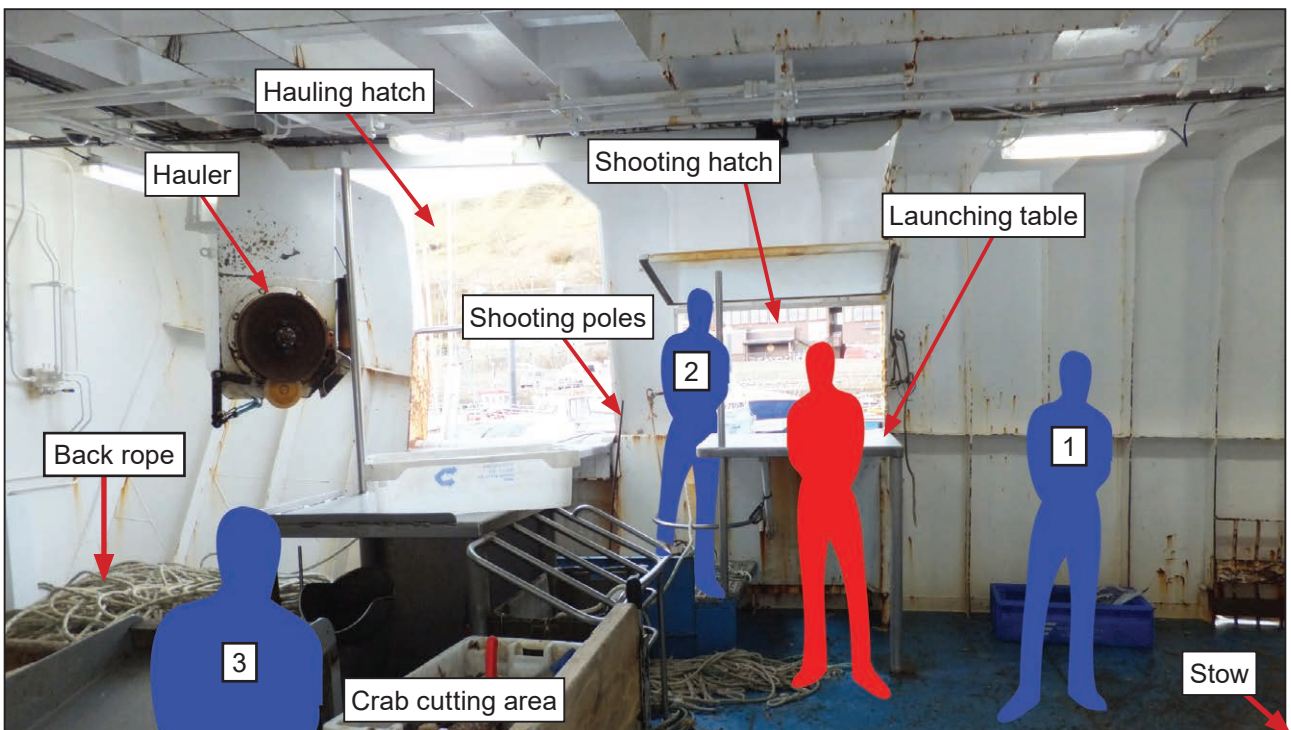
Figure 1: The deckhands' positions on the working deck

There were two methods of shooting creels employed on *North Star*. The self-shooting method, which could be used in sea conditions up to sea state 6, and the manual shooting method. The manual shooting method involved Deckhand 1 moving the creels one at a time from the stow to the launching table where Mark Elder was stationed (**Figure 1**). Mark then removed a leg rope from the shooting poles and toggled the creel to it before Deckhand 2 moved the attached creel to the vessel's side ready for it to be launched. Deckhand 3 was stationed at the cutting table, processing the crabs from the previous haul. The skipper was alone in the wheelhouse monitoring the vessel's speed and the closed circuit television system (CCTV) that showed what was happening on the working deck. There was also a tannoy system that enabled the skipper to communicate with the crew and vice versa. The sixth crewman was off-watch and in the crew mess room (**Figure 2**).

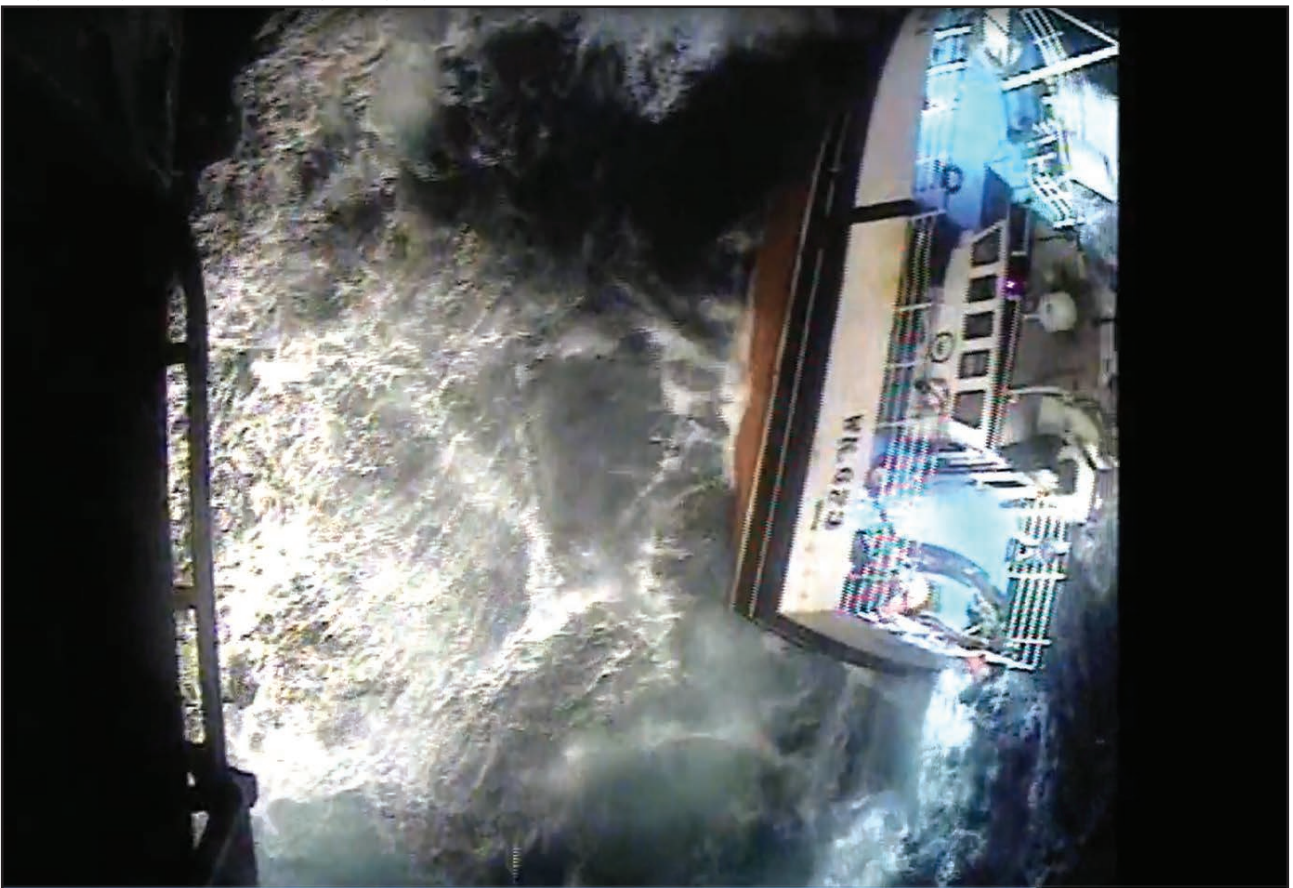
Figure 4: Image of *North Star* in the seaway taken from the rescue helicopter video footage

By 1915, the rescue helicopter was on scene and, using VHF radio, *North Star's* crew were briefed on highline techniques. *North Star* was moving violently in the sea and swell (**Figure 4**), making it impossible to attempt a highline transfer and, at 1955, the captain of the rescue helicopter informed the coastguard that he was returning to base. Following the helicopter's departure, *North Star's* skipper set a course to return to Scrabster. After administering CPR continuously for almost 90 minutes without any response, and with no prospect of external assistance, *North Star's* skipper instructed the crew to cease their resuscitation efforts.

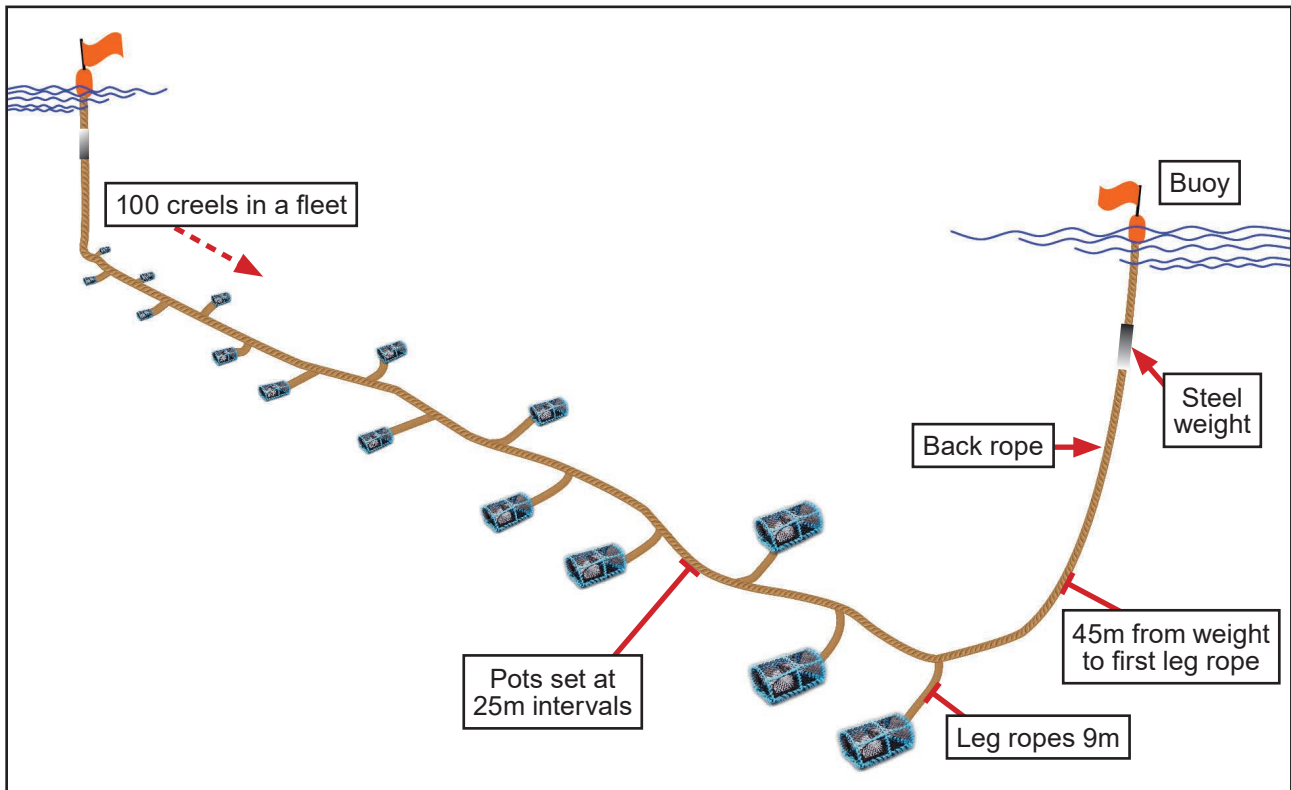
Figure 5: Creel arrangement

Each of *North Star's* fleets of creels consisted of 100 creels, each weighing approximately 20kg when dry, spaced approximately 25m apart toggled on to 9m length leg ropes. At 45m from either end of the back rope there was a steel weight (Figure 5).

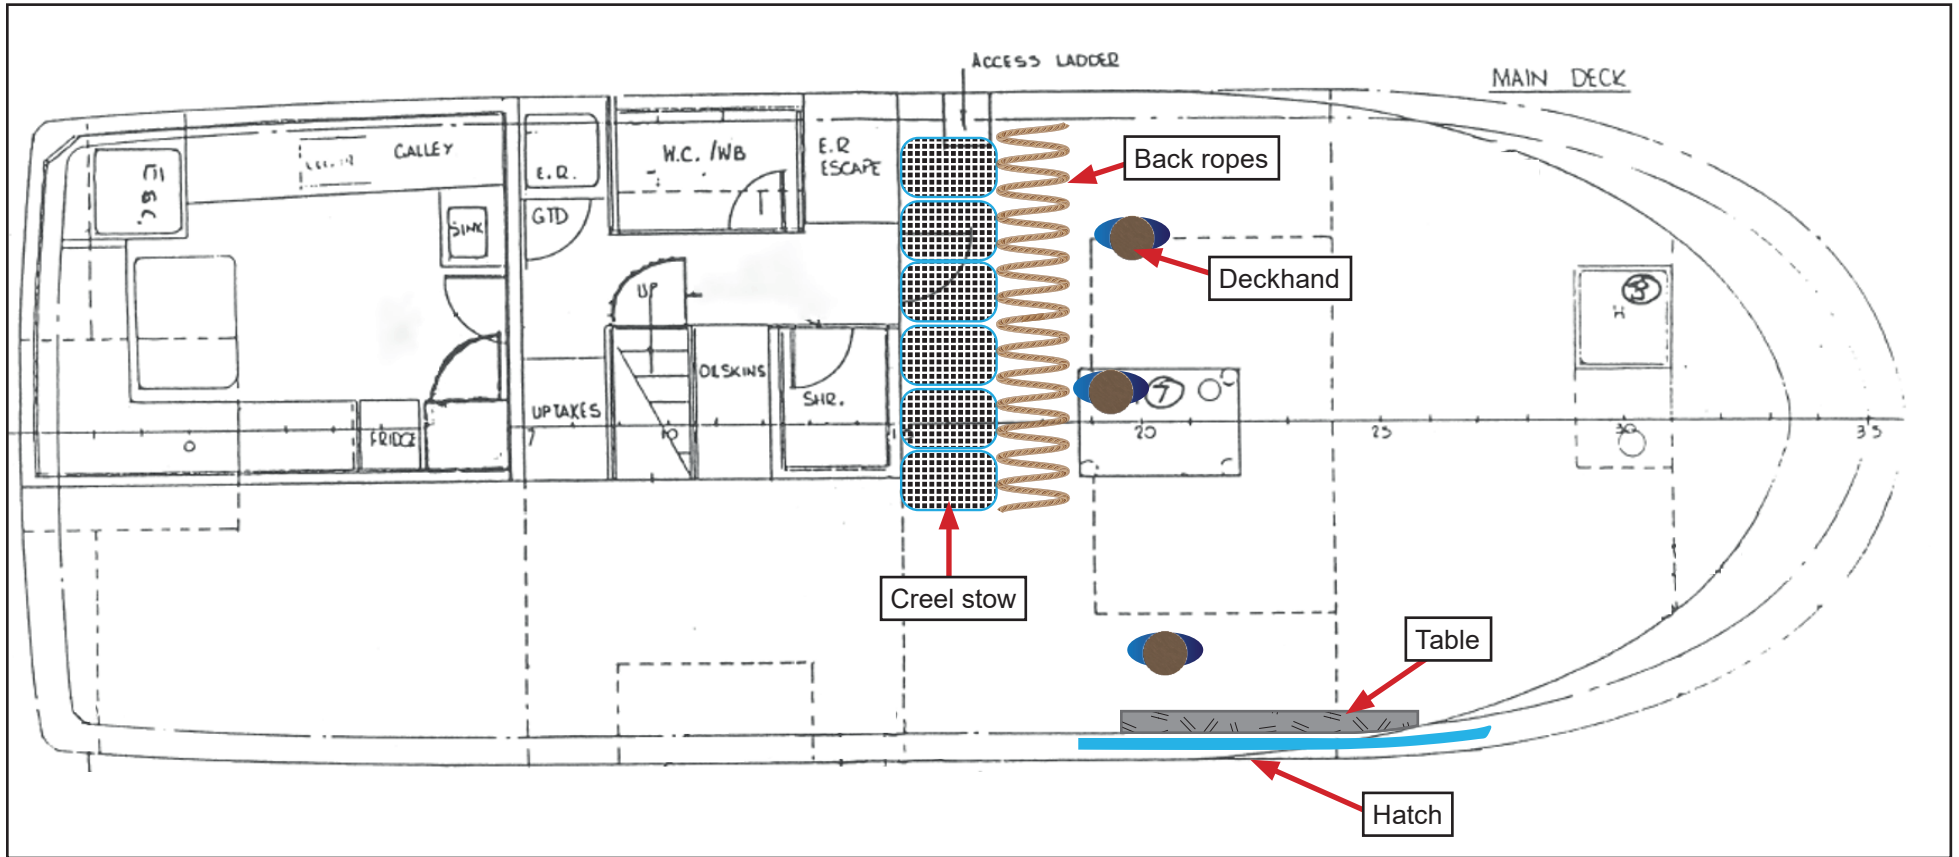
Figure 6: Former working deck layout

Prior to modification, *North Star* was not equipped with a self-shooting system and the creels were launched manually. The creels were stowed athwartships and the back rope, which was also stowed athwartships, was flaked on the deck between the creels and the crew (Figure 6). While stowed, the creels were toggled on to the leg ropes in series and then manhandled, one at a time, to the deckhand located at the table adjacent to the shooting and hauling hatch (Figure 6). There had been previous incidents of deckhands becoming entangled in the back rope as the creels were passed from the stow to the shooting hatch. On those occasions, either the deckhand had been able to quickly disentangle themselves from the rope or the skipper had managed to stop the vessel in the water in time to prevent the deckhand from being dragged overboard.

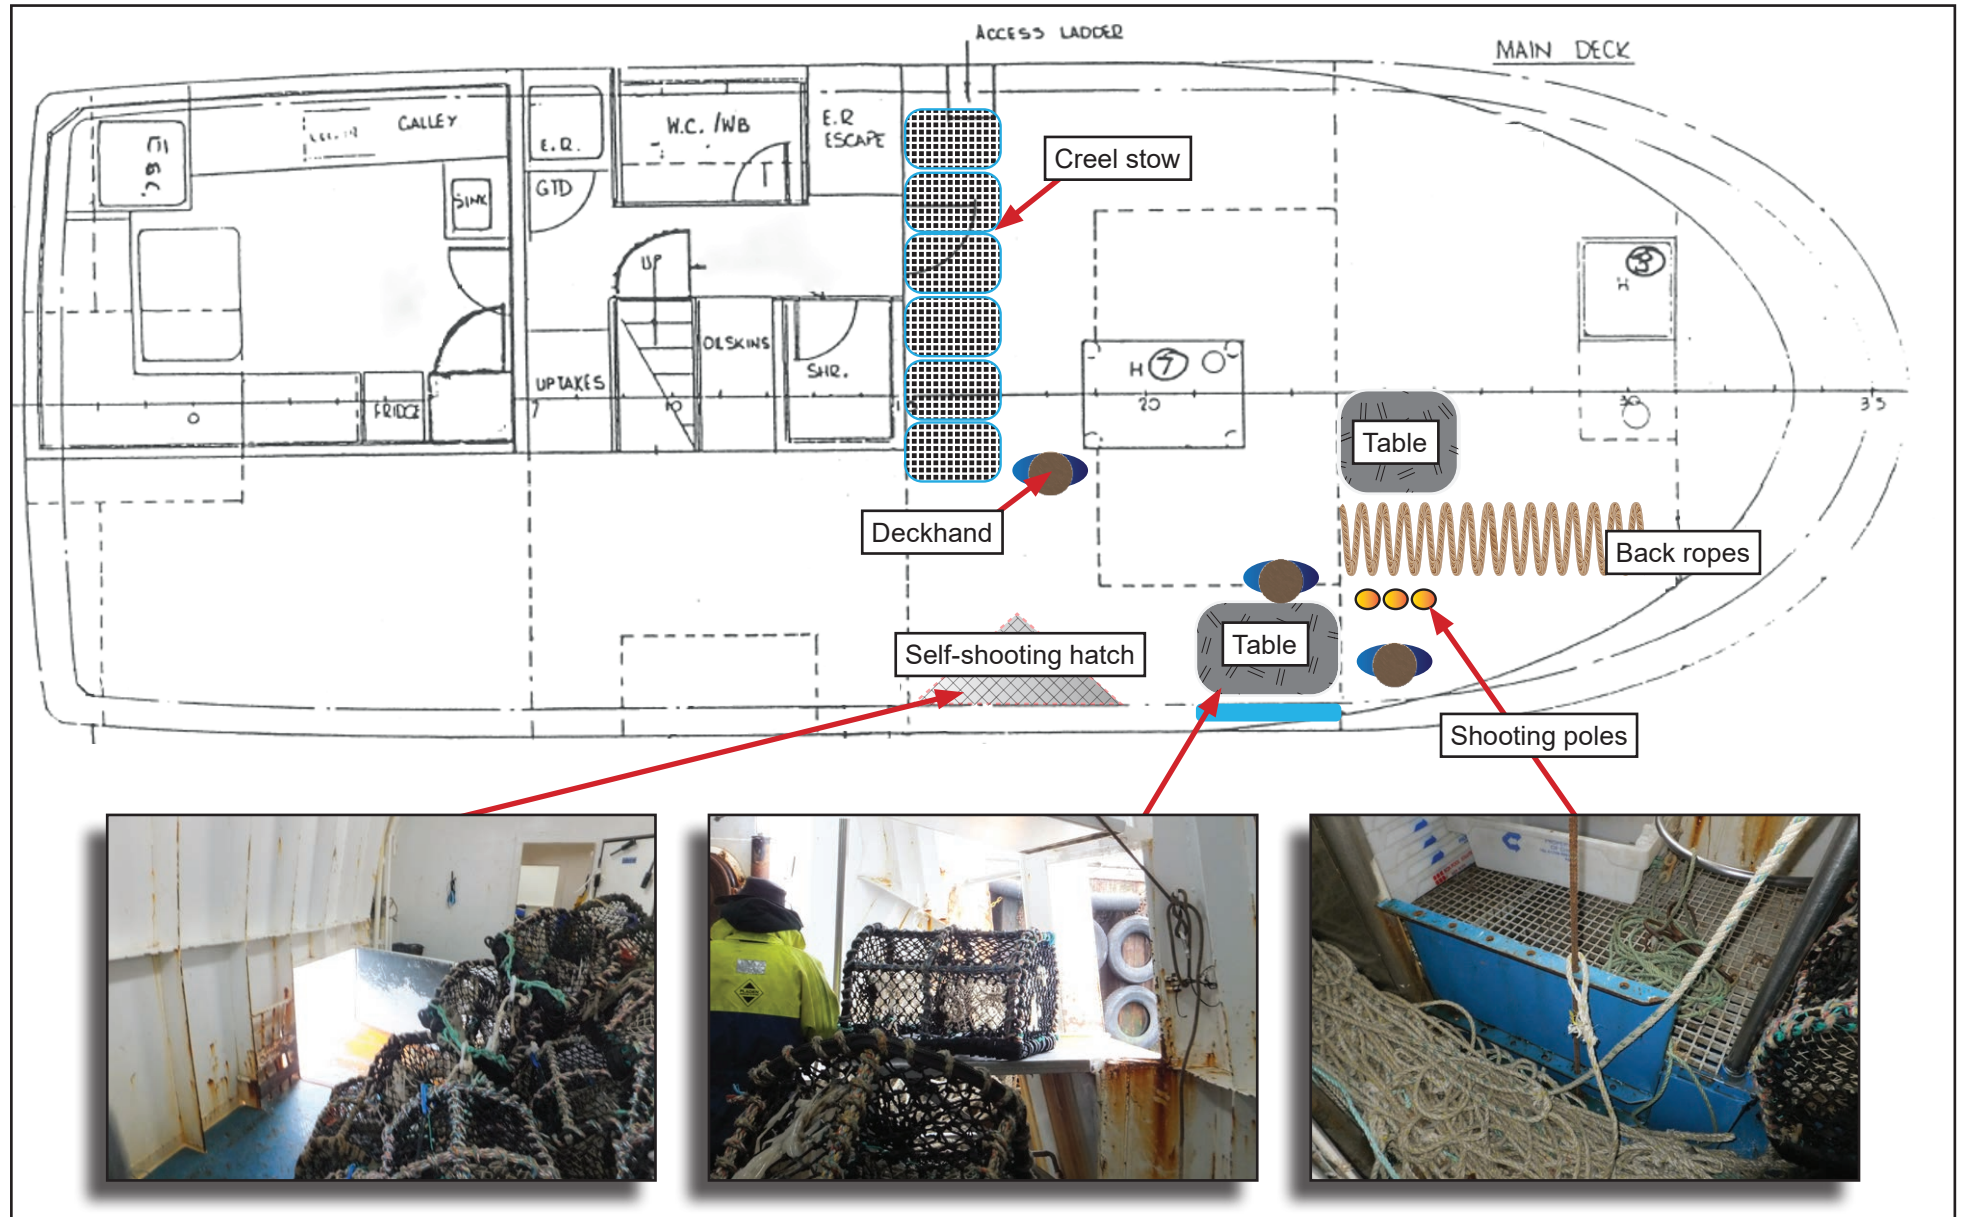
Figure 7: Modified working deck layout

After modifying the working deck layout in August 2017, the back rope was stowed in a fore and aft direction, forward of the crew (Figure 7). There were no pound boards to separate the back rope from the crew; instead, the senior skipper instructed them to keep their feet on the deck to prevent their entanglement in the moving ropes. When shooting manually, a creel was placed on the table, where it was toggled on to a leg rope before being moved to the shooting hatch in readiness for it to be launched overboard. Once the shooting of creels began, the skipper varied the

The modifications to *North Star* in August 2017 included installation of a self-shooting system that could be used in weather conditions up to and including force 6 (22-27kts). Above this limit the vessel tended to ship seas across its working deck. The self-shooting system stationed the crew away from the running ropes, behind a partition. The creels were stowed in the usual athwartships position, but all were toggled on to the leg ropes in sequence before the first buoy and weight were deployed. The first buoy and weight were then deployed through the self-shooting hatch (**Figure 7**), followed by the fleet in sequence.

Without a physical barrier to prevent Mark from becoming entangled in the back rope, he was in an extremely precarious position that relied on his ability to keep his feet on the deck. In the rough seas, *North Star* was moving violently (**Figure 4**) and, given the rate at which the creels were being shot, Mark is likely to have been more focused on toggling the creels on to the leg ropes rather than on keeping his feet flat on deck. He therefore inadvertently stepped into a bight of back rope. As the 'Fishermen's Safety Guide' warns, familiar and repeated tasks can cause lapses of concentration.

North Star's owner, Scrabster Seafoods Limited, has since installed a physical barrier to reduce the risk of crew becoming entangled in the back rope. The company has also reviewed its risk assessments, ensured its crew have attended mandatory safety training, provided personal flotation devices on board, and introduced a drug and alcohol policy.
