Mapping Hidden Aircraft Defects with Dual-Band Infrared Computed Tomography

N. K. Del Grande
P. F. Durbin

This paper was prepared for submittal to the
SPIE Nondestructive Evaluation of Aging Aircraft Airports,
Aerospace Hardware & Materials
Oakland, California
June 6-8, 1995

April 3, 1995

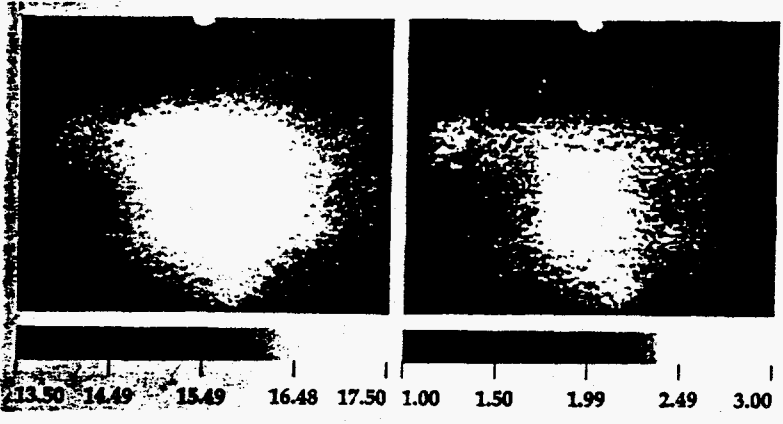
Figure 1

In Figure 1, we used the VIEW image processing code to correct for hot spots from non-uniform pulsed heat sources. We developed correction algorithms for a uniformly-thick (1 mm) aluminum panel and tested them on a known reference standard with gradual thickness variations from about .8 mm, at the center, to 1 mm at the perimeter. The non-uniform heat source produced a 1 °C surface temperature rise for a 13.0 % (uncorrected, at left) and 15.8 % (corrected, at right) thickness reduction. The corrected, compared to the uncorrected, metal-loss per degree Celsius was larger by 22%.

Temperature Maps at 0.4 s (left), Timegrams at 0.04 s (right), SH at top, LH at bottom

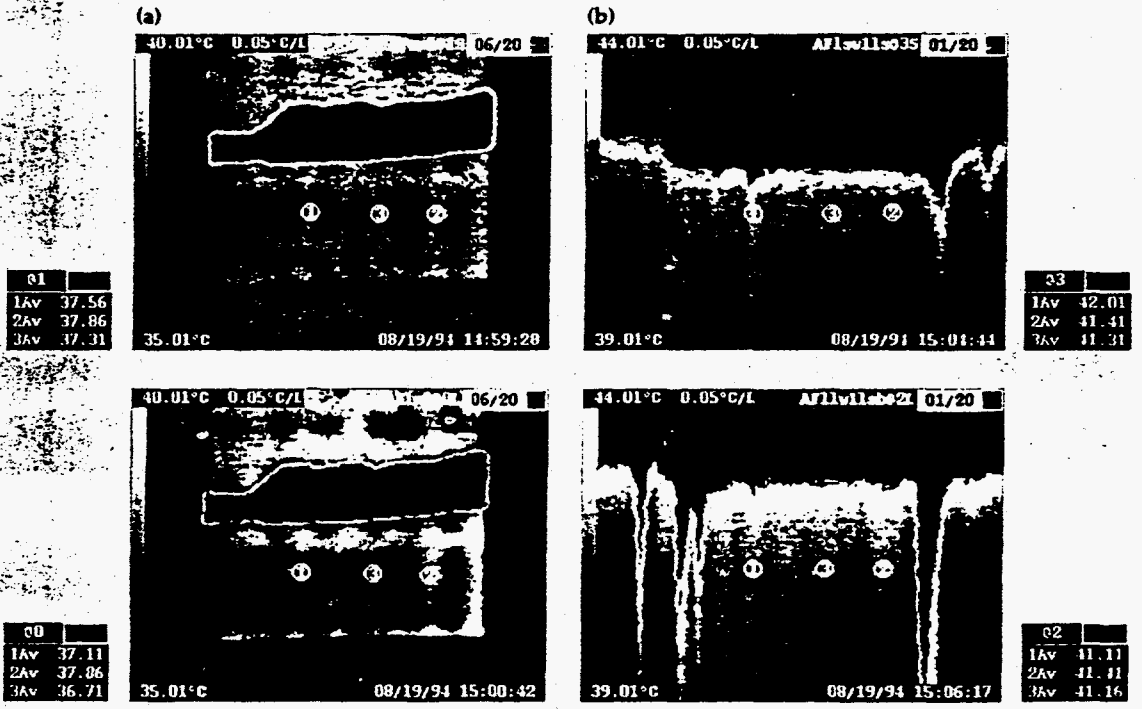
Figures 2, 3, 4 and 5 apply to a corroded Boeing KC-135 panel obtained from Tinker Air Force Base in Oklahoma. Figure 2 shows the 3 to 5 micron (SW) apparent temperature and timegram, e.g., cooling rate, maps respectively at the top, left and the top, right. Figure 2 also shows the 8 to 12 micron (LW) apparent temperature and timegram, e.g., cooling rate, maps respectively at the bottom, left and the bottom, right. The SW and LW temperature maps are taken at 0.4 seconds after the flash. The timegram (cooling rate) maps have times increasing from 0 seconds for the top line of the linescan, to .08 seconds for the bottom line of the linescan, after the flash peak temperature. To emphasize small temperature differences, temperature values were off scale on the timegrams at less than .04 s. Note the spot temperatures at defect sites #1 and #2, which are typically warmer than the spot temperatures at normal sites, without defects, e.g., #3.

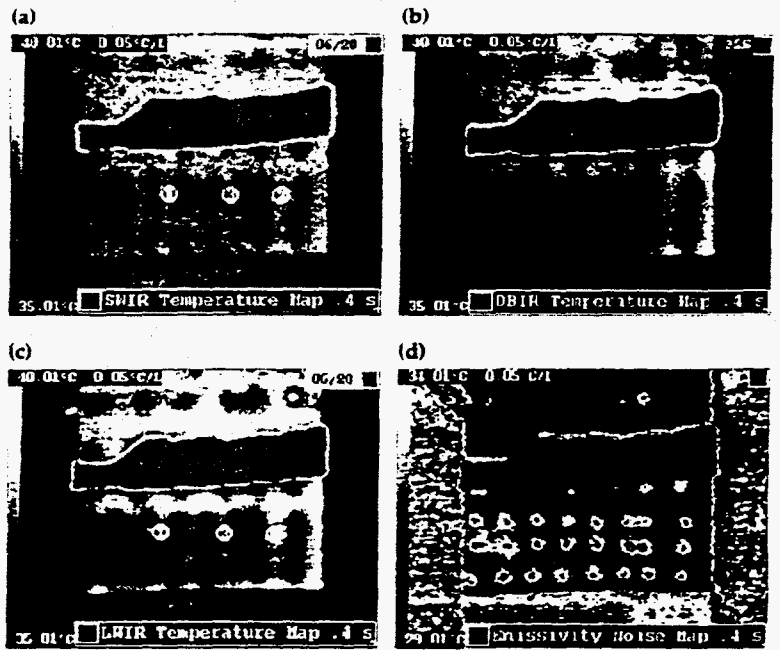
Figure 3.

Figure 3 shows similar thermal patterns for the SW and LW apparent temperature maps, and the high-contrast DBIR temperature map, which differ significantly from the emissivity-noise map. This is to be expected when, as is customary, the panels are painted black. The black paint allows the target to absorb about six times as much heat, compared to the absorbed heat for unpainted (bare-metal) aluminum targets, since bare metal targets are highly reflective.

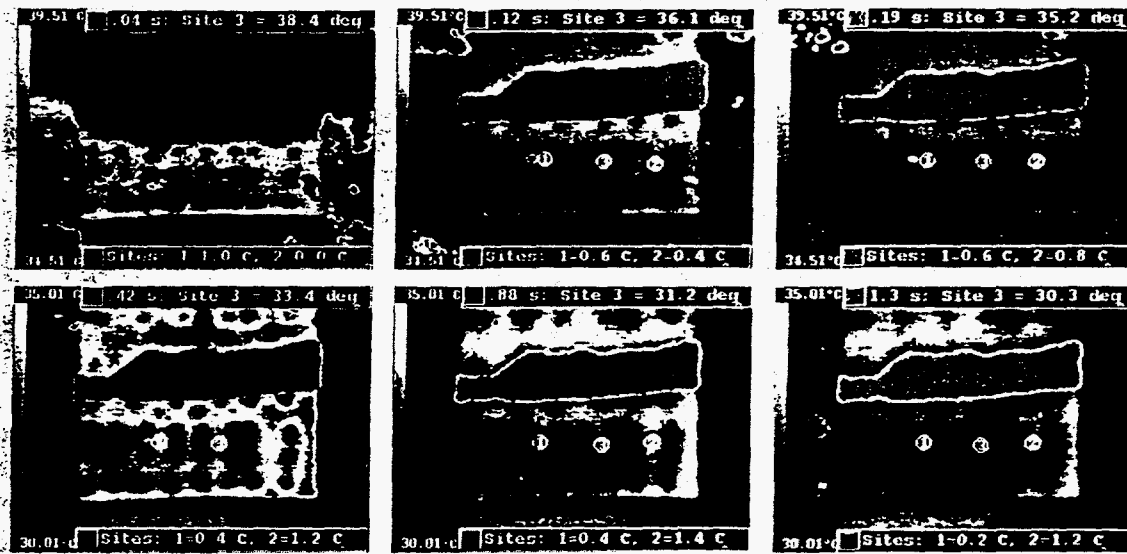
Figure 4.

Figures 4 and 5 trace the dynamic and thermal inertia signatures of shallow excess sealants, e.g., at site #1, and corrosion-loss defects, e.g., at site #2. In Figure 4, at times less than .15 seconds, site #1 is warmer than site #2, and both are warmer than site #3. At times more than .15 seconds, site #2 is warmer than site #1. In Figure 5, early-time thermal inertia maps, at .08 to .3 s after the flash, tag shallow sealant globs within the lap splice (left of center), while late-time thermal inertia maps, at .9 to 1.6 s after the flash, tag deep corrosion, e.g., metal-loss thinning (right of center).

Interpreting airframe bulges as "pillowing" from expansion of corrosion by-products is highly subjective. Visible indicators of surface bulges vary only slightly for different types of material defects (e.g., corrosion by-products, sealant globs, shallow inserts, insulation wads and production ripples). We interpreted the type of material defect with greater objectivity, by measuring the dynamic pulsed-thermal and thermal inertia responses. This improved the precision, definition and interpretability of our defect-type characterizations for the Boeing KC-135 panel shown in Figure 4 and Figure 5.

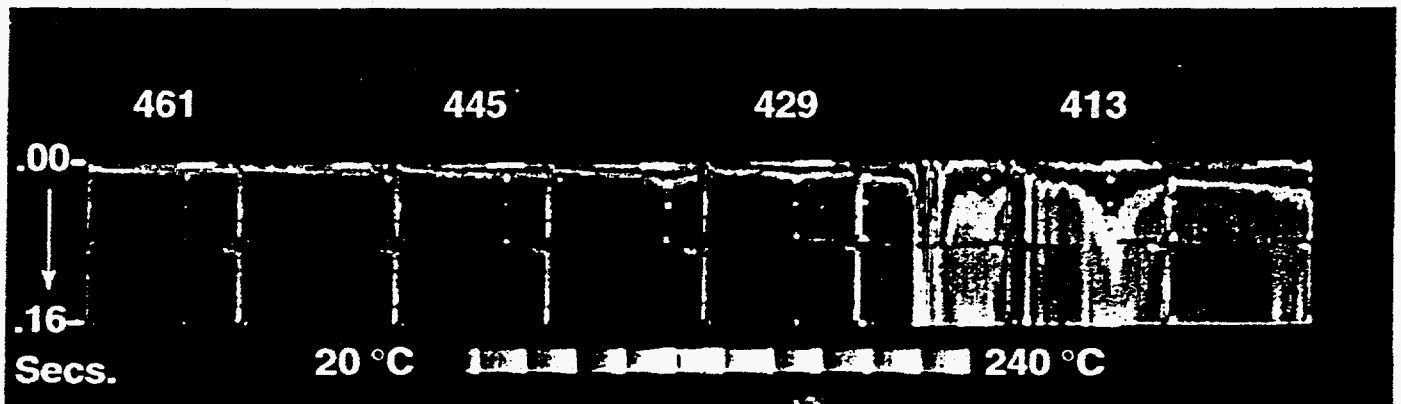
(C) Timegram cooling rate maps tag lap-splice corrosion damage.

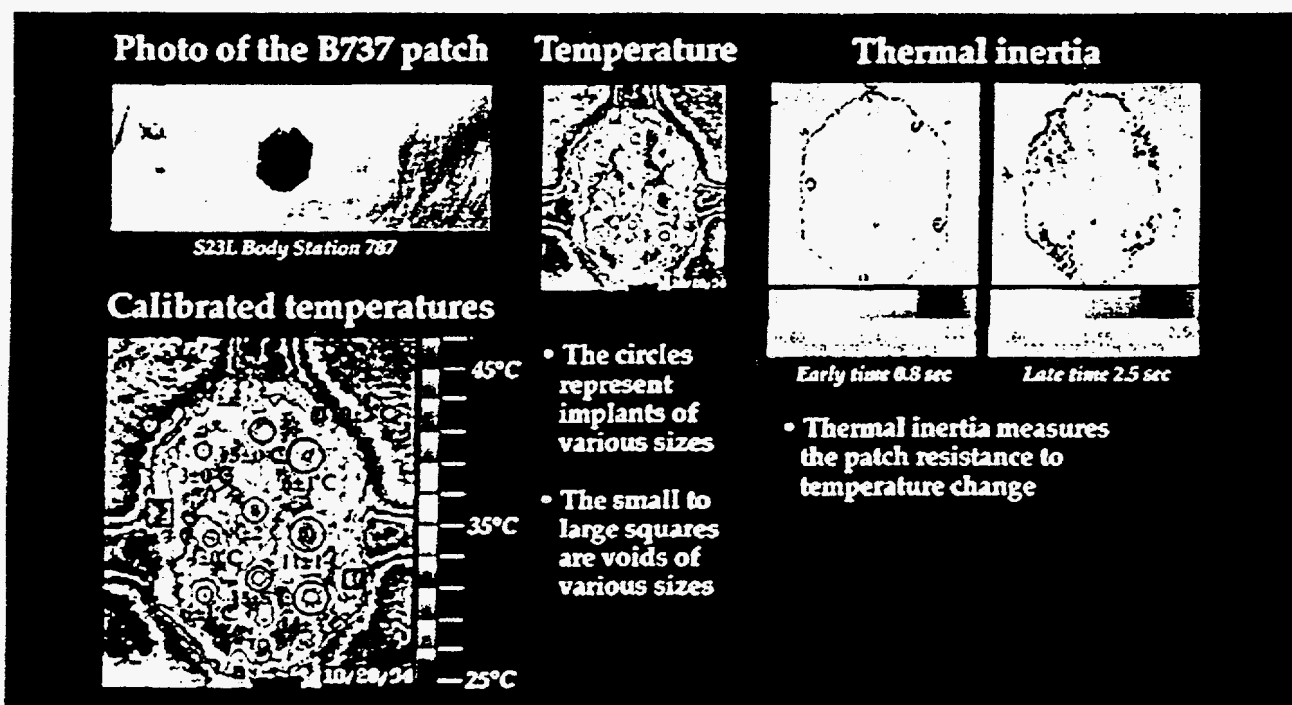
Figure 7 (B) characterized defects within the B 737 boron-epoxy patch at S23L, Body Station 787. The combined use of ultrasensitive temperature-difference measurements at 0.4 seconds after the flash, with early-time, e.g., 0.8 second, and late-time, e.g., 2.5 second, thermal inertia maps measured relative flaw sizes, types and depths. The circled implant sizes increased from left to right and were nearest the outer-surface at the bottom, and deeper within the patch at the top. The voids along the patch perimeter had four different volumetric sizes. The deep, unbonded sites with air gaps above structural rivets beneath the boron-epoxy patch were best seen on the late-time thermal inertia maps.

(B) Boron patch temperature maps measure flaw sizes and dynamic thermal inertia maps determine flaw types (implant, void, unbond) and depths.
