Marine Casualties Investigative Body

COSTA CONCORDIA

Marine casualty on January 13, 2012

Report on the safety technical investigation

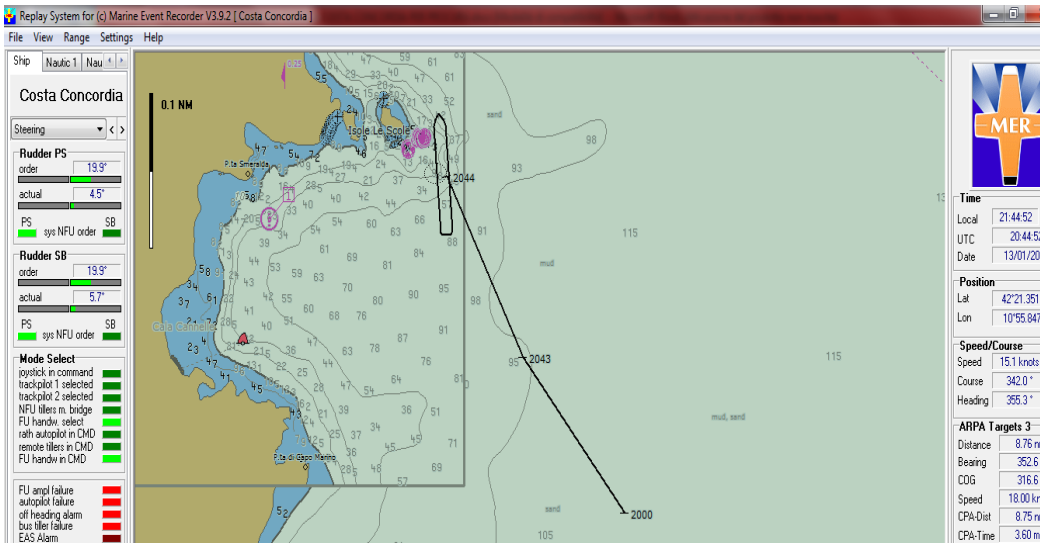
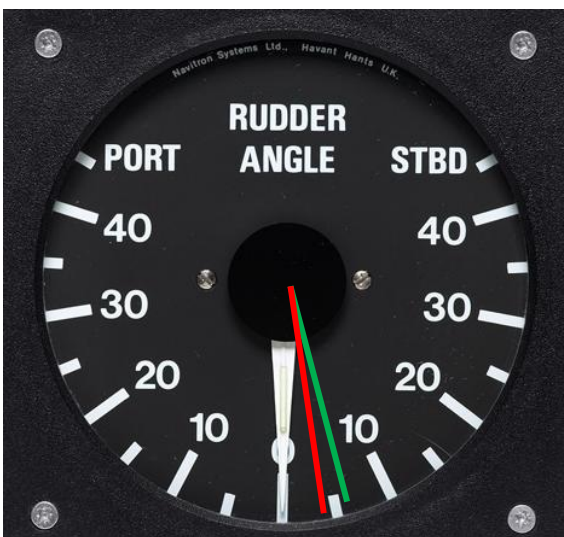
The helmsman , on the contrary, it performs 20 degrees to starboard rudder and the rudder therefore not "continuing" its course, as it should according to the intentions of The Master to the left, but returned again to starboard. In fact, the rudder left up to 4.5 degrees to starboard actual (first 2 degrees to starboard) and 5.7 degrees to starboard to starboard (before 3.9 degrees to starboard).

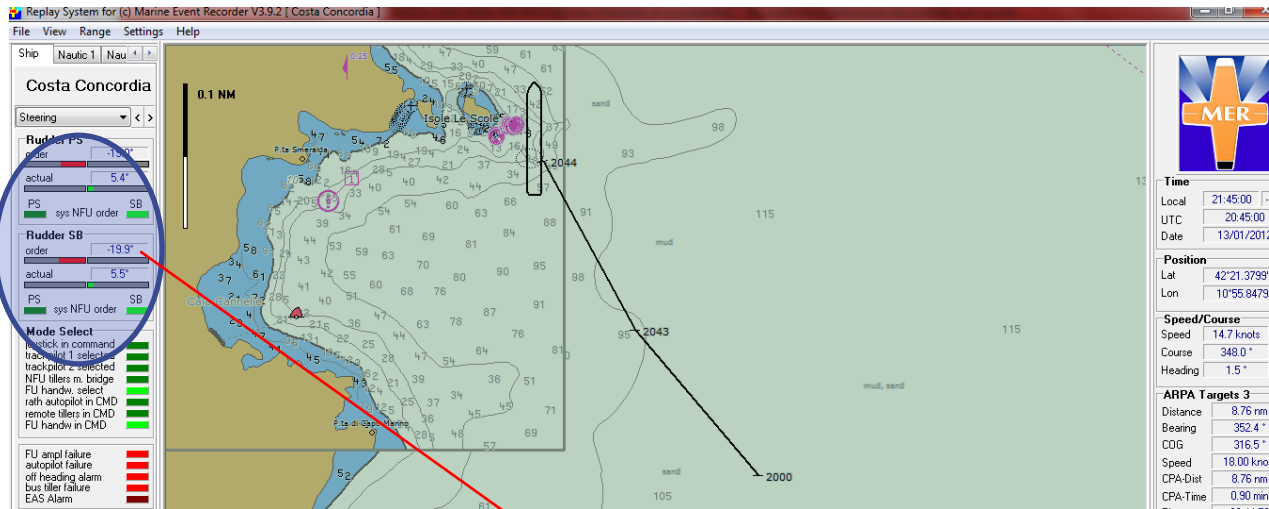
The helmsman realizes the error and corrects it by bringing the left rudder (spend about 8 seconds from the moment when the helmsman maneuver from 20 degrees to starboard at 20 degrees to the left) but the effect on the rudder given by the previous maneuvers carried determines a further shift to the left toward the starboard side and a slight movement to the left of the starboard. In fact, the rudder left up to 5.4 degrees to starboard actual (before 4.5 degrees to starboard) and 5.5 degrees to starboard to starboard (before 5.7 degrees to starboard).

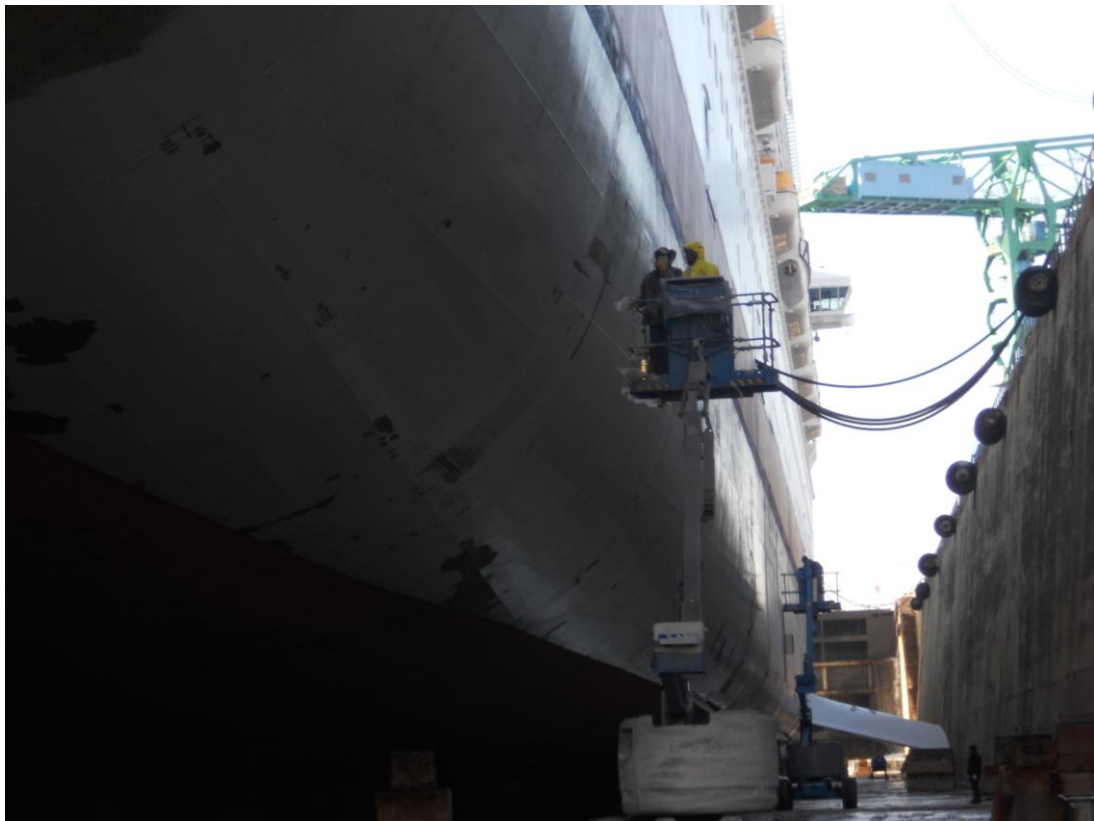
Following pictures show the hull area interested by the contact (taken from sister ship Costa Serena):

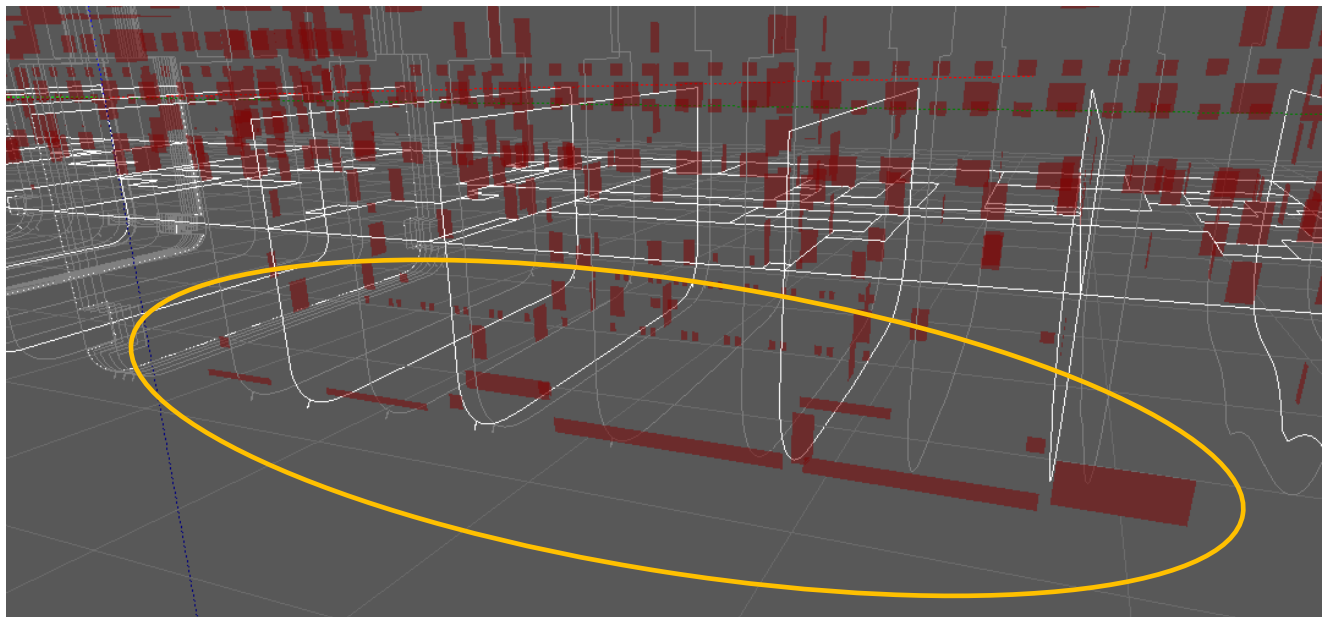
Main damage breach openings

Assumed damaged extent (according with flooding simulation)

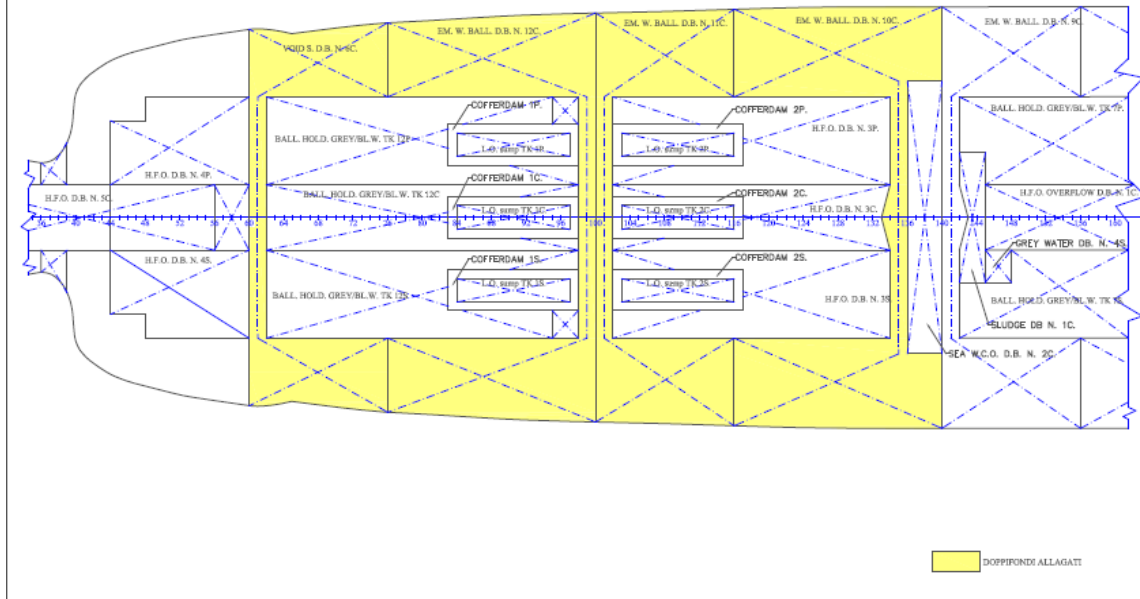
Doppifondi allagati

Here it is possible to view the flooded compartments with their relevant extension from side to side (the central double bottoms have not been involved by the flooding).

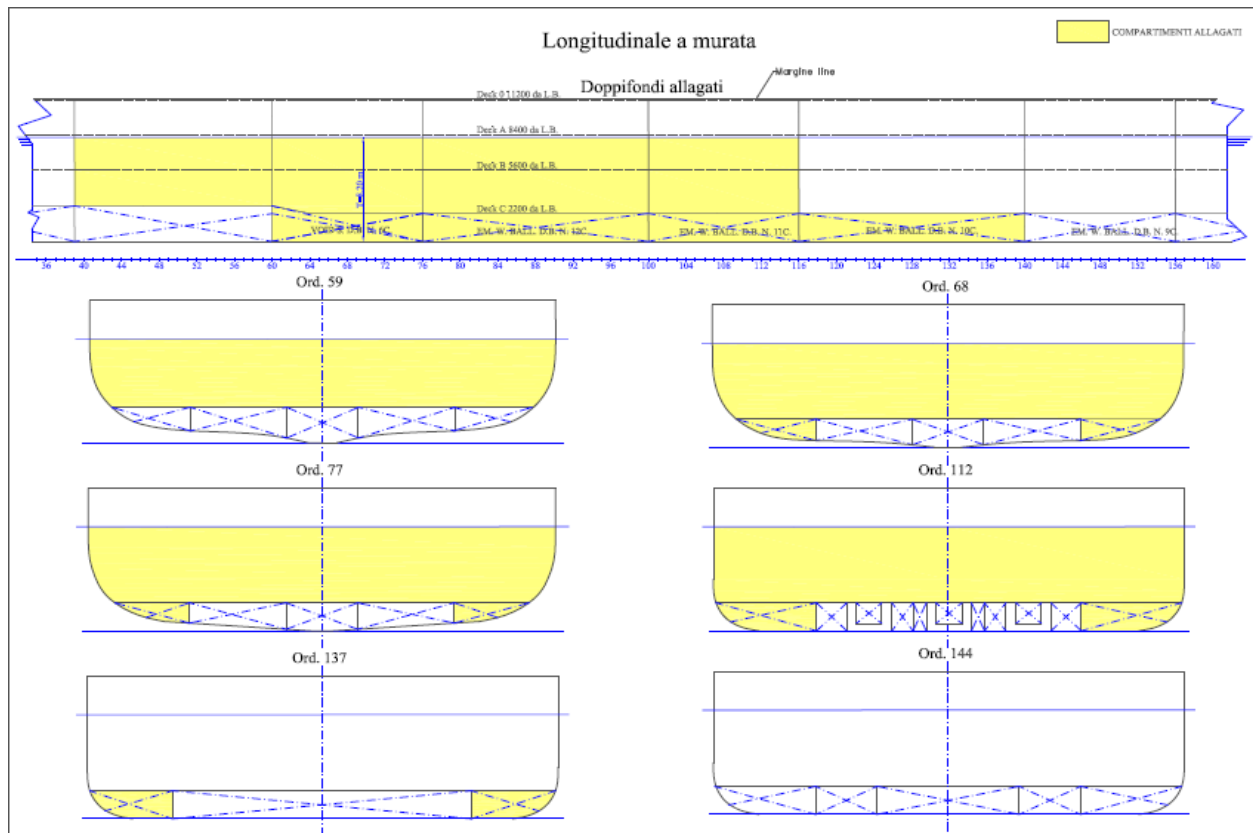
Here in this pictures the yellow parts represent the compartments and side double bottoms immediately flooded from outside at the time of the impact both on the longitudinal plan at side shell and in significant transversal sections too.

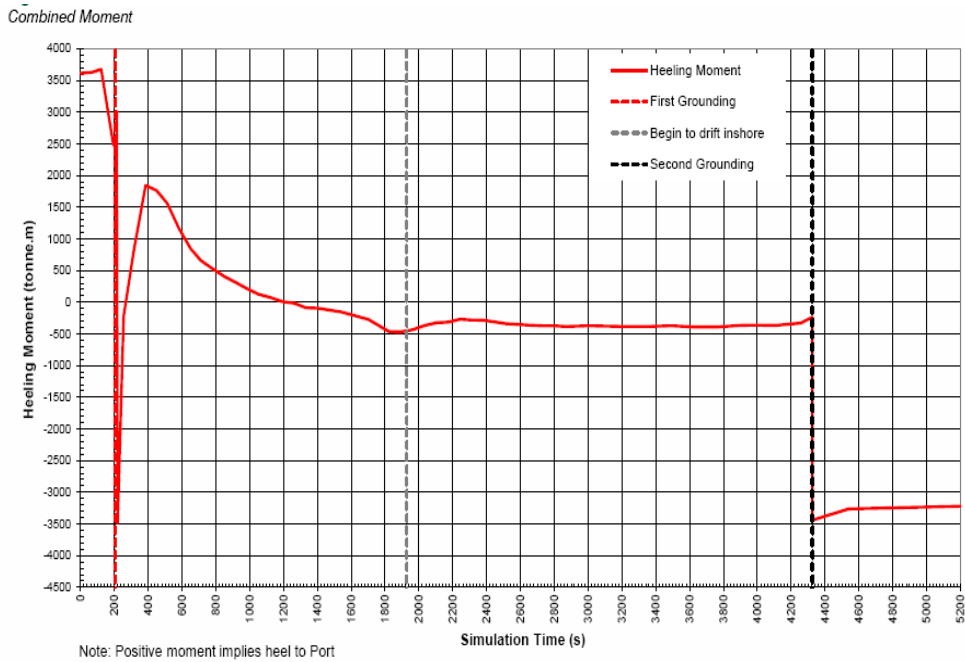
The drifting applicable moments are due to the wind (NE 18 knots), turning, final grounding and the weight of the rock got stuck into the hull (97t). The combined moment diagram after the impact with the Scale is the one here below – Figure n. D:

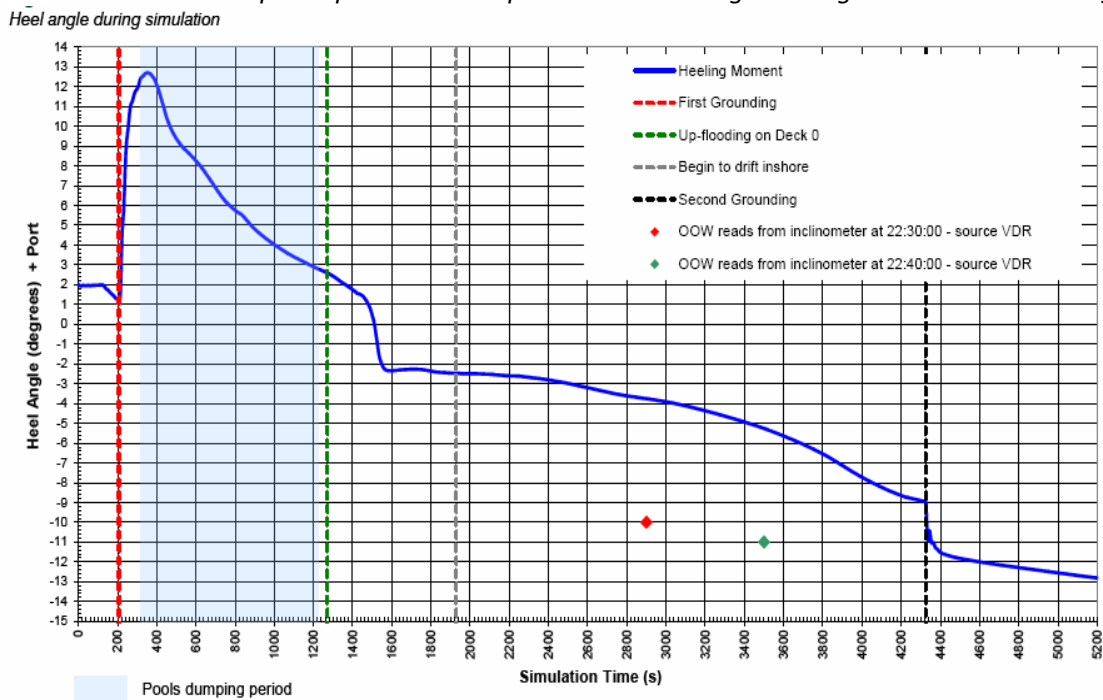
Following this combined moment and the flooding sequence described in Chapter 6.1 in the main 10 points we obtain the ship's response with respect to the heel angle through time as shown in Figure E:

We may evince that the two data points relating to the VDR information on actual heel angles at 22.30 and 22.40 hours read on the ship's inclinometer reveal that the simulation underestimates the heel angle to the stbd side by about 6°.
