MARINE SAFETY INVESTIGATION REPORT

**Safety investigation into the lifting sling failure
and subsequent damage to the rescue boat on board the
Maltese registered chemical / oil tanker**

SICHEM LILY

MARINE SAFETY INVESTIGATION REPORT NO. 02/2014

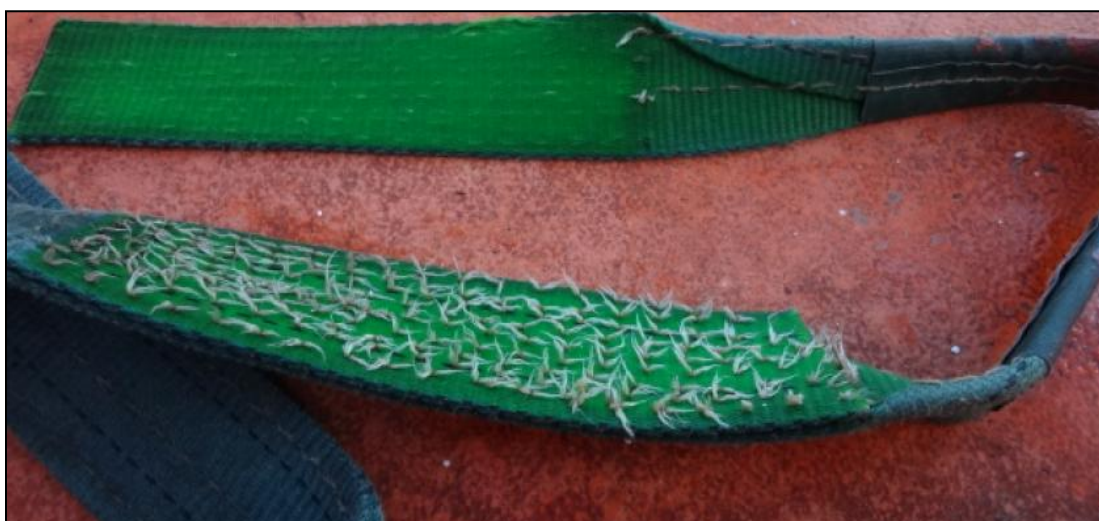
On the third attempt, as the boat was being launched and lowered at a faster speed, the lifting sling attached to the boat's forward lug (Figure 5) failed when the brakes were applied. This caused a sudden shift of load to the remaining lifting slings. The two aft lifting slings, unable to take the extra tension, also failed almost concurrently, and the rescue boat fell into the sea.

Figure 5: Failed section of the forward lifting sling

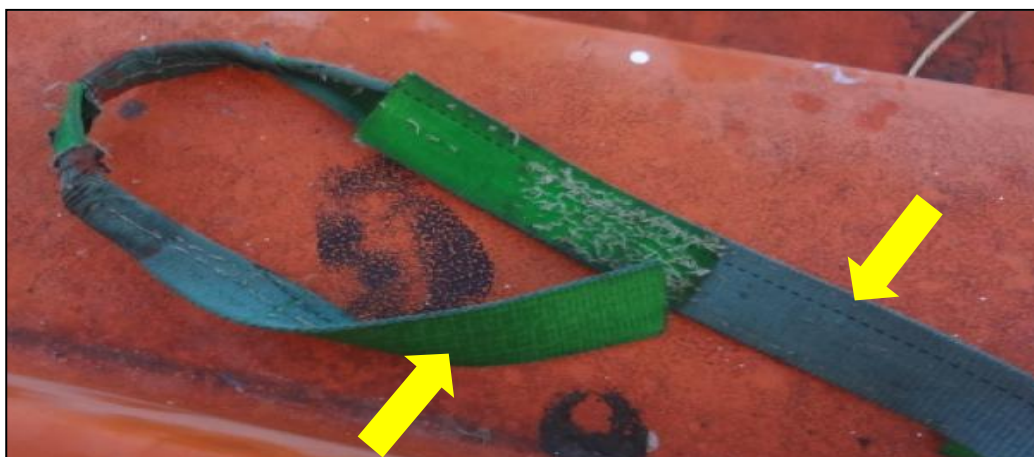
The visual examination show that the lifting slings were evenly aged. The green colour of webbing material exposed to the sun appeared bleached and lighter, whereas the inside sections of the loop surfaces had a bright greenish colour (Figure 6).

Figure 6: Failed section exposed to sunlight

There was no evidence of damage, abrasion, wear, cuts or snags. The stitching at the spliced section was clearly pulled out and appeared to be the result of thread failure.

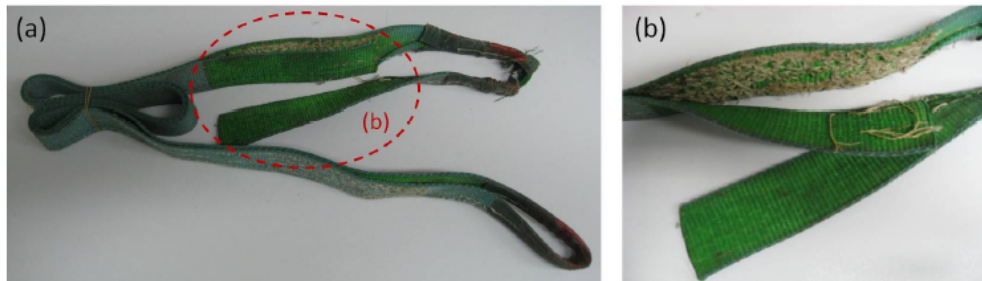
Visual examination of the lifting sling showed that failure of all three legs occurred at the (load-bearing) stitching where the eye loop lap was stitched to the sling body, as shown in Figure 1. In this case, the sling manufacturer has created a continuous loop which is closed by joining the ends of the webbing together with a portion of the web sling length. Separation of the stitch pattern at the splice appeared to be the result of thread failure. The stitching was clearly pulled out of two of the three plies constituting the single load-bearing splice in this sling type. Thus, the principal objective of this work was to determine why this specific mode of failure had occurred in at least one of the legs during launch of the rescue boat. Considering the three-point lifting arrangement of the boat [2] and the fact that all three legs have indeed failed it appears that the failure of a single leg during operation necessarily created a sudden shifting of load to the remaining legs which notably exceed the *residual* strength of these legs thereby causing their almost concurrent failure.

Figure 1 (a) One of the three sling legs, showing web splice failure and (b) load bearing splice region showing lap pulled apart.

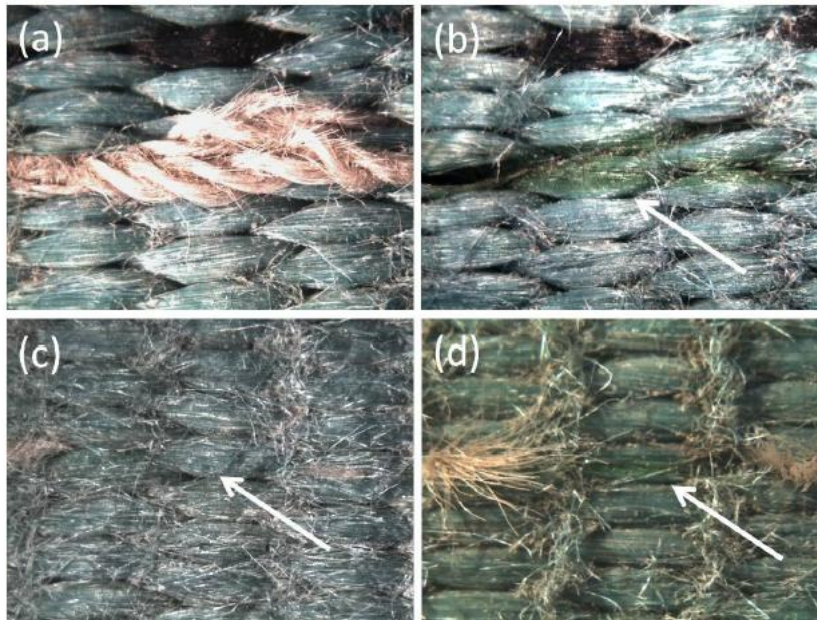
Several locations where the (white) sewing thread should have been masking the underlying webbing filaments appeared discoloured, suggesting that local breaking of the stitching had been occurring for some time (Figure 2c). Such sites could easily be distinguished from others where the stitching was more recently removed and thus still appeared markedly greener in colour (Figure 2d).

Figure 2 (a) Webbing section with superimposed unbroken stitch; (b) Same sling portion shown in (a) after stitch has been removed; (c) Recently broken stitch exposing underlying webbing; (d) Sling portion where stitching has been completely removed for some considerable amount of time. Arrows mark regions which were originally crossed over by a stitching thread.

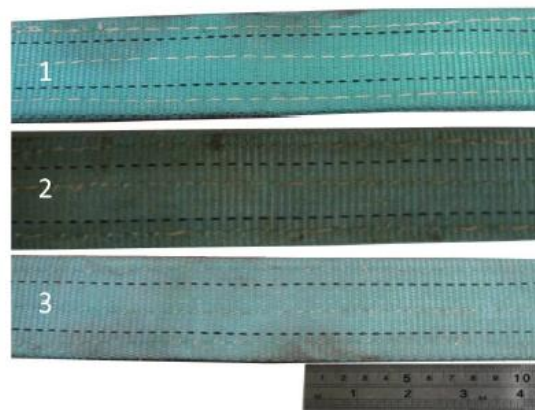
constituting this section were completely detached. It is important to highlight that sling sections such Figure 3 (1) and (2) were often two faces of the same stretch of sling, suggesting that the a particular side of each leg was more often exposed to direct sunlight. Clearly, substantial degradation of the stitching does not need to be from both sides of the webbing to render it useless.

Figure 3 Three sections of the sling showing different level of stitching damage.

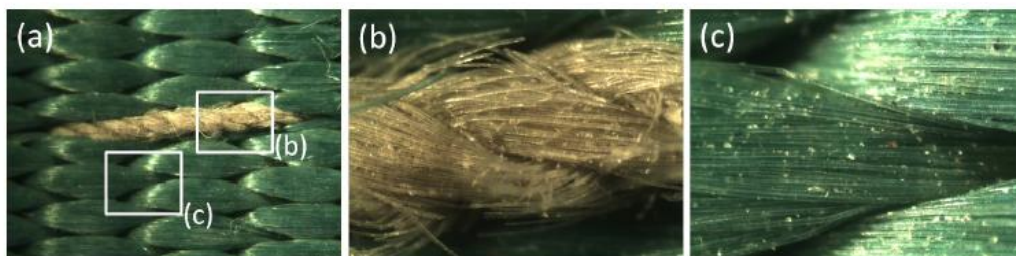
Interestingly higher magnification imaging (Figure 4) of the section shown in Figure 3 (1) shows that individual yarn fibres forming apparently ‘healthy’ stitches may still be damaged, while the same cannot be said for threads forming the sling webbing (Figure 4c). The latter shows no sign of wear and tear, except for the presence of salt crystals and other fine grit. Furthermore, during examination of more extensively degraded sections, such as those shown in Figure 3 (2) and (3), no ruptured yarns were observed in the webbing and damage was limited to individual broken fibres (Figure 2). In contrast, as already described the stitching was extensively damaged.

Figure 4 Optical micrographs of relatively undamaged regions of the sling.

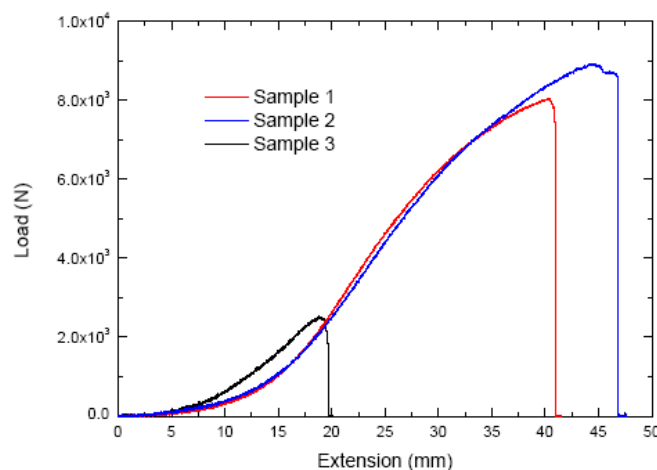
Clearly, neither loading parameters nor the sample condition and layout precisely replicated those experienced by the sling during operating; however, this test could demonstrate how the degree of thread damage largely affected the residual strength of the stitched lap. Figure 7 shows the results obtained for all three tensile tests. The samples obtained from the three sling legs show markedly different maximum loading prior to failure. The sample with the stitching in the poorest condition (sample 3) showed a massive reduction in the load required to separate the two plies. Once the load applied reached around 253 kg the stitching thread pulled clean through the webbing material. Indeed very few stitches had to break before this could happen since for the most part the stitches were partly or broken altogether.

Figure 7 Load-Extension plots for samples 1, 2 and 3 with measured maximum loads of 8.93 kN, 8.04 kN and 2.53 kN respectively.

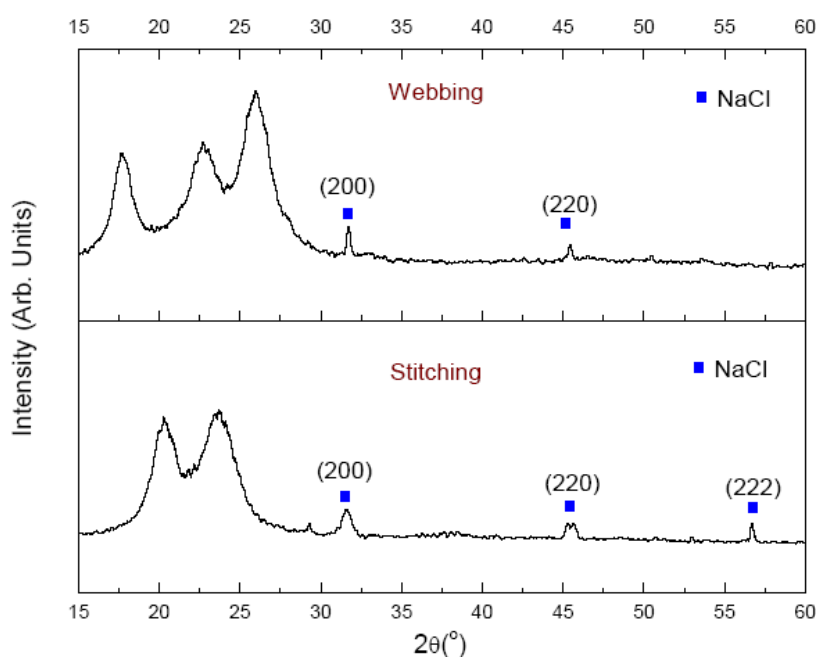
marine salt i.e. sodium chloride (NaCl); while the broad peaks below this angle are indicative of semi-crystalline polymers. These characteristic broad features are consistent with 'incoherent scatter' from the amorphous component of the solid. Then diffraction patterns generated were correlated with literature for synthetic polymer fibres to *polyester* and *nylon* for the webbing and stitching respectively [4-6].

Figure 8 X-ray diffraction patterns of webbing and stitching fibre samples.

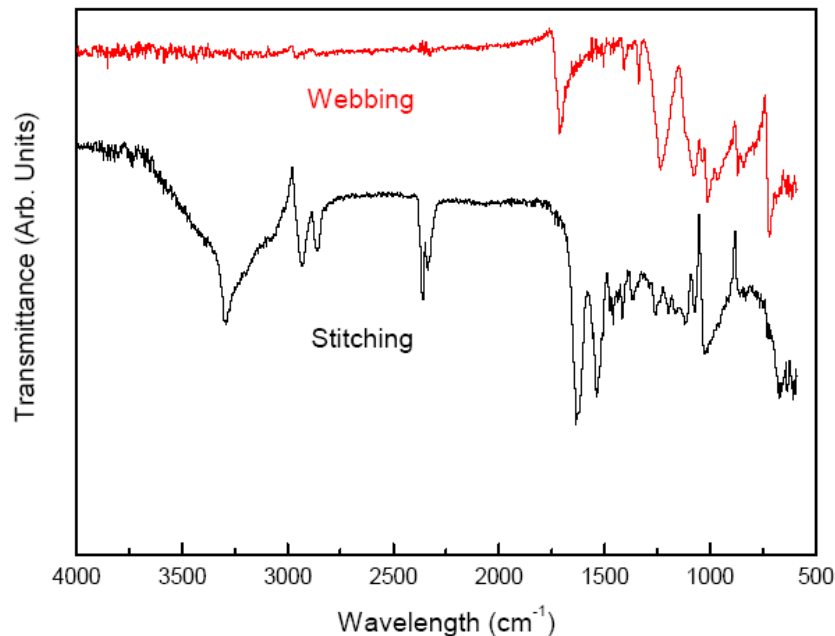
FTIR was conducted using a Shimadzu IRAffinity-1 spectrometer which is an ideal analytical tool for screening and profiling polymer samples. An attenuated total reflectance (ATR) attachment allowed for 'in-situ' measurement of the two fibre samples in the spectral range of 500cm^{-1} to 4000cm^{-1} . The resultant spectra for both samples are shown in Figure 9. Comparing the two with reference spectra using the positions of the strongest peaks which dominate the respective spectrum, the materials were identified as polyamide (nylon) and polyester for the stitching and webbing respectively [8, 9].

Figure 9 ATR-IR spectra of webbing and stitching fibre samples.
