Marine Surveys UK
Matt West
4 Brook Cottages
Mill Lane
Westbourne
Emsworth
Hants
PO10 8RT

Survey Report no: 10652

Type of Vessel: Jeanneau Arcadia

This survey was carried out in 2010 at Marina, United Kingdom. The above named being a prospective purchaser of the vessel.

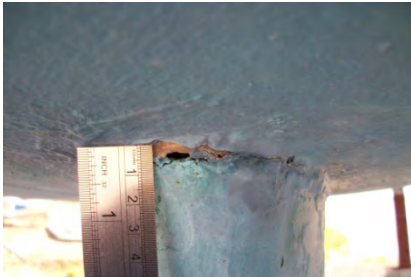
- There is a 5mm gap towards the forward end, where the keel is not flush with the moulding. It is possible to insert a spike in 25mm. This is common to find on the further most keel stud on many yachts
- There is large amount of sealant at the joint.

Fig 1 5mm gap at forward end keel

Suggestion for both is rake out sealant at keel joint and refill with a good mastic like Sikaflex 291.

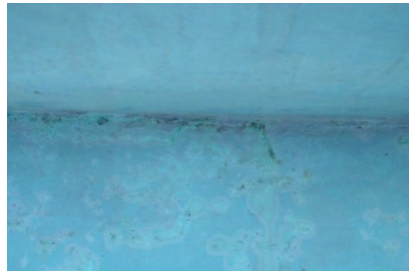
Fig 2 Sealant at keel joint

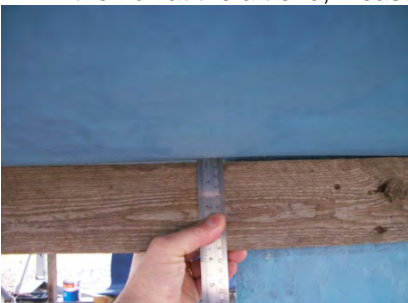
Fig 3 Area of hull deflection

Recommendation – support boat under floors and gentle jack up aft end of yacht to take the weight off the aft end of the keel. Check inside for movement. If hull goes back to shape, laminate addition floor and longitudinal support in area affected to give additional strength in case of further grounding.

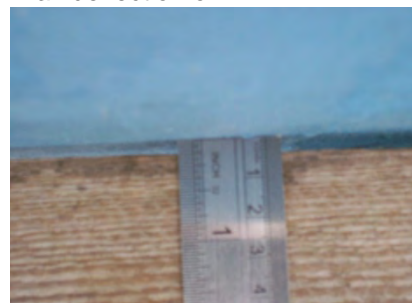
Fig 4 Detail of hull deflection

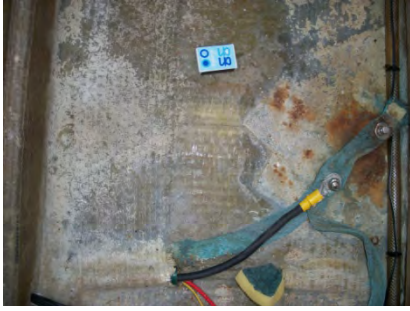
The inside of the boat was checked and there is visual evidence of dry laminate at the aft end of the keel under the top laminate, when hammer tested it sounds "hollow".

Fig 5 Aft keel bolt is seen to right

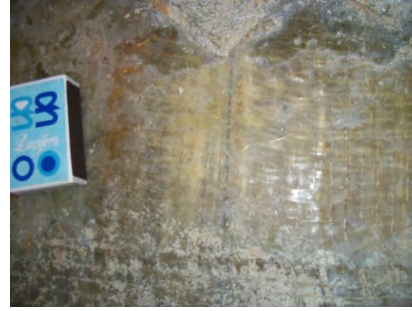
Fig 6 Lighter area is suspected damaged laminate

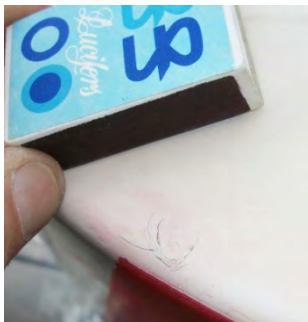
Fig 7 Gel coat damage on transom

Suggest that a simple gel coat repair is made to avoid water ingress and future deterioration.

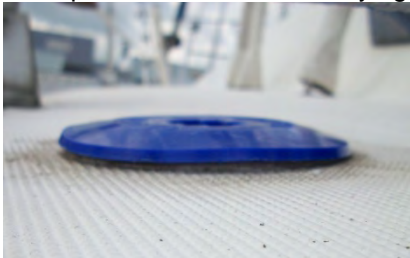
- f) It was noted at port side amidships deck area, higher moisture readings (20) than average (10), around the water filler and at the genoa tracks (18). It was noted that the water filler was a replacement and was not lying flush to the deck and could be allowing water into the balsa core.

Fig 8 Water filler no flush

It is suggested that the water filler be removed, check for correct size, the bare balsa sealed and the filler refitted. The genoa track readings are commensurate with the age of vessel.

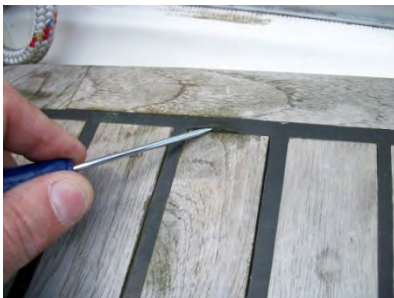
Fig 9 Mastic de-bonding

It is a personal choice if this is to be replaced or just cleaned.

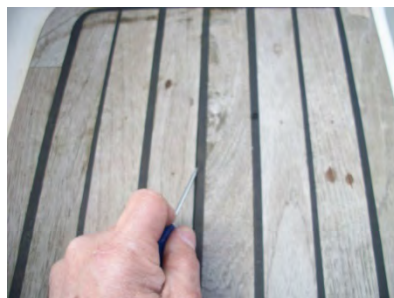
Fig 10 Mastic de-bonding

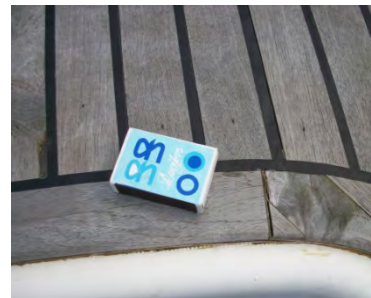
Fig 10a Crack in teak

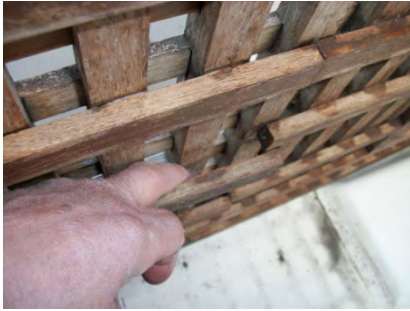
- f) The cockpit sole grating is coming apart on the underside. Suggest this is glued back together.

Fig 11 Underside of cockpit

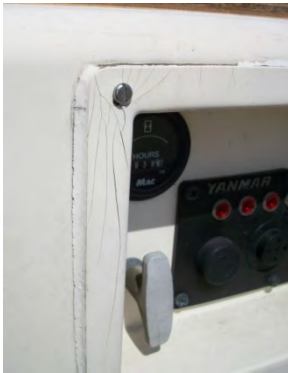
- g) Engine control panel moulding in cockpit has Gel coat crazing. Suggest simple gel coat repair or replacement.

Fig 12 Crazing on engine panel moulding

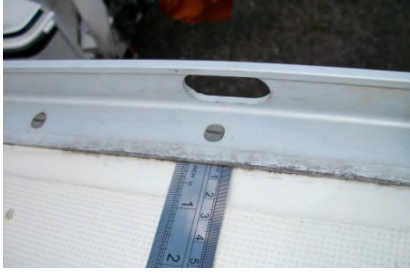
- b) Toe rail of aluminium extrusion, lying fair and secure except where noted.
c) Starboard Toe rail amidships, evidence of slight crushing causing rail to lift slightly. Checked with moisture meter, no evidence of water ingress.

Fig 15 Slight area of lift stb side

Suggest both c & d are acceptable as removal will be expensive and probably damage the currently secure bond. Toe rail can be polished to make more acceptable.

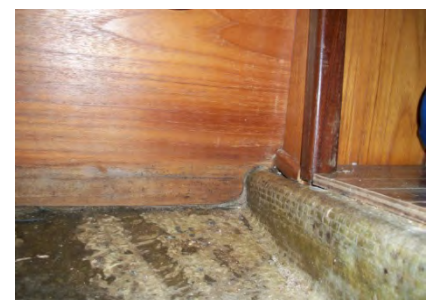
- h) The starboard saloon under berth locker front at its lower aft inboard end is showing visual signs of water ingress from the bilge area. A spike can be pushed through the veneer. As this area is below the cabin sole, suggest dry out, clean off and seal and at the same time seal the edge of the hole cut for bilge pipe in same panel.

Fig 18 starboard saloon under berth locker front and floor laminate

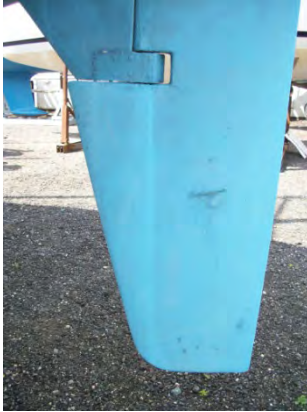
- a) The rudder consists of two moulded halves, bonded together around a stainless steel stock and stainless steel frame. It is skeg supported one third of the way down its depth and semi balanced below the skeg.
- b) The stock was confirmed stainless steel marine quality by checking with a magnet.
- c) There are no splits or weeps noted at the edges, top or bottom. There is a 90mm split on the port side, still showing signs of weeping. Moisture reading on the port side around it are very high (47) while on Stb side low in the same area. Hammer testing sounded a localised area of delaminating or hollow area.

Fig 17 Rudder from port side clearly showing a line of weeping

Recommendation – Due to localisation of damage, lack of any splits, a professional local repair can be made. Grind out area around split from port side until dry area found. Re-laminate and bond to frame and seal with epoxy. Fair in finish.

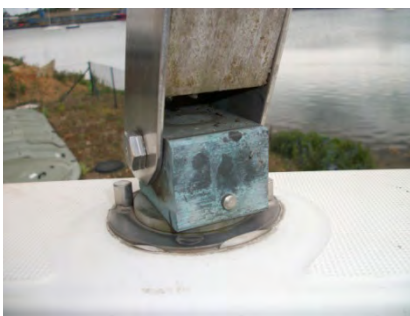
- d) The rudder is supported on a shoe constructed of a nylon type material bush supported by two stainless steel plates with stainless steel nuts and bolts. All found in good condition.
- e) Slight play was found in the lower bush and none in the upper bush. This is at an acceptable level.
- f) No movement was detectable between the blade and stock where it emerges from the top of the blade when the strength of one man was applied to the trailing edge of the blade with the tiller locked in position.
- g) The tiller is of solid teak in good condition, mounted on a yellow metal knuckle joint. This is slightly loose on the stock the play is exaggerated at the outboard end of the tiller. Suggest that the pin is removed, the knuckle removed and a new pin fitted to take up the play.

Fig 18 Tiller knuckle and fixing pin.

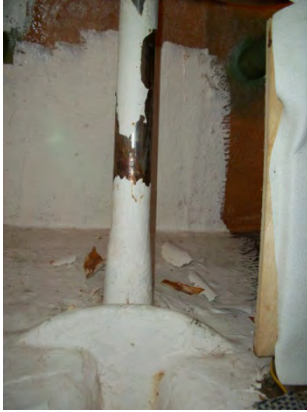
- h) The stainless steel rudder tube is seen to be well bonded to the hull. There is no seal at the upper end which is open and some 600mm above the water line as per the manufacturers design. There was no sign of corrosion stains at the base; on closer inspection and spike tested these are surface under the flow coat where no oxygen could get to the stainless steel.

Fig 19 Signs of surface rust on rudder tube

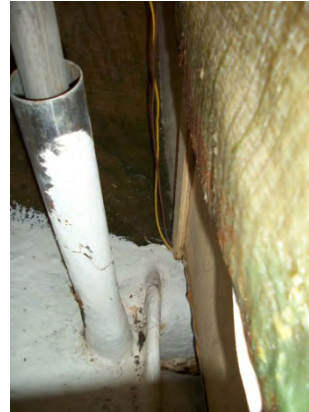
Fig 19a Rudder tube with open top above water line.

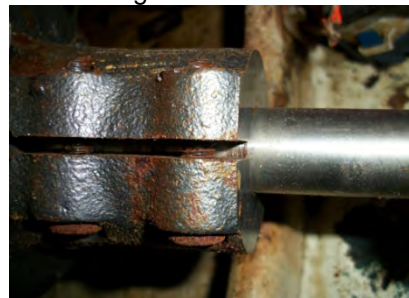
Fig 21 Detail of shaft in coupling has spun in the past in the Fenwick

- g) This age of Jeanneau yachts fitted with Yanmar engines had French made Fenwick couplings and while looking like a genuine Yanmar coupling did not grip the shaft as well. The shafts were known to come out of the boat and through the stern gland causing yachts to sink. You will note two jubilee clips fitted forward of the gland on the shaft, these are a safety feature in case the coupling were to give way again, although I would suggest the PSS fitting will prevent the shaft dropping out again. I suggest a genuine Yanmar coupling is purchased and fitted if there is any further spinning.

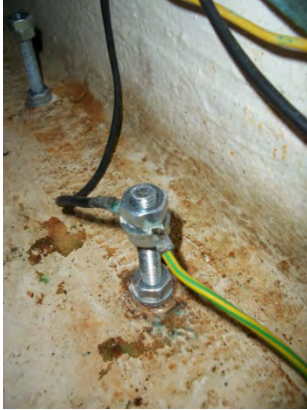
- a) The conventional stud mounted anode was checked to be electrically bonded to the shaft and propeller but not to P Bracket, which is manufacturer spec.
- b) Anode is not in need of replacement. Inside new studs can be seen to have been fitted with new bonding cables to engine. Suggest that the inboard nuts are laminated to hull which is good practice.

Fig 21 New anode studs and cables, note lower nuts should be laminated to hull

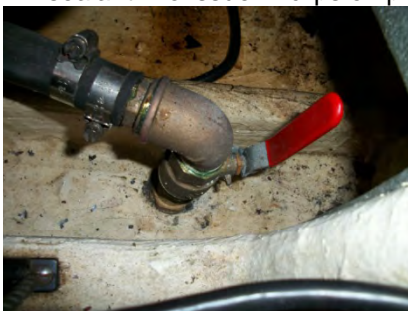
- a) Engine intake: access in engine bay. Consisting of yellow metal thru hull fitting, with DZR ball valve and pipe connection, all in satisfactory condition. 2 clips on fitting. It should be noted that the thru fitting has been replaced and the yellow metal used cannot be determined. It should only be bronze and not brass. If no receipts are available the purchaser should check condition often when in the water as brass is not suitable for underwater fittings.

Fig 22 Engine intake. Suggest laminate nut to hull.
Page 13 of 13

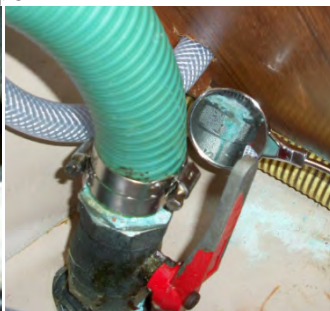
- b) Toilet outlet: Bronze thru hull with DZR ball valve. Inboard fitting showing a lot of green corrosion which could indicate a brass outlet Tailpipe has been fitted. 2 clips on pipe. **Recommend removing pipe connection and check condition of Tailpipe.**

Fig 23 Toilet outlet. Note corrosion reflected in mirror.

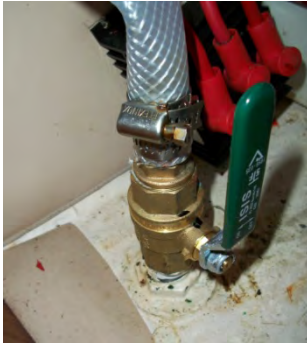
- d) Heads water inlet. Bronze thru hull, new ball valve in yellow metal. New pipe fitted, badly kinked. 2 clips on pipe. See heads section.
- e) Galley sink drain, Bronze thru hull, with DZR ball valve. Some sign of flow coat cracking around sealant. No issue. 2 clips on pipe.

Fig 25 Toilet water intake

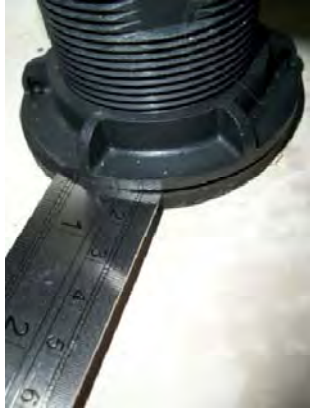
- f) Log and depth thru hulls. Raytheon Plastic thru hulls. Depth is fair to hull, log is not fair to hull. Inside yacht log nut is not tight to hull at forward end. *Recommendation – remove log thru hull and refit flush and tighten nut securely.*

Fig 27 Log thru hull not tight to hull inside yacht.

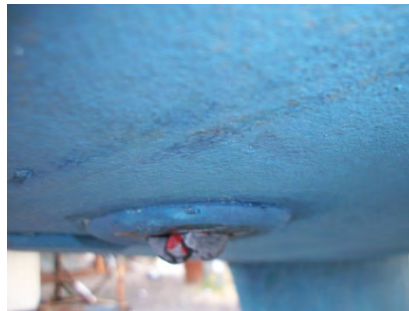
Fig 28 Log thru hull not tight to hull.

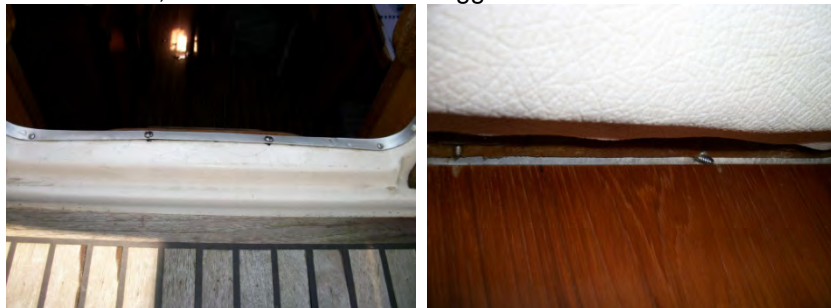
- a) Main companionway access hatch is of Perspex / Plexi-glass material, in good condition and secure in its runner. 2 Perspex / Plexi-glass wash boards in good condition. Lower wash board locks in place. Main wash board relies on hatch being closed to stay in position, an arrangement that will need to be addressed if sailing offshore.
- b) Aluminium trim frame around companionway bent and screws broken allowing water into aft cabin and onto engine. Suggest laminate is built up and new frame fitted.
- c) Fore hatch of aluminium framed Perspex type, securely hinged with positive method of closure. Hinge is at aft end meaning it opens forward. Good for ventilation, not good for heavy weather sailing. Size is adequate to use as emergency exit. Hatch frame is distorted and while able to

close and lock, it will not be water tight and I suggest will leak with water over the decks. Suggest that due to the use you will doing the hatches are replaced

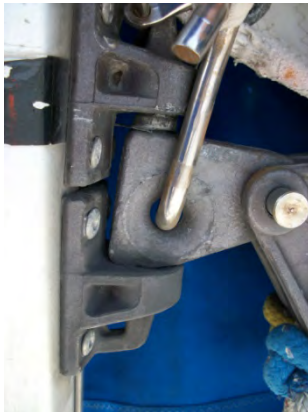
- a) Silver anodised in similar condition to mast.
- b) Main sheet and kicking strap attachment points secure.
- c) Goose neck bushes worn. Suggest they are replaced before they damage the fittings.
- d) Slab reefing hooks in good order.

Fig 29 Gooseneck bushes

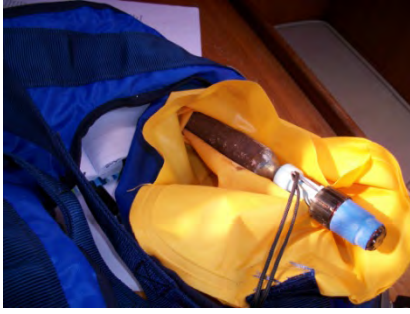
- c) 2 x Baltic automatic inflation life jackets found and 1 child manual inflation found. The jackets look in good condition, the inflation cylinders are corroded.

Fig 30 Life jacket cylinder

Recommendation – There should be working life jackets for all persons aboard.

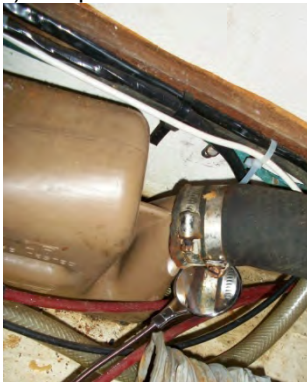
- d) Engine stop cable inboard end loose. *Recommend Tighten stop cable*
- e) Engine throttle inboard end loose. *Recommend Tighten engine cable*
- f) Cooling water levels correct and contains inhibitor
- g) Engine oil level correct and inspection under oil filler reveals no coolant contamination or condensation in oil.
- h) Clips at rear of exhaust silencer corroded. Hammer tested. Suggest replace.

Fig 31 Exhaust box clips

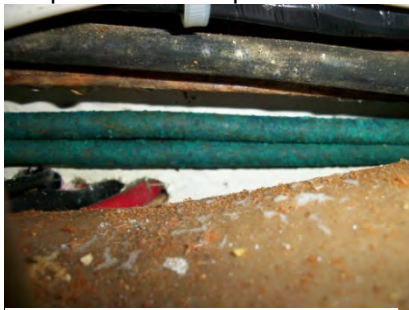
- a) Stainless steel tank stated 27 litre capacity is mounted high in Cockpit locker, no signs of leaks. Access good to 5 sides. Mirror check hidden base seams. All in good visible condition.
- b) Fuel shut off valve difficult to operate under tank. Probably full of water / sludge. *Recommend clean diesel tank and shut off valve.*
- c) Leak at secondary filter bleed screw, *Recommendation replace copper washer.*
- d) Primary filter Glass bowl type mounted in engine compartment and $\frac{3}{4}$ full of water /emulsified diesel. *Recommend drain and clean primary diesel filter.* Suggest relocate in cockpit locker by tank.
- e) Copper tubing in engine compartment by exhaust box is green and corroded. This was scrapped in places and found to be pitting. Suggest while other work is carried out fuel lines in engine compartment are replaced.

Fig 32 Fuel pipes in engine

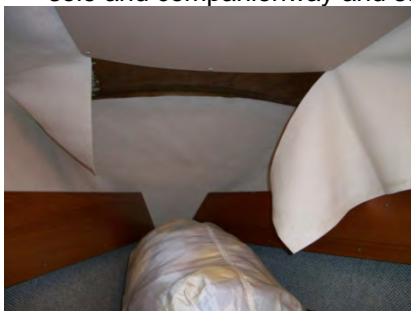
- a) Cushions all in good condition
- b) Headlining is down in forepeak and aft cabin. This needs to be reattached using suitable glue. There is evidence of work in progress as new headlining in locker. Apart from cabin sole and steps around companion way all wood is in good condition. Suggest clean and varnish of cabin sole and companionway and steps.

Fig 33 Forepeak headlining

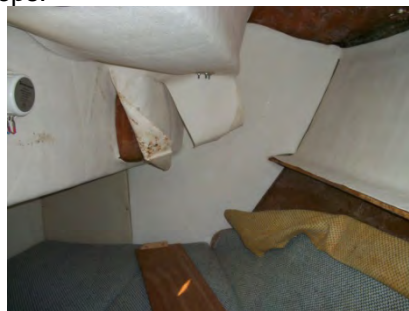
Fig 34 aft cabin headlining

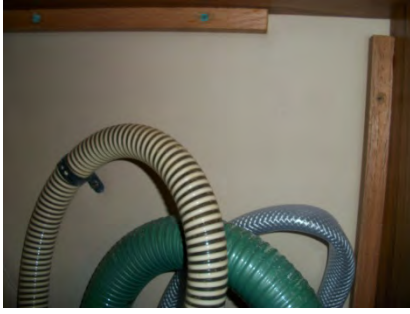
- a) Toilet is a Dutch Rajke & VD Meyde, similar to the Jabsco Twist and Lock type. The intake valve lever is badly corroded but operable. A new toilet, if desired is available for under £100 and easy to install.
- b) The swan necks for both inlet and outlet pipes of the heads could easily be 300mm higher but would require new lengths of hose fitted. I would suggest that these are lengthened and fitted to prevent the possibility of water coming back up the pipes if the valves are left open when sailing although the toilet has valves to prevent this too.
- c) The toilet intake pipe is new but has been poorly installed and is kinked in many places. The above would solve this.

Fig 35 Room to raise swan necks and give better flow to inlet.

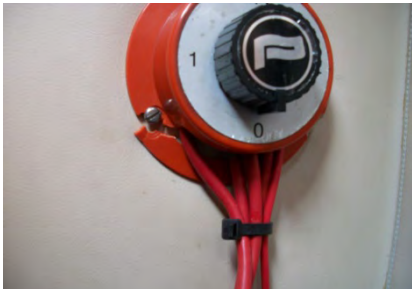
Fig 36 Broken isolator switch

Recommendation – the DC circuits should be checked and attended to by a qualified marine electrician noting the points above.

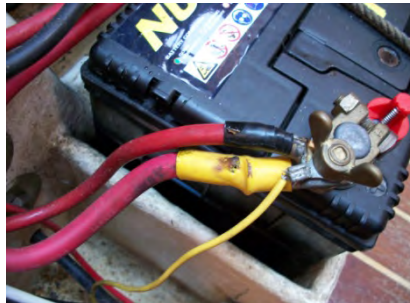
Fig 37 Cranking battery hot terminal

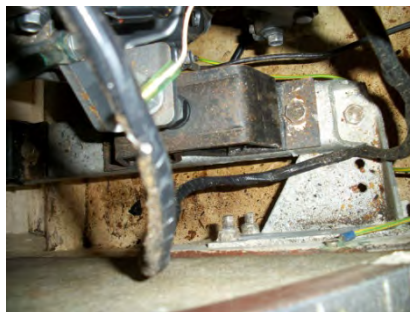
Fig 39 Loose wiring in engine
