SEALANT, WATERPROOFING & RESTORATION INSTITUTE • WINTER 2021 • 43.1

## Masonry Restoration of the Minnesota State Capitol Building

BY TIM MILLER

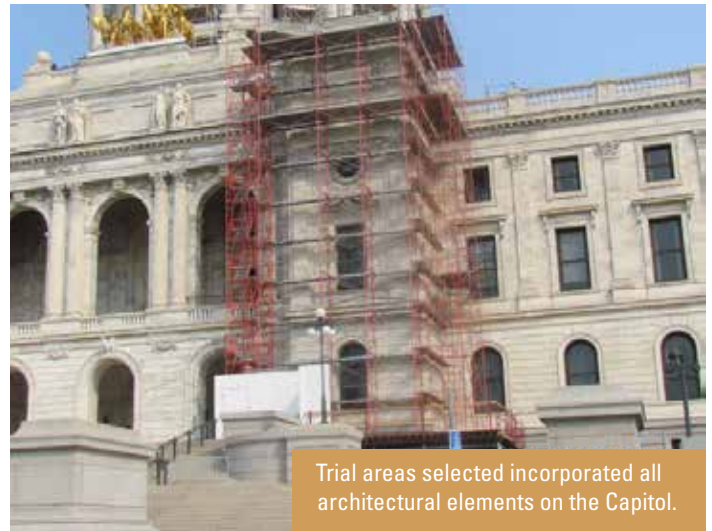
Trial areas selected incorporated all architectural elements on the Capitol.

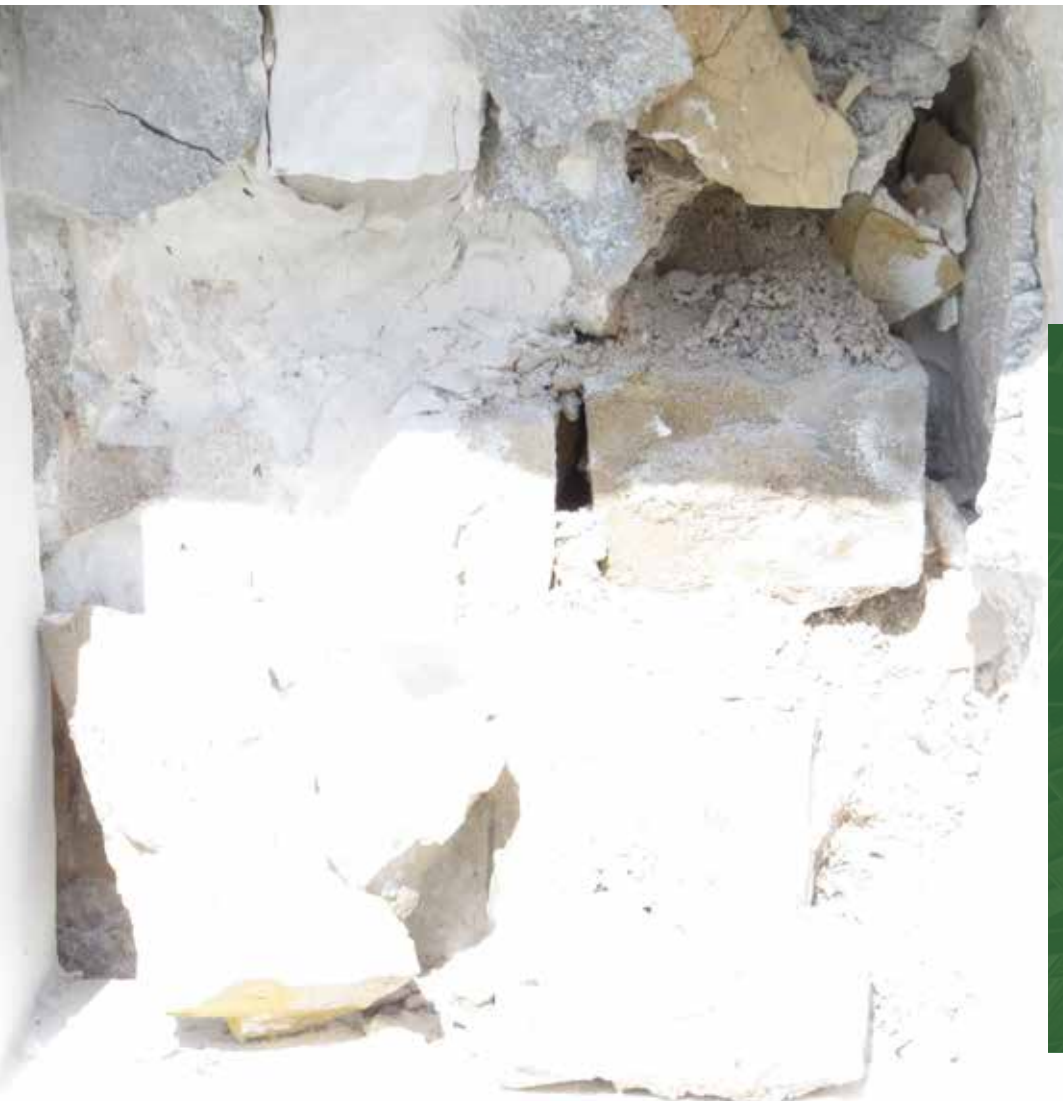
Typical condition of backup masonry.

- The backup masonry was saturated and was unable to ever completely dry out due to lack of an engineered drainage system.
- The brick and stone showed heavy evidence of freeze / thaw damage. Minnesota winters often have extreme temperature swings, from above freezing to below zero in as little as 18 hours. As water expands approximately 10% upon freezing, this wreaks havoc with saturated masonry.

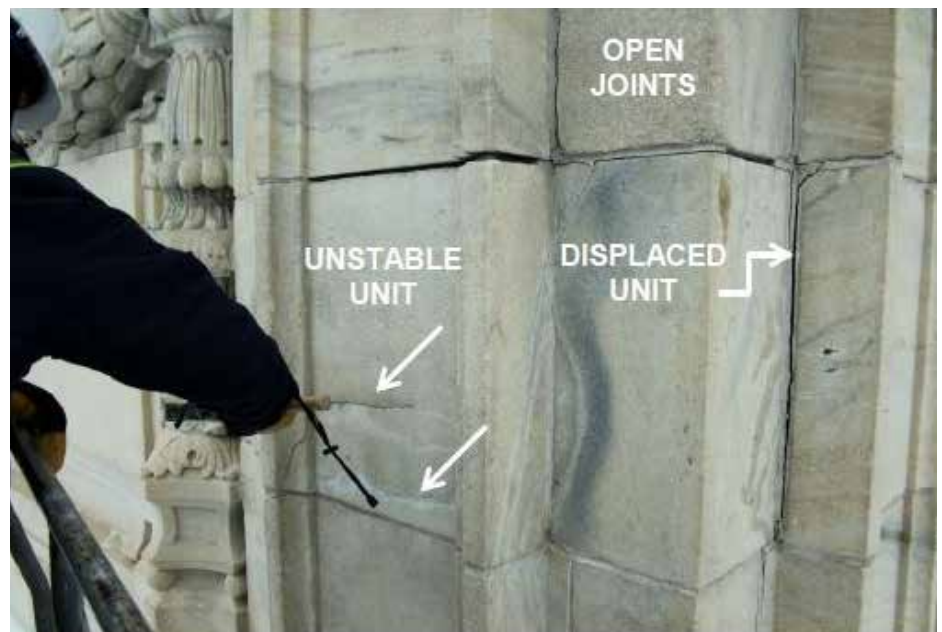
Trial areas showed long term water infiltration from above, almost exclusively from poor maintenance of skyward facing joints.

Examples of deterioration on the building exterior.

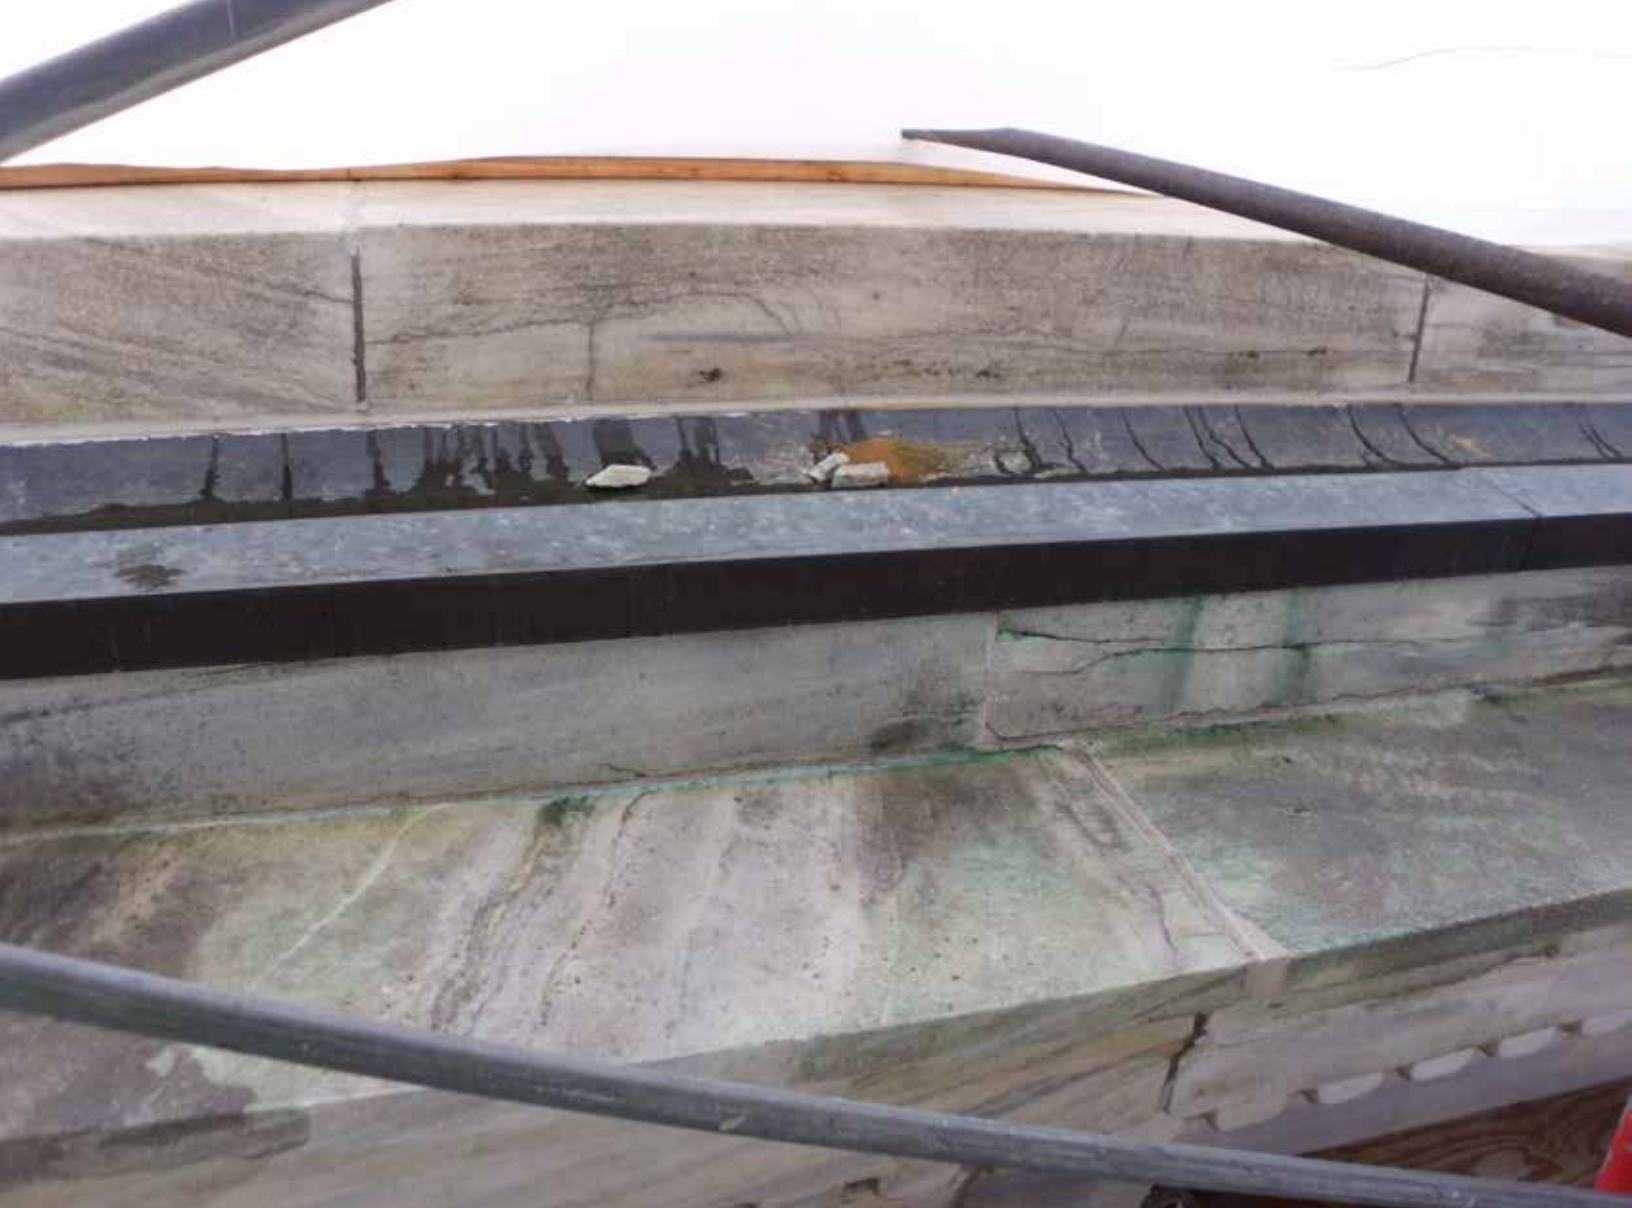
Vein cracking at cornice.

- Freeze/thaw damage expansion also caused several units to shift outward.
- Stone anchors were corroded and for the most part ineffectual.
- Larger stone units, especially at the cornice, showed heavy vein erosion in the marble and diagonal cracking.

Repairs were made on a case-by-case basis depending on the condition of the stone. In some cases Dutchman repairs were opted for. Displaced units that were 100% undamaged were removed and salvaged. If required, the backup was repointed or replaced and the stone reinstalled with new stainless steel anchors. Unsalvageable units were replaced with new units. Mark 1 Restoration handled stone replacement such as this throughout the project. Chipped, surface cracked or spalled but otherwise structurally sound units were removed and re-anchored and then repaired by AMR. Profiles were patched and carved also utilizing Jahns.

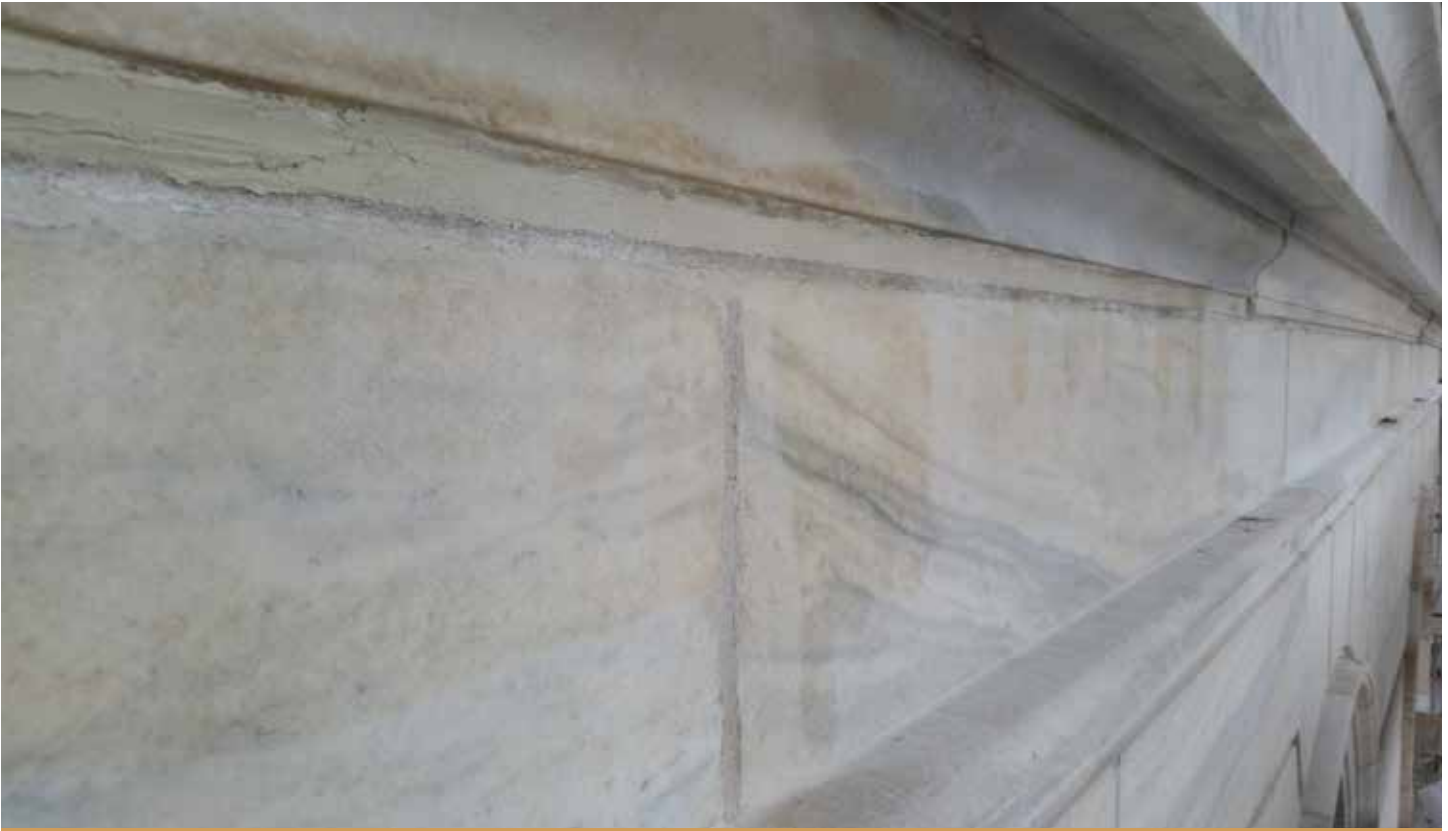
There was no pre-approved standard color, every area that was patched required a different blend of colors to match both the base and the marble veining. The highly carved elements such as those on the pilasters and capitals demonstrated the most severe damage and loss of detail. It was determined that these projecting units have larger surface areas that are more exposed to damaging climate factors. In addition, ornately carved figures are more vulnerable to distress than are flat surfaces. Also the original carving practices utilized hand chisels and hammers; unfortunately this method exacerbates naturally occurring micro-fractures, leaving the stone more vulnerable to water infiltration.

Eroded element, base patching started.

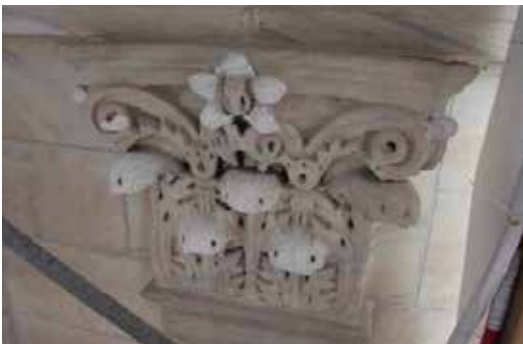
Before and after replacement elements were put into place.

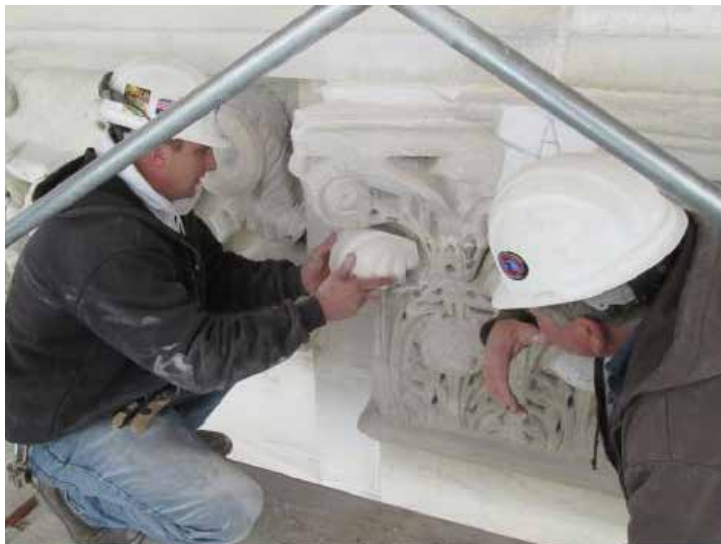
Specially carved pieces being installed.

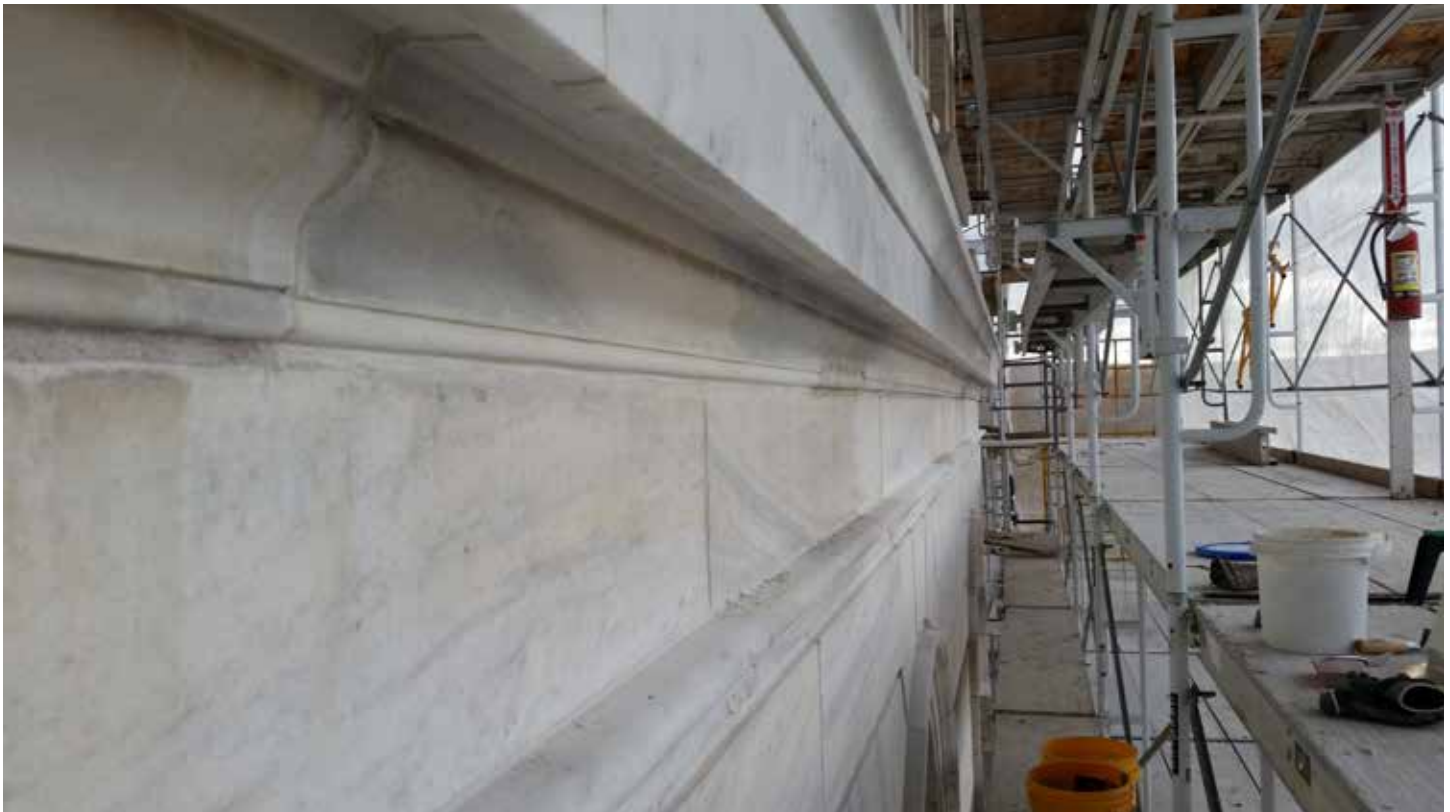
Eroded element, patched to match profile.

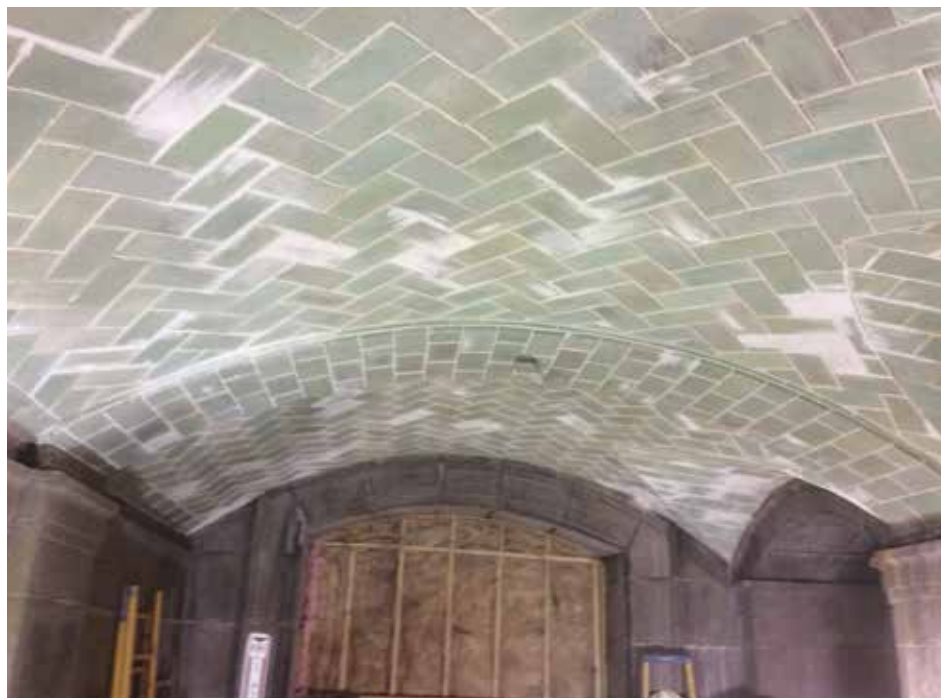
There was extensive penetration of the Guastavino tile by ceiling grid support hangers, as well as numerous missing tiles. Our journeywomen had to develop a patching mortar that would hold, and then match the existing color of the tile. They then needed to find or fabricate the tools needed to match the notched profile, as well as develop the techniques necessary to match the profile of

Damaged tile, base patching started.

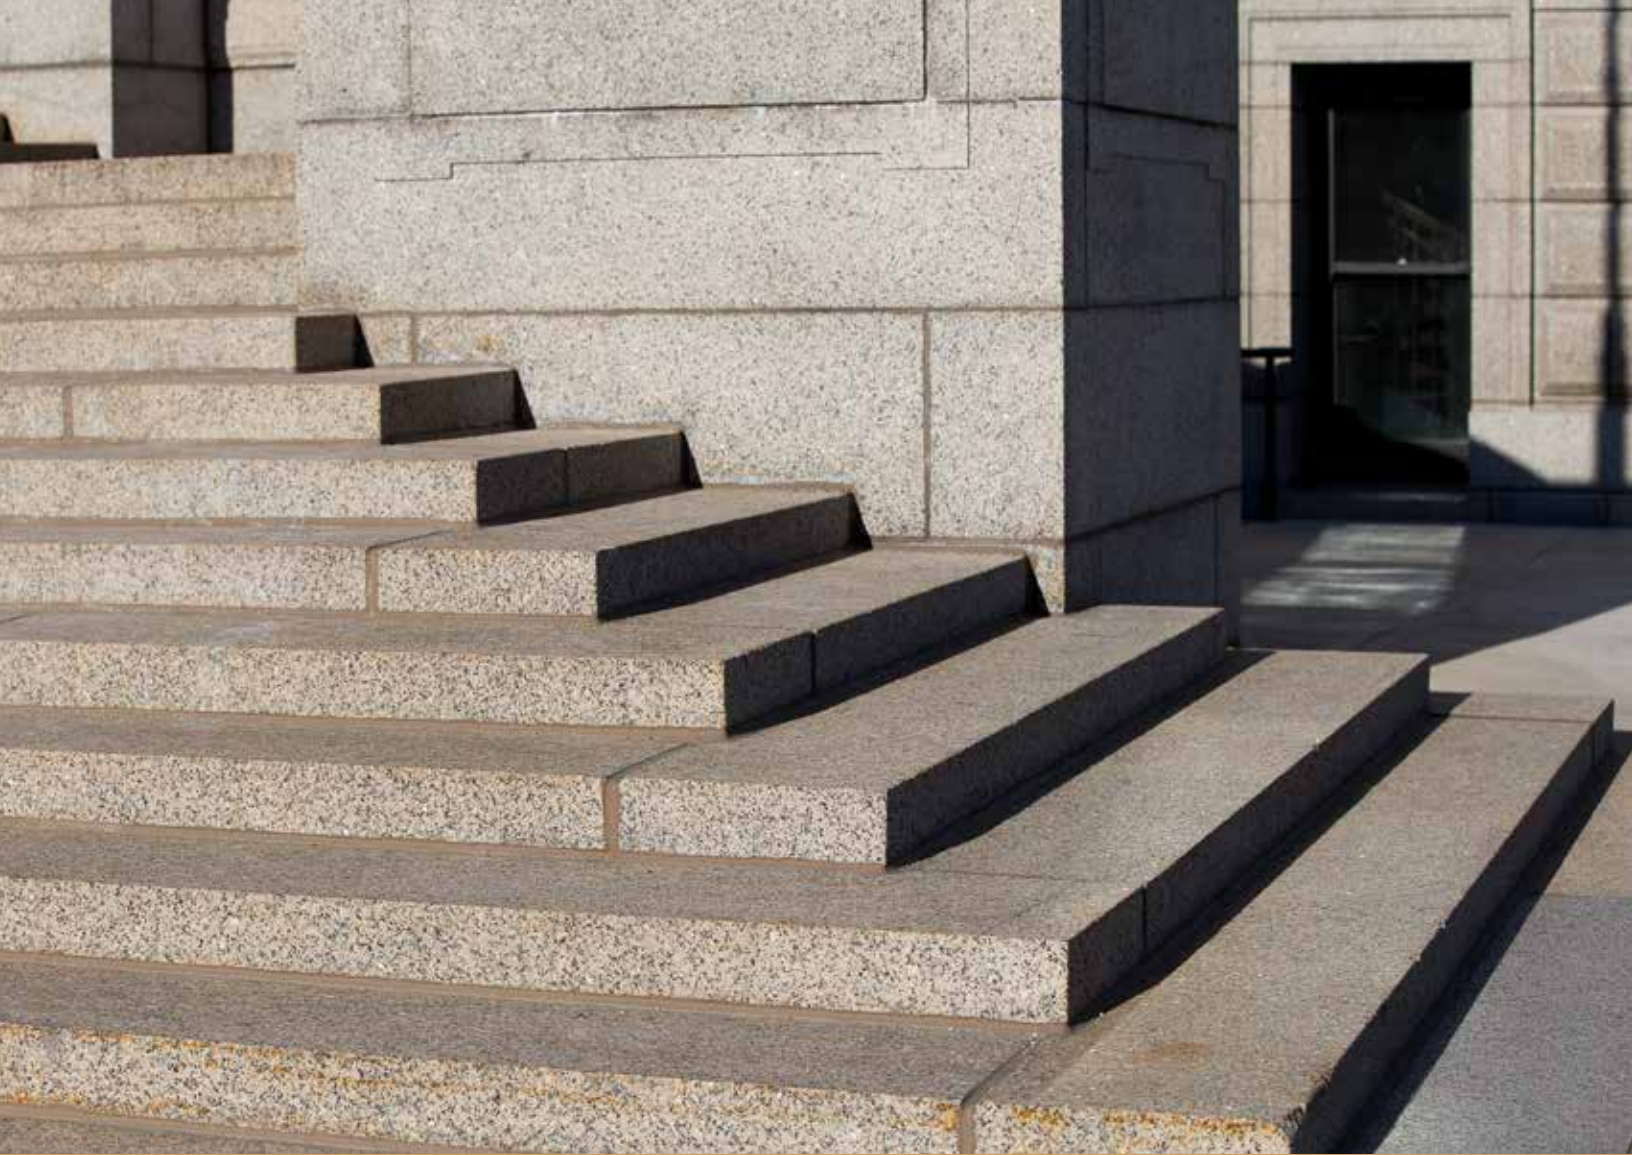
One of the larger unforeseen repairs that arose was the replacement of the 15,000 square foot stairs fronting the Capitol. Since they were repaired in the 1990's it was assumed they were sound, however shifting treads led to the discovery that the limestone foundation has lost its bearing capacity. The stair system was dismantled and rebuilt with the original treads salvaged and reinstalled.

Front stairs of the Capitol.

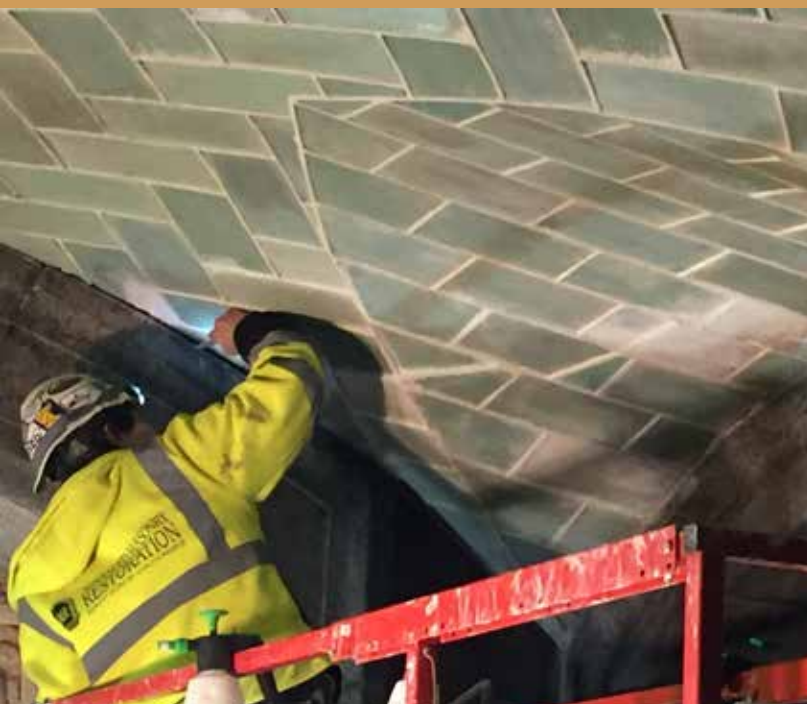
Profile matching in progress.

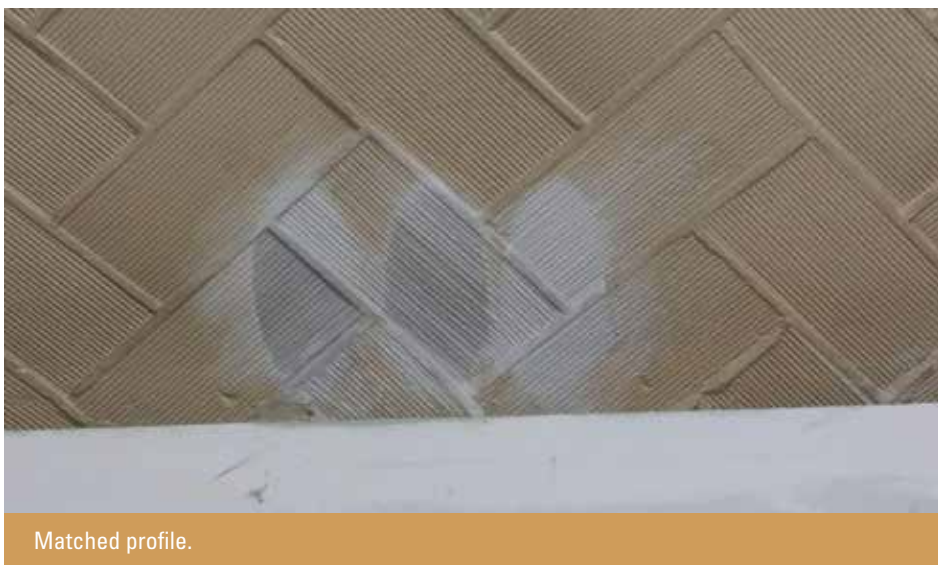
Matched profile.

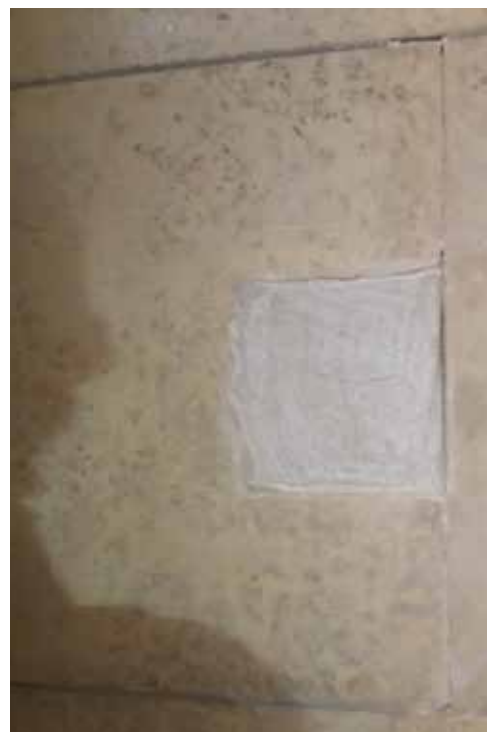
Interior marble base patch.

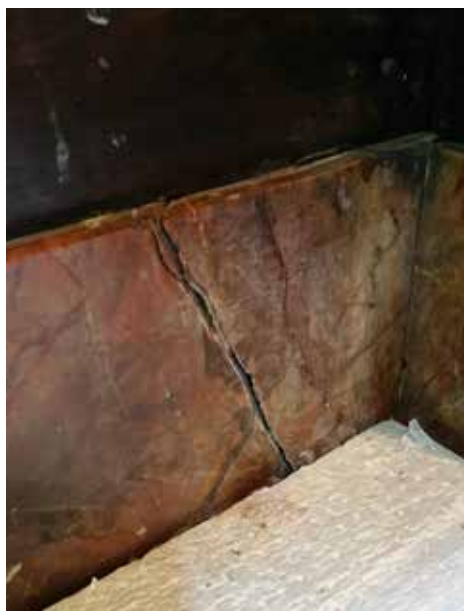
Cracked marble.

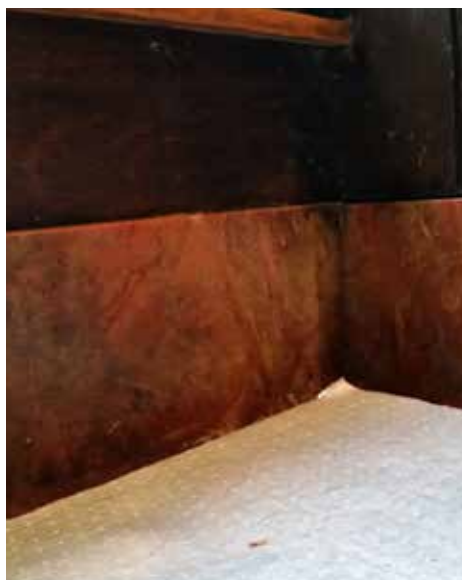
Completed patch, profiled and colored to emulate natural veining.

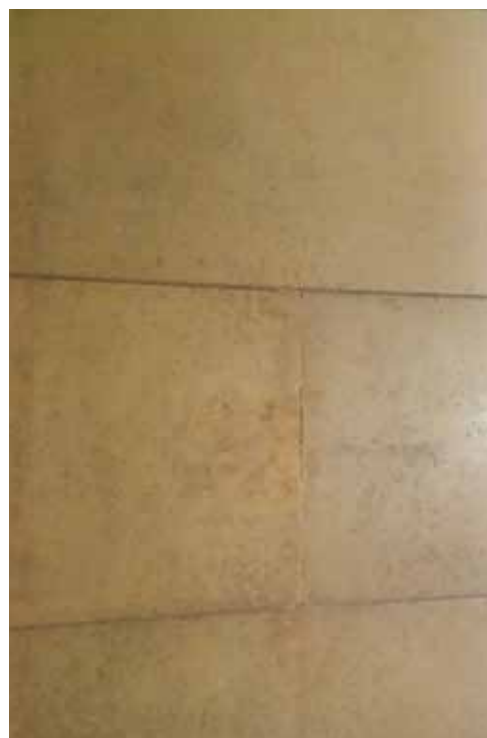
Completed patch.
