New MTS 4100 NVH Analyzer Identifies Vibration Sources

New Design Rear Axle Output Seal and Axle Shaft

Under Body Noise on Uneven Road Surface

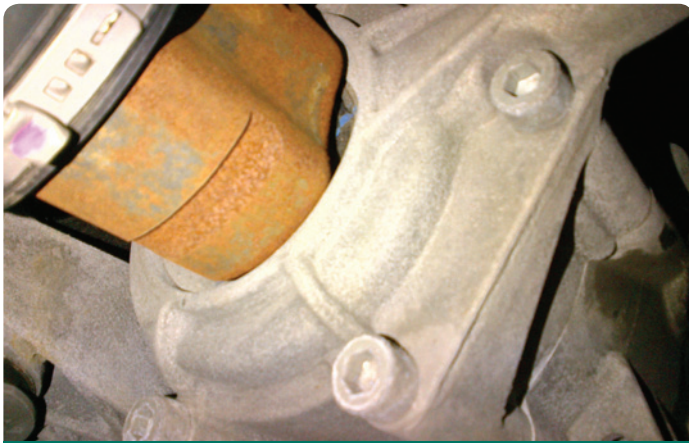
The old style seal is black and the axle shaft that mates with it does not have a slinger. The black (first design) seal is GM P/N 20986535.

Old style black seal

TIP: Do not mix the different seals and axle shafts. Installing first design seals with the second design axle shafts OR installing second design seals with first design axle shafts will result in a leak.

If a rear axle component is incorrectly ordered and it comes with a seal that is incompatible with the vehicle's axle shafts, it is not necessary to return the part. Simply get the axle seal that matches the existing axle shafts and replace the seal(s) using the seal replacement procedure in the appropriate Service Information.

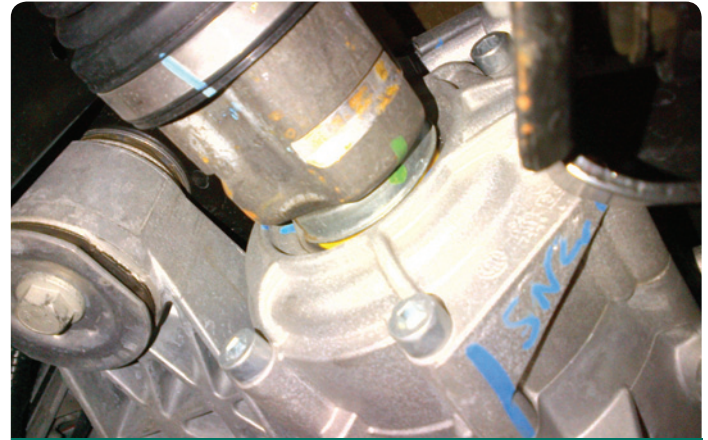
The new style seal material is yellow and it mates with an axle shaft that has an integral slinger. The yellow (second design) seal is GM P/N 22845699.

New style yellow seal

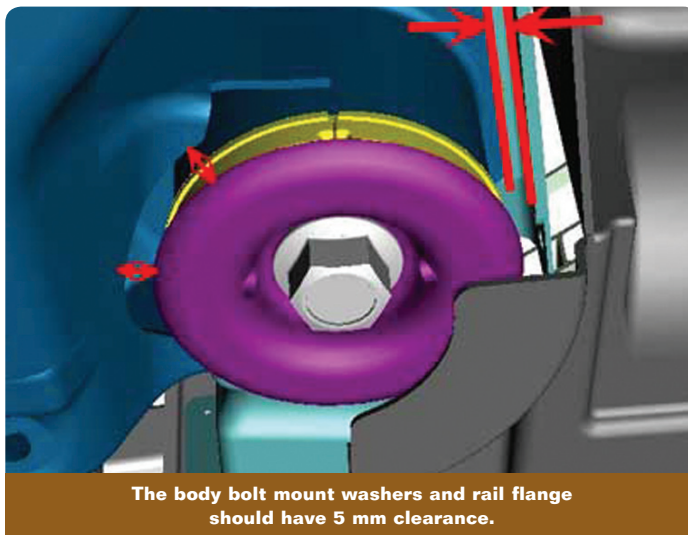
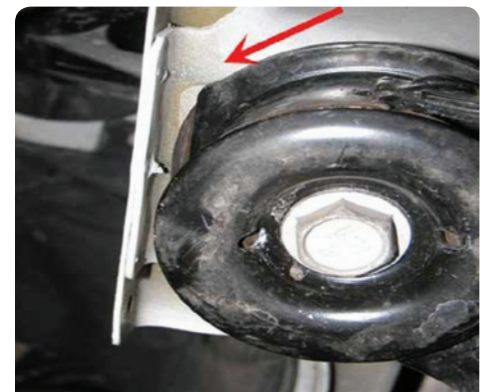
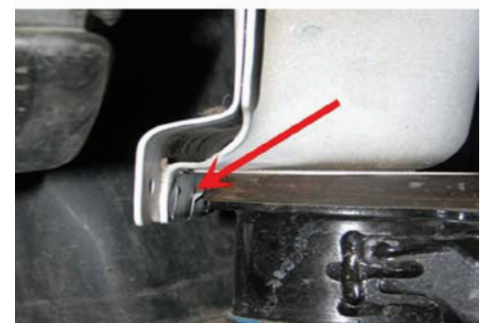
2008-2012 Malibu models may experience a noise heard from under the front of the body or suspension area. The pop, snap, creak or clunk noise may be present on braking, turning or driving on an uneven road surface.

The noise may be caused by the front cradle body mount bolt washers or cradle making contact with the frame rail.

Inspect the washer-to-cradle clearance and the cradle-to-frame rail flange clearance. Inspect for any witness marks. The body bolt mount washers and rail flange should have 5 mm clearance.

Inspect the washer-to-cradle clearance and the cradle-to-frame rail flange clearance.

Loosen all cradle mount bolts, center the cradles as needed, and torque to specification. Then perform a 4-wheel alignment.

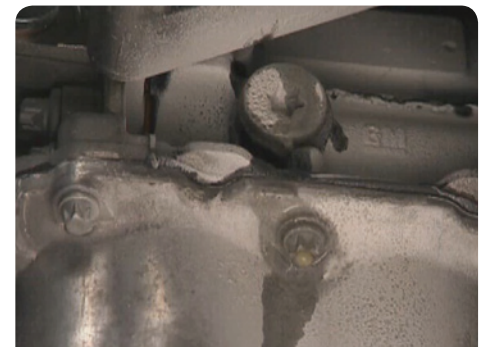
A leak can be traced through the powder back to the source.

Trace the leak path through the powder back to the source of the leak and make the necessary repairs.

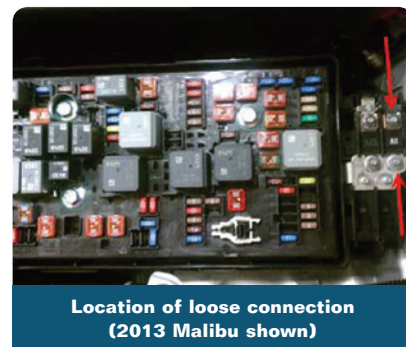
On some 2011-2012 Lacrosse, 2012 Regal, and 2013 Malibu models with electric power steering (RPO NJ1), there may be an intermittent Service Power Steering message displayed on the Driver Information Center along with a set DTC U0131 (Lost Communication With Power Steering Control Module).

This condition may be caused by a loose B+ feed at the X50A Underhood Fuse Block or the 80A fuse retaining bolts in the Underhood Fuse Block. The battery feed is X6 on the LaCrosse and Malibu and X8 on the Regal. The condition also may be caused by a loose connection at G111.

Location of loose connection (2013 Malibu shown)

Secure the B+ feed or fuse nuts as needed. In addition, check the connection at G111.
