Mays Consulting & Evaluation Services, Inc.

BUILDING ENVELOPE ASSESSMENT
COLUMBUS METROPOLITAN LIBRARY
SOUTH HIGH BRANCH
COLUMBUS, OHIO
DECEMBER 12, 2018
MAYS PROJECT # COH44-011

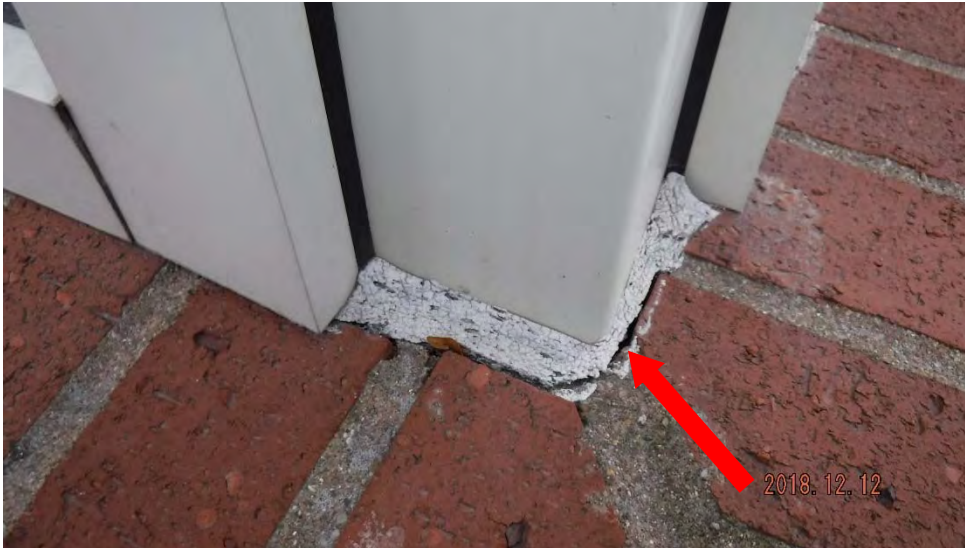
1. Finding – Window to Veneer Sealant Joints: The sealant joints between windows and the various veneers was found to be cracking/shrunk and in poor condition at many locations on the building.

1a. Cracking/shrunk sealant joints (see #1 on elevation photo for location).

Recommendation – Window to Veneer Sealant Joints: Remove existing sealant from joints, prep joints, and install new backer rod and sealant as needed.

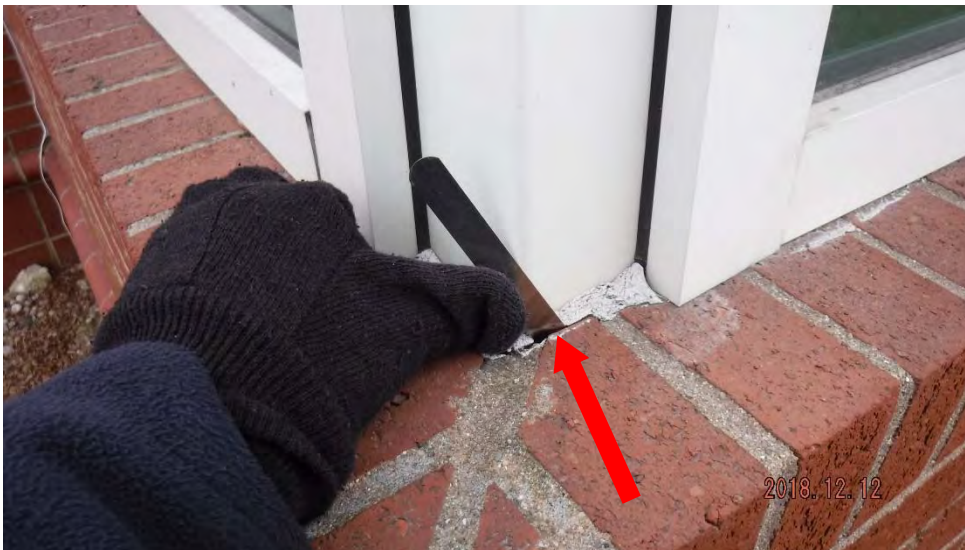
1b. Probe inserted several inches into open space at sealant joint (see #1 on elevation photo for location).

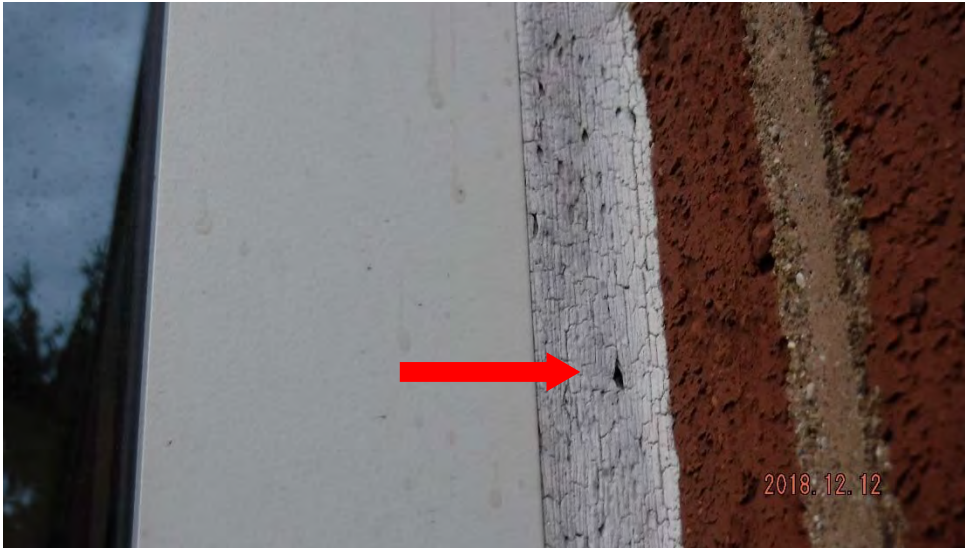
1c. Cracking/shrunk sealant joint (see #1 on elevation photo for typical location).

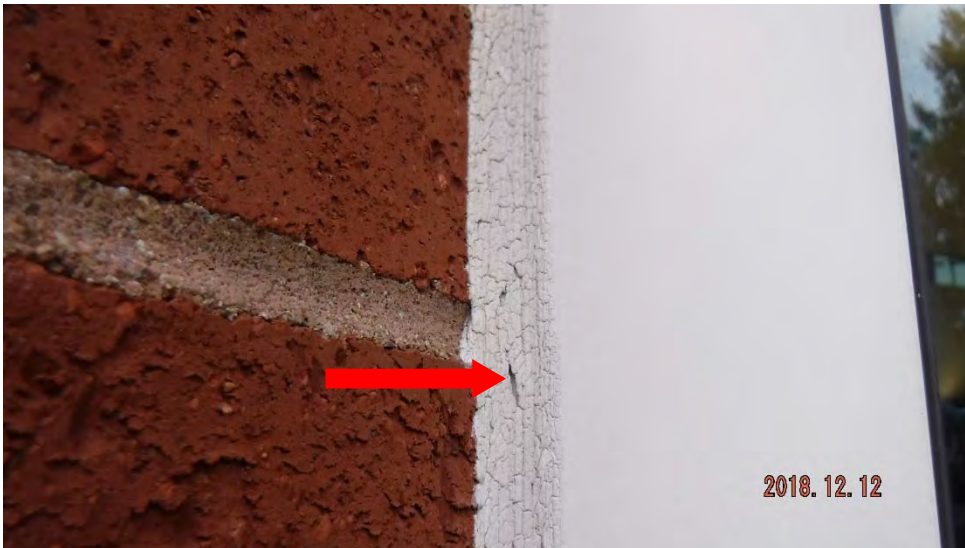
1d. Cracking/shrunk sealant joint (see #1 on elevation photo for typical location).

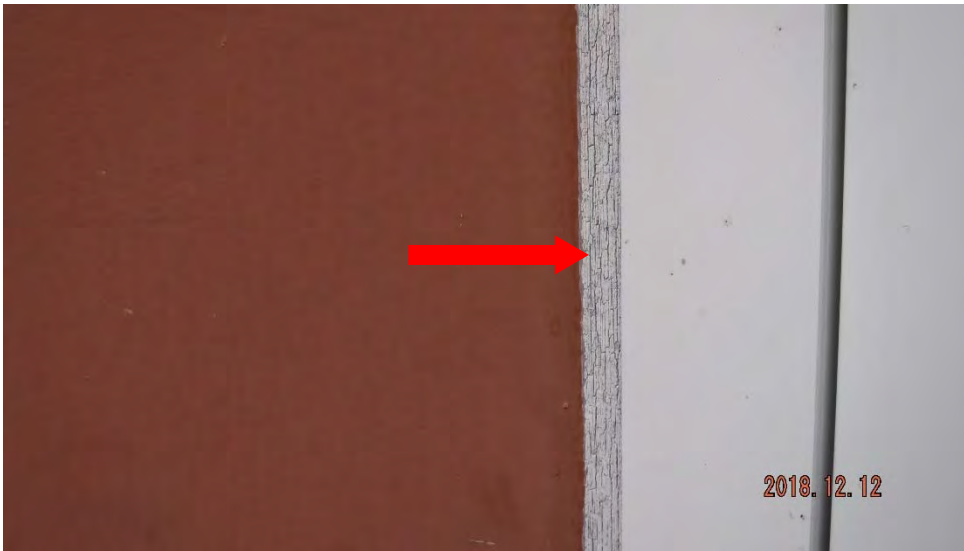
2. Finding – Steel Column to Veneer Joints: The sealant joints between the steel columns and the adjoining veneers was found to be cracking/shrunk at numerous locations.

2a. Cracked/shrunk sealant joint between steel column and window/door framing (see #2 on elevation photo for location).

Recommendation – Steel Column to Veneer Joints: Remove existing sealant from joints, prep joints, and install new backer rod and sealant as needed.

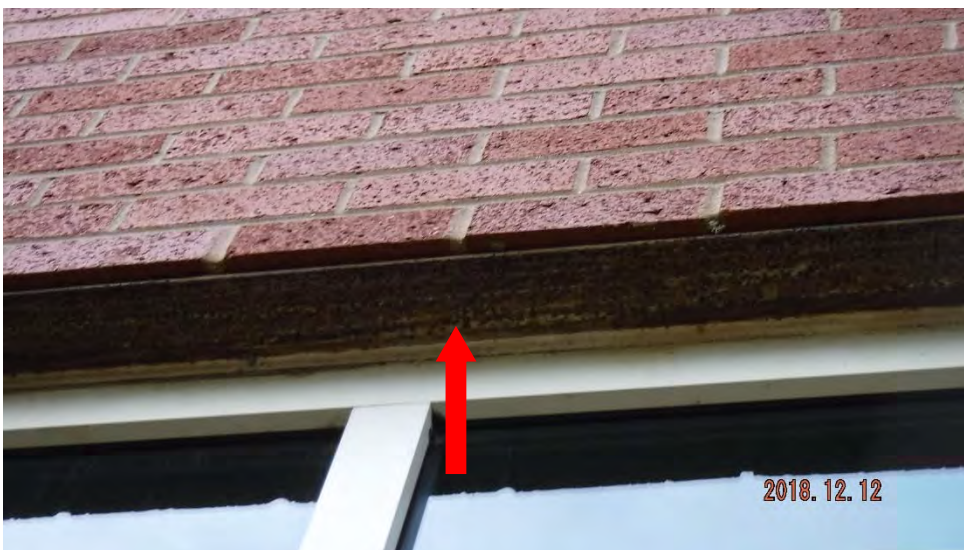
3. Finding – Window Lintels: The window lintels were found to have moderate to heavy corrosion at several locations on building.

3a. Corrosion on window lintel (see #3 on elevation photo for location).

Recommendation – Window Lintels: Properly prep and clean, then re-paint the lintels.

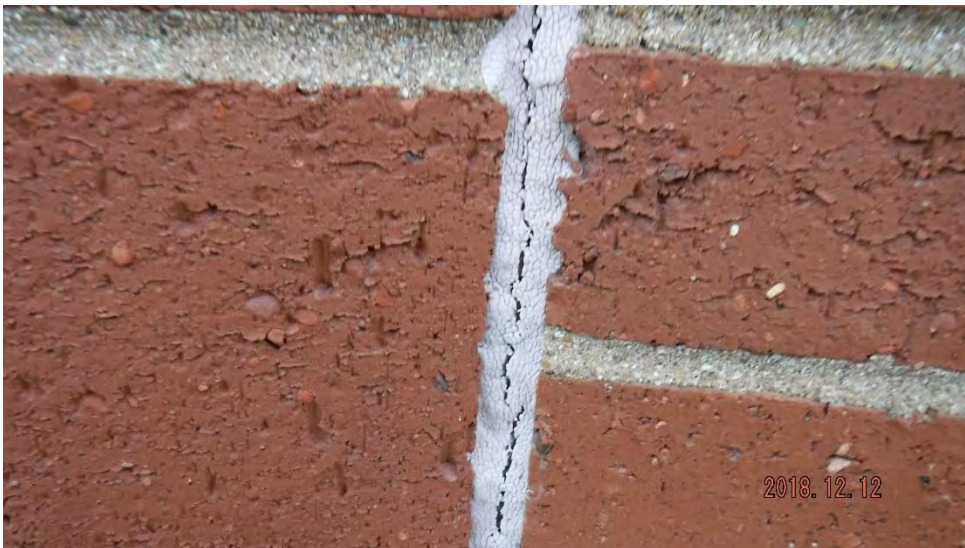
4. **Finding – Masonry Control Sealant Joints:** The masonry control sealant joint(s) are cracking/shrunk at various locations on the building.

4a. Cracked/shrunk masonry control sealant joint (see #4 on elevation photo for location).

Recommendation – Masonry Control Sealant Joints: Remove existing sealant from joints, prep joints, and install new backer rod and sealant as needed.

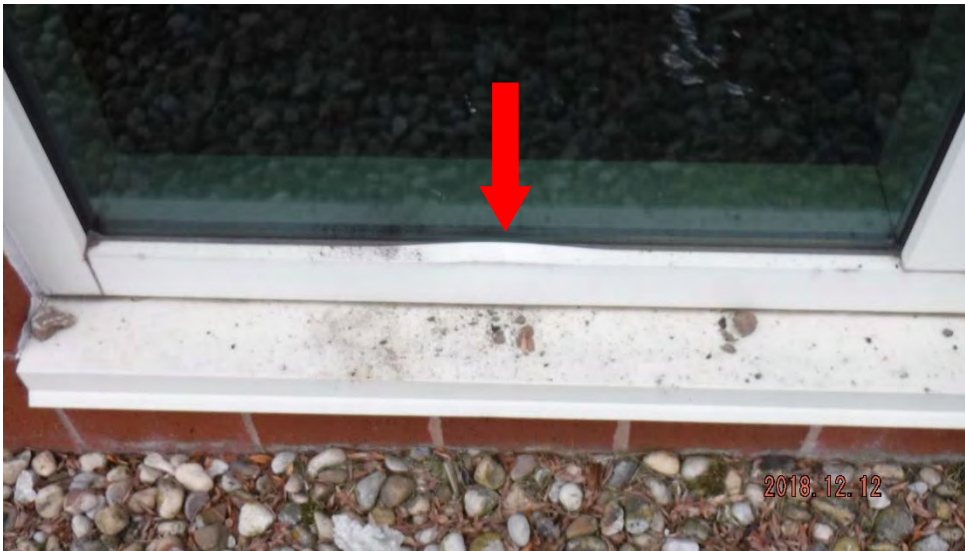
5. Finding – Window Pressure Plate: There is a window pressure plate that was found to be damaged.

5a. Damage to window pressure plate (see #5 on elevation photo for location).

Recommendation – Window Pressure Plate: Repair or replace the damaged window pressure plate.

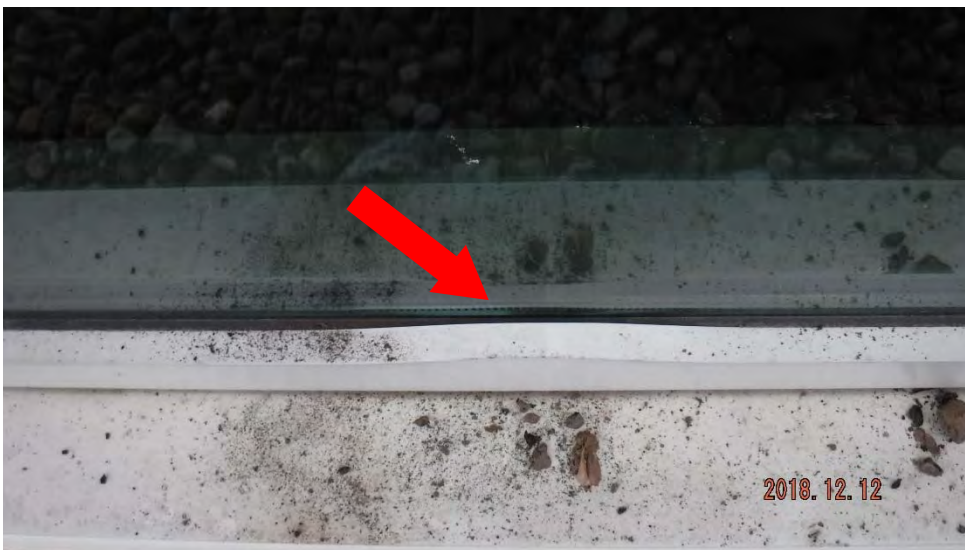
5b. Closer view of damaged pressure plate (see #5 on elevation photo for location).

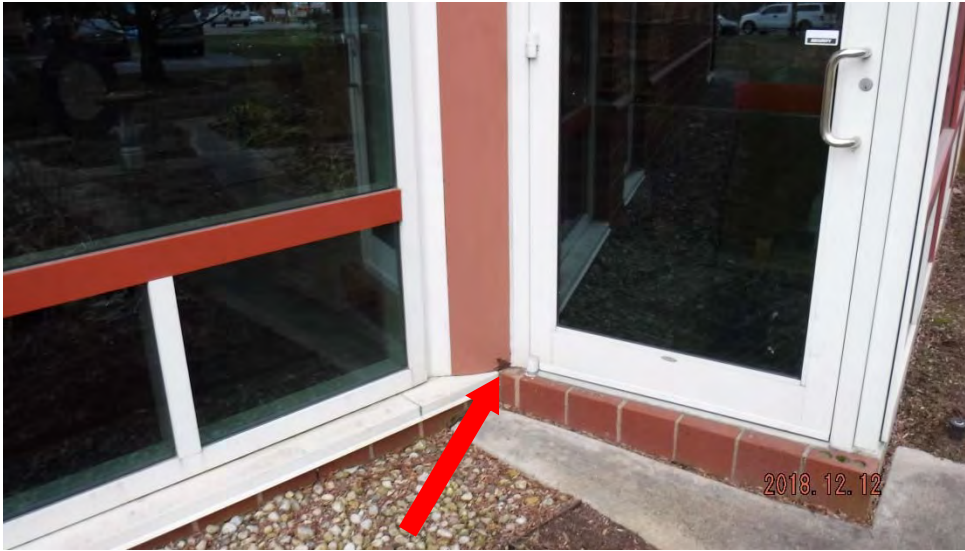
6. Finding – Steel Column Corrosion: The base of the steel column was found to have moderate to heavy corrosion.

6a. Overview of steel column. See area of corrosion at arrow (see #6 on elevation photo for location).

Recommendation – Steel Column Corrosion: Make proper repairs to column and re-paint as needed.

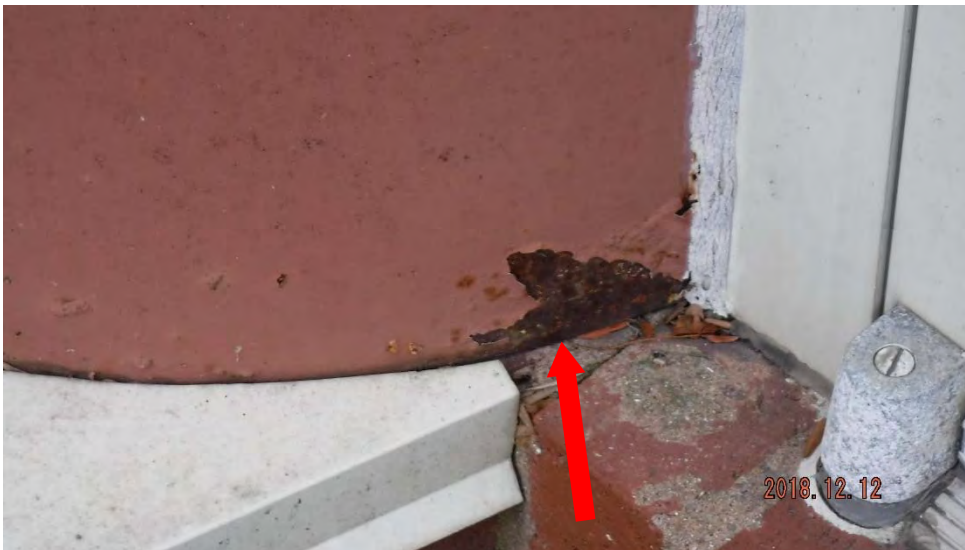
6b. Corrosion at base of steel column (see #6 on elevation photo for location).

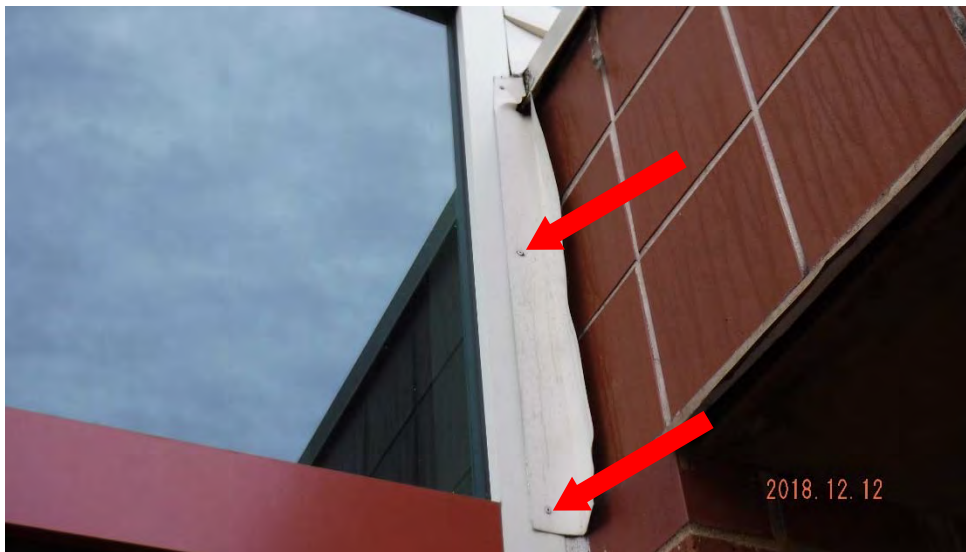
7. Finding – Metal Flashing: There is a metal flashing installed at inside corner between windows and masonry wall. It is assumed this piece was installed as water may have been migrating into building at this joint. The metal flashing was through fastened into the window framing.

7a. Overall of the metal flashing. See fasteners through fastened into window frame (see #7 on elevation photo for location).

Recommendation – Metal Flashing: Remove the flashing and determine area of leakage. Make necessary repairs to the window framing, and seal the areas between the wall and window to alleviate the need for the metal flashing.

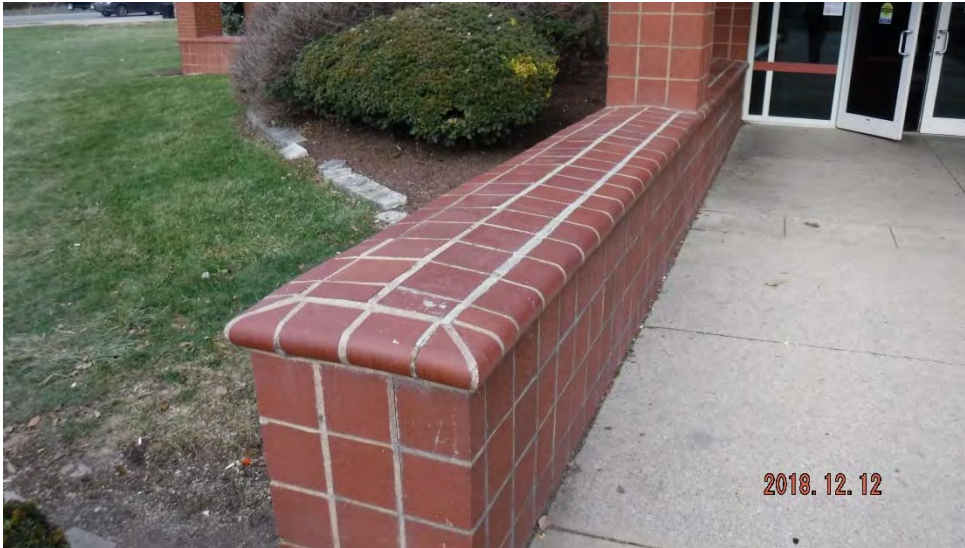
1. Finding – Freestanding Masonry Wall: There is a freestanding masonry wall at the main entrance on the east elevation. The wall has missing mortar at masonry joints, cracked/shrunk mortar joints, and several failed sealant repairs at cracked/shrunk mortar joints.

1a. Freestanding wall at main entrance (see #1 on elevation photo for typical location).

Recommendation – Freestanding Masonry Wall: Grind out the cracked/shrunk mortar joints, and failed sealant joint repairs. Tuckpoint joints as needed.

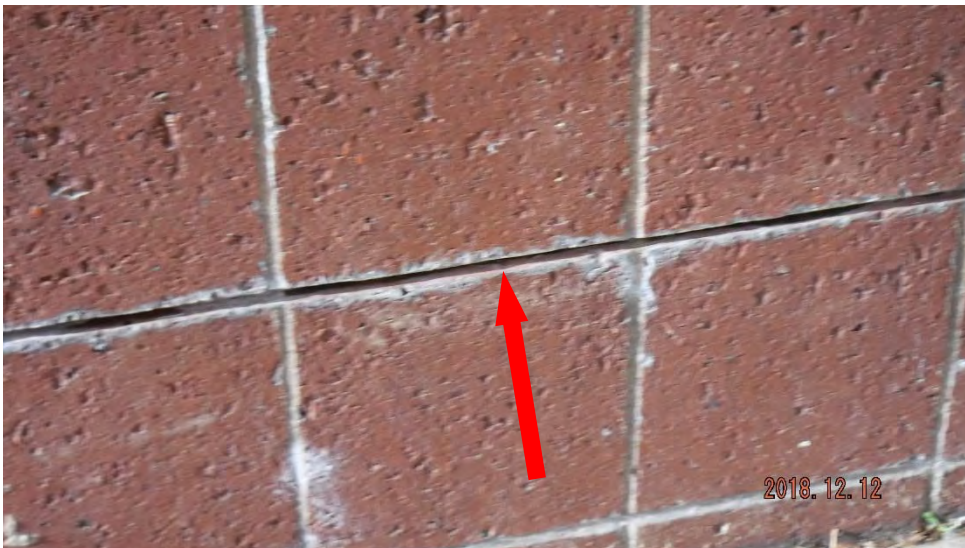
1b. Missing mortar at masonry joint (see #1 on elevation photo for typical location).

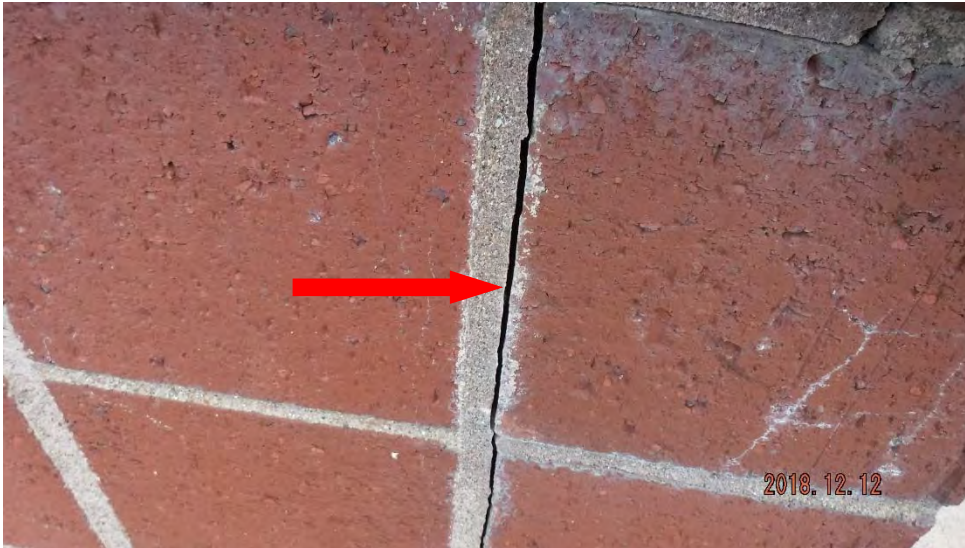
1c. Cracked/shrunk mortar joint (see #1 on elevation photo for typical location).

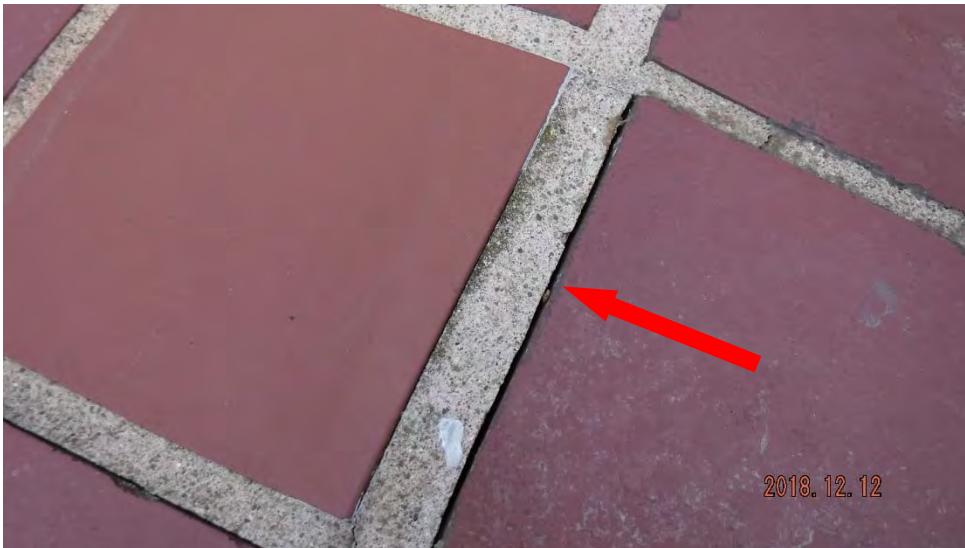
1d. Cracked/shrunk mortar joint(s) (see #1 on elevation photo for typical location).

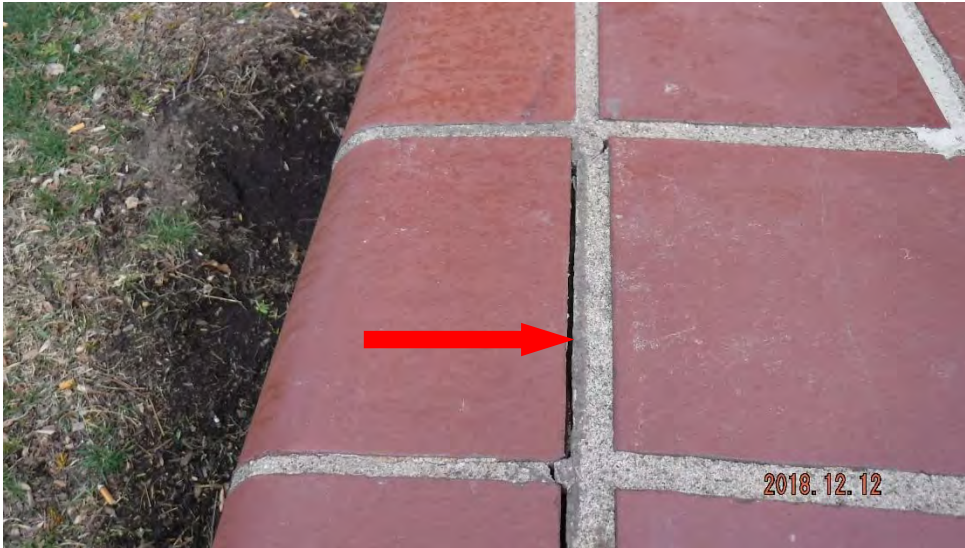
1e. Cracked/shrunk mortar joint(s) (see #1 on elevation photo for typical location).

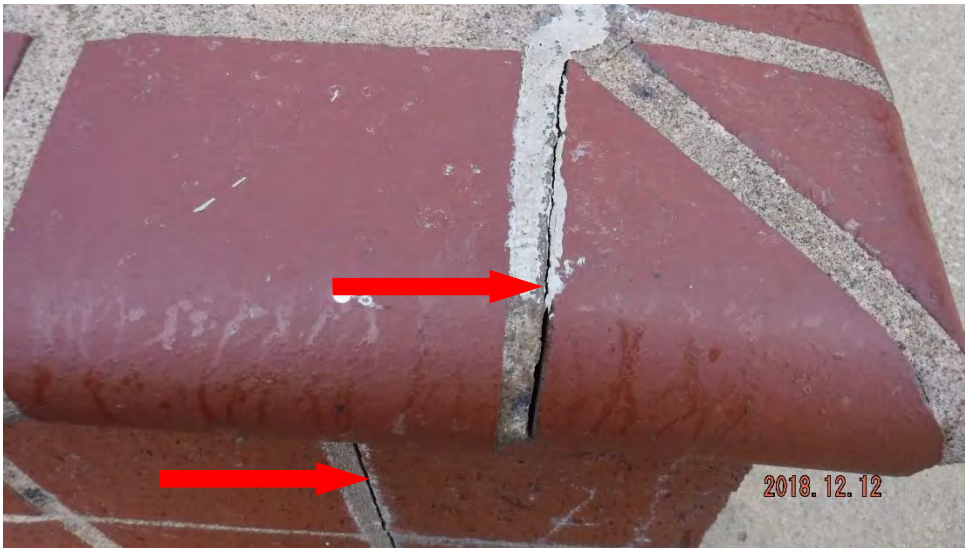
1f. Cracked/shrunk mortar joints and failed sealant repairs (see #1 on elevation photo for typical location).

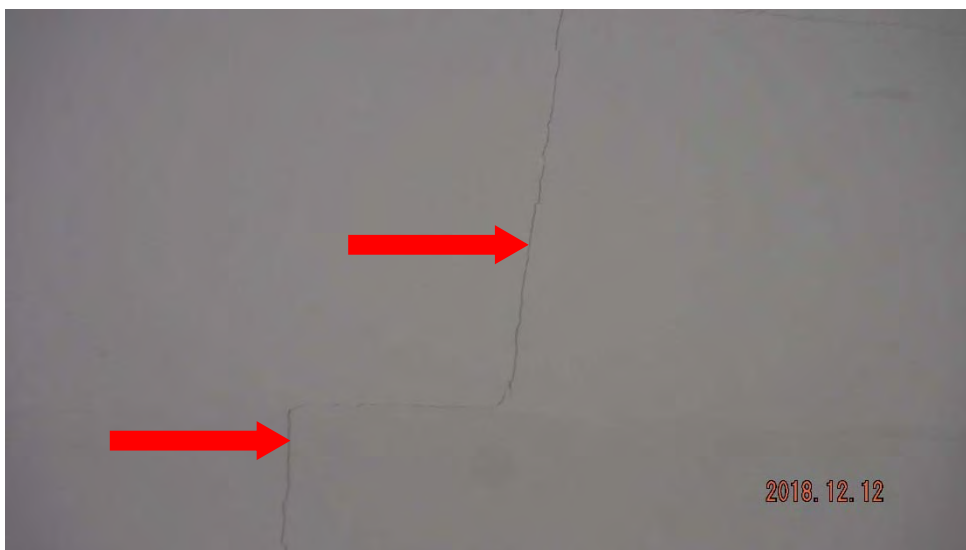
2. Finding – Soffit Ceiling at Open Walkway Structure: The ceiling area at the open walkway structure leading to main entrance appears to be painted gypsum board. There is a metal flashing between the ceiling and the masonry wall for this structure. The ceiling was found to be in poor condition. There are numerous cracks/splits in the board. Deterioration at the perimeters can be seen. The paint is chipping/flaking off at many areas. The metal flashing between the ceiling and wall is loose or missing at several areas.

2a. Cracks in soffit ceiling (see #2 on elevation photo for typical location).

Recommendation – Soffit Ceiling at Open Walkway Structure: Replace or repair the gypsum board, then prep and re-paint as needed. Re-secure the metal flashing if possible, or replace with new as needed.

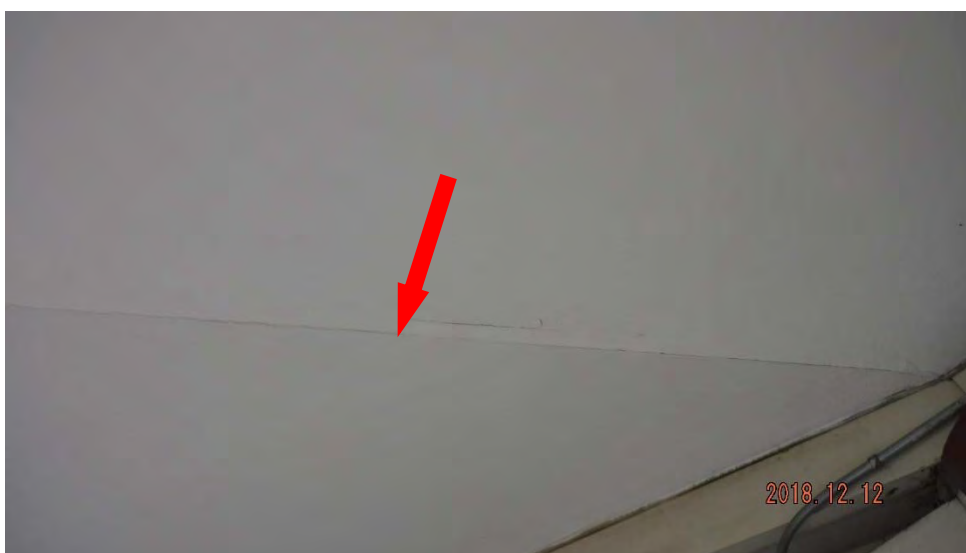
2b. Cracks in soffit ceiling (see #2 on elevation photo for typical location).

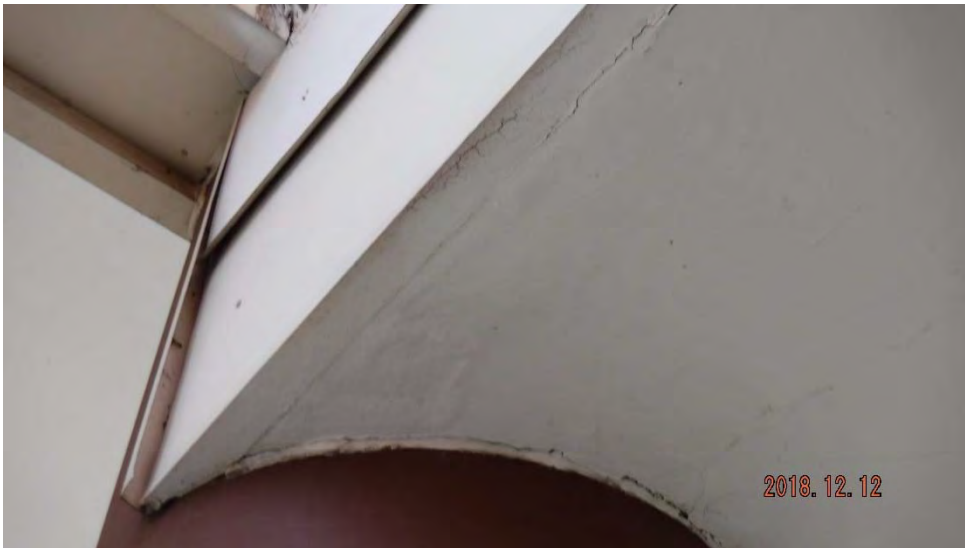
2d. Deterioration of soffit ceiling and chipping/flaking paint (see #2 on elevation photo for typical location).

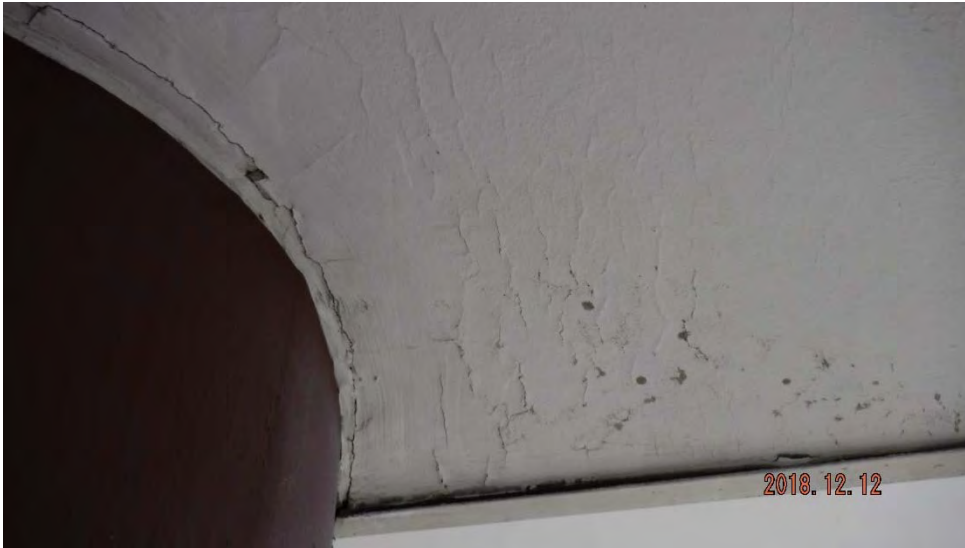
2e. Deterioration of soffit ceiling and chipping/flaking paint (see #2 on elevation photo for typical location).

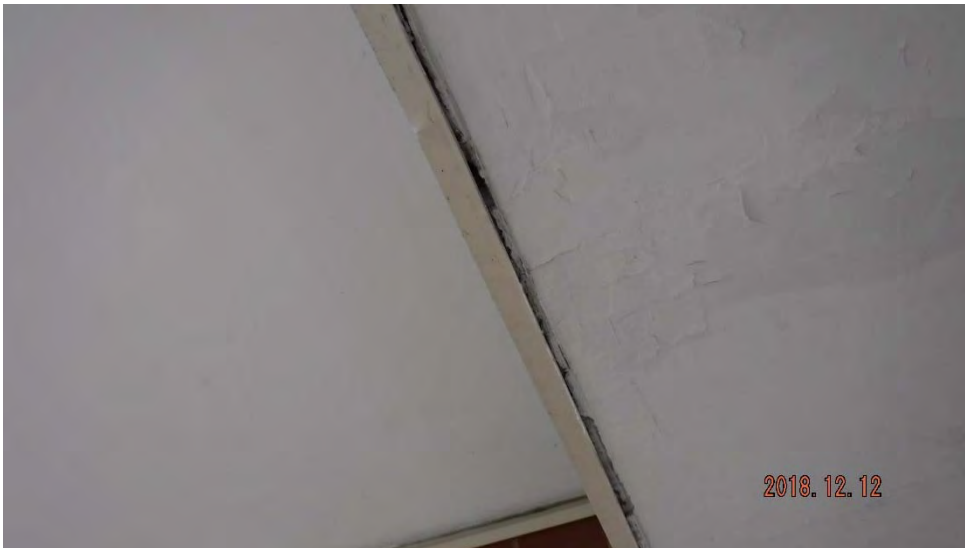
2f. Deterioration of soffit ceiling and chipping/flaking paint (see #2 on elevation photo for typical location).

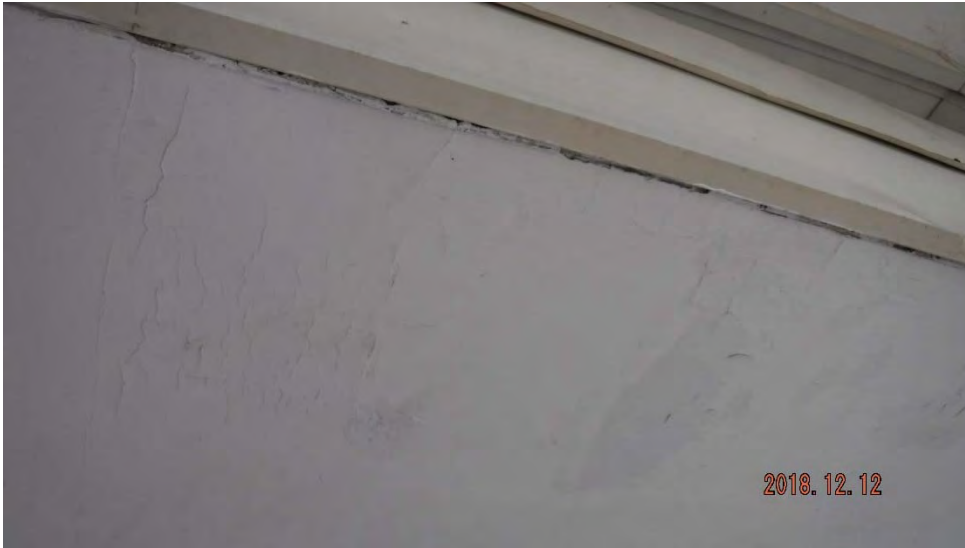
2g. Deterioration of soffit ceiling and chipping/flaking paint (see #2 on elevation photo for typical location).

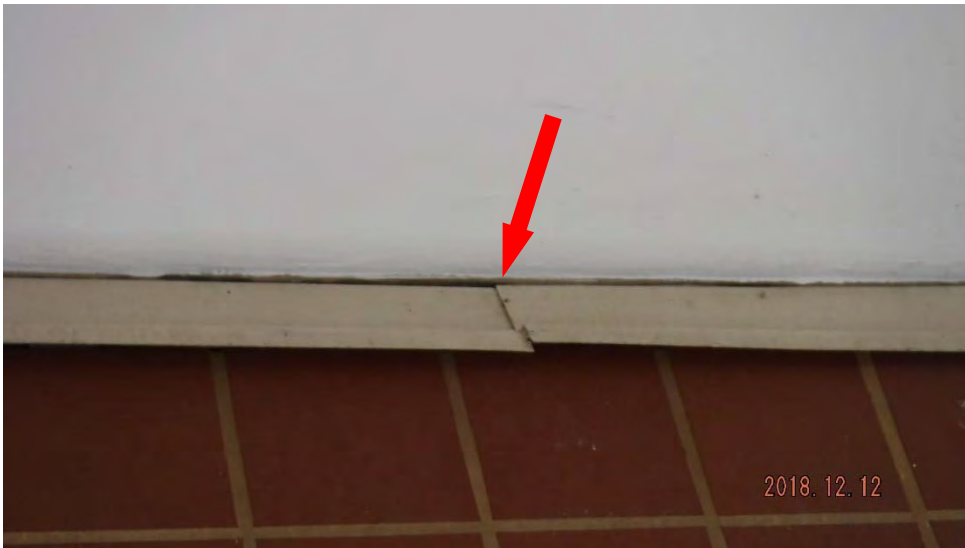
2h. Loose metal flashing (see #2 on elevation photo for typical location).

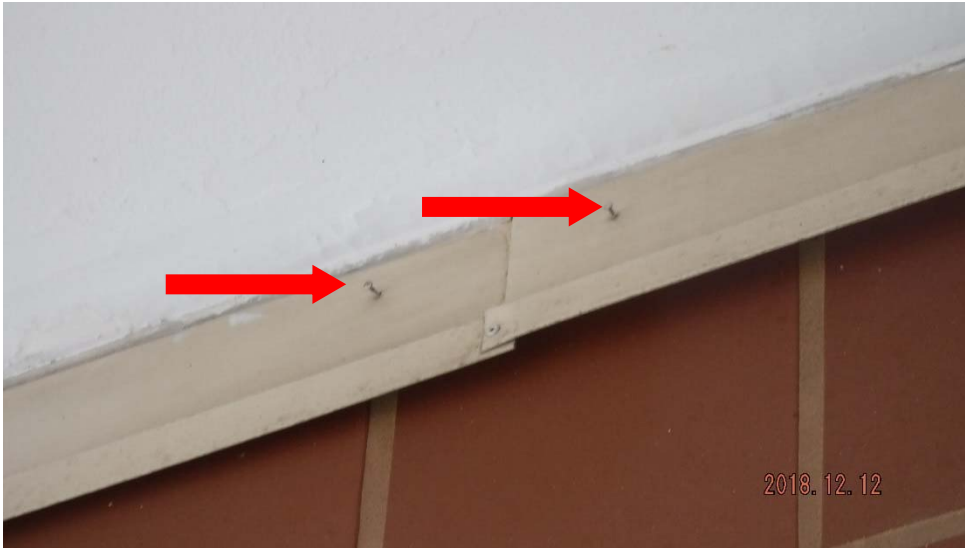
2i. Loose fasteners for metal flashing (see #2 on elevation photo for typical location).

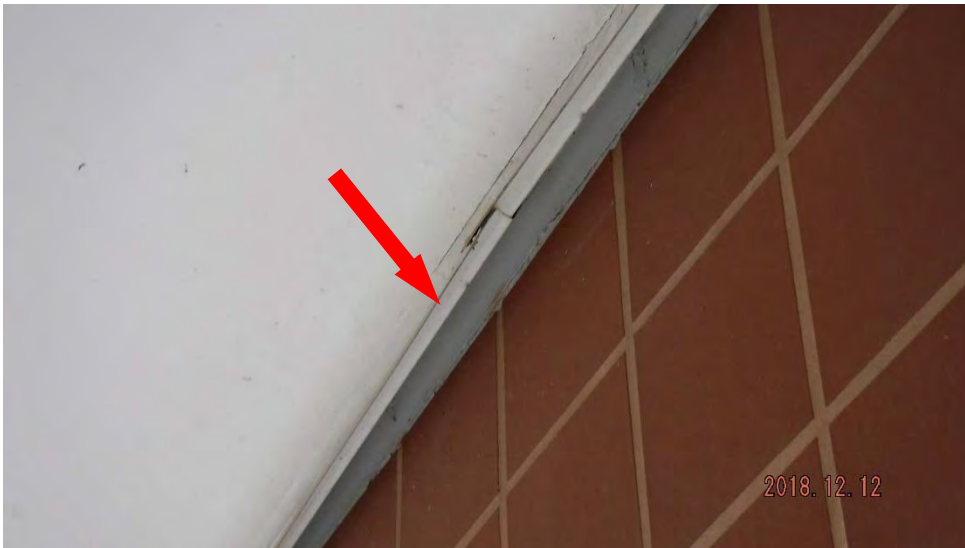
2j. Missing metal flashing (see #2 on elevation photo for typical location).

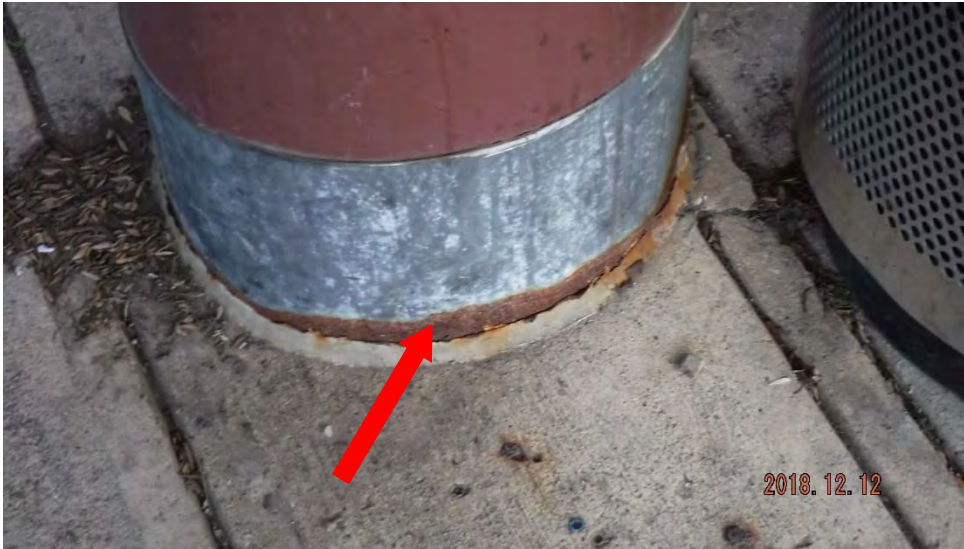
3. Finding – Steel Column Corrosion: The base of the steel columns was found to have moderate to heavy (severe) corrosion.

3a. Corrosion at base of steel column (see #3 on elevation photo for location).

Recommendation – Steel Column Corrosion: Make proper repairs to columns and re-paint as needed.

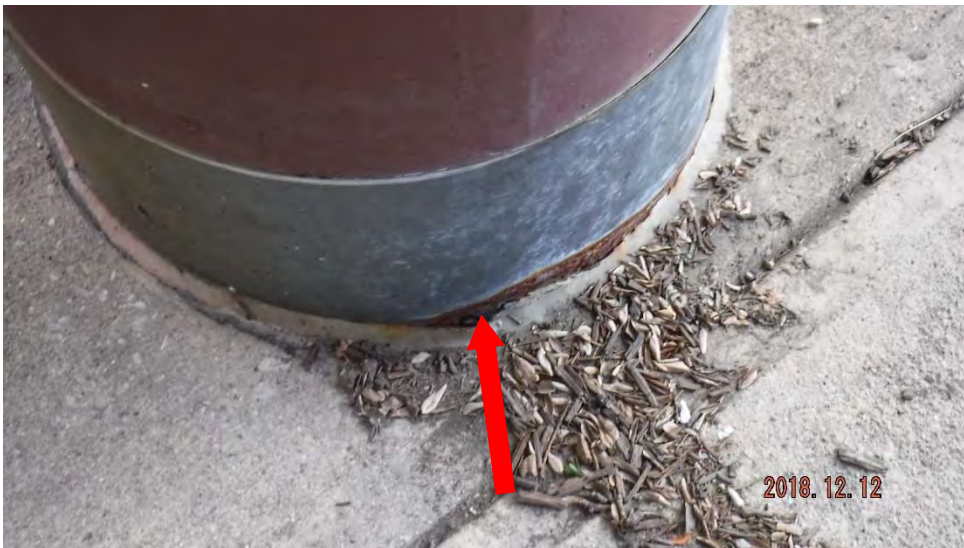
3b. Corrosion at base of steel column (see #3 on elevation photo for location).

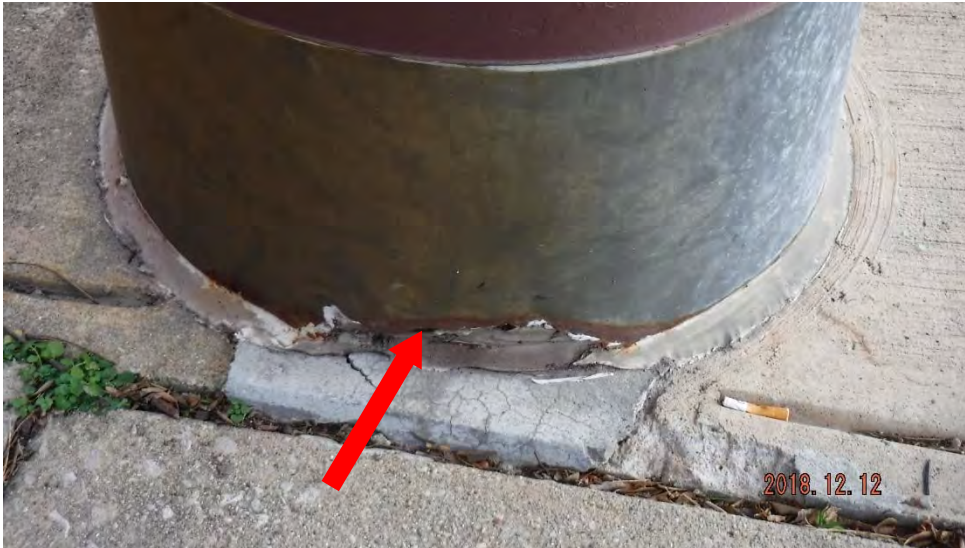
3c. Corrosion at base of steel column (see #3 on elevation photo for location).

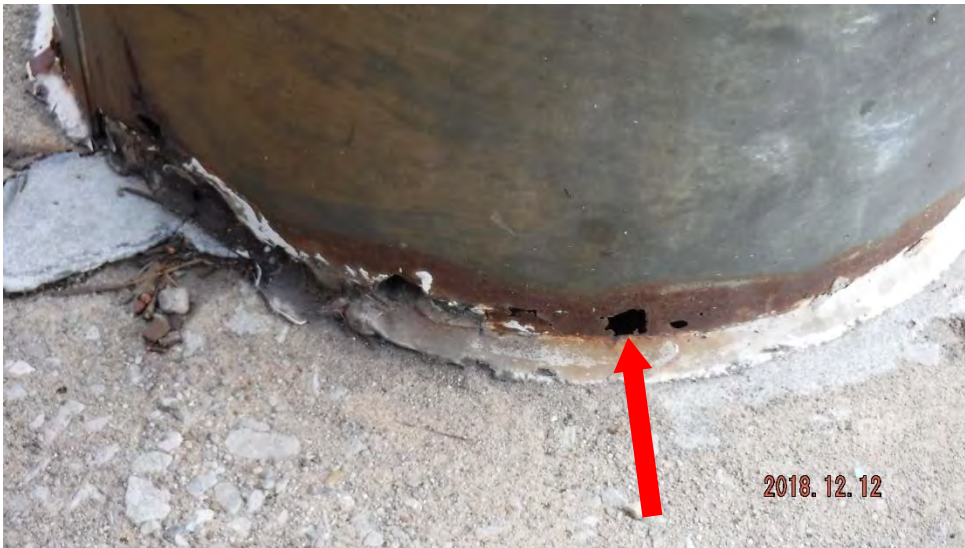
3d. Severe corrosion at base of steel column (see #3 on elevation photo for location).

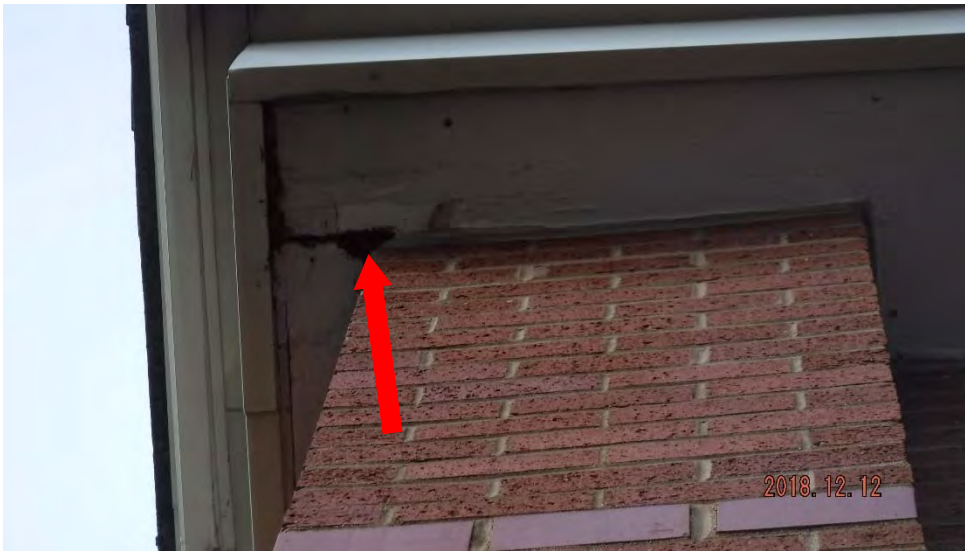
4. Finding – Overhang Soffit: The overhang soffits around the building are in disrepair. There is deterioration, exposed fasteners, cracked joints, and chipping/flaking paint.

4a. Disrepair of soffit and chipping/flaking paint (see #4 on elevation photo for typical location).

Recommendation – Overhang Soffit: Repair or replace deteriorated areas, fix cracked joints, properly prepare all surfaces and then re-paint.

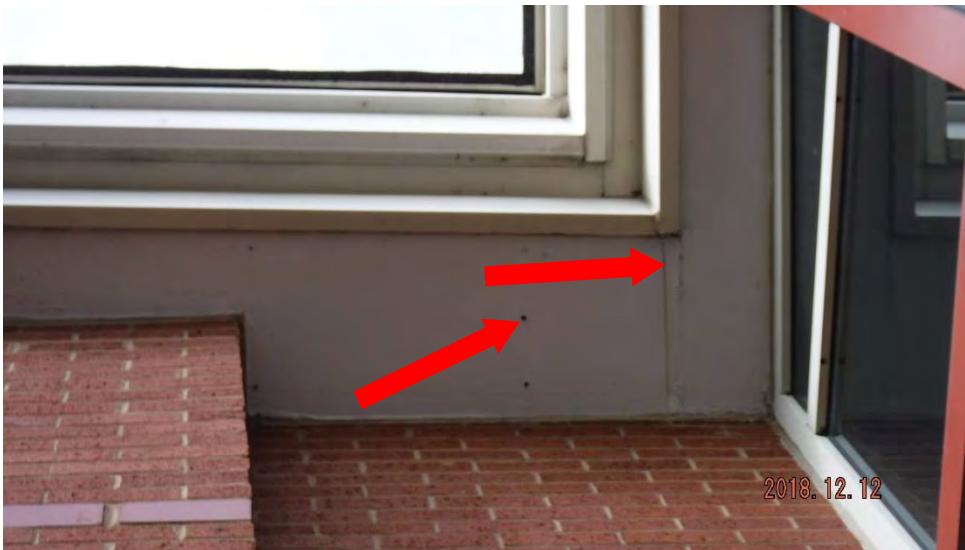
4b. Exposed fasteners and cracked joint (see #4 on elevation photo for typical location).

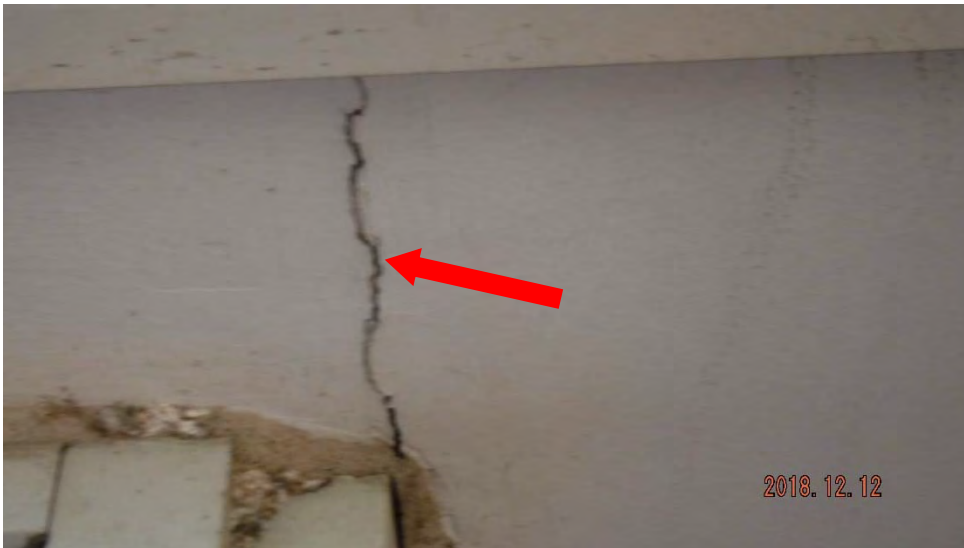
4c. Crack in soffit (see #4 on elevation photo for typical location).

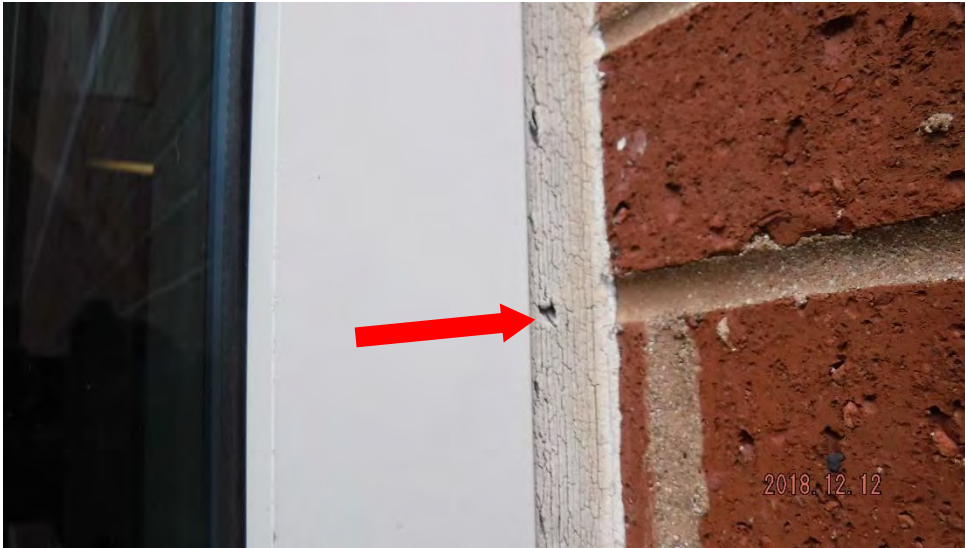
5. Finding – Window to Veneer Sealant Joints: The sealant joints between windows and the various veneers was found to be cracking/shrunk and in poor condition at many locations on the building.

5a. Cracking/shrunk sealant joint (see #5 on elevation photo for typical location).

Recommendation – Window to Veneer Sealant Joints: Remove existing sealant from joints, prep joints, and install new backer rod and sealant as needed.

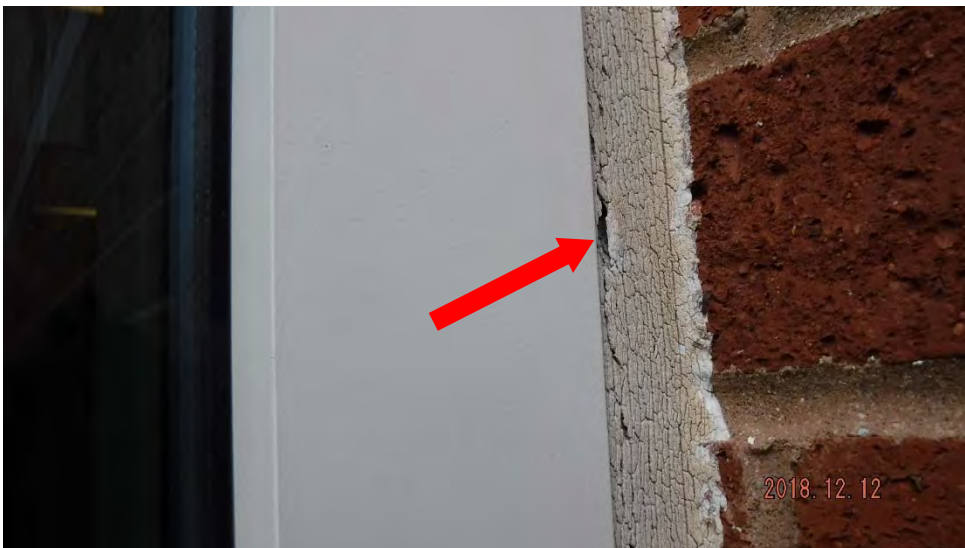
5b. Cracking/shrunk sealant joint (see #5 on elevation photo for typical location).

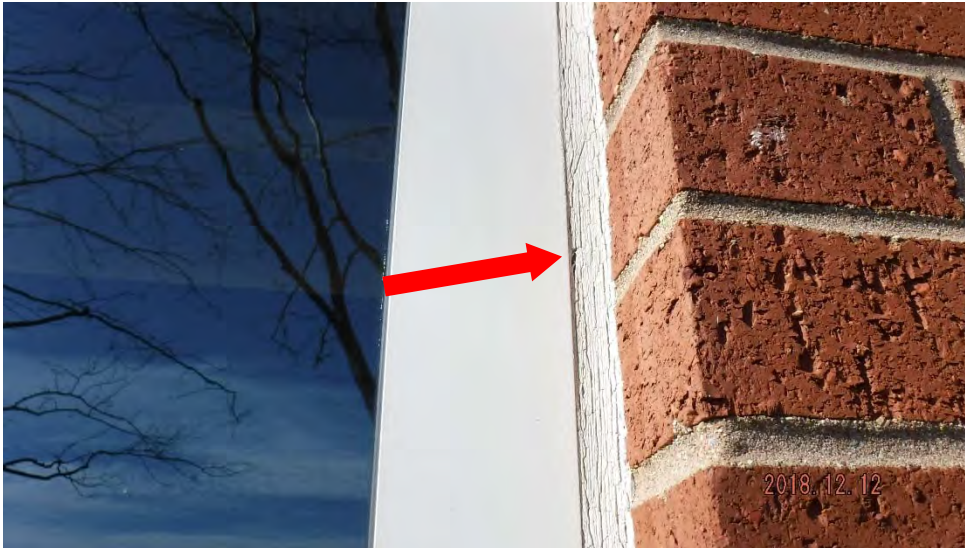
5c. Cracking/shrunk sealant joint (see #5 on elevation photo for typical location).

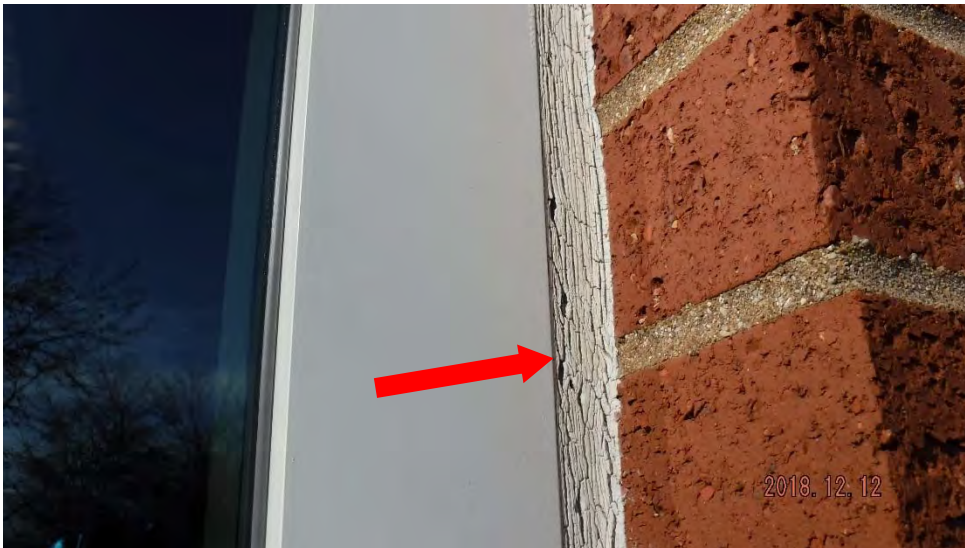
5d. Cracking/shrunk sealant joint (see #5 on elevation photo for typical location).

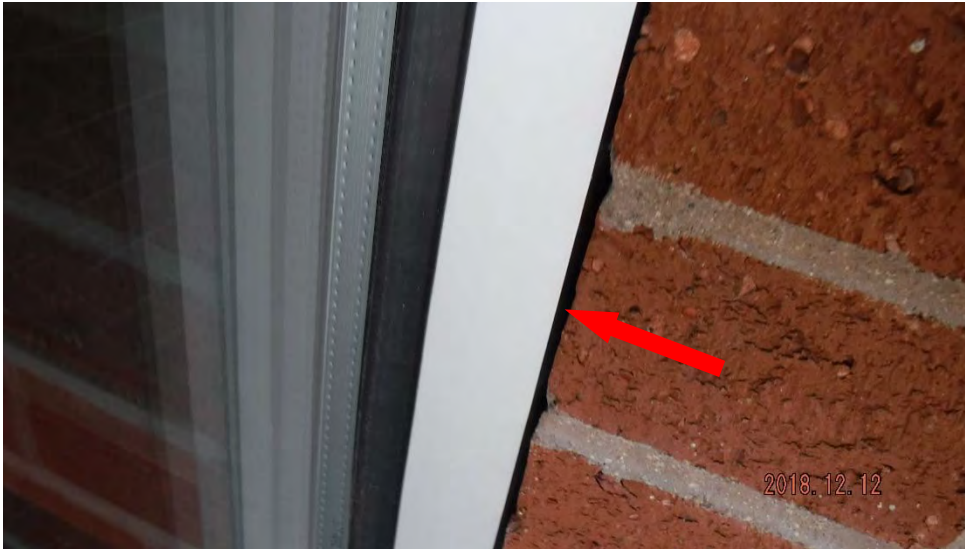
6. Finding – Gap at Masonry to Window/Door Frame: There is a gap between the masonry wall and the window/door framing that was never sealed.

6a. Gap between masonry and window/door frame (see #6 on elevation photo for location).

Recommendation – Gap at Masonry to Window/Door Frame: Prep the joint and install backer rod and sealant as needed.
