Mays Consulting & Evaluation Services, Inc.

BUILDING ENVELOPE ASSESSMENT
COLUMBUS METROPOLITAN LIBRARY
SOUTH HIGH BRANCH
COLUMBUS, OHIO
DECEMBER 12, 2018
MAYS PROJECT # COH44-011

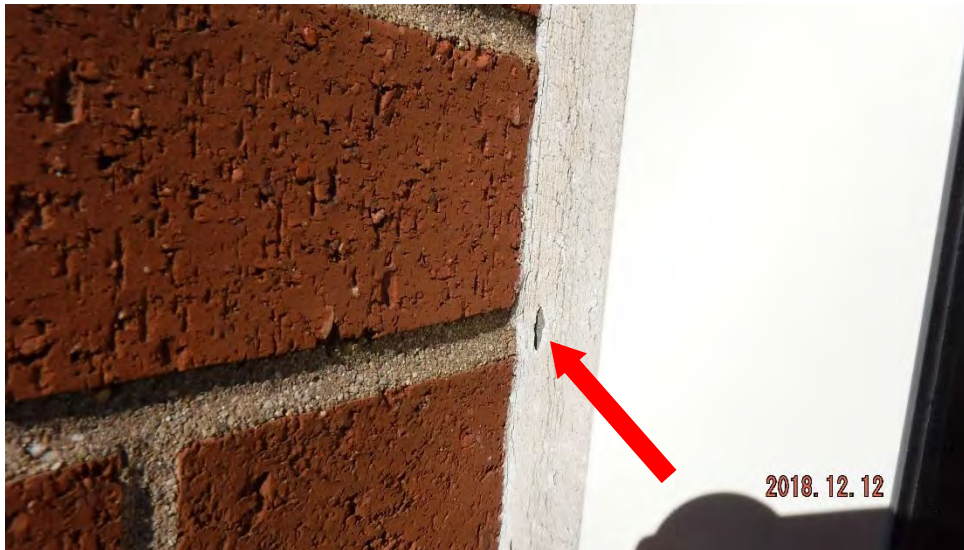
1. Finding – Window to Veneer Sealant Joints: The sealant joints between windows and the various veneers was found to be cracking/shrunk and in poor condition at many locations on the building.

1a. Cracking/shrunk sealant joint. Exposed backer rod visible (see #1 on elevation photo for typical location).

Recommendation – Window to Veneer Sealant Joints: Remove existing sealant from joints, prep joints, and install new backer rod and sealant as needed.

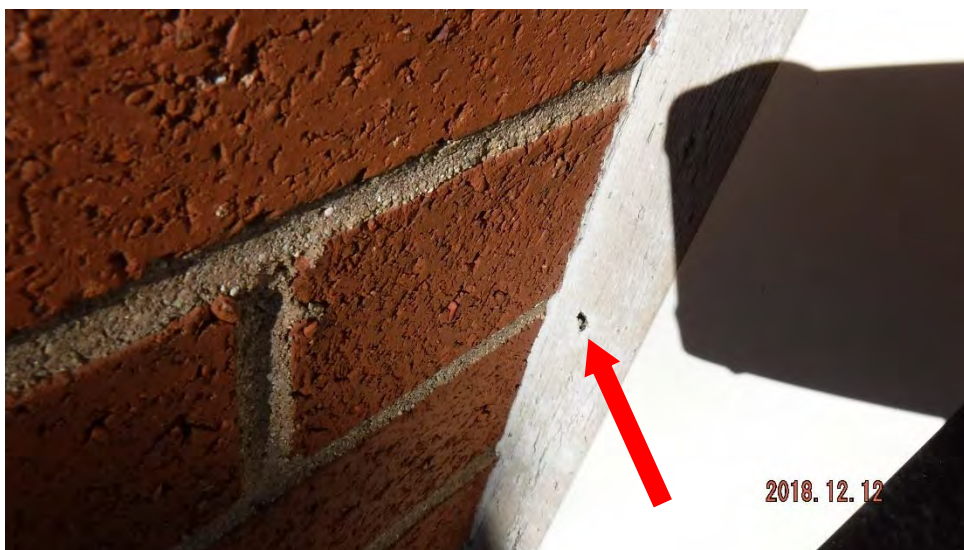
1b. Cracking/shrunk sealant joint (see #1 on elevation photo for typical location).

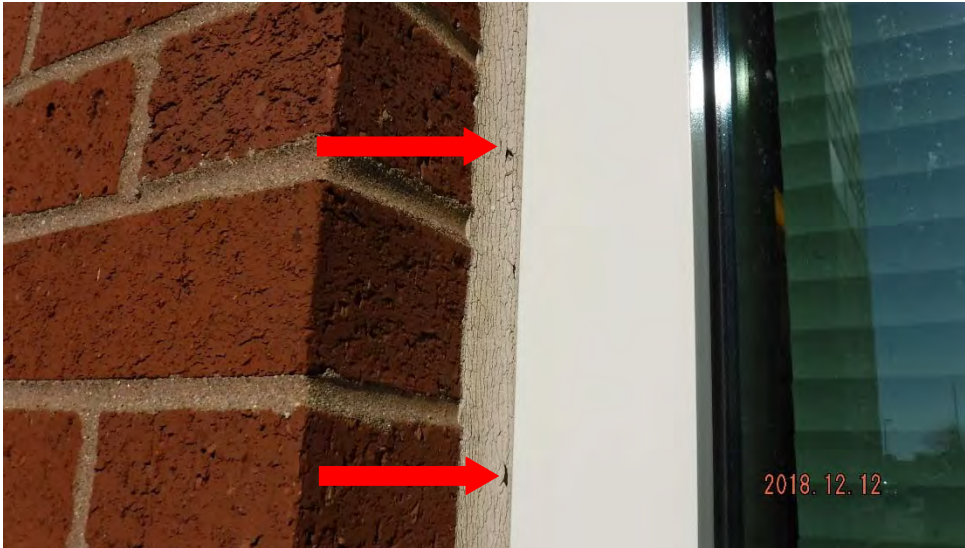
1c. Cracking/shrunk sealant joint (see #1 on elevation photo for typical location).

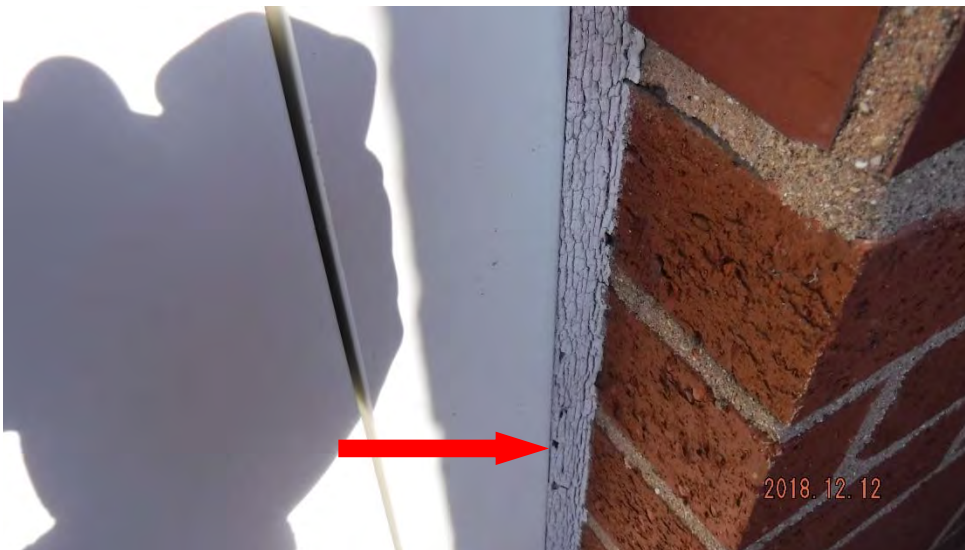
2. Finding – Door to Veneer Sealant Joints: The sealant joints between doors and the veneer was found to be cracking/shrunk and in poor condition at locations around the building.

2a. Cracked/shrunk sealant joint (see #2 on elevation photo for location).

Recommendation – Door to Veneer Sealant Joints: Remove existing sealant from joints, prep joints, and install new backer rod and sealant as needed.

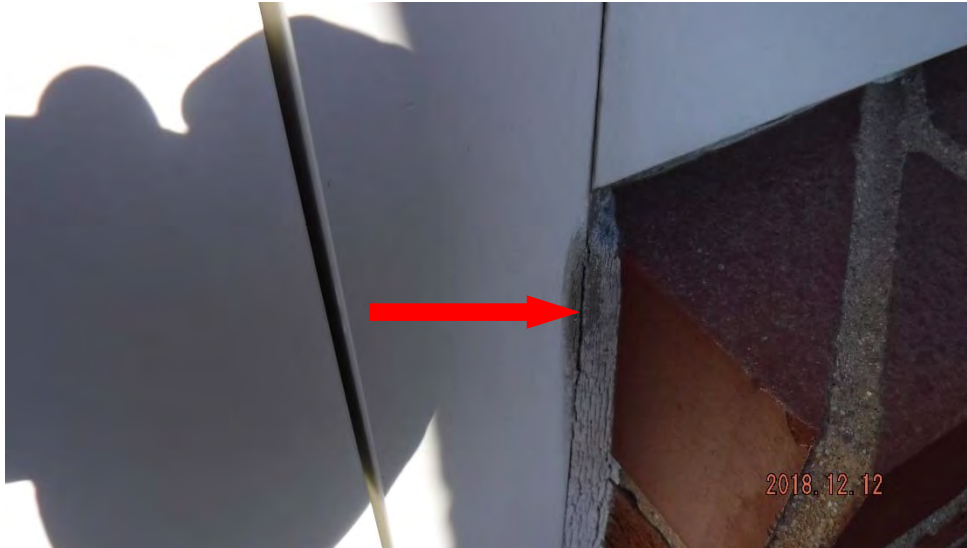
2b. Cracked/shrunk sealant joint (see #2 on elevation photo for location).

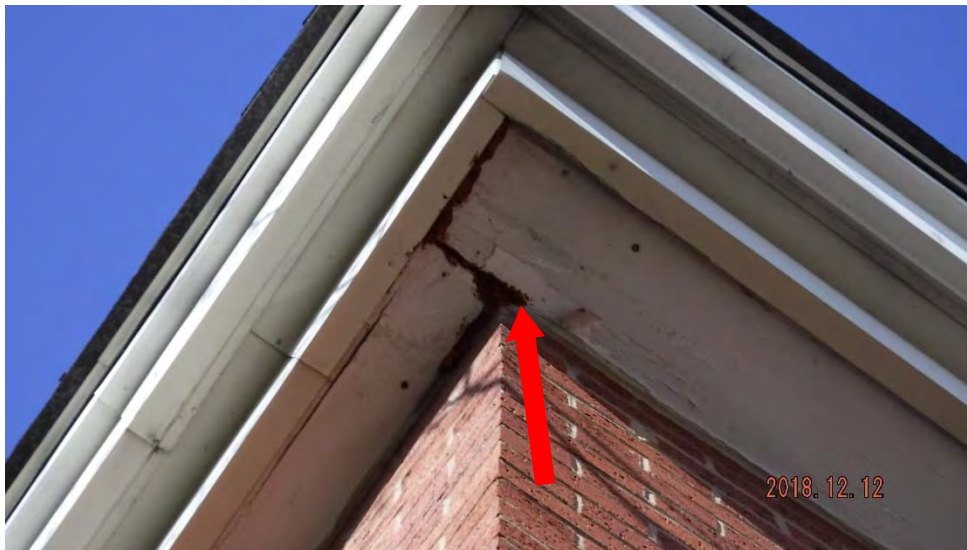
3. Finding – Overhang Soffit: The overhang soffits around the building are in disrepair. There is deterioration, exposed fasteners, cracked joints, and chipping/flaking paint.

3a. Disrepair of soffit and chipping/flaking paint (see #3 on elevation photo for typical location).

Recommendation – Overhang Soffit: Repair or replace deteriorated areas, fix cracked joints, properly prepare all surfaces and then re-paint.

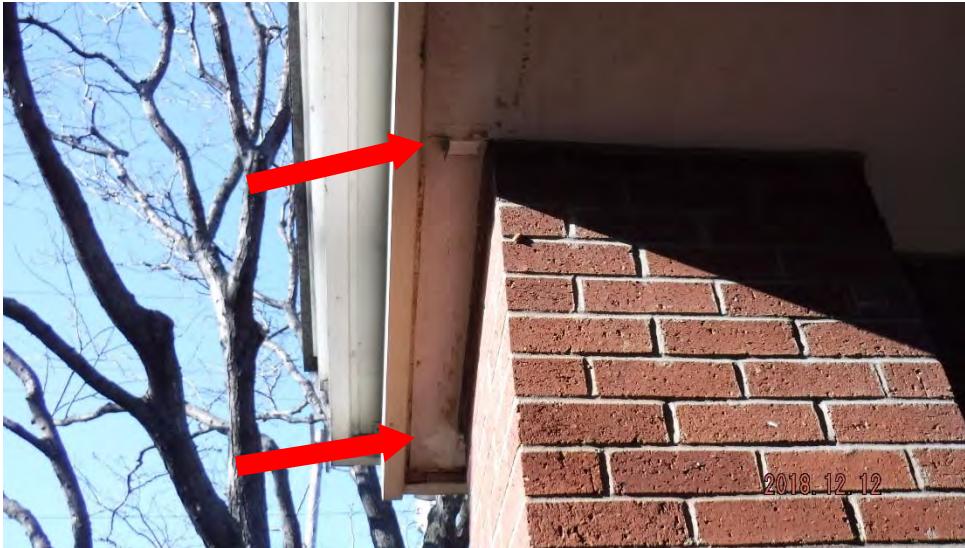
3d. Disrepair of soffit and chipping/flaking paint (see #3 on elevation photo for typical location).

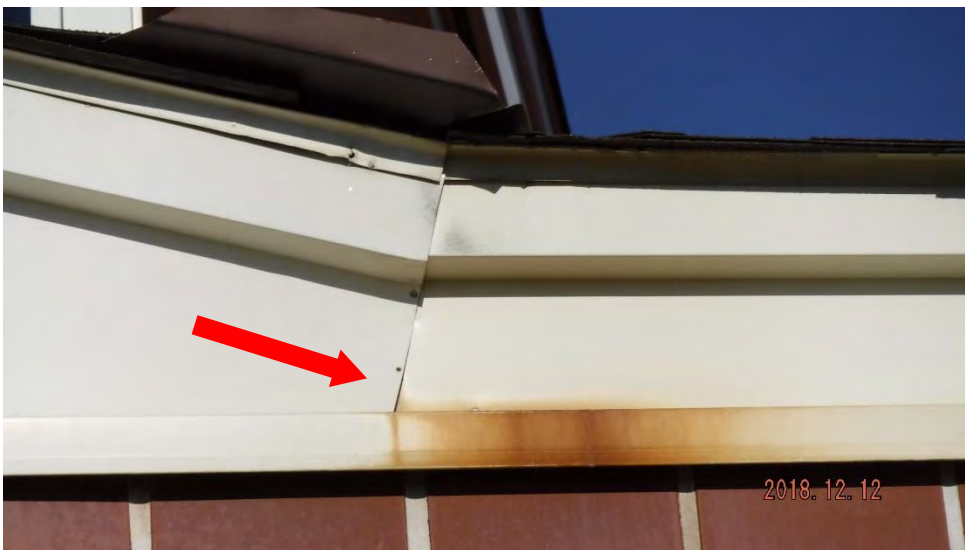
- 4. Finding – Fascia and Cap/Drip Metal:** At the open walkway framing located outside of front entrance to library, there is a piece of loose fascia metal and some corroded cap/drip metal directly below the loose fascia metal.

4a. Loose fascia metal and corrosion on cap/drip metal (see #4 on elevation photo for location).

Recommendation – Fascia and Cap/Drip Metal: Re-fasten the loose fascia metal and replace or remediate the corroded cap/drip metal.

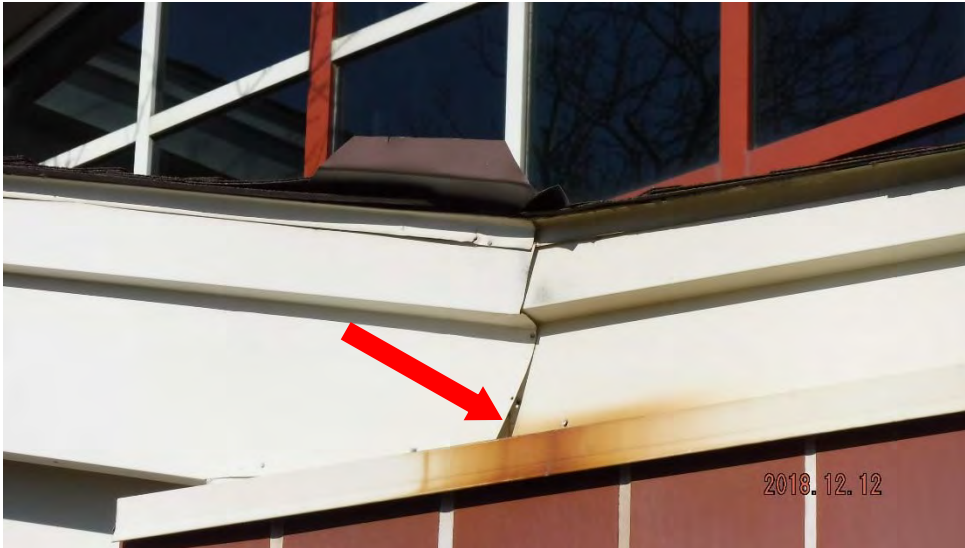
4b. Loose fascia metal and corrosion on cap/drip metal (see #4 on elevation photo for location).

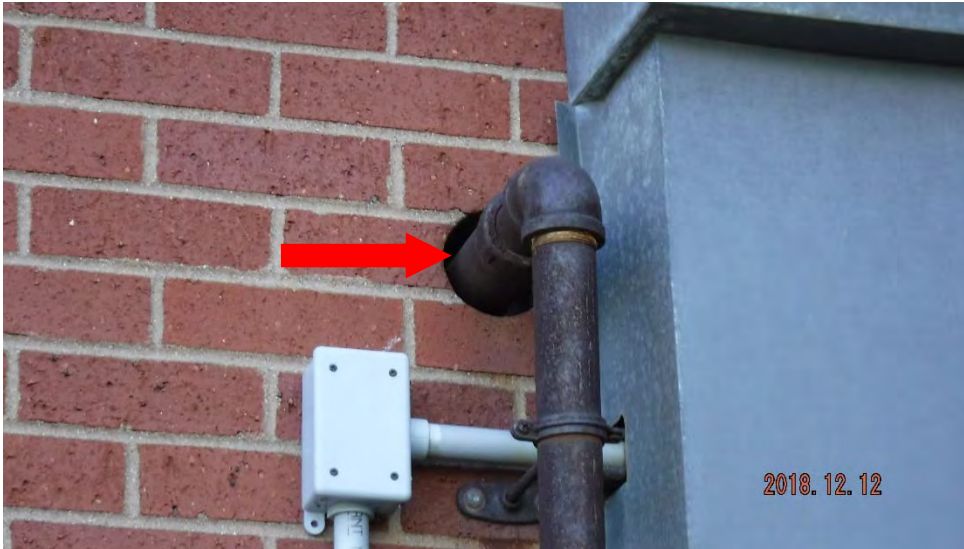
1. Finding – Wall Penetrations: There are some penetrations protruding through the masonry veneer that are not sealed.

1a. Open joint between penetration and veneer (see #1 on elevation photo for location).

Recommendation – Wall Penetrations: Prep the joint between the protrusion and the veneer, then install backer rod and sealant as needed.

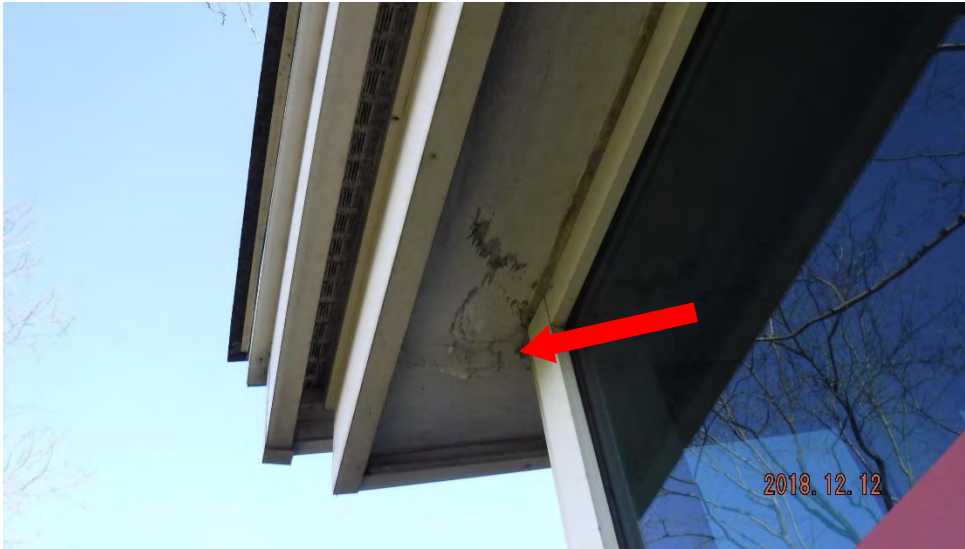
2. Finding – Overhang Soffit: The overhang soffits around the building are in disrepair. There is deterioration, exposed fasteners, cracked joints, and chipping/flaking paint.

2a. Disrepair of soffit and chipping/flaking paint (see #2 on elevation photo for typical location).

Recommendation – Overhang Soffit: Repair or replace deteriorated areas, fix cracked joints, properly prepare all surfaces and then re-paint.

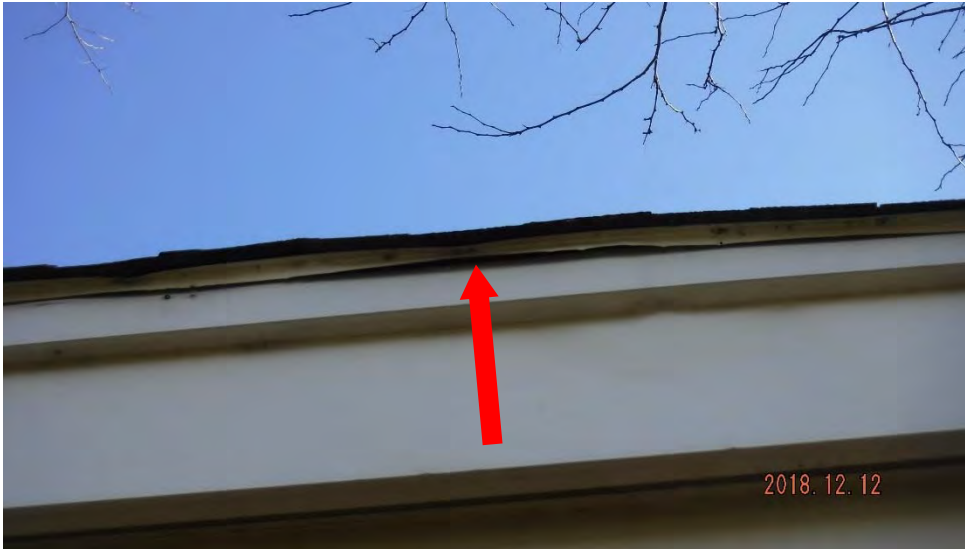
3. **Finding – Drip Edge Metal:** There is a section of drip edge that has been damaged, or has become distorted, and is not properly lapping over the fascia metal.

3a. Damaged or distorted drip edge metal (see #3 on elevation photo for location).

Recommendation – Drip Edge Metal: Make necessary repairs to drip edge so it will work as intended, or replace drip edge if needed.

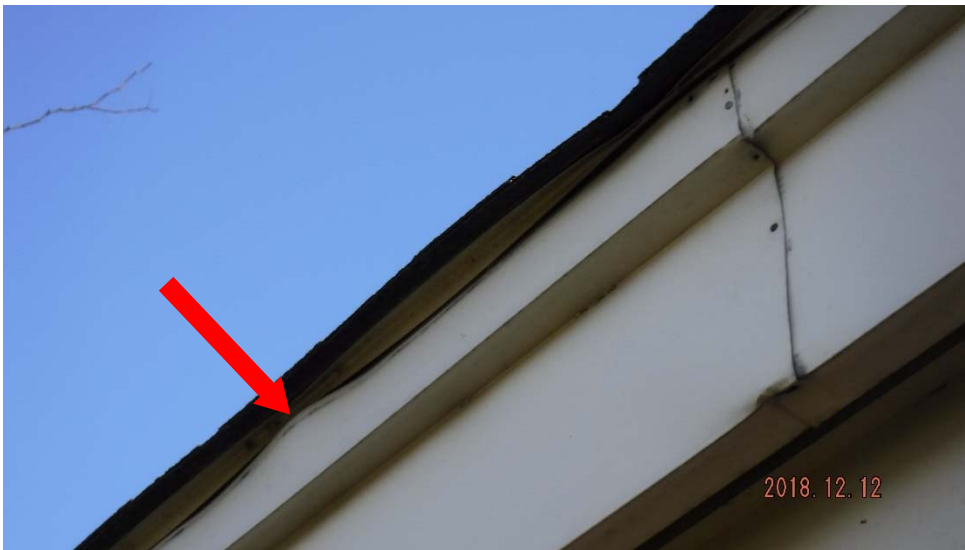
3b. Drip edge metal not lapping over fascia metal as required (see #3 on elevation photo for location).

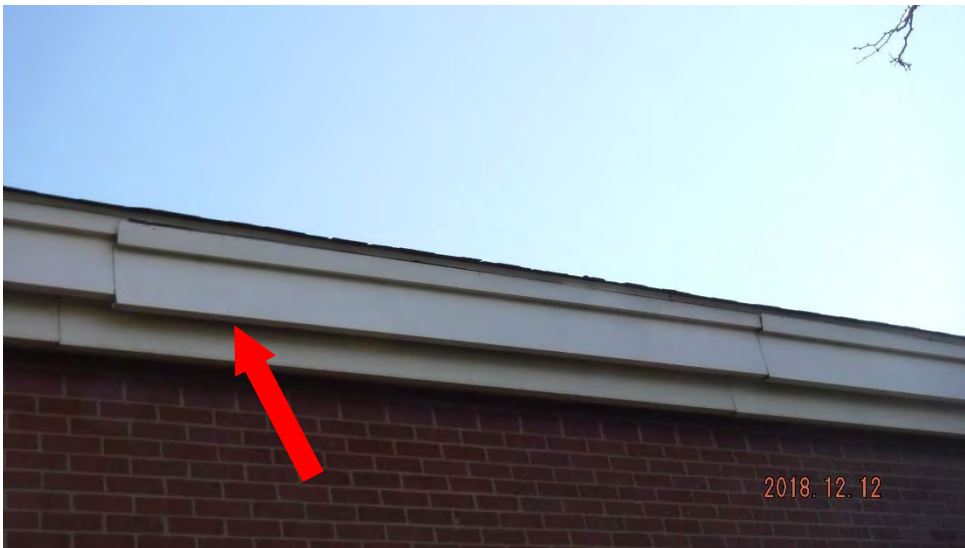
4. **Finding – Fascia Metal:** There are several sections of loose fascia metal located around the building.

4b. Unsecured/loose fascia metal (see #4 on elevation photo for location).

Recommendation – Fascia Metal: Re-secure the fascia metal or replace if needed.

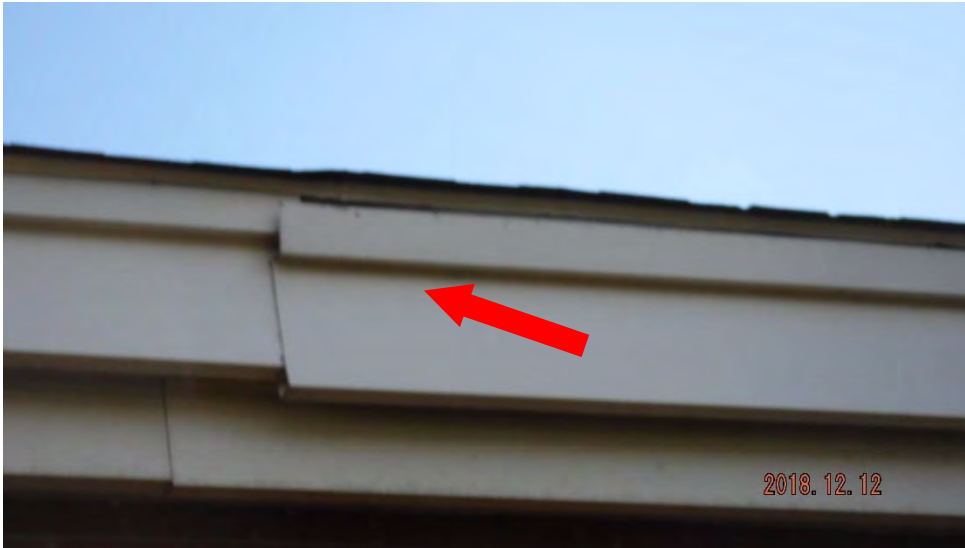
4c. Unsecured/loose fascia metal (see #4 on elevation photo for location).

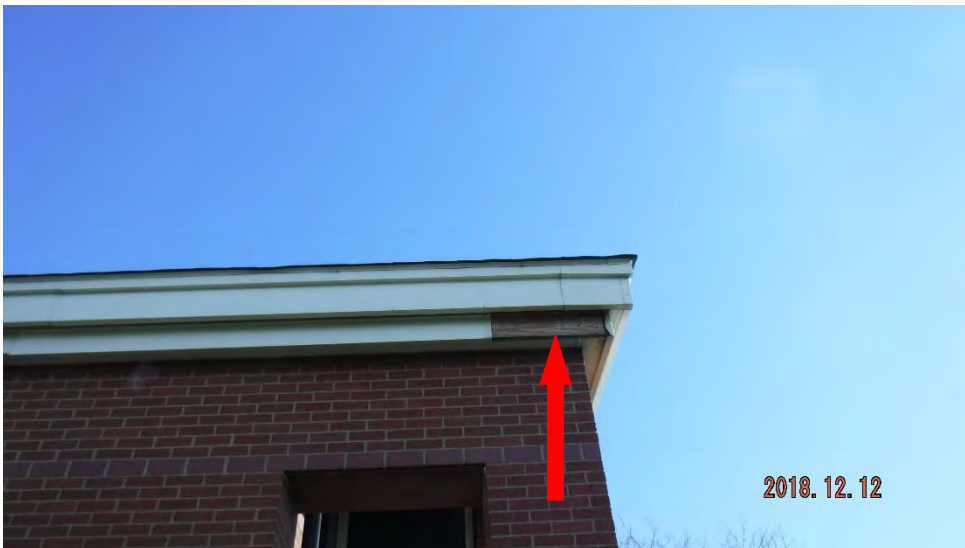
5. Finding – Fascia Metal: There is a section of missing fascia metal. The wood fascia member is exposed in this area at present.

5a. Overview of area where fascia metal is missing (see #5 on elevation photo for location).

Recommendation – Fascia Metal: Install new section of fascia metal.

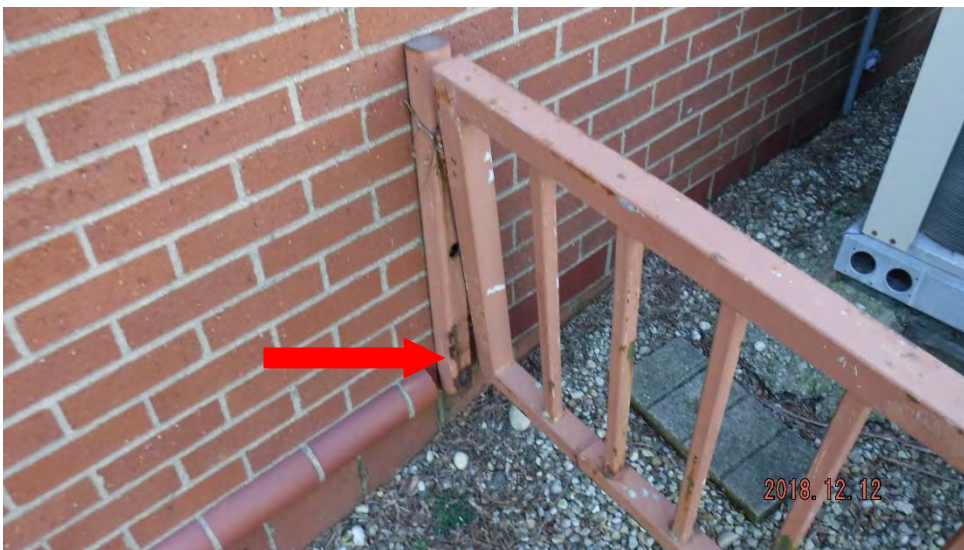
6. Finding – Gate Hinge: There is a broken/missing gate hinge for gate where HVAC equipment is stored.

6a. Broken gate hinge (see #6 on elevation photo for location)

Recommendation – Gate Hinge: Install new hinge for gate.

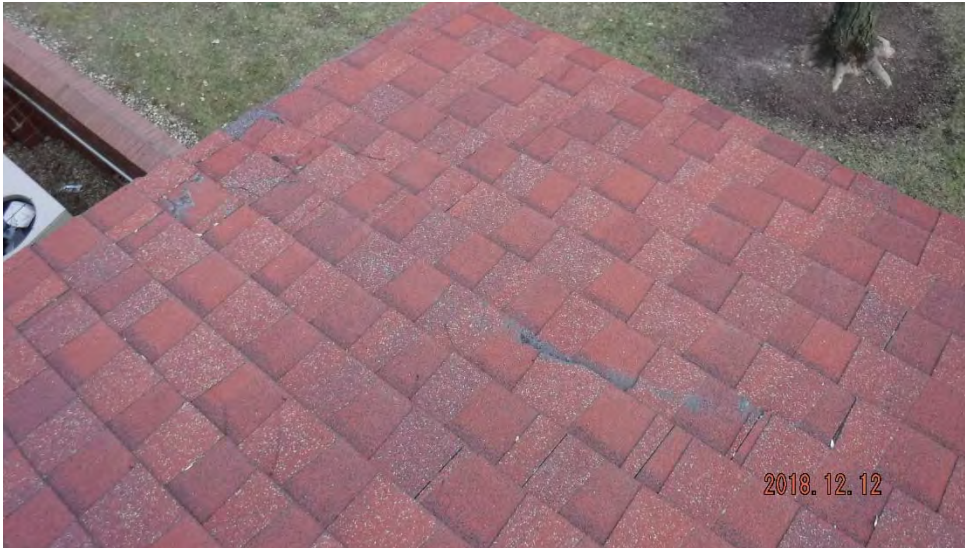
3. Finding – Shingles: There were several damaged shingles found at lower roof area close to eave. There is a tree located close to this same area. It is thought that a limb from the tree had probably dropped on roof in this area at some point and caused the damage.

3a. Damaged shingle area (see #3 on plan view for location).

Recommendation – Shingles: Replace damaged shingles. Cut tree branches back to prevent limbs from falling onto roof in the future.

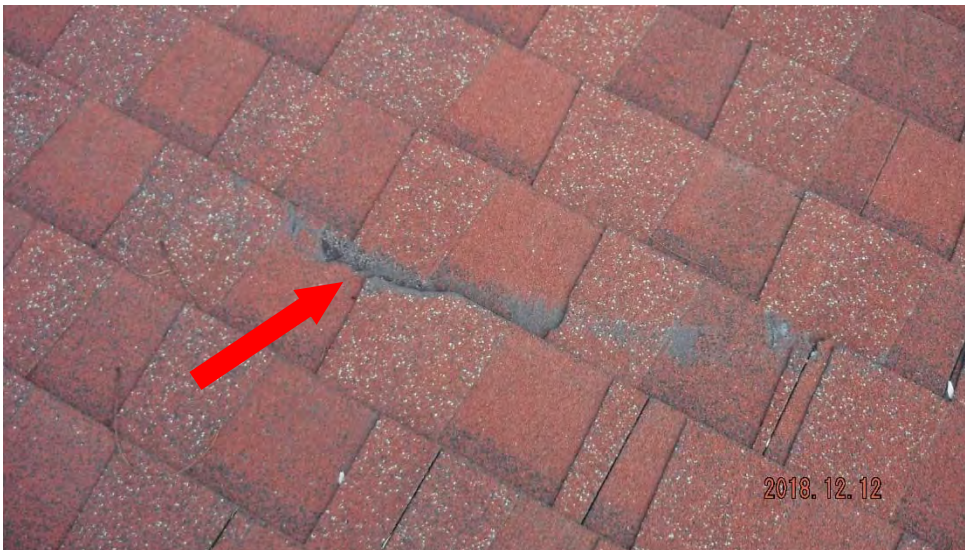
3b. Damaged shingles (see #3 on plan view for location).

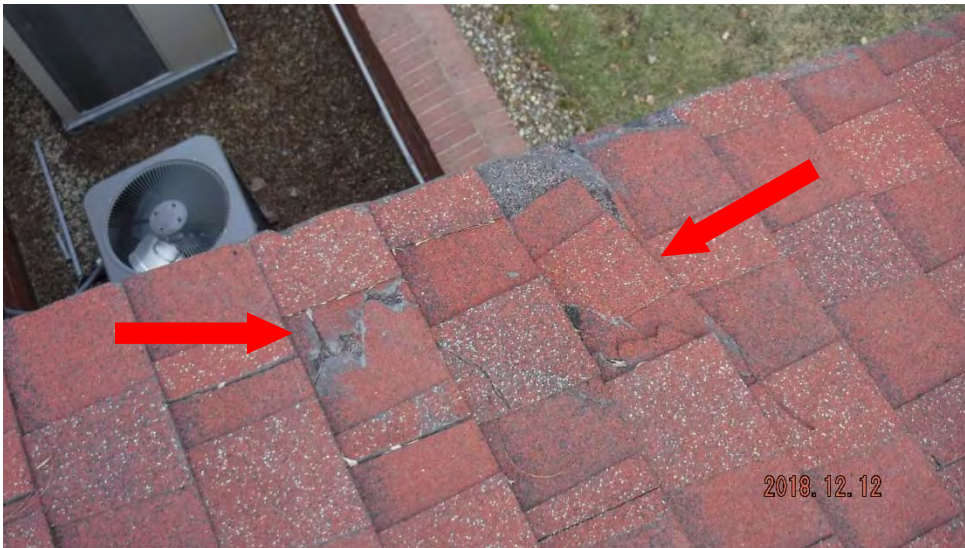
3c. Multiple damaged shingles (see #3 on plan view for location).

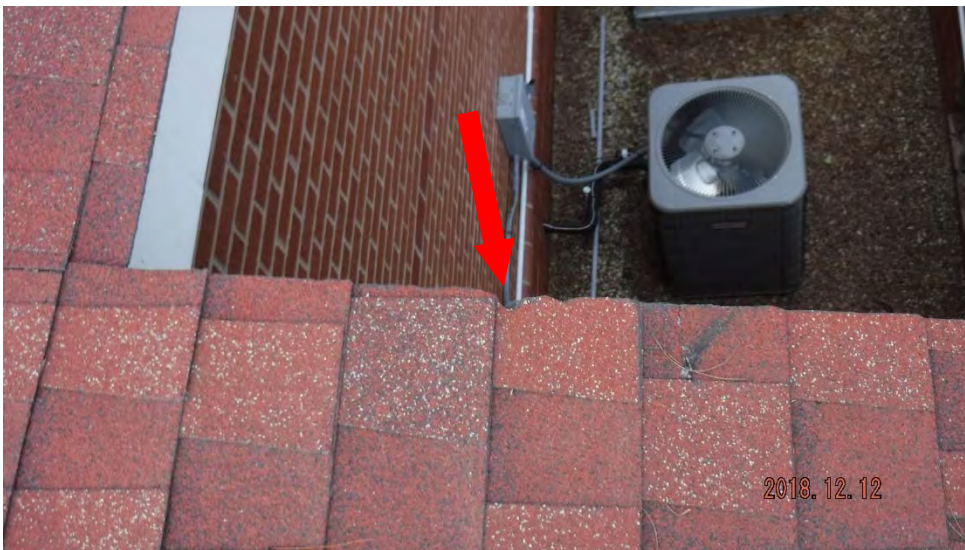
3d. Damaged shingles (see #3 on plan view for location).

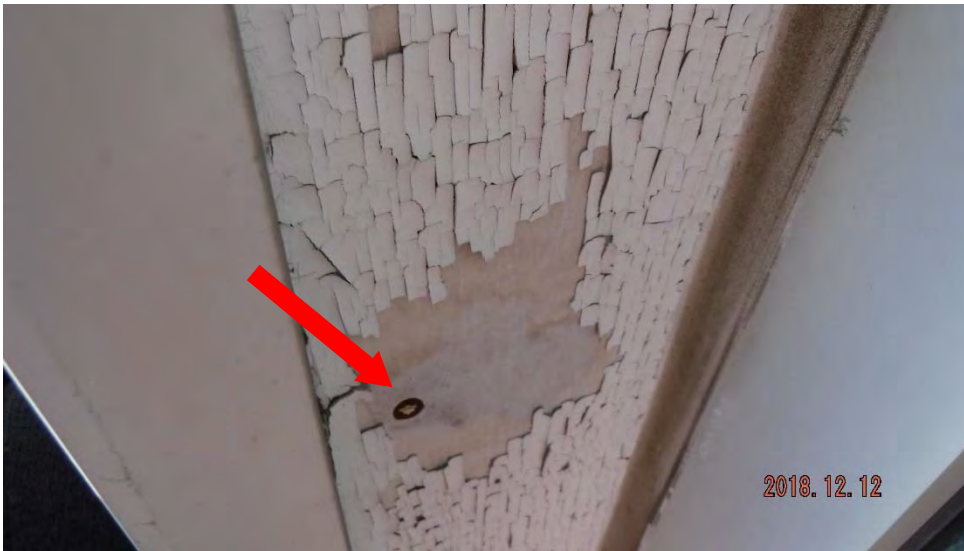
1. Finding – Overhang Soffit: The overhang soffits at the clerestory are in disrepair. There is deterioration, exposed fasteners, cracked joints, and chipping/flaking paint.

1a. Exposed fastener and chipping/flaking paint (see #1 on elevation photo for typical location).

Recommendation – Overhang Soffit: Repair or replace deteriorated areas, fix cracked joints, properly prepare all surfaces and then re-paint.

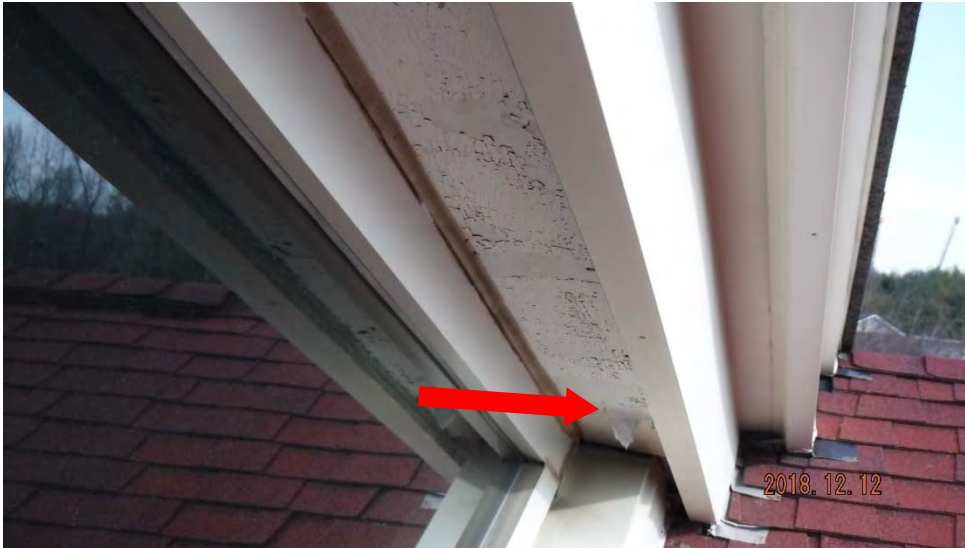
1c. Chipping/flaking paint (see #1 on elevation photo for typical location).

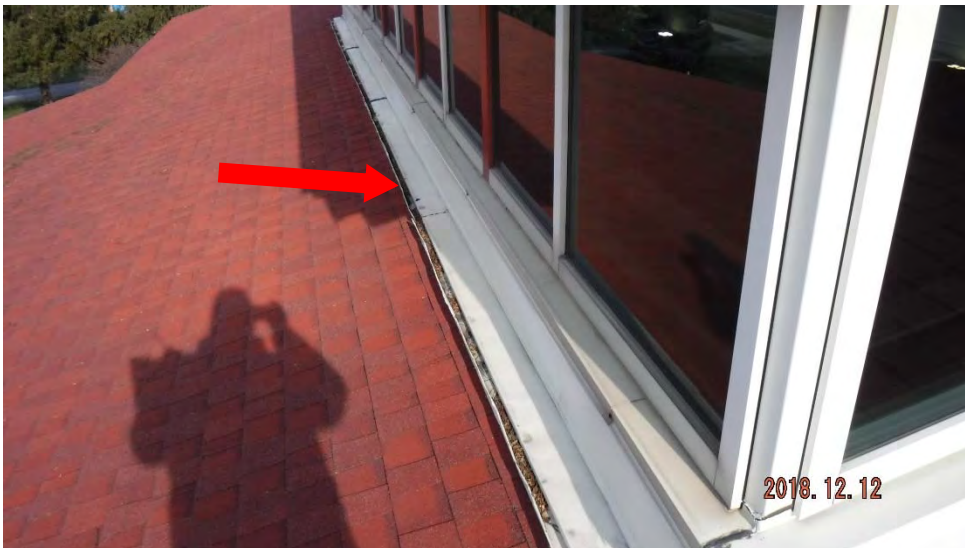
2. Finding – Headwall Vent: The headwall vent at base of clerestory windows has had sealant repairs in the past at the joints of the vent. Many of these sealant repairs have since peeled off or cracked exposing the joints.

2a. Overview of headwall vent at clerestory (see #2 on plan view for location).

Recommendation – Headwall Vent: Properly clean the joints of the headwall vent, prep and re-seal the joints as needed.

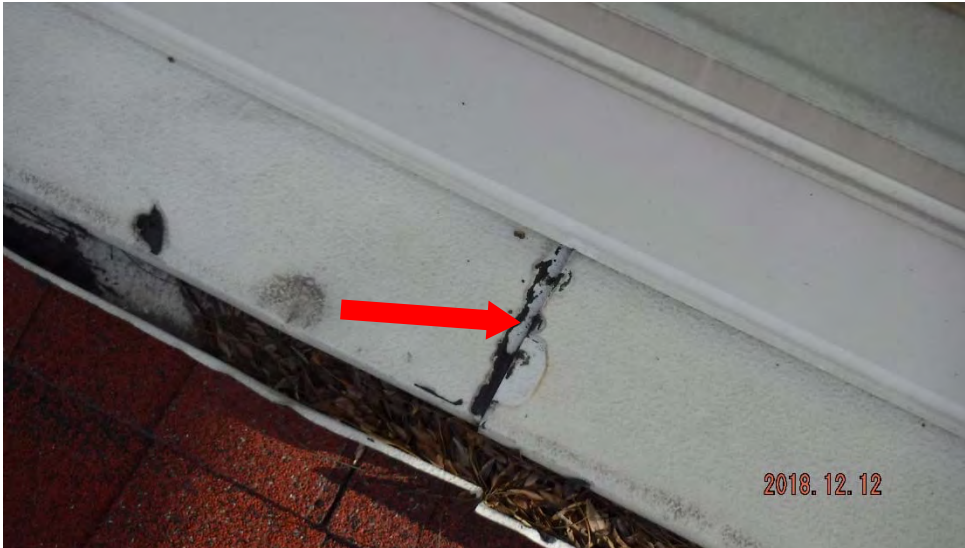
2b. Missing sealant at the vent joint (see #2 on plan view for typical location).

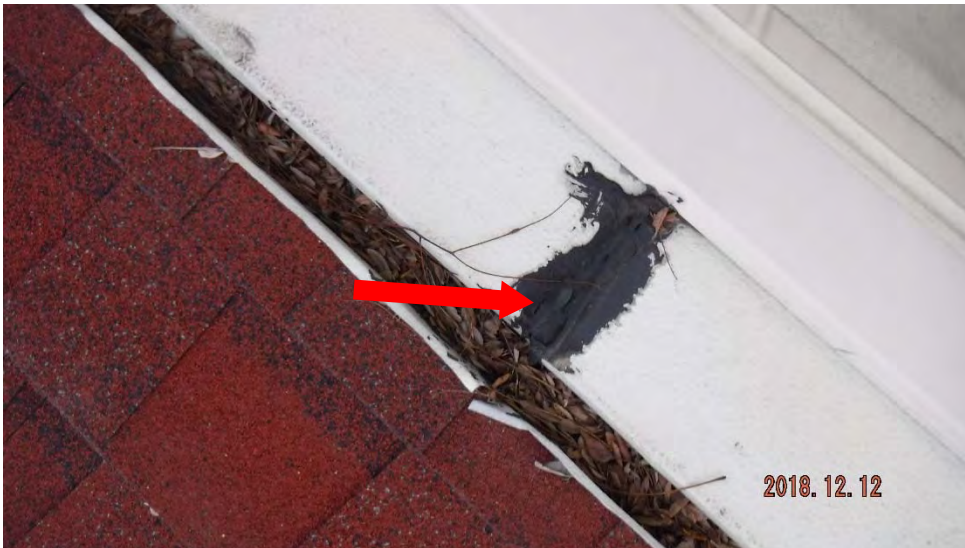
2c. Cracking of the sealant at the vent joint (see #2 on plan view for typical location).

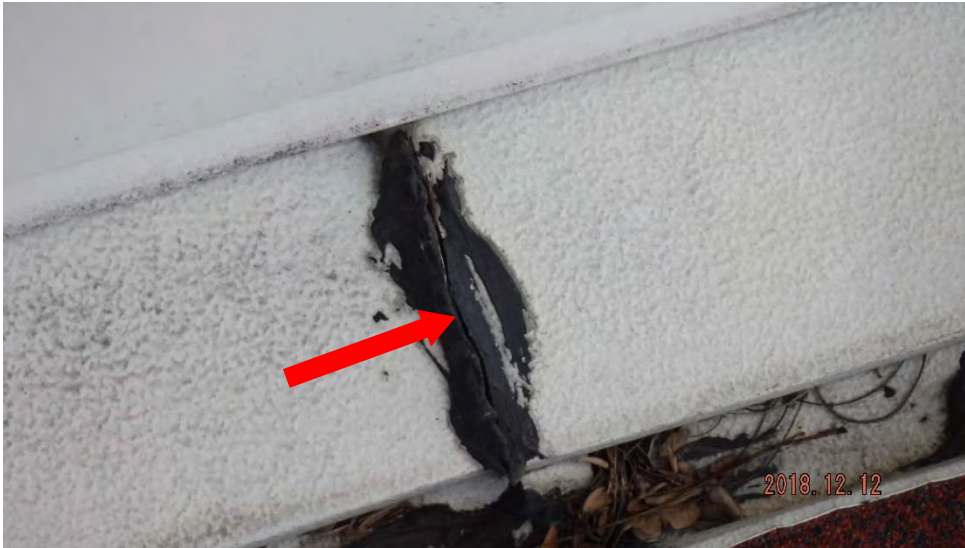
2d. Cracking of the sealant at the vent joint (see #2 on plan view for typical location).

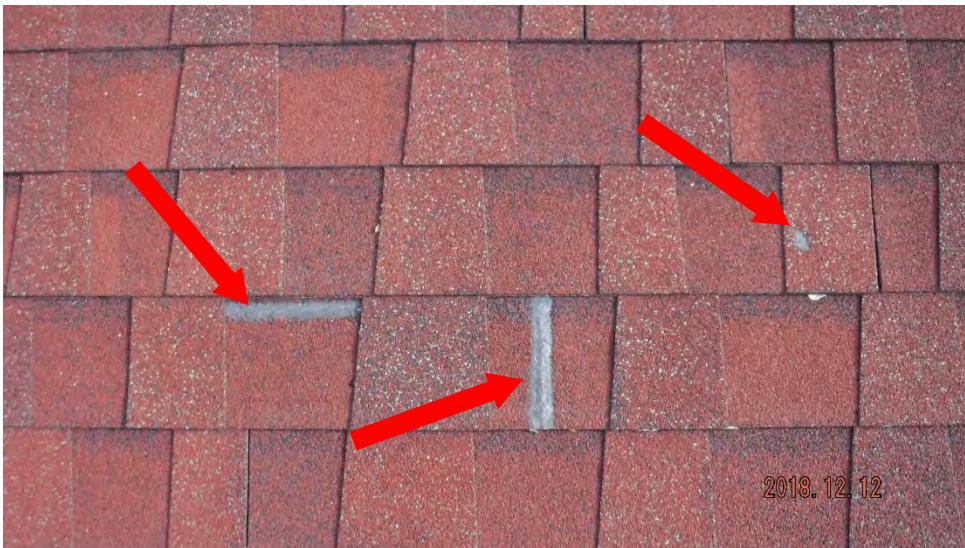
3. **Finding – Shingles:** There appears to be some deficiencies in the roof shingles at some areas. The granules are missing and fabric within the shingles is exposed.

3a. Exposed fabric in deficient shingles (see #3 on plan view for typical locations).

Recommendation – Shingles: Replace the deficient shingles as needed.

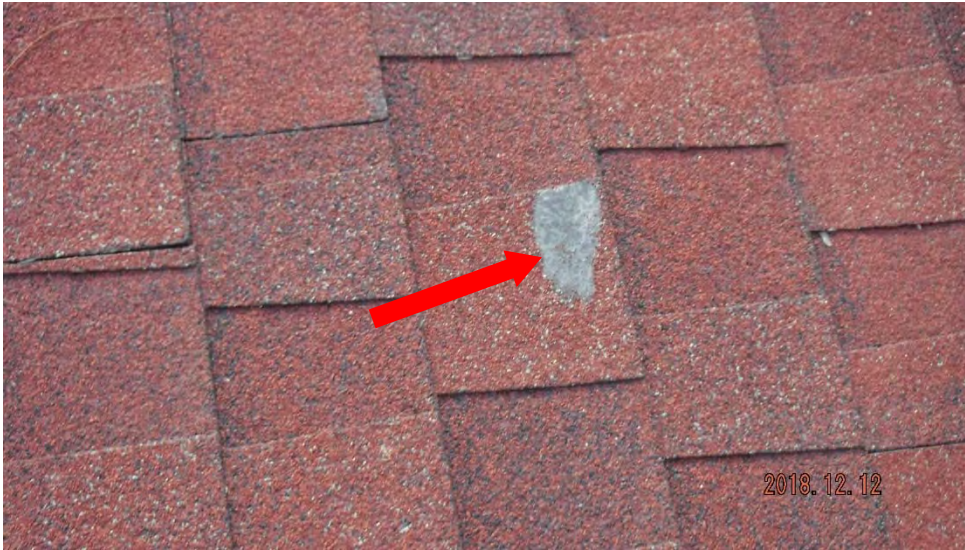
3b. Exposed fabric in deficient shingle (see #3 on plan view for typical locations).
