Commander  
United States Coast Guard  
Atlantic Area

## MEMORANDUM

Subj: MAJOR INCIDENT INVESTIGATION (MII) INTO THE CIRCUMSTANCES  
SURROUNDING THE LOSS OF LIFE DURING THE F/V ORIN C SAR CASE IN  
THE SECTOR BOSTON AOR ON 3 DECEMBER 2015

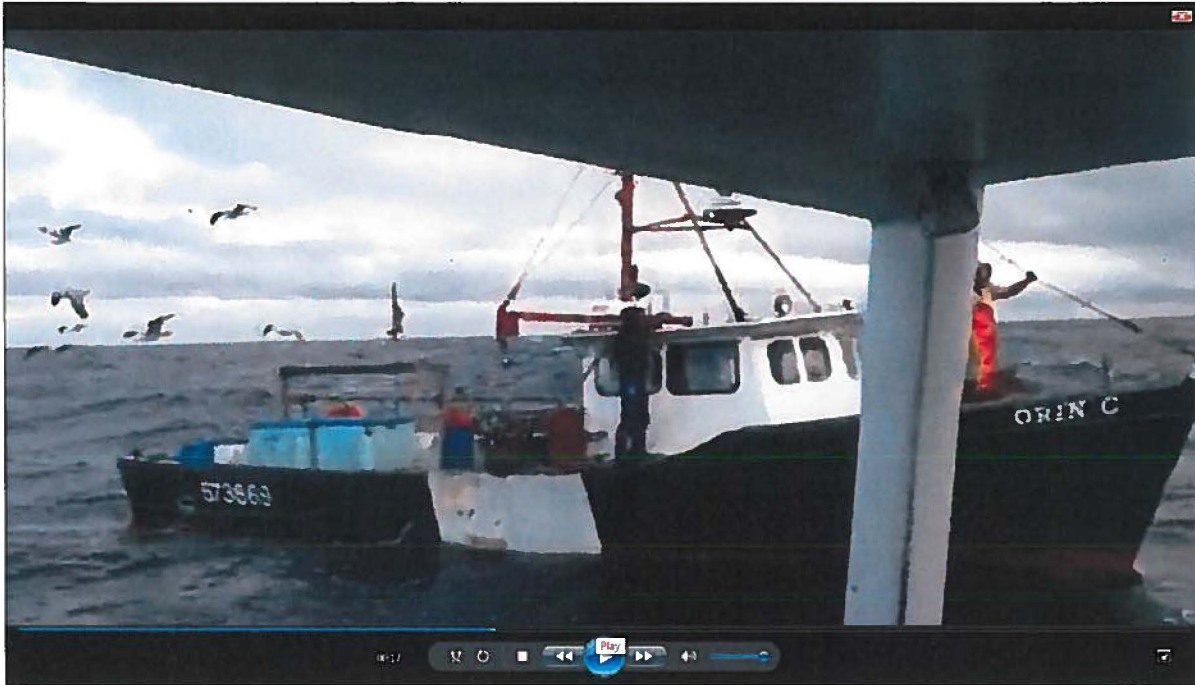
~~F/V ORIN C 03 Dec 15 prior to tow by F/V FOX Y LADY~~

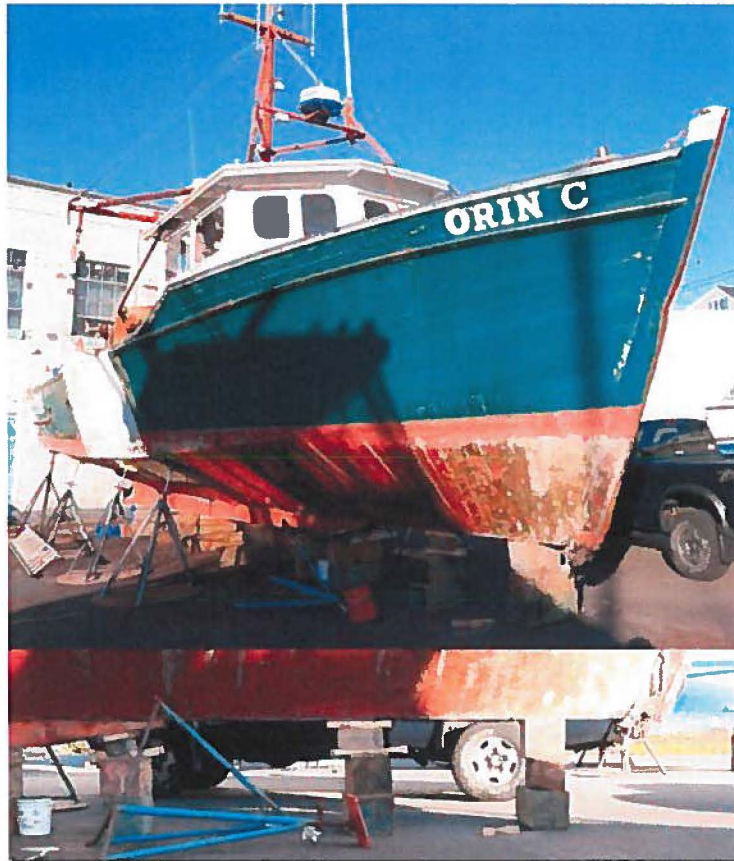
Photo from FisherlyNation.com article showing keel damage

1. Previous damage - As mentioned in paragraph 4.b.3 above, the ORIN C was a 39 year old wooden boat. She had suffered keel/bottom damage in a grounding off Ten Pound Island at some point, as documented in the article in *FisheryNation.com*. Photos show a portion of the forward keel removed for repair. Attempts to gain more information from the owner of the repair facility on the physical condition of the ORIN C at that time proved unsuccessful. (Exhibits 3, 15)

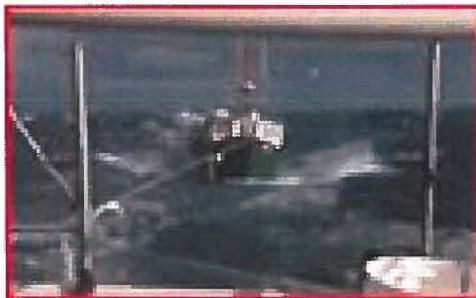
3. At approximately 1215 FOXY LADY began a tow using approximately 250 feet of stranded synthetic long line. However, the tow line parted at least three times, shortening the length of the tow line to under 100 feet. (Exhibits 3, 10)

Tow by FOXY LADY

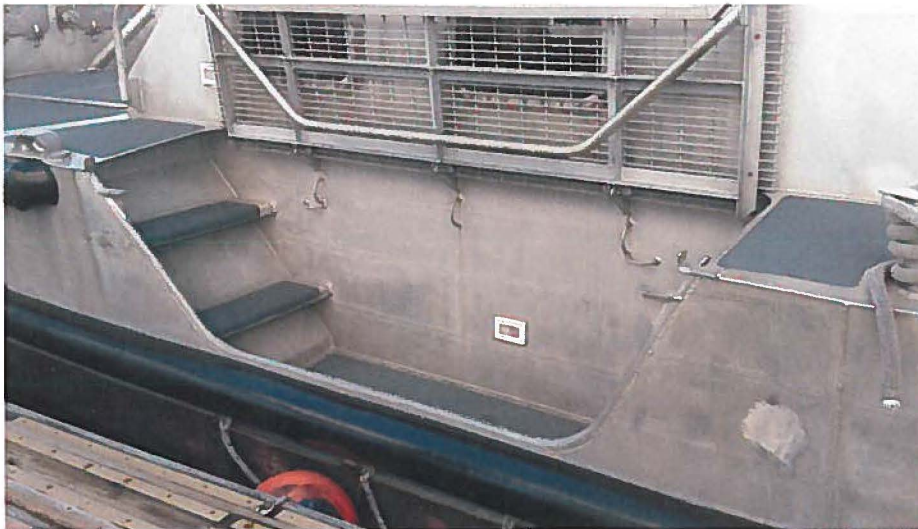
and he deployed into the water wearing his drysuit. The swimmer brought the third crewman to the side recess on the starboard side of CG47259. The time from the third crewman entering the water to being brought to the side of the CG47259 was approximately three to four minutes. The third crewman appeared unresponsive and was not breathing. (Exhibit 3)

Starboard side recess on CG47259

25. At 2030, the third crewman was recovered into the side recess of the CG47259. Watery white foam was reported to be discharging from the mouth of the third crewman. It took the efforts of seven crew aboard CG47259 approximately four minutes to get the third crewman onto the CG47259 due to extreme sea state and the third crewman's size estimated at close to 300 lbs. It took several more minutes to get the third crewman up to the aft deck in order to have space to perform CPR. (Exhibit 3)
