MEMORANDUM FOR FILES

SUBJECT: Ambler Asbestos Piles Superfund Site, OU1 & OU2, Ambler, PA – Site Inspection Report

1. **DATE OF INSPECTION:** 8 December 2015, 0900 HRS to 1200 HRS.

4. **PURPOSE:** Conduct a quarterly site inspection.

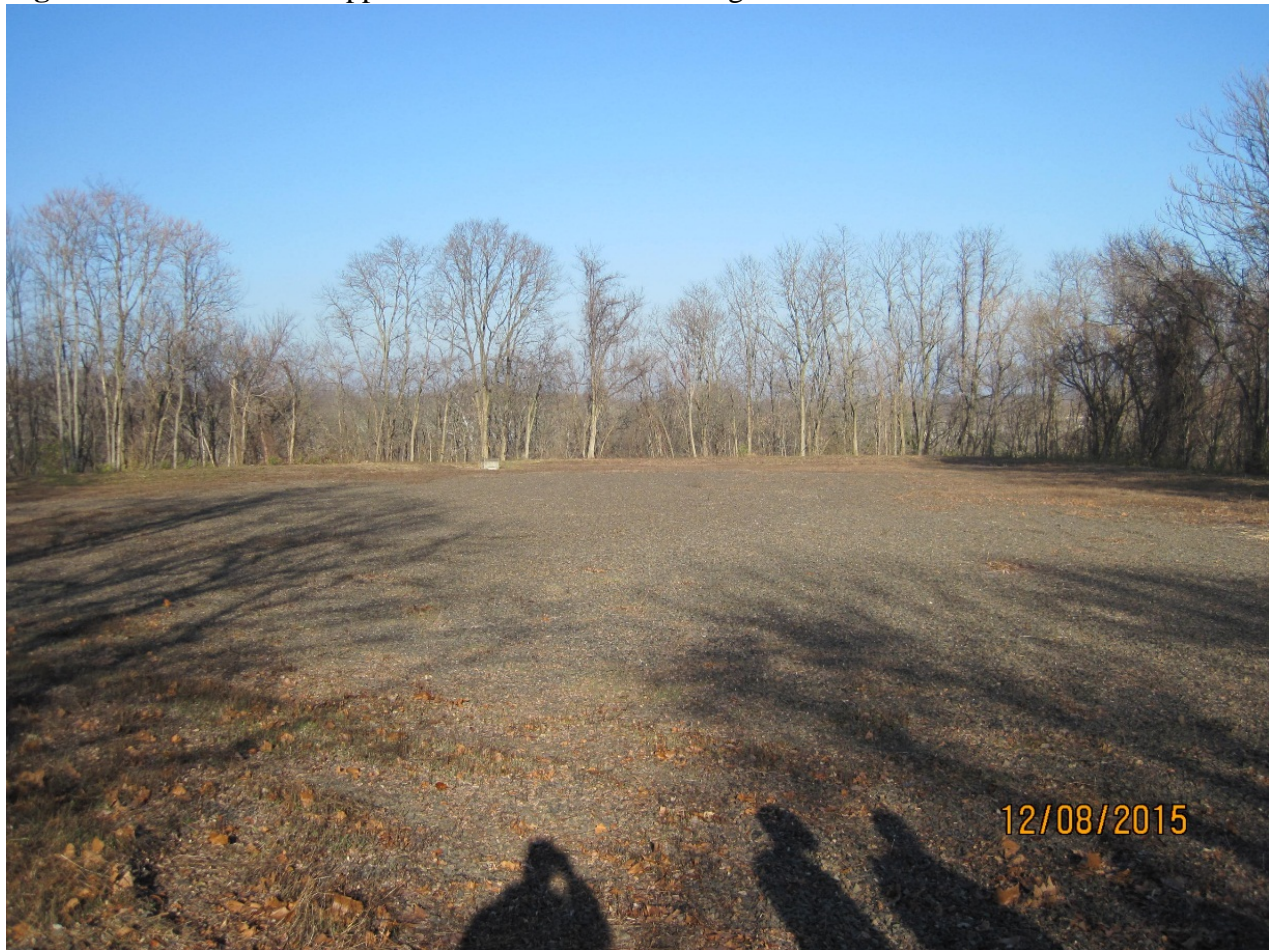
Vegetation that was observed on the Upper Locust Street Pile (see attached map) during the September inspection had been recently mowed. According to Mr. Williams, the vegetation rebounds after mowing and he will begin spraying it with an herbicide in spring.

Figure 1: Plateau of the Upper Locust Street Pile looking north towards outlet box.

7.1 The vegetation encroaching on the Locust Street Piles and the Plant Pile should be killed and removed on the pile plateaus. The extent of vegetation removal should extend to within a few feet of the top of slope on the plateaus. Any dead trees on the slope should be cut and removed. (Figures 1, 2, 4, 7, &10)

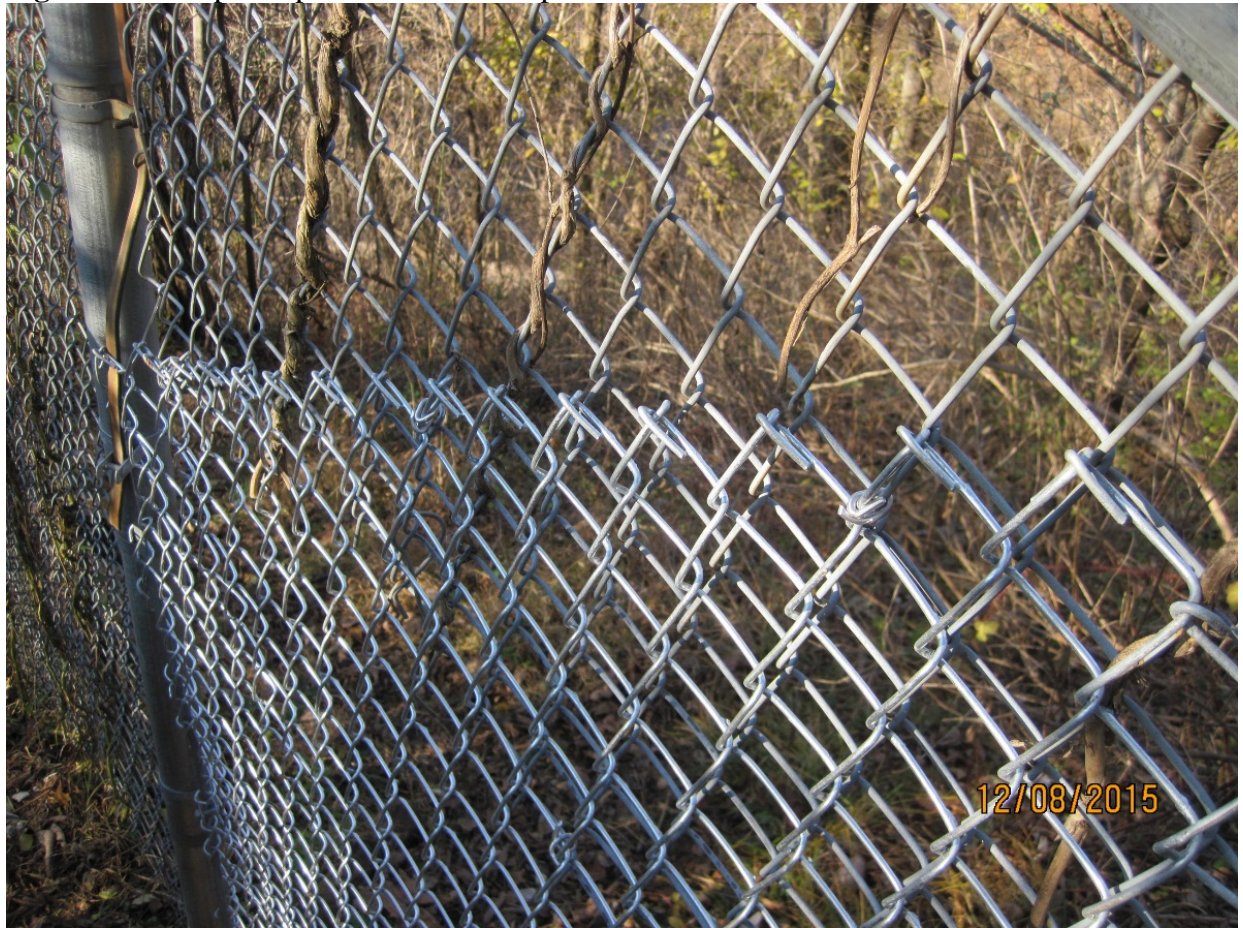
All previously observed holes in the fence had been patched using permanent crimp type connectors (see Figure 2). These patches will deter people from entering the site that do not have tools to cut the fence. Asbestos rings were observed hanging on some of the fence supports (see Figure 3). The rings are presumably found outside of the site in the Wissahickon Creek and placed there by pedestrians. WSP will remove and dispose of them properly.

Figure 2: Example of permanent fence repair.

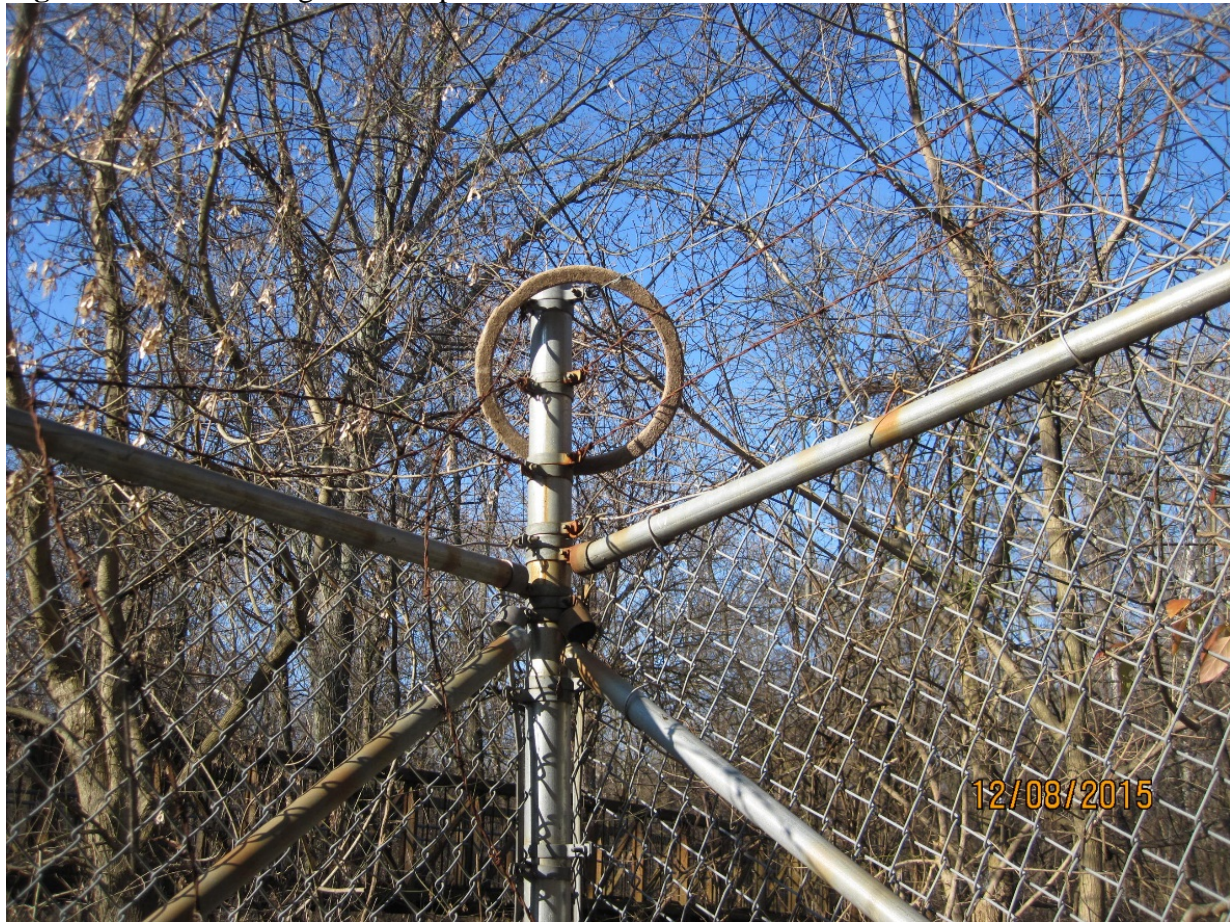
Figure 3: Asbestos ring on fence post.

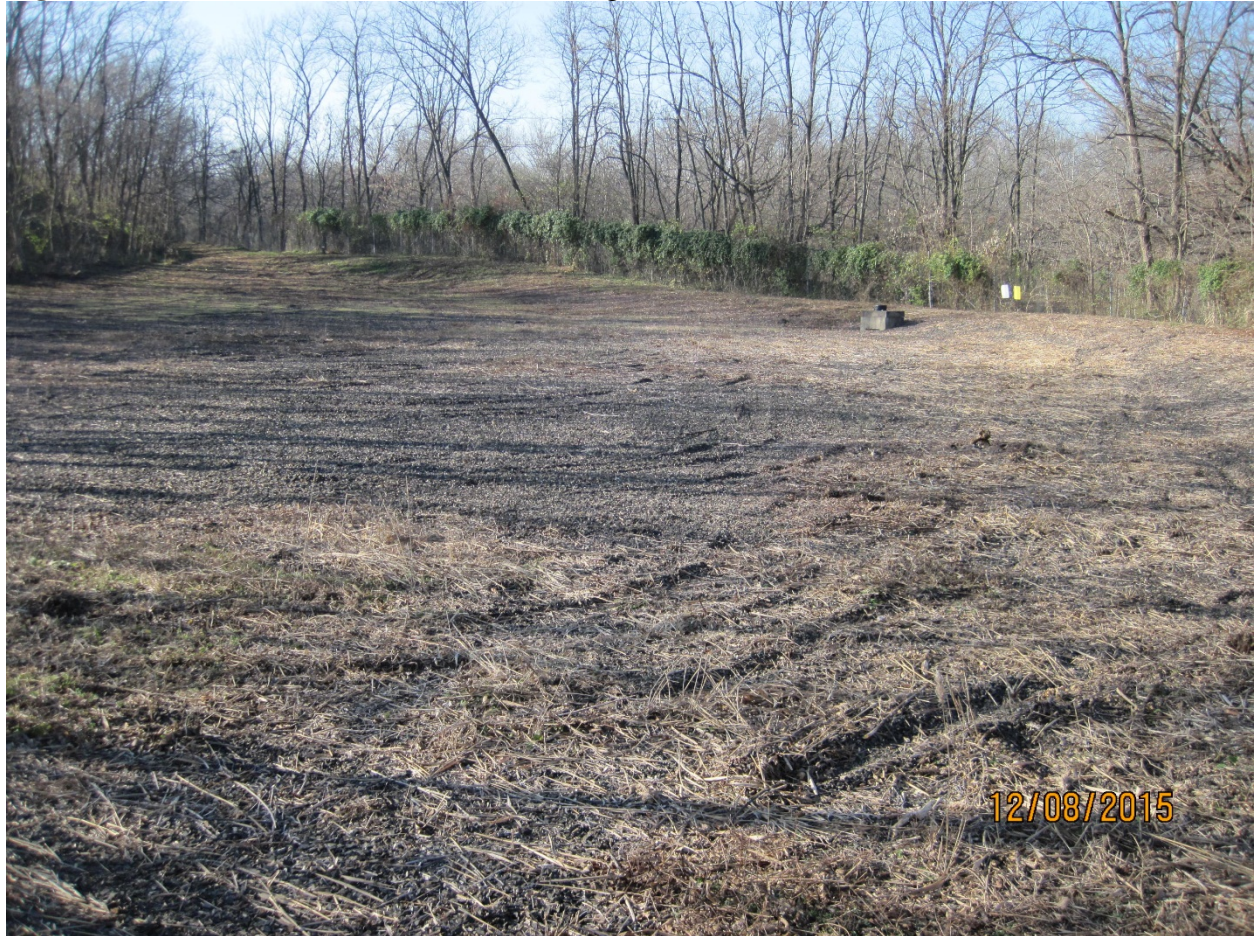
The Lower Locust Street Pile is in a similar condition to the Upper Locust Street Pile and has vegetation growing across the gravel that has been mowed. This vegetation will also be part of Mr. Williams's herbicide program in spring. The plateau drains for both Locust Street Piles appeared to be in good condition.

Figure 4: The Lower Locust Street Pile looking southwest toward outlet box.

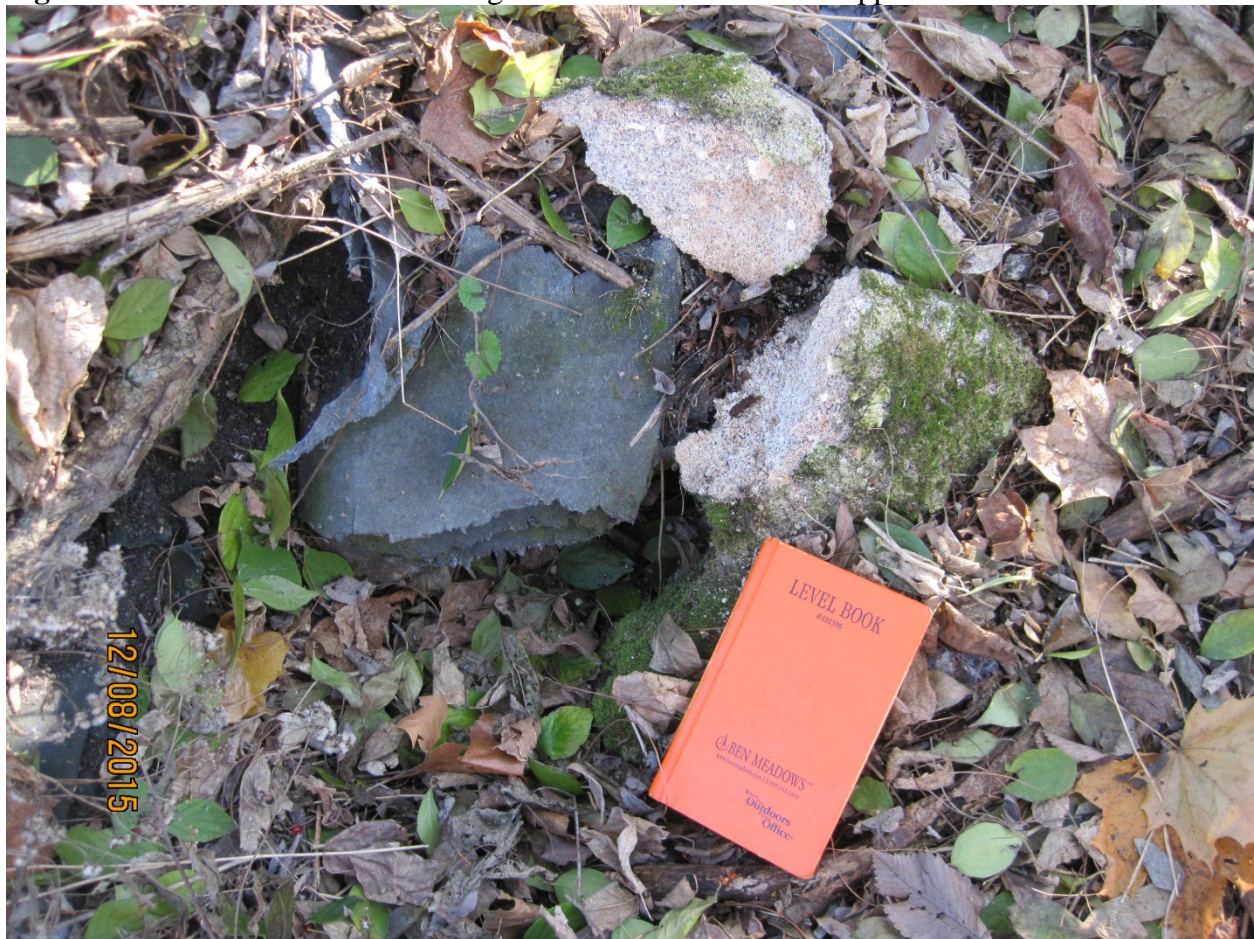
Debris was found along the path on top of the Upper Locust Street Pile at approximately 40.14907, -75.22566. There was a substance that looked like concrete, but was brittle and easy to break. There was also a grey fiber board located in the same area (see Figure 5). It is unclear if either of these items contain asbestos or if they are merely residential waste illegally dumped on site over the years. WSP will have these items tested for asbestos content.

Figure 5: Possible asbestos containing material observed on the Upper Locust Street Pile.

7.8 Trash at 40.14907, -75.22566 should be tested for Asbestos containing material.

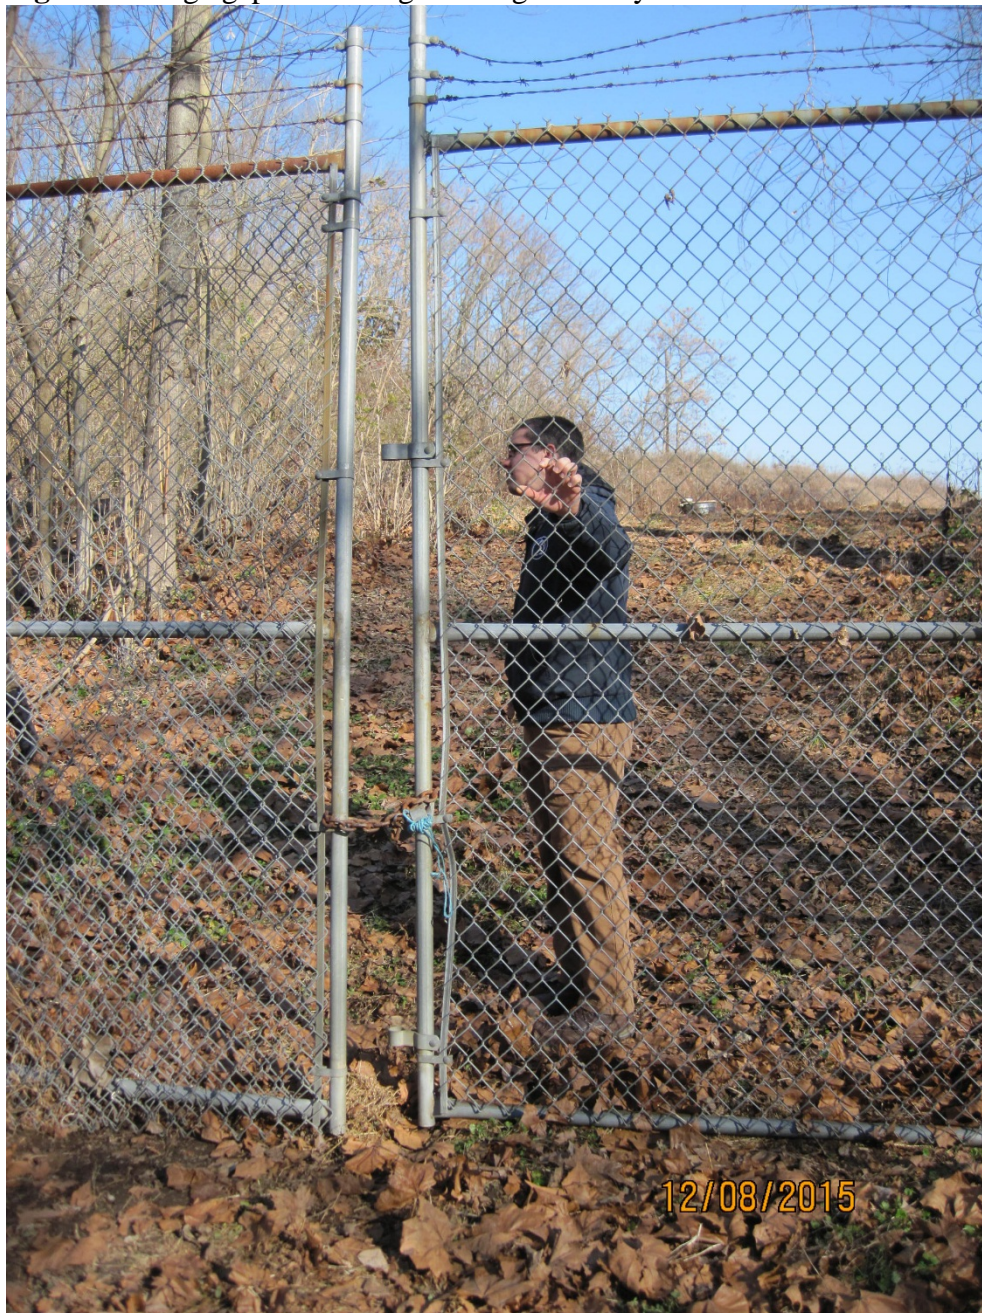
The gate along the right-of-way leading to the Wissahickon Creek between the Plant Pile and Upper Locust Street Pile has a gap large enough to permit human access (see Figure 6). This should be fixed as soon as possible to limit entry. Suggestions include adjusting hinges on both gates and replacing the missing pipe between the gates to narrow the gap. There are numerous pieces of trash along the inside of the fence including old appliances, tires, and drums that should be removed and disposed of properly. Another smaller fence gate in this area has a large opening underneath the gate due to erosion. WSP agreed to fill in the area under the gate to limit access.

Figure 6: Large gap in access gate to right of way.

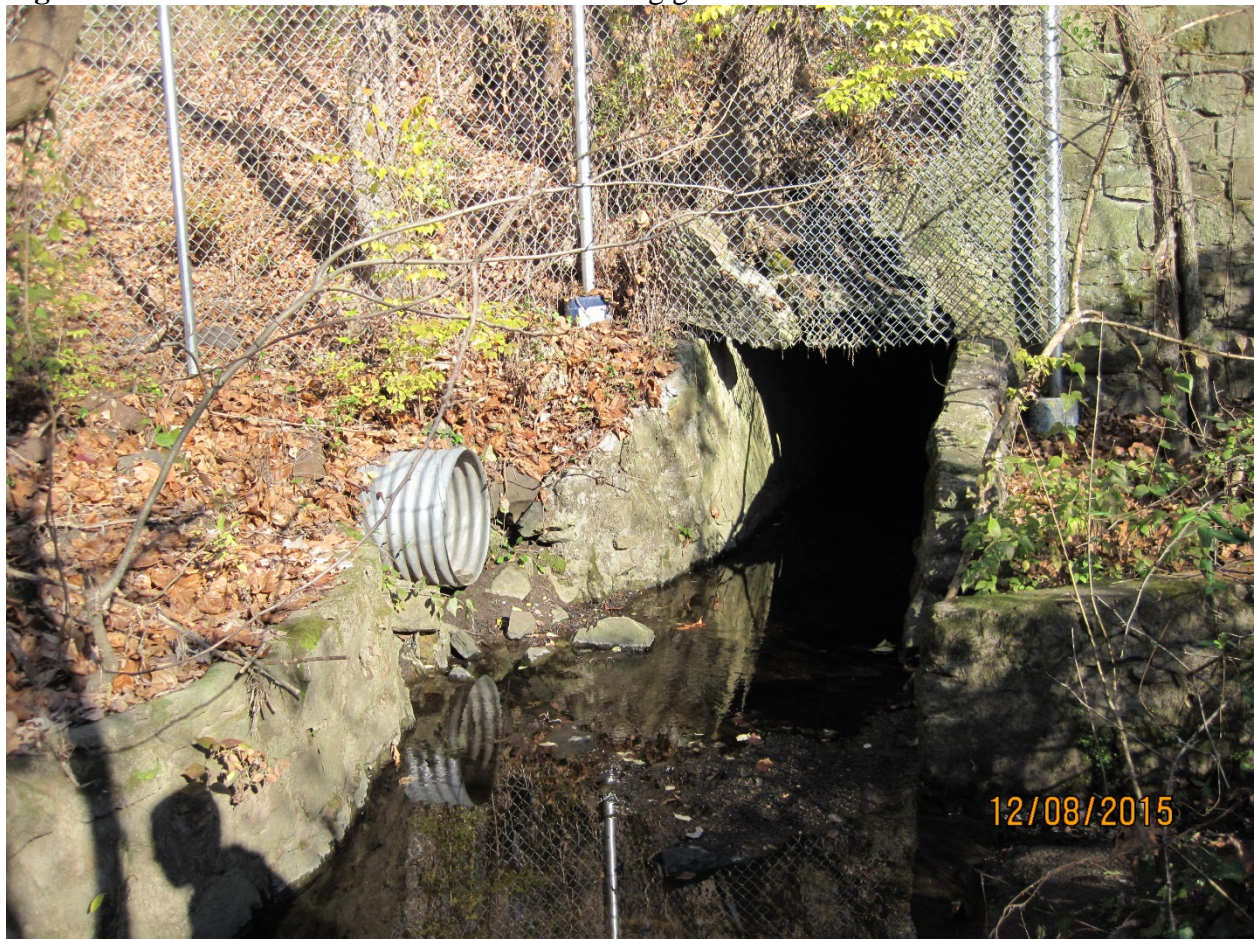
The fence near the “brick drain” outlet located along the southwest side of the Upper Locust Street Pile is still clogged with debris from flooding. The EPA, USACE, WSP, and Bartlett discussed alternatives to the current fence running across the culvert. It was decided that WSP will have the clogged fence removed and add to the existing perimeter fence to maintain restricted access. A swing gate similar to one installed for the BoRit project along Maple Street will be installed across the culvert. This will limit children from entering the culvert but will allow water and debris to flow freely. WSP has proposed to line the channel with geotextile and rip rap. Some minor regrading/filling may be necessary to reestablish the channel subgrade prior to installing the geotextile and riprap. See attached drawings for three designs from the Borit gate.

Figure 7: Stone culvert to be closed off with swing gate.

7.3 The clogged fence at the drainage outlet should be removed and a swing gate should be installed on the stone culvert. The site should be secured by adding fence or making it higher as required. The erosion at the outlet should be repaired using geotextile/rip rap and possibly some fill to reestablish the eroded subgrade. (Figure 6)

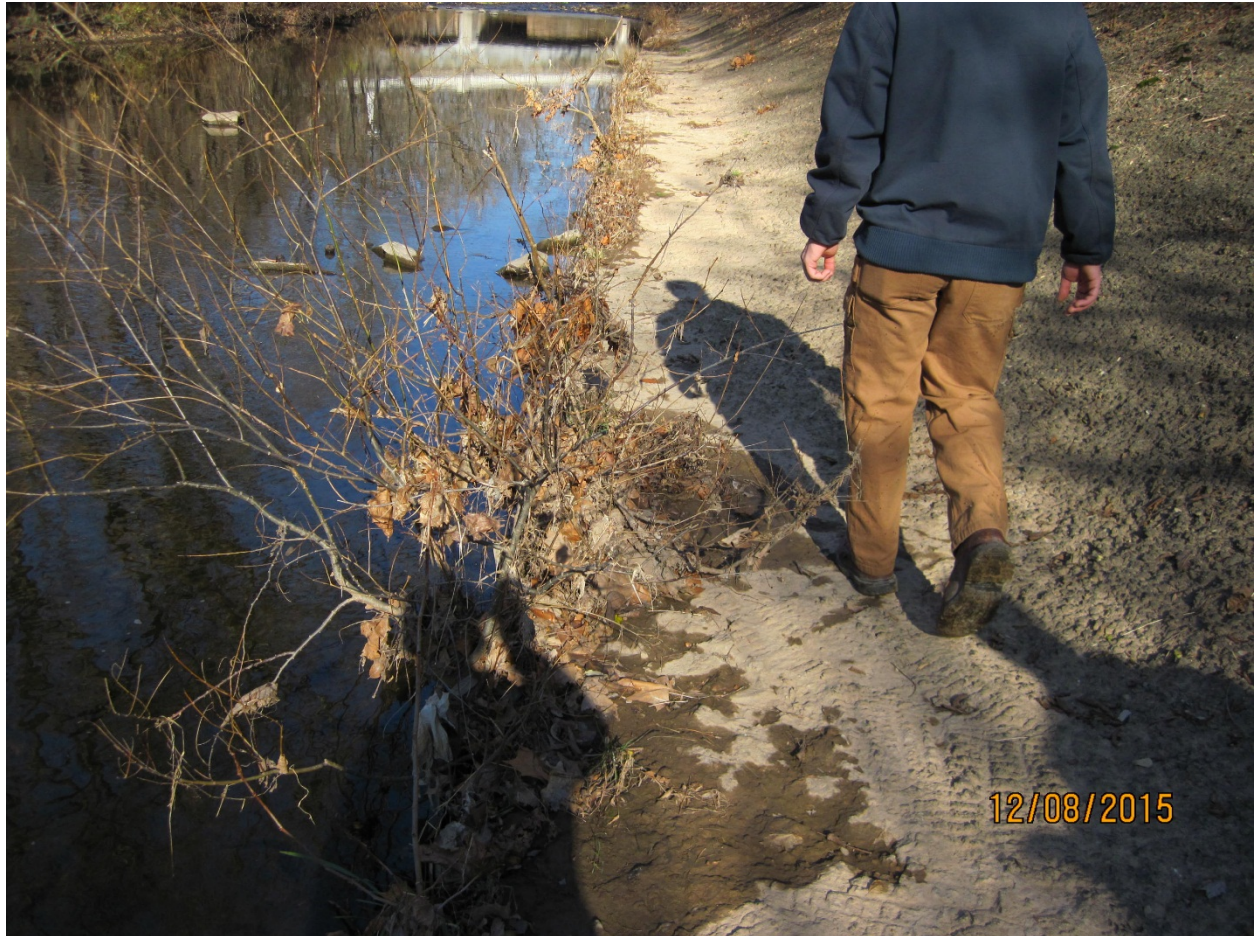
The concrete embankment along the Wissahickon appeared to be in good condition. However, vegetation is starting to grow along the edge of the water (see Figure 8). Due to the close proximity of the water, herbicide will not be used to kill these plants, they will be cut by Mr. Williams until the roots eventually die.

Figure 8: Looking north along the Wissahickon Creek, note vegetation growing along the creek bank.

7.2 Vegetation growing along the water's edge at the toe of the concrete embankment along the Wissahickon Creek should be killed and removed. (Figure 5)

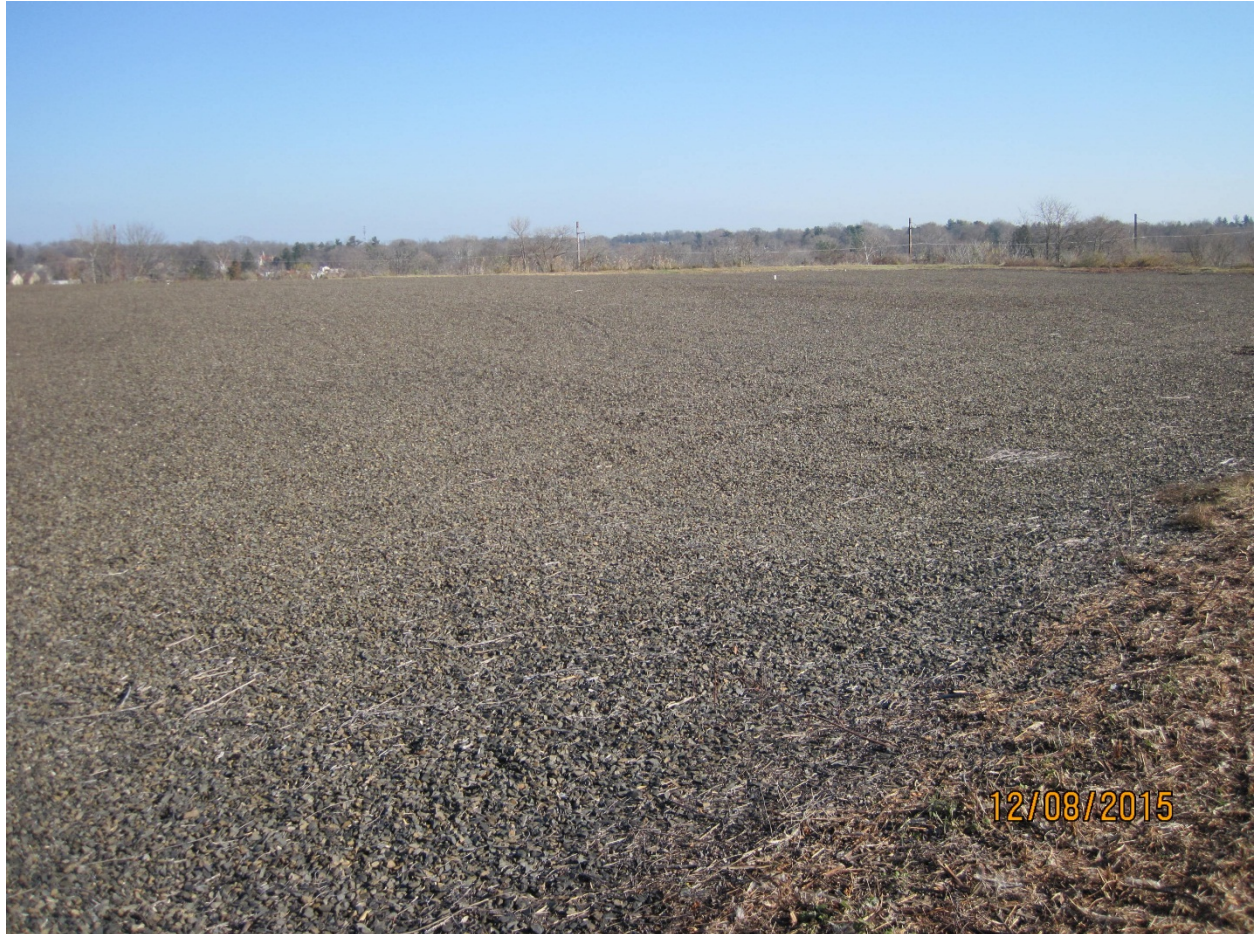
Unlike the Locust Street Piles, the gravel area in the middle of the Plant Pile is mostly clear of vegetation (see Figure 9). The outlet box's concrete lid was off and lying next to the box. The lid should be put back on the outlet box to prevent possible vandalism to the exposed cap subdrain pipes. The inspectors did not note any significant change in the size of depressions or tension cracks in the pile since the previous inspection. The repairs to erosion on the side slopes are scheduled to be completed this winter and therefore the same recommendations from the previous inspection are included in section 7. The inspectors discussed options to repair and monitor the rest of the pile. WSP will submit a proposal in the future.

Figure 9: Plateau of the Plant Pile.

7.4 The concrete lid of the Plant Pile outlet box should be put back on the box. (Figure 8)

7.5 The erosion along the Plant Pile's slopes in the southeast and southwest corners should be repaired. After the areas are topsoiled and reseeded as part of the repair, the area should be covered with a non-degradable erosion control mat to assist in reestablishing vegetation. (Figure 9)

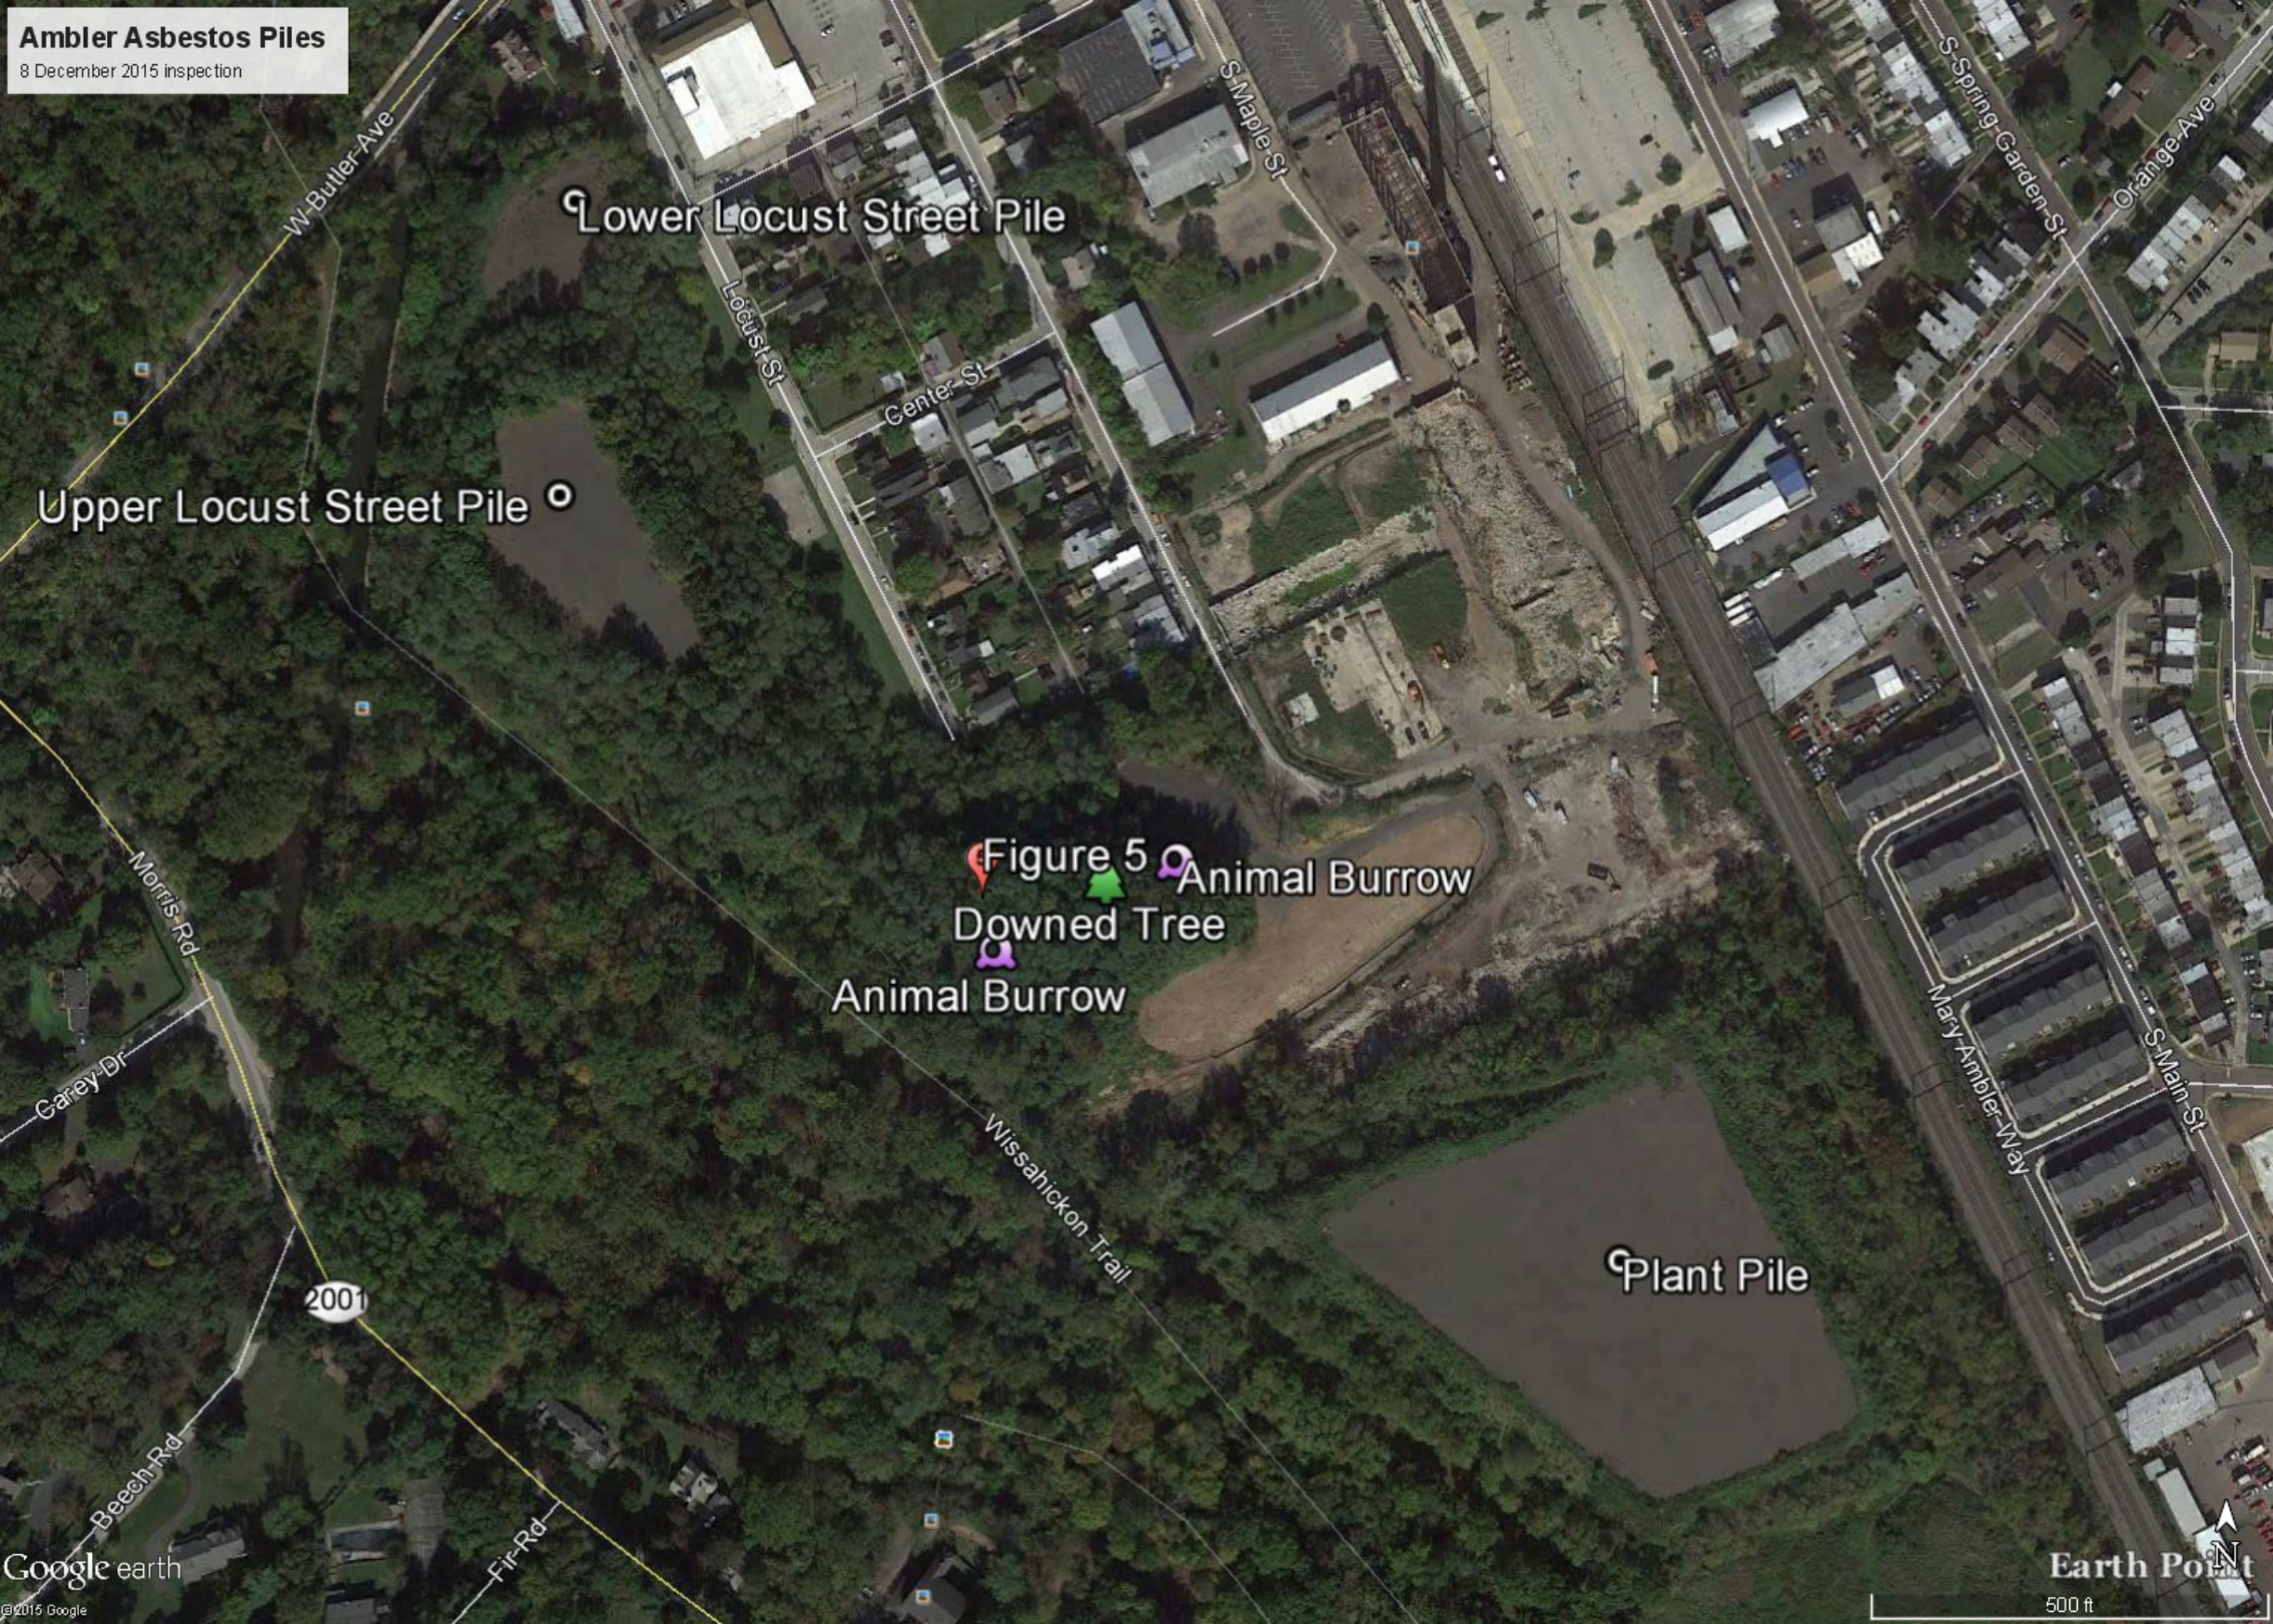
The inspection team also saw downed trees at 40.14960, -75.22673 and 40.14903, -75.22511. There were animal burrows at 40.14924, -75.22617; 40.14914, -75.22491; and 40.14909, -75.22480. The soil cover should be repaired in these areas as soon as possible. See the attached map for reference.

Figure 5
Animal Burrow
Downed Tree
Animal Burrow

7.7 Holes in the soil cover should be repaired at: 40.14960, -75.22673; 40.14903,-75.22511; 40.14924, -75.22617; 40.14914, -75.22491; and 40.14909, -75.22480.
