Engine Wiring Harness Chafing Repairs

TECH LINK

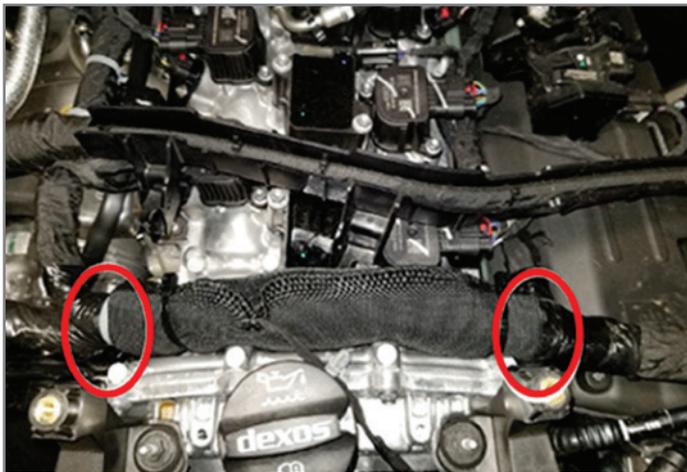
The engine wiring harness on the 2.7L engine (RPO L3B) on some 2019-2021 Silverado and Sierra models may contact several underhood components. Inspect the harness for any damage where it crosses over the top of the camshaft carrier cover.

Harness over the top of the camshaft carrier cover

If engine wiring harness contact is isolated during the inspection, carefully inspect for internal wiring damage and repair any wiring as needed following the wiring repair procedures in the appropriate Service Information. Once the inspections or repairs have been made, protect the engine wiring harness from future damage using the appropriate Zip Tie Fir Tree Clip and/or Kevlar Velcro Sleeve.

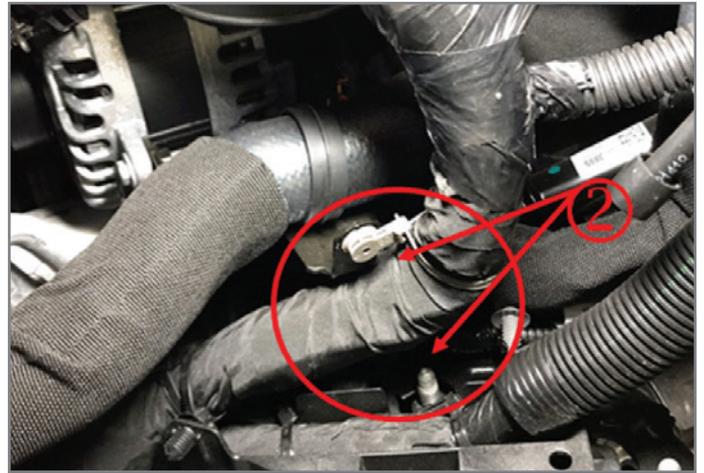
Under normal driving conditions, the engine will rock back-and-forth in its mounts, which may result in harness contact with the generator bracket that may not be present with the engine off. It may be necessary to disconnect several engine harness connections to reposition the harness for inspection.

Check for harness contact with the generator bracket.

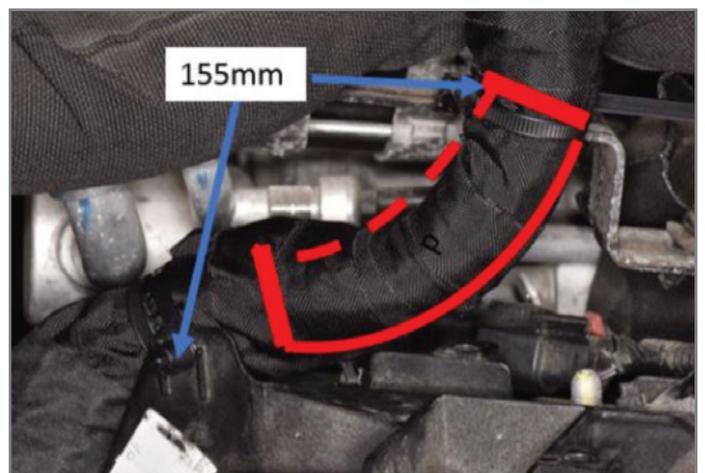
Position the wiring harness to protect it from future damage.

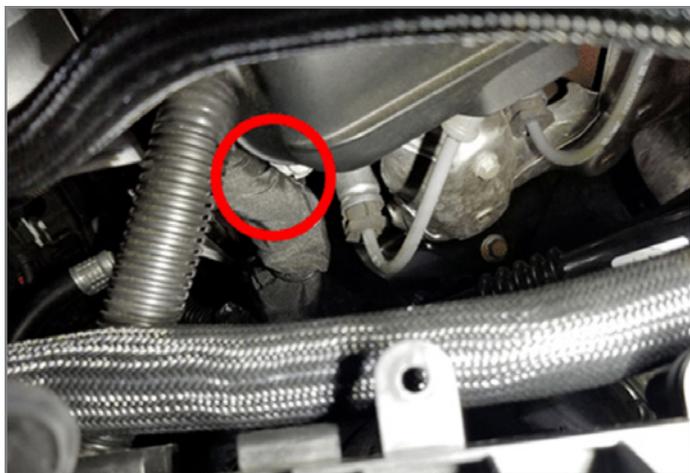
On the 4.3L engine (RPO LV3) on some 2019-2021 Silverado and Sierra models, check the engine wiring harness for any rubbing on the front corner of the left cylinder head or drive belt idler bracket and shorting any number of circuits to ground. Due to the number of circuits in the harness, there may be a wide variety of different symptoms that may occur, depending on the circuit that is damaged.

Contact at the front corner of the left cylinder head.

Repair any damaged wiring found by following the wiring repair procedures in the appropriate Service Information. Once repairs are completed, protect and reposition the engine wiring harness to prevent future damage.

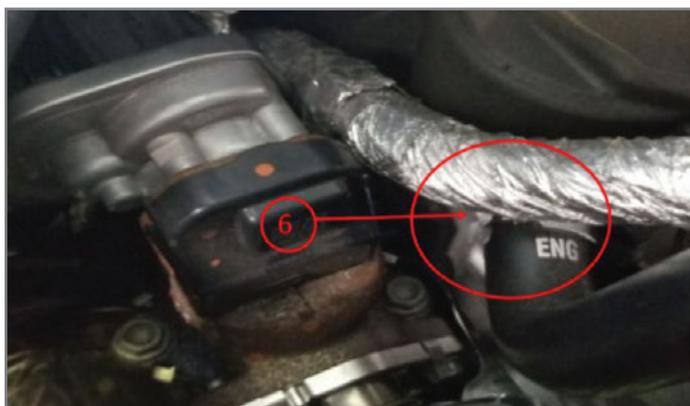
The 3.0L diesel engine (RPO LM2) on some 2019-2021 Silverado, Sierra; 2021 Tahoe, Suburban, Yukon and Escalade models may have a pinched or chafed wiring harness at approximately 18

PVC hose clamp at the crankcase pressure regulator

inches (46 cm) from the ECM connectors and on top of the generator, or at the PVC hose clamp at the crankcase pressure regulator that is approximately 4 inches (10 cm) from the crankcase sensor connector pigtail harness breakout.

Do not replace ECM for these concerns without thoroughly inspecting the engine wiring harness. If any concerns are found, follow the wiring repair procedures in the appropriate Service Information

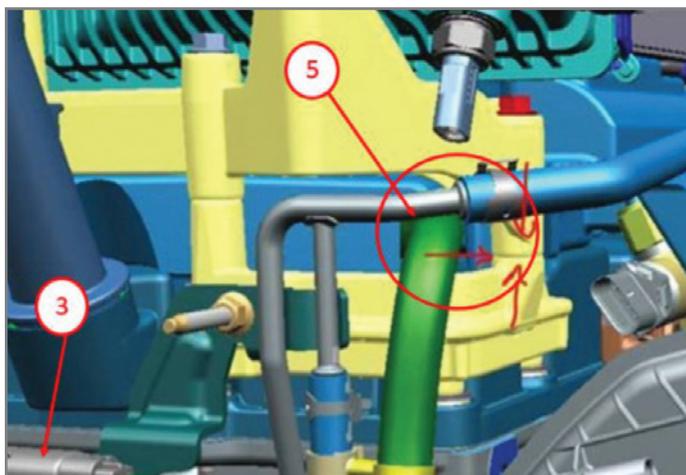
If DTCs P0201, P0202, P0203, P0204, P0205, P0206, and/or P0216 are set, inspect for poor terminal tension at connector X160 and that the terminal locking feature is not missing. Also inspect the fuel injector connectors to make sure they are fully connected/seated and for damage to the fuel injector wiring harness near the X160 connector.

Inspect the fuel injector wiring harness near the X160 connector.

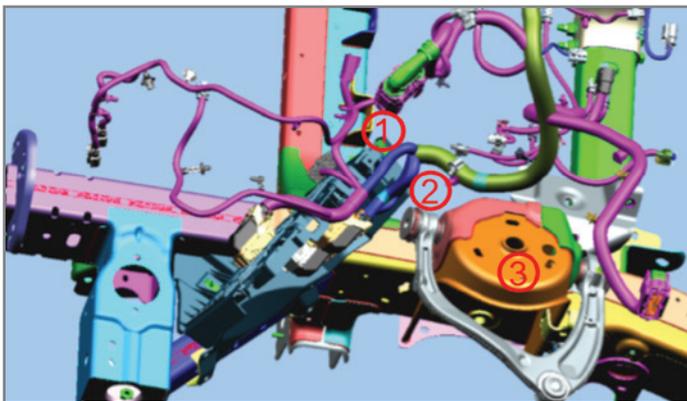
The engine wiring harness on the 2.7L engine (RPO L3B), 3.0L diesel engine (RPO LM2), 4.3L engine (RPO LV3), 5.3L engine (RPO L82, L84) and 6.2L engine (RPO L87) may be contacting the ECM/TCM bracket, driver-side upper control arm and/or the shock tower bolt due to engine vibration. Harness sleeves, anti-abrasion tape and zip ties should be used to secure the harness from these contact points.

1. ECM/TCM bracket
2. Upper control arm
3. Shock tower bolt

At the ECM/TCM bracket, wrap the harness using a harness sleeve and secure with zip ties to prevent movement.

For upper control arm contact, wrap the wiring harness in the harness sleeve and anti-abrasion tape. Secure the harness to the harness clip above the ECM/TCM bracket.

At the shock tower, there is a wire harness canal where the harness should be positioned. Insert the harness sleeve and secure the harness to the canal using zip ties.

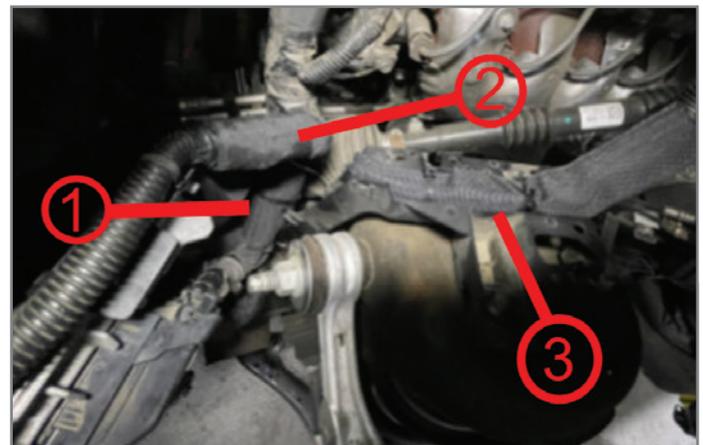
Secure the wiring harness at all three points.

Verify the wiring harness is secure at all three points.

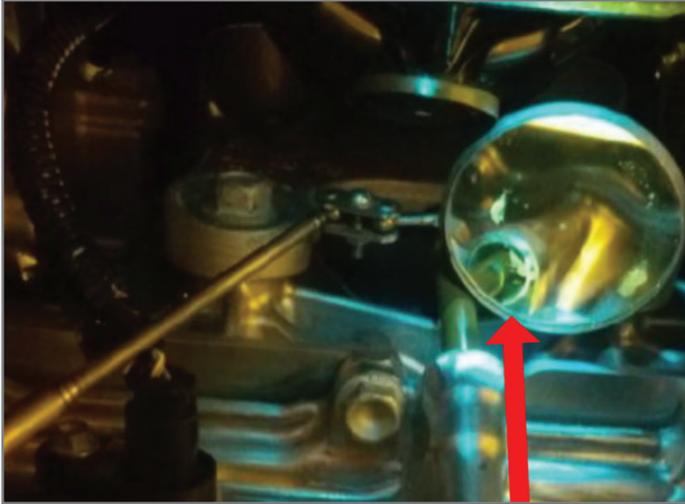
Check for an oil leak from the dipstick tube O-ring with an inspection mirror. There may not be any oil residue around the dipstick tube O-ring area.

Check for an oil leak from the dipstick tube O-ring.

Remove the dipstick tube and inspect the dipstick tube O-ring for damage. Replace as necessary. Use extra care when replacing the dipstick tube. There may be sharp edges on the lower crankcase extension that could potentially damage the O-ring during installation.

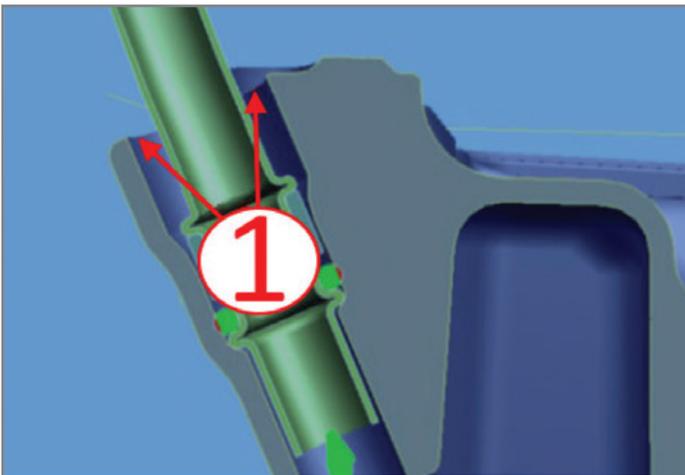
Look for sharp edges on the lower crankcase extension during O-ring installation.

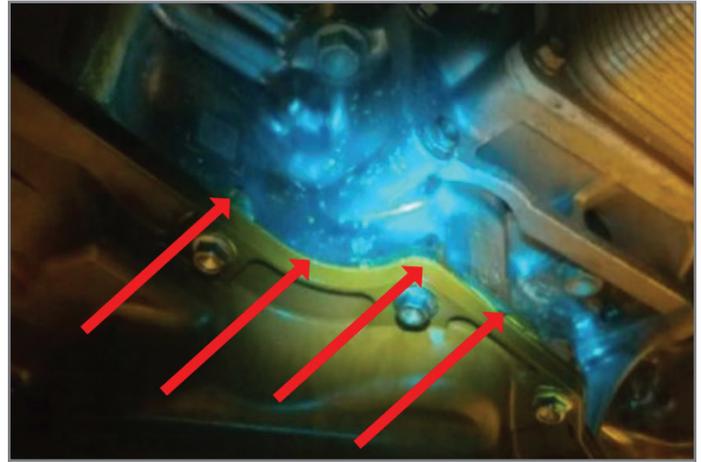
Black light and tracer dye identify an oil leak from the composite oil pan sealing surface.

Verify that the dipstick tube does not show any signs of damage or leaks to the seal before replacing the oil pan gasket. A black light and tracer dye can be used to identify an oil leak from the composite oil pan sealing surface.

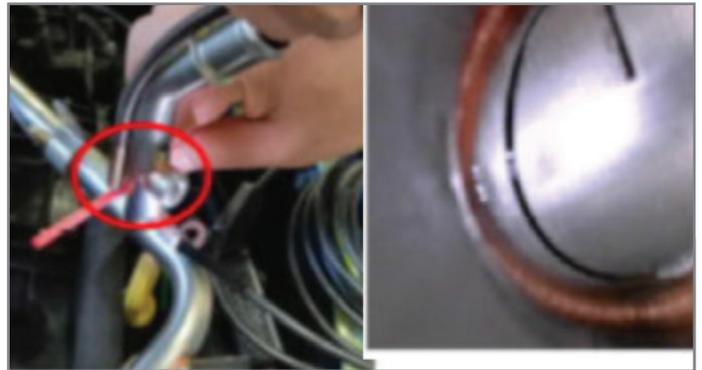
An internal blockage of the exhaust manifold outlet pipe may result in insufficient heating performance. If the pipe is blocked, replace the pipe. Refer to Exhaust Manifold Outlet Pipe Replacement in the appropriate Service Information.

Use a general boroscope to check for a blocked exhaust manifold outlet pipe.

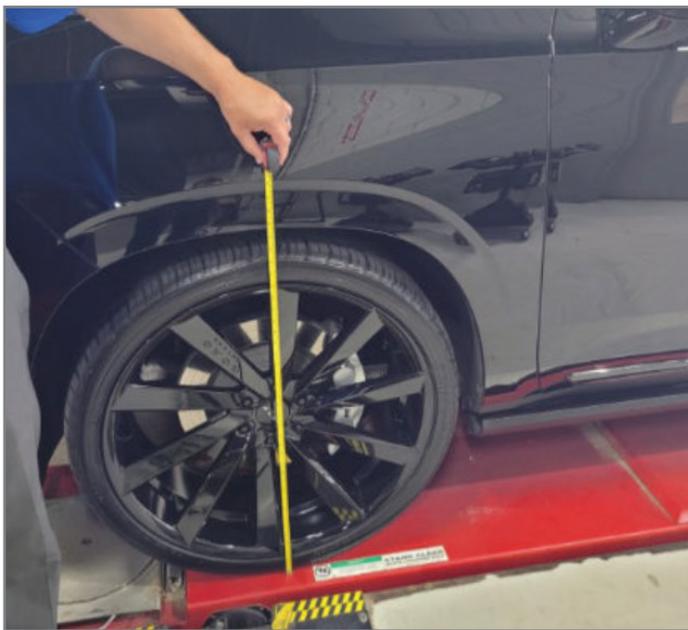
A Service Leveling System message or Speed Limited message on the Driver Information Center (DIC) on some 2021 Tahoe, Suburban, Yukon and Escalade models may be due to aftermarket modifications. If an aftermarket lowering kit is installed on these models, it may cause an incorrect vehicle ride height variance, which may be indicated by a decreased distance between the top of the tire and the fender well.

Incorrect vehicle ride height

If these DIC messages are displayed, check if the vehicle ride height has been altered. Refer to the Trim Height Inspection procedure in the appropriate Service Information. Trim height is a predetermined measurement relating to vehicle ride height and incorrect trim heights can cause the vehicle to bottom over bumps, damage the suspension components, and show symptoms similar to wheel alignment problems. Always check the trim heights when diagnosing suspension concerns and before checking the wheel alignment.

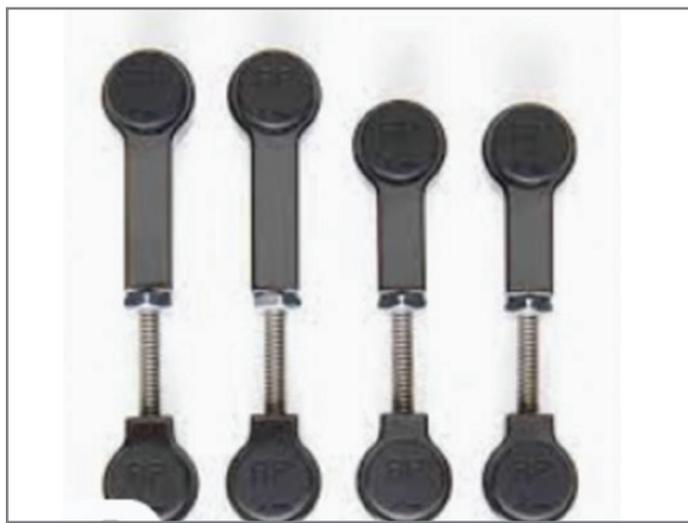
Once the suspension has been found to be lower than the factory specifications, check for installed aftermarket adjustable suspension height sensor links.

Aftermarket adjustable suspension height sensor links

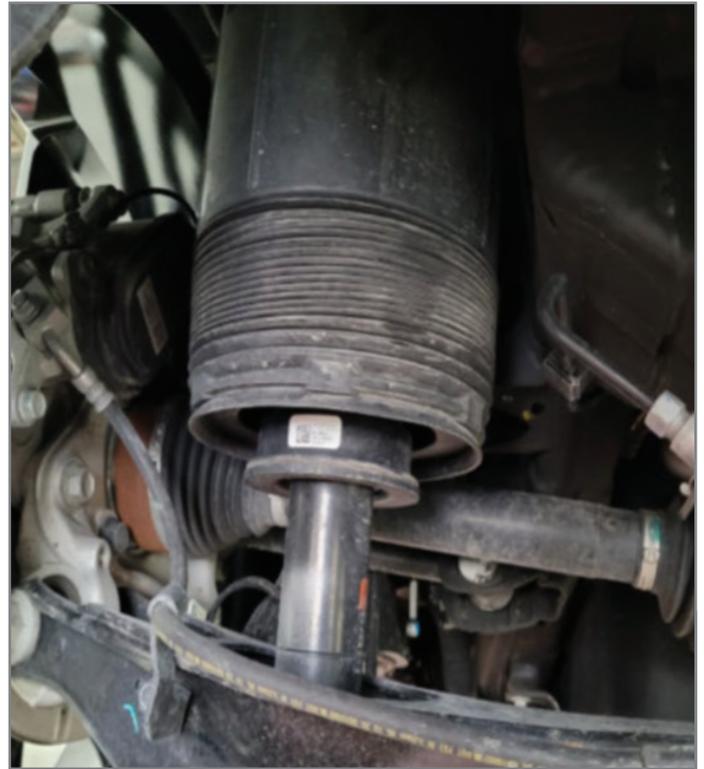
Changed angle of rear axle drive shaft

In addition, the aftermarket adjustable height sensor links also will change the angle of the rear axle drive shaft due to the suspension being lowered.

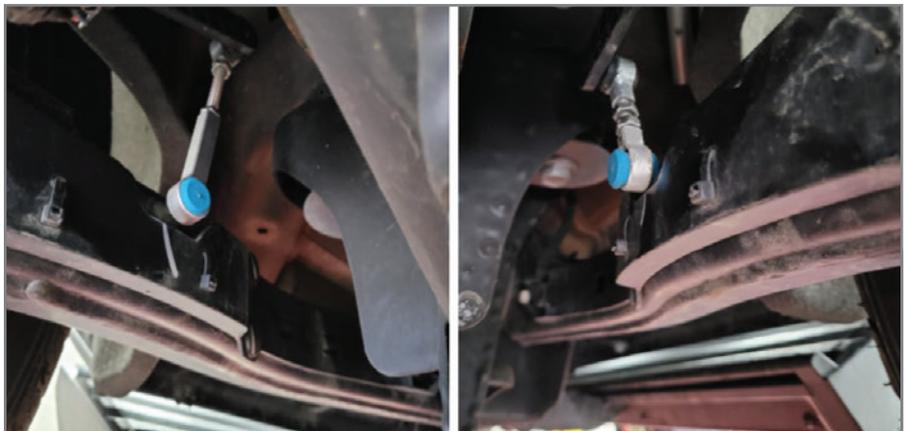
Aftermarket adjustable height sensor links that are incorrectly adjusted side-to-side or not secured properly will result in inaccurate height sensor readings.

Links incorrectly adjusted side-to-side
