SERVICE BULLETIN

EC12-012j

January 30, 2015

MIL ON WITH DTC P0101

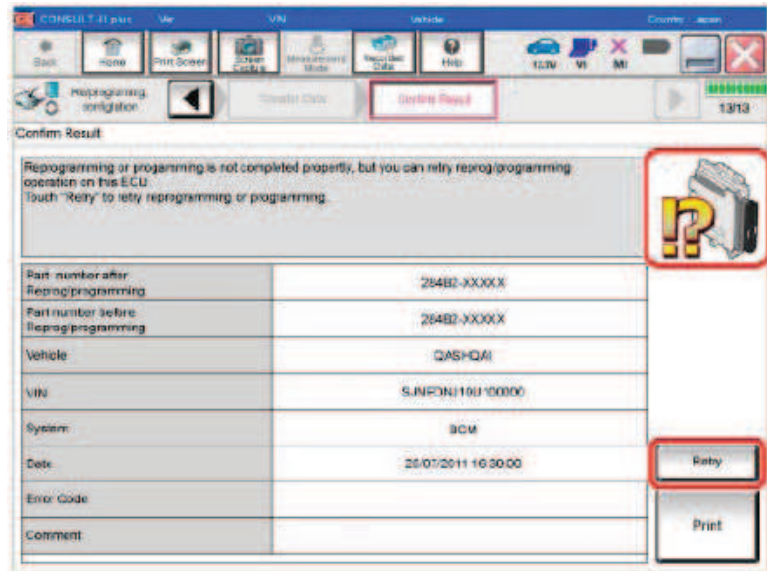
Figure 5

If reprogramming does not complete and the “!?” icon displays as shown in Figure 5:

- Check battery voltage (12.0–15.5 V).
- Ignition is ON, engine OFF.
- External Bluetooth® devices are OFF.
- All electrical loads are OFF.
- **Select retry and follow the on screen instructions.**
- “Retry” may not go through on first attempt and can be selected more than once.

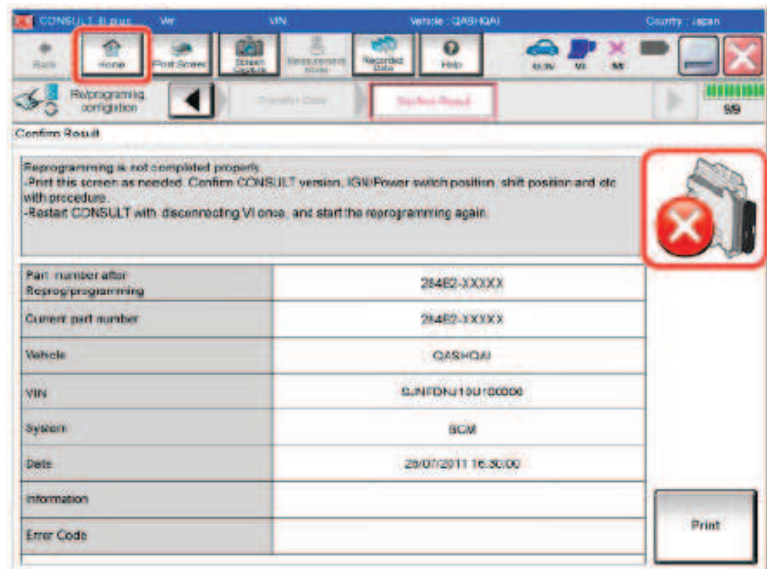
Figure 6

If reprogramming does not complete and the “X” icon displays as shown in Figure 6:

- Check battery voltage (12.0 – 15.5 V).
- CONSULT A/C adapter is plugged in.
- Ignition is ON, engine OFF.
- Transmission is in Park.
- All C-III plus / VI cables are securely connected.
- All C-III plus updates are installed.
- **Select Home, and restart the reprogram procedure from the beginning.**
