Mill River Stream Team Shoreline Survey Report & Action Plan June 30, 2007

**Mill River Shoreline Survey Findings
By
Section**

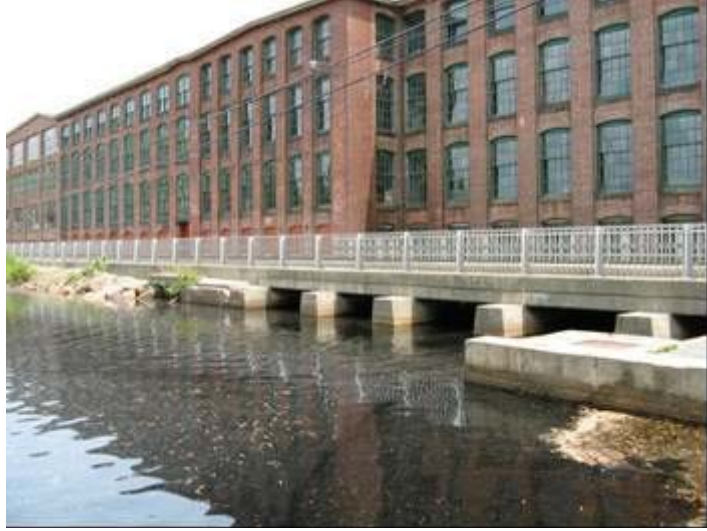
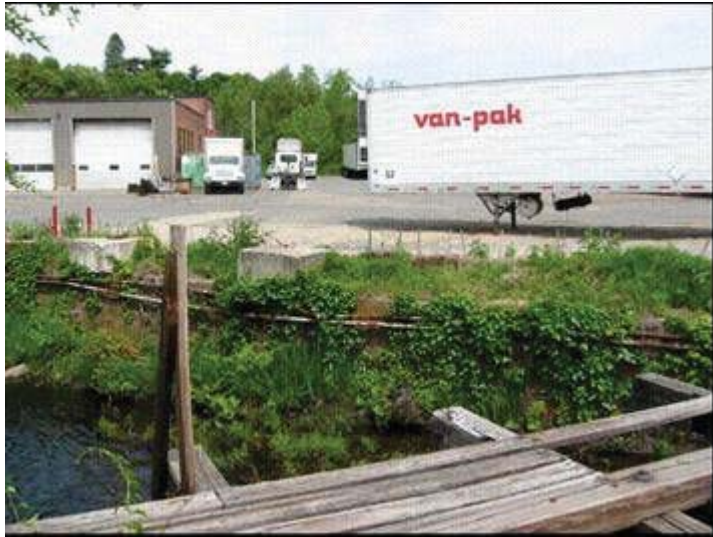
Section 2

South of the Hopedale Pond, the River flows under the old Draper Mill building down to Route 16 in Hopedale. The mill building is vacant but the town is trying to lease out the space. South of the mill, the area is mainly industrialized with several parking lots and a couple of roads. The surveyor noted that this section of the Mill River was in bad shape due to trash such as machinery parts, metal handrails, and several abandoned booms. It was also noted that many small business dumpsters overflow near the River Bank. Roadside Trash was noted as well. Historically, the water level has never exceeded 2.5 feet and phosphorous suds were accumulating in this location. No wildlife was evident. The surveyor observed River Bank erosion and limited vegetation. Pipe runoff was found on Fitzgerald Street. The discharge from the pipe looked clear and the structure surrounding it was good, but the road area around the storm drain was not maintained.

- Collect and remove abandoned booms
- Engage area businesses and residents in trash cleanup and control
- Ask businesses to put up fencing to prevent their trash from going into the River
- Arrange for bulky waste to be removed

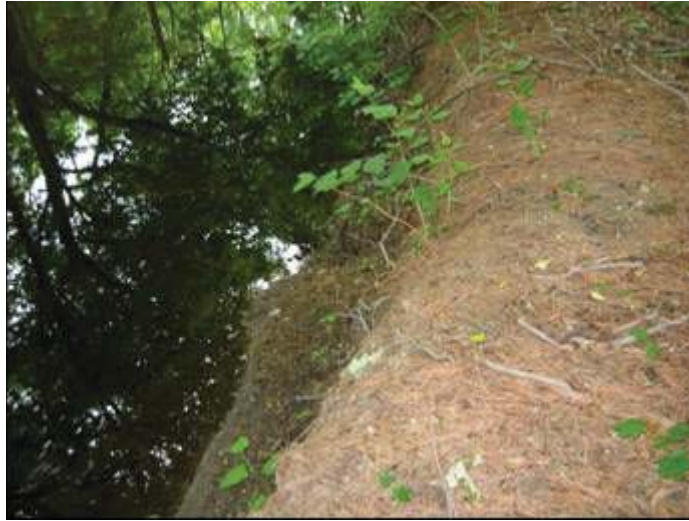
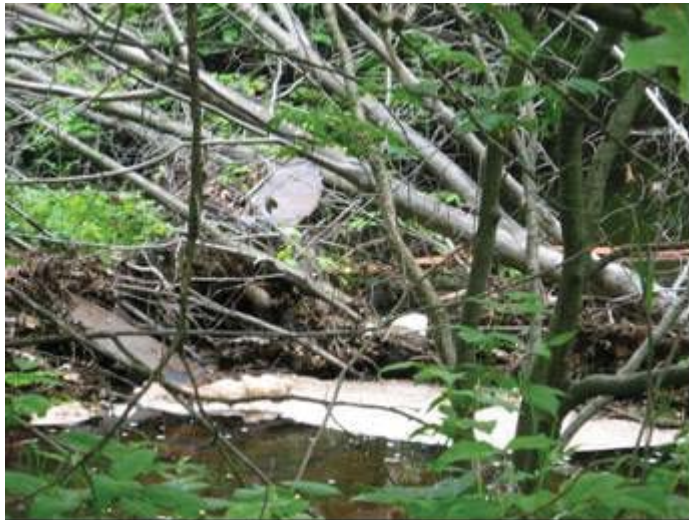
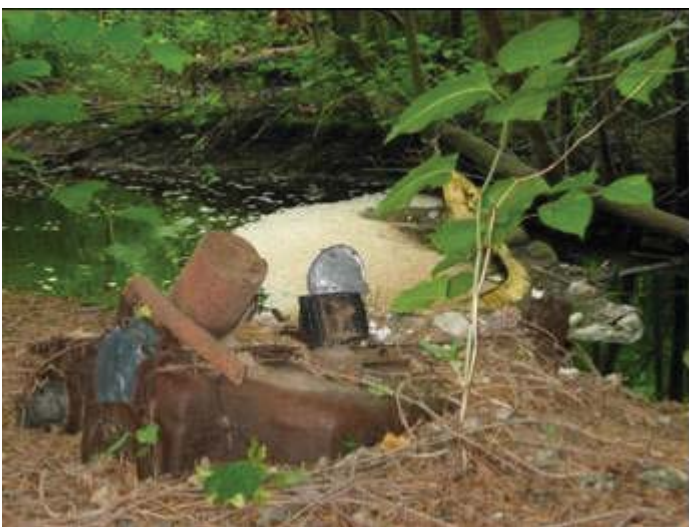
Section 3

The surveyor noted that both sides of the River Bank were eroding and didn't have much vegetative protection. The water flow was slow. Trash such as bags and orange cones were found near the Hopedale Wastewater Treatment Facility. An abandoned boom was located here as well.

- Remove boom
- Clean up trash

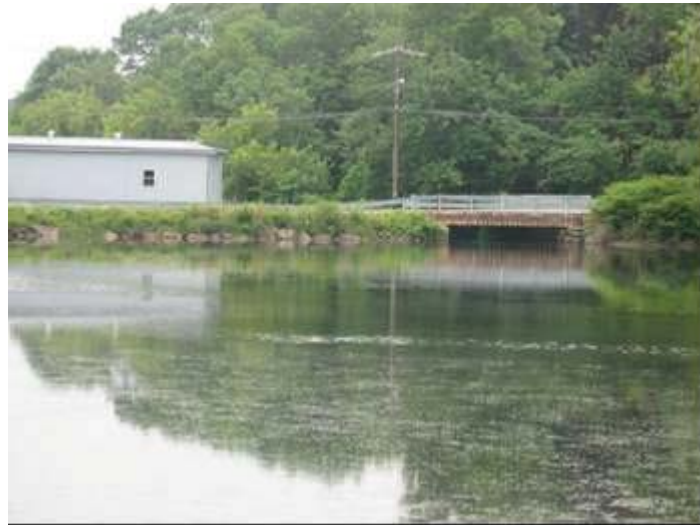
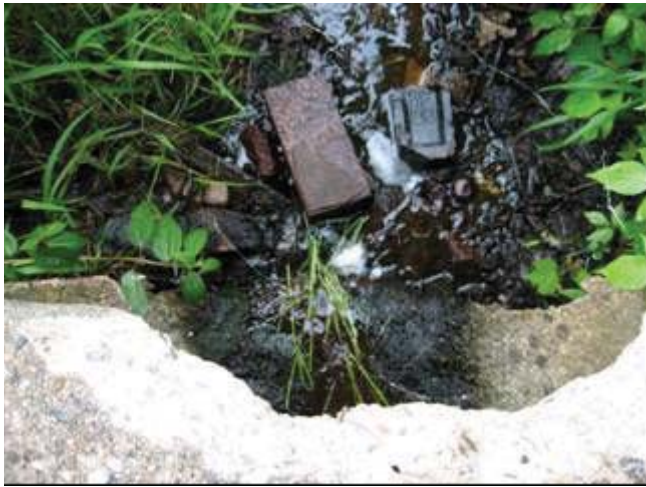
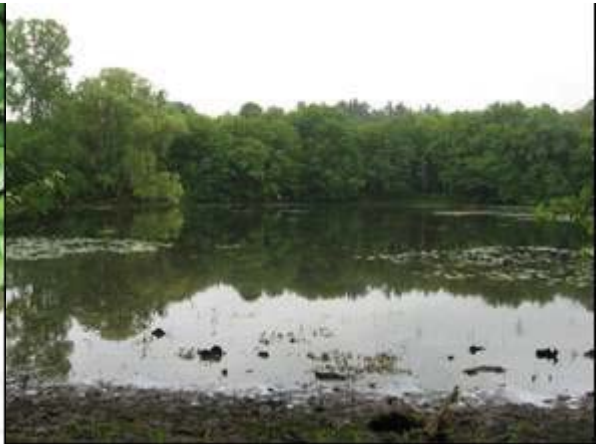
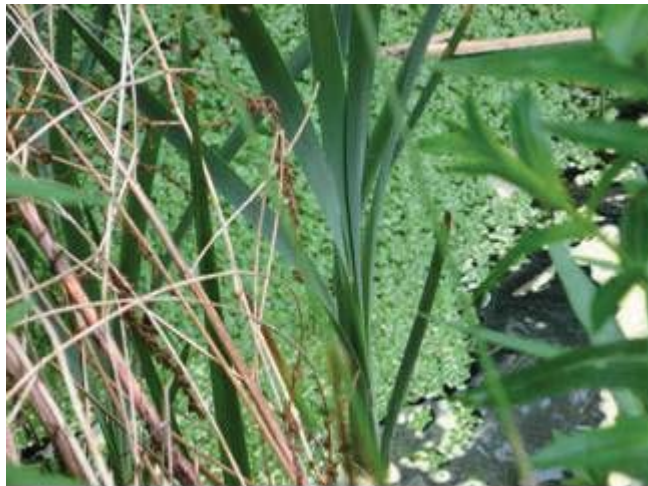
Section 4

The surveyor resides near Spindleville Pond and, over the years, has observed a significant decrease in the water level. Located upstream is the Hopedale Wastewater Treatment Facility.

The surveyor noted several locations with serious runoff and erosion issues. The prevalent invasive plant here is milfoil found in large quantities throughout the Pond.

Sudsy water was observed and seen discharging from a pipe on the Green Street side of the Pond. The surveyor noted that the Town would be installing new wells in this area soon that could further impact the water level.

- Track source of water discharging from the pipe on Green Street to address sudsy discharge
- Involve town in maintaining and building up banking along Green Street.

- Avoid clear-cutting every year to stop erosion and dense re-growth.

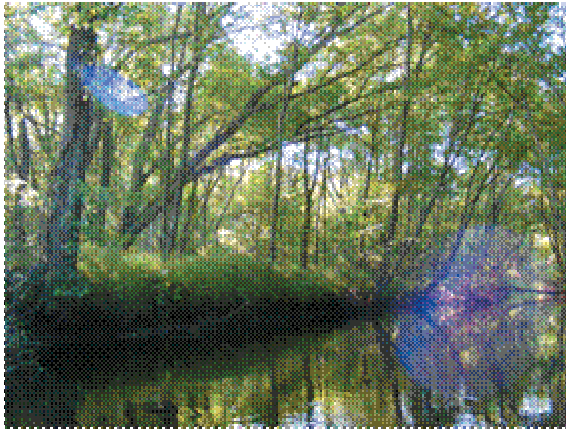
Left bank near Hopedale Country Club

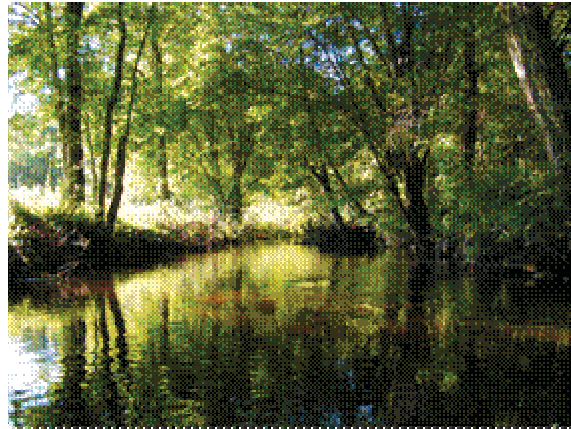
Left bank near Hopedale Country Club
