REPORT OF INVESTIGATION  
(SURFACE AREA OF UNDERGROUND MINE)

MULTIPLE FATAL SUFFOCATION ACCIDENT

Loveridge No. 22 (ID No. 46 01433)  
Consolidation Coal Company  
Fairview, Marion County, West Virginia

February 6, 1986

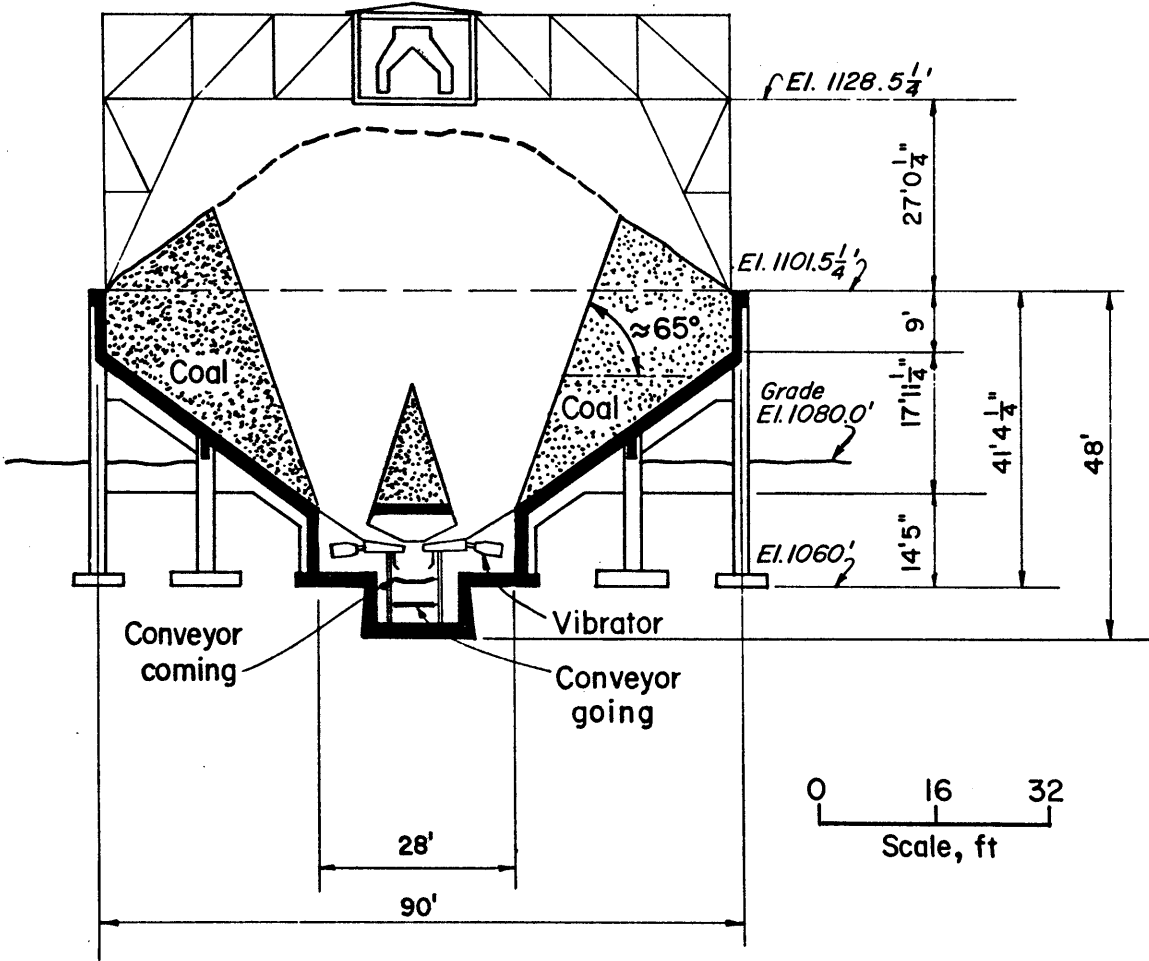
APPENDIX D  
 SECTIONAL VIEW SHOWING  
 UNCOMPACTED COAL PILE  
 AFTER DRAWOFF

9. Tests were conducted on a sample of raw coal taken from the Loveridge No. 22 mine slope belt. The results of the test indicate that the angle of repose of the loose raw coal is 35 degrees; however, the draw off angle of the same uncompacted material is approximately 65 degrees. The draw angle of compacted material is near vertical. A report of the testing procedures and the findings of these tests is located in Appendix G. A typical cross sectional view of uncompacted coal pile after draw off is in Appendix D.
