Report on 2003 Field Season

**Monitoring the Effectiveness and Validating Response to the Road
Related Mitigation Practices Implemented on the Pike's Peak Highway**

Initial Year

March 8, 2004

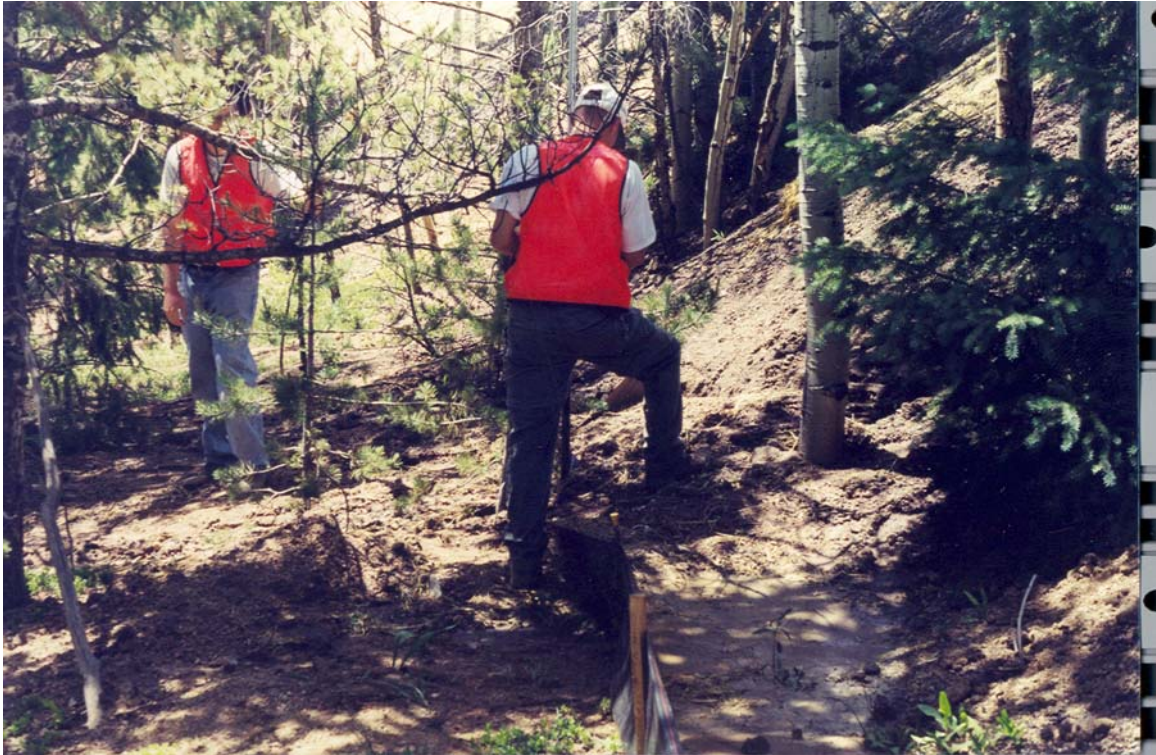
The chronology of events at site 007FS started with the silt fence installation on May 14. Between May 15 and June 11, a storm generates enough water to cause rilling (probably the June 5 storm, see Table 1 or Appendix B) and the highway crew installed excelsior logs with wooden stakes along the shoulder of the highway and additional fill material was dumped on the fill slope. By June 30, 45.1 ft³ of fill had accumulated in the upper fence (Table 4), though some material flowed over the center of the fence and some around the right edge (Figure 2). The lower fence had no fill material in it. On July 3, the upper silt fence was cleaned out and a baseline area was surveyed.

On July 16, a second fence was installed behind (and slightly offset) the upper fence to capture any material that might overtop the first fence, and then the area between the two upper fences was surveyed. On August 5, pictures (see DVD) were taken of the fill slope just up the road from where the silt fences were installed where large gullies had formed in the fill slope despite the excelsior logs. This fill slope material was not captured in the silt fences (nor could it have been) and thus not quantified, but the images do depict the impact storms (probably July 29, 075RG) can have on exposed fill slopes. On September

Figure 2. Surveying fill slope material in 007FS upper fence, June 30, 2003.

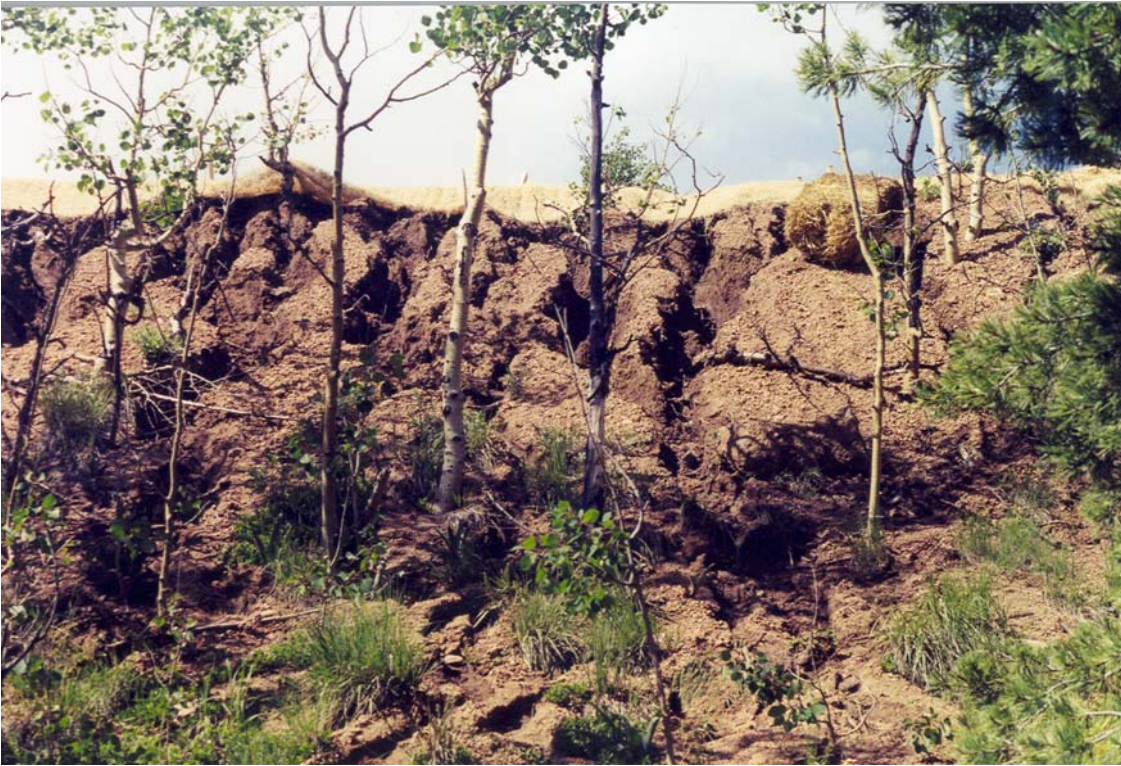
The chronology of events for site 039FS is similar to that of 007FS. The silt fence was installed on May 27. Then, the fill slope experienced rilling and by June 11, excelsior logs and straw bales had been placed along the shoulder of the pavement. A photograph taken on June 30 (Figure 3) shows the erosion of the fill slope just above the upper silt fence. On July 2, fill material in both the upper and lower fences was surveyed. On July 7, both fences are cleaned out and surveyed which indicated 32.9 ft³ of fill had accumulated in the upper fence and 38.1 ft³ in the lower (Table 4). Because fill slope material had overtopped the upper fence, a second fence was installed below the original fence on July 16 and that area was surveyed. On July 28, a rain event measuring 0.09 inches at 075RG, generated 19.7 ft³ sediment in the lower fence (Table 4) and because water was observed going around the left side of the fence (see DVD for photographs), a second lower fence was installed and both lower fence areas were surveyed. On September 24, the upper and lower silt fence areas were cleaned and resurveyed. No sediment accumulation was noted in the upper fences after the July 16 survey or in the lower fences after the July 28 survey.

Both 007FS and 039FS are in Basin 1, which was paved in 2001, located on inside bends of curves and each slope was treated with mulch or fiber matrix to increase stability. Along each of these road curves, there is no design to control drainage and when the fill

Figure 3. View of fill slope 039FS from the upper silt fence taken on June 30. Note the straw bales lining the top of the slope and in the upper right of the picture.

slopes began to fail excelsior logs were installed as a temporary measure to control rilling from surface runoff. However, reducing surface runoff increased water infiltration and saturation of the fill slope exacerbating erosion potential and lead to mass failure of the bank (Figure 4). From the silt fence measurements and these photographs, the effectiveness of mulch or fiber matrix as a sole means to stabilize fill slopes is minimal. Additional photographs of each site area on the data DVD under their respective directories.

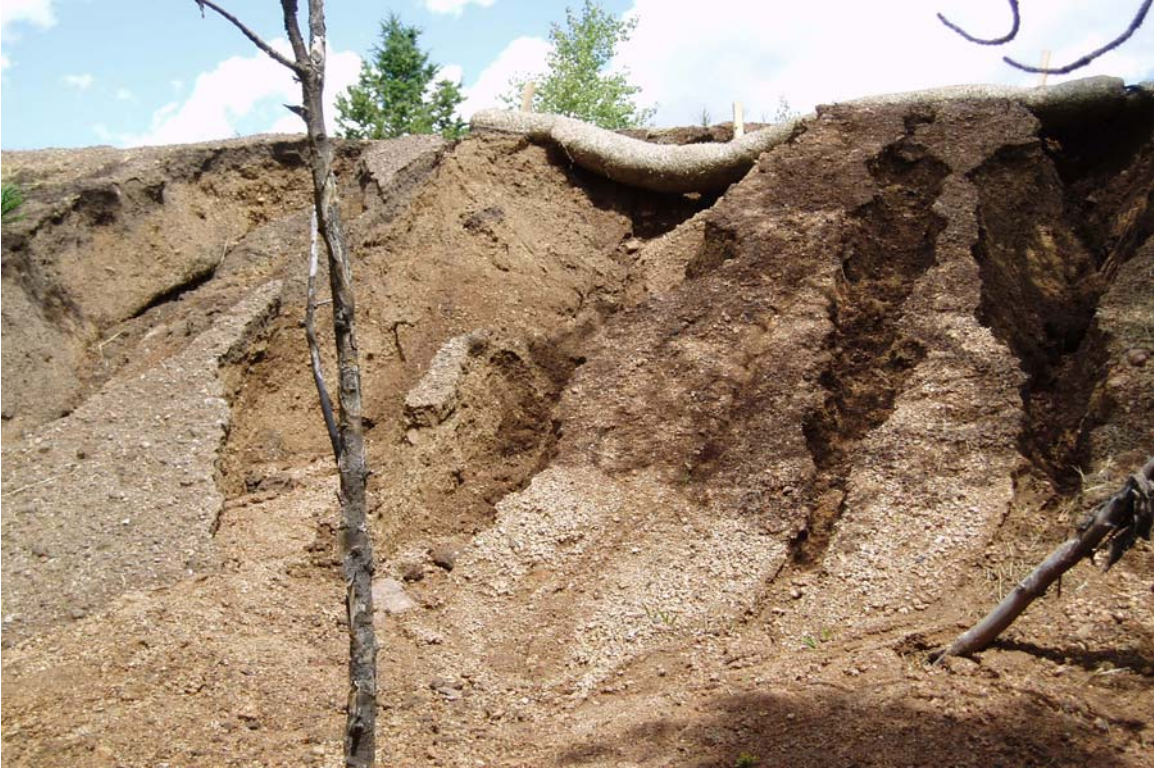
Figure 4. Fill slope failure near 007FS associated with temporary excelsior log control. Note crust of mulch or fiber matrix treatment on slope.

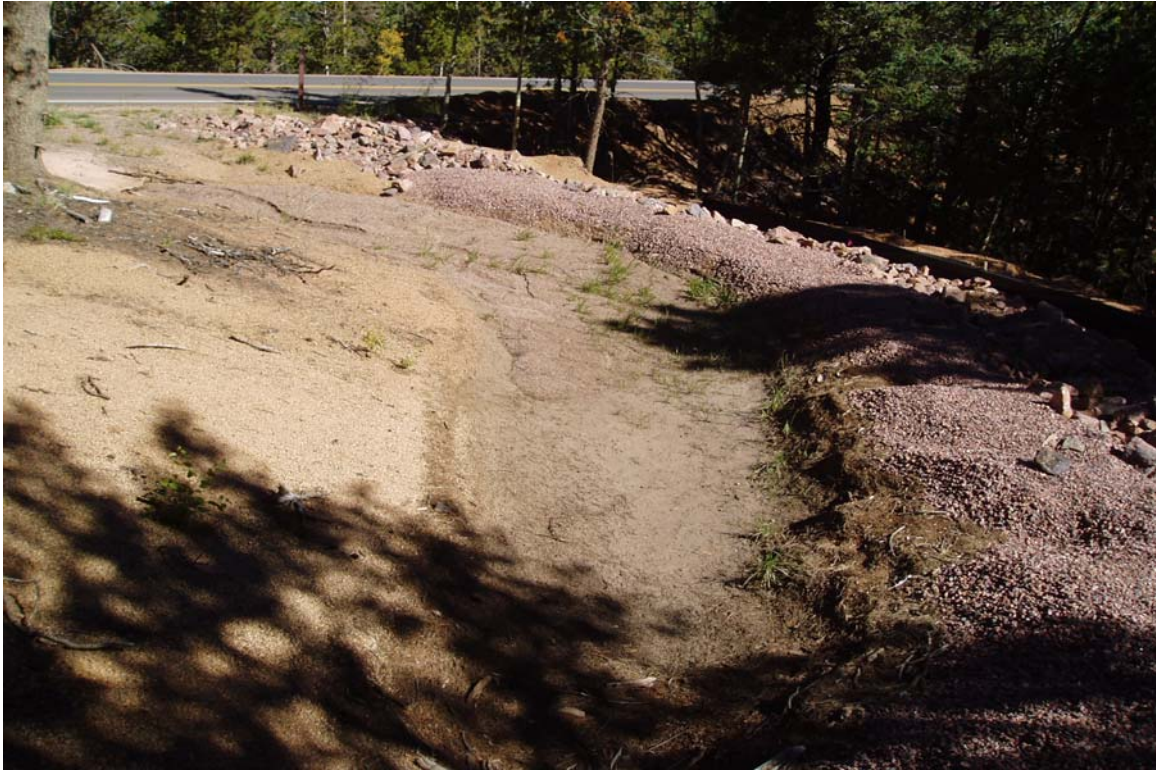
A summary of survey location, dates and sediment volume accumulated is presented in Table 8. The five rock weirs located in Basin 1 captured between 5.8 and 40.2 ft³ of sediment with no accumulation in the corresponding silt fences. The largest sediment accumulation occurred in 008RW which had a sediment plume that extended the entire length of the weir basin (Figure 5). Baseline surveys of the five weirs in Basin 2 were

Figure 5. Note extent of sediment plume in 008RW on September 22, 2003.

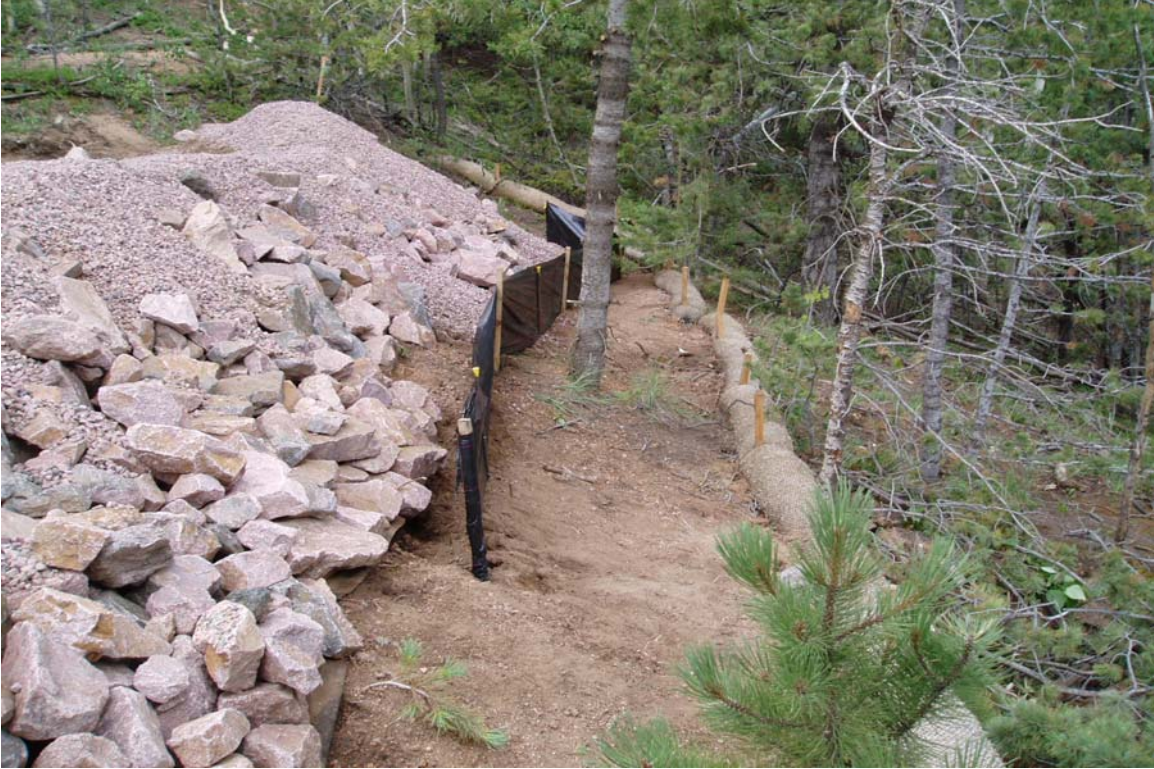
made in mid to late September except for 152RW. Just after installing the silt fence below the weir on July 29, a rain event (approximately 0.5 inches in 0.5 hours, 075RG) washed large quantities of sediment into the structure, flowing both around and under the rock weir. The road above 152RW was under construction but had not been paved yet,

nor had the drainage ditch been treated, all of which likely contributed to the sediment load produced. The weir was surveyed after the storm runoff subsided on July 29 and

subsequently resurveyed on September 16, after the basin was cleaned, yielding a 198 ft³ difference in volume (Table 8). Without a pre July 29 survey of the weir this volume is speculative at best, but the photographs on the data DVD qualitatively show the extent of the sediment. It should be noted that excelsior logs installed downhill of the weir intercepted sediment that passed under or around the rock weir (Figure 6).

Figure 6. Slope below 152RW after storm on July 29. Note lack of transported material below excelsior logs.
