MAGELLAN YACHT
Surveys

Type of Vessel: Moody 36

Purpose: **Pre-Purchase Survey**

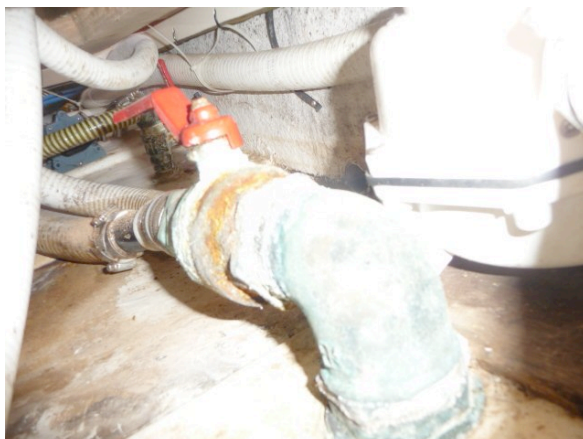
- ✚ Heads inlet: Yellow metal thru hull fitting with strainer and ball valve. This is seized and in very poor condition. Owner advised he didn't know it was there, and never closed it. It should be replaced. Hoseclips are corroded and should be replaced at the same time. Access under companionway steps.
- ✚ Heads discharge: Yellow metal thru hull fitting with ball valve, this too is seized. Similar to the inlet, this should be replaced. Hoseclips are corroded and should be replaced at the same time. Access under companionway steps.

Heads discharge under saloon sole

- ✚ **All seacocks other than the heads basin outlet, should be dismantled. The heads inlet, heads discharge and the galley sink outlet should all be replaced and the rest should be dismantled, serviced or renewed if**

necessary. Hoseclips to the three replacement valves mentioned here should also be replaced.
