General Sketch Showing Excavation 4/29

General Sketch Showing Guided Wave Perform 4/21/09

General Sketch UT Inspections Perform on 4/29/09

General Sketch Showing Replaced Pipe Up to 4/29/09

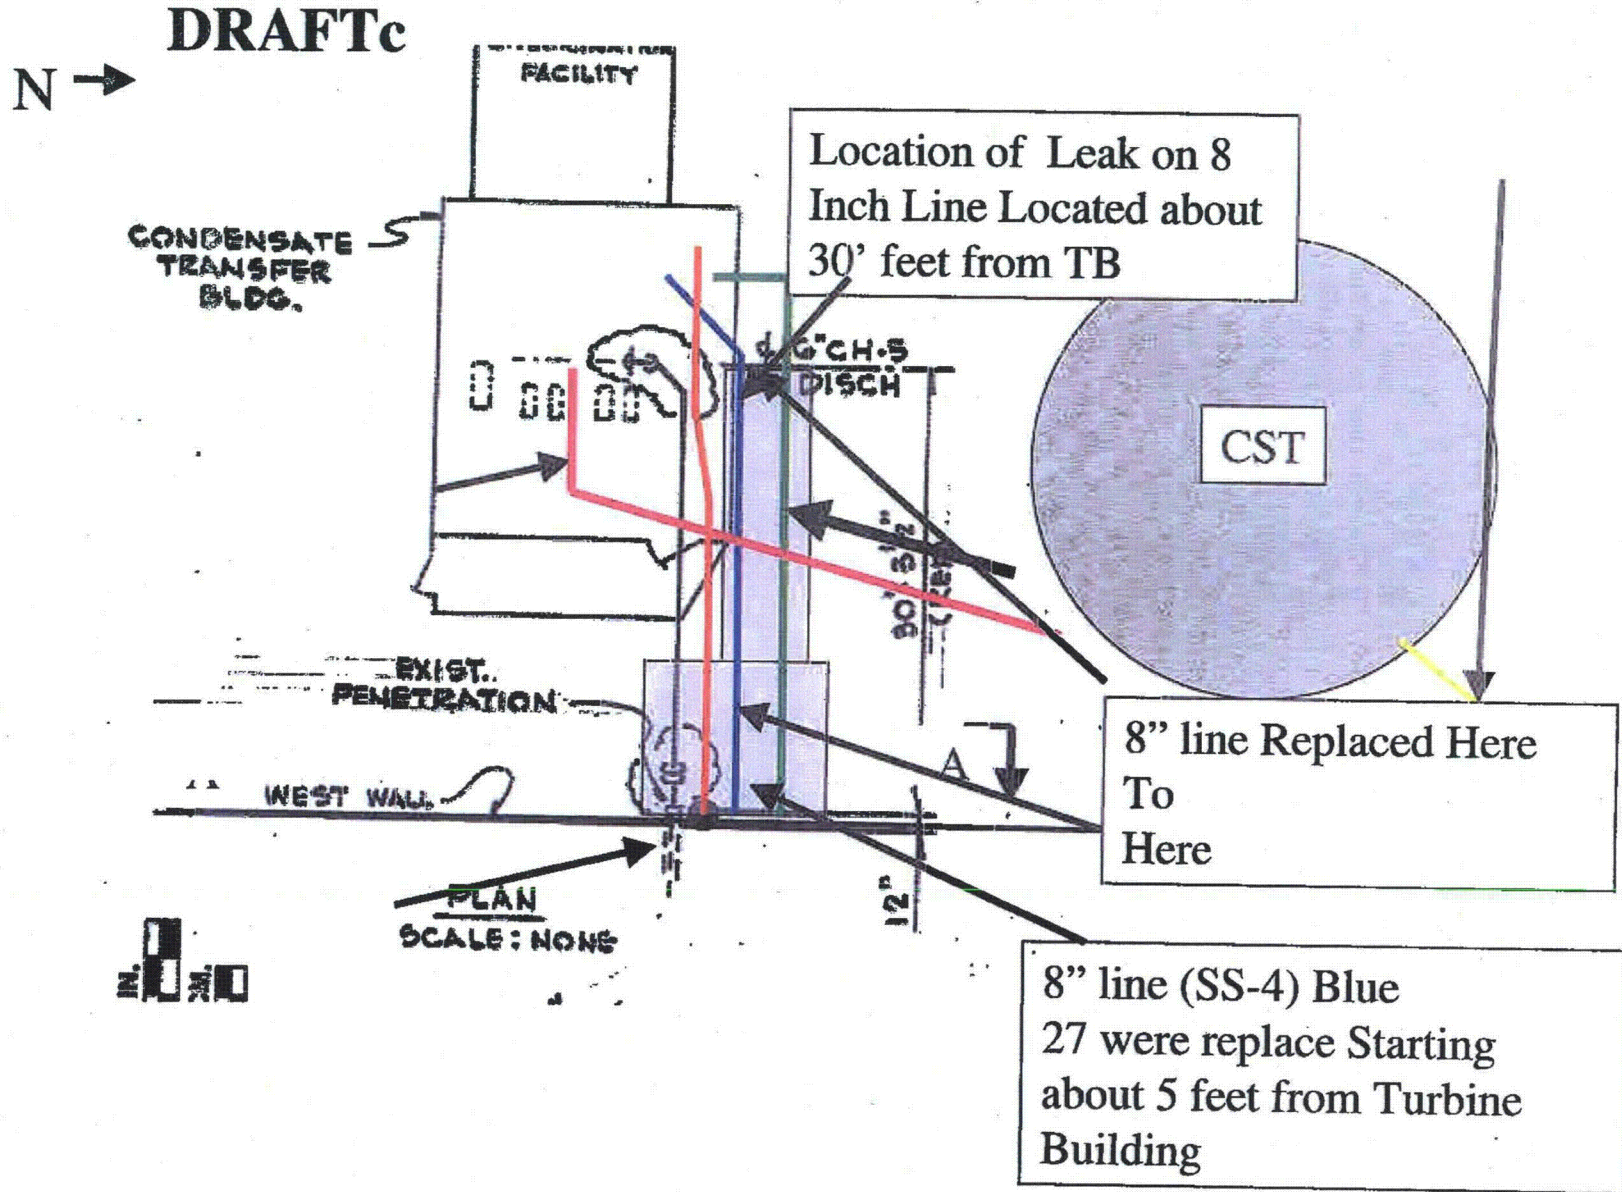
The distances in this diagram are from the collar used for Guide Wave Testing of these piping to the locations that showed degradation (wall thinning).

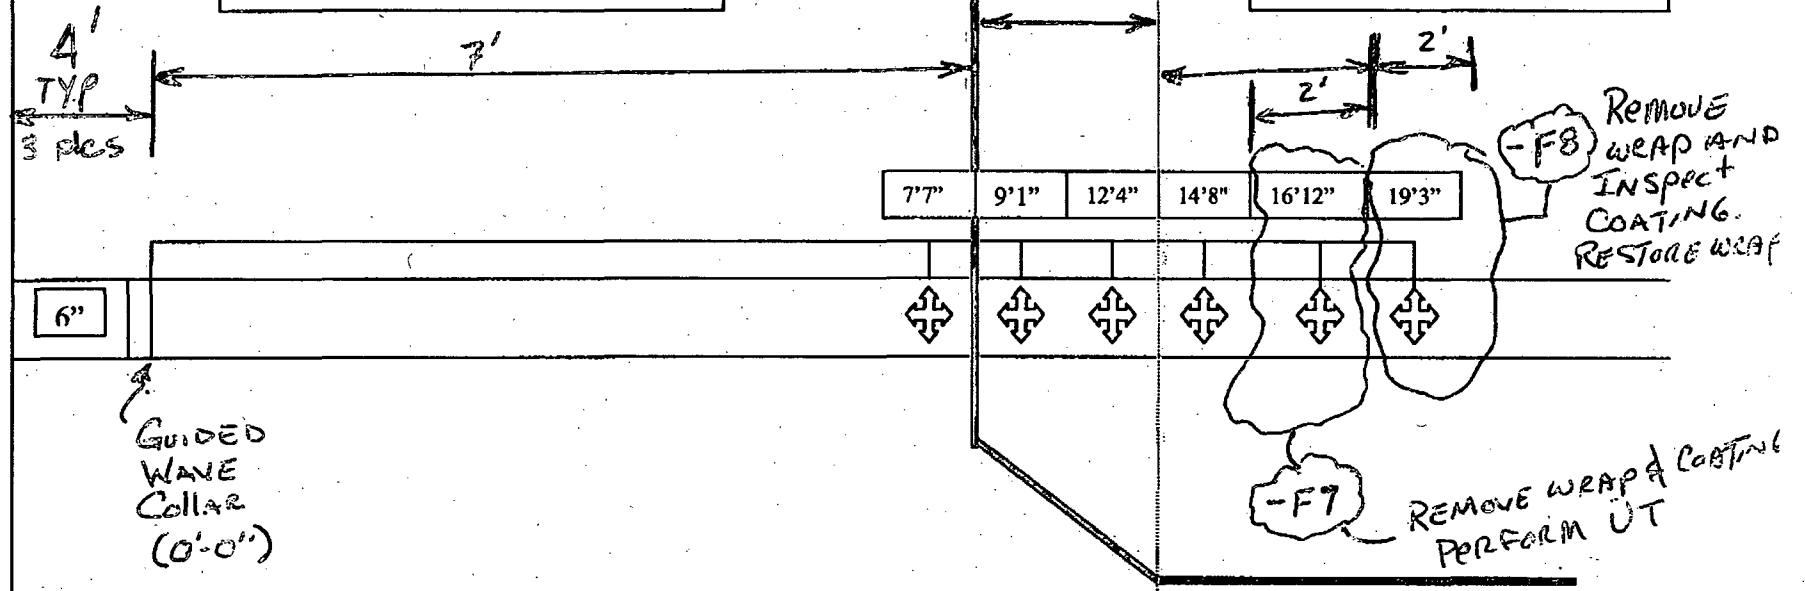
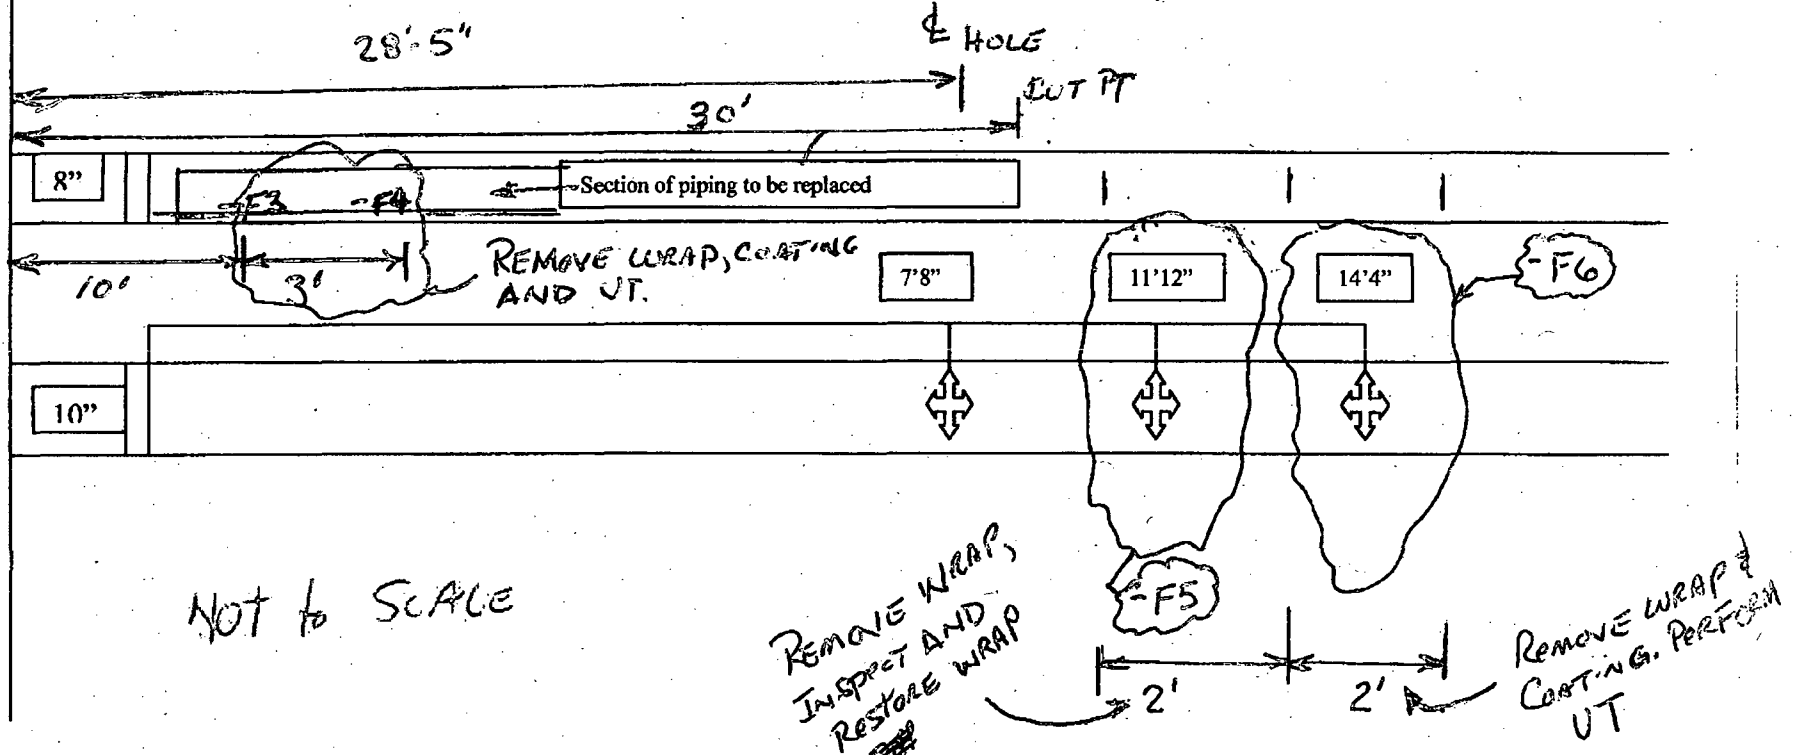
Pipe: 6" CH-5	Ring: R2F06(268)
Site: Oyster Creek Unit 1	Config: 0.6FR, T(0,1)
Location: Elbow +8"	Calibration: Automatic (2491.06 mV)
Size: 6 inch (7.125mm)	Version: 3.95, Wavemaker G3-14

Feature	Location	Size (mV)	ECL	Extent	Class	Notes
+F1	0'7"	0.189	-	60	Bitumen	
+F2	0'8"	0.123	-	45	45 deg Bend	
+F3	2'3"	2.2	-	30	45 deg Bend	
+F4	4'3"	0.996	-	15	Earth	
+F5	4'5"	0.945	-	12	Sleeve	
+F6	5'5"	0.664	-	4	Wall	
+F7	8'7"	0.48	-		End	
-F1	-0'8"	0.45	-	70	Bitumen	
-F2	-1'6"	1.31	-	0	Earth	
-F3	-7'7"	0.397	5	30	Minor	40% circumference affected approximately 12% wall loss Probable coating failure or change in coating thickness
-F4	-9'1"	0.252	-	60	Other	Probable coating failure or change in coating thickness
-F5	-12'4"	0.15	7	0	Medium	25% circumference affected approximately 28% wall loss
-F6	-14'8"	0.0697	7	0	Medium	25% circumference affected approximately 28% wall loss
-F7	-16'12"	0.0656	7	0	Medium	20% circumference affected approximately 35% wall loss
-F8	-19'3"	0.0456	7	0	Medium	25% circumference affected approximately 28% wall loss
-F9	-20'6"	0.0731	-	50	45 deg Bend	
-F10	-21'2"	0.0428	-		End
