NASA TN D-7439

APOLLO EXPERIENCE REPORT - SPACECRAFT STRUCTURAL WINDOWS

by Orvis E. Pigg and Stanley P. Weiss

Lyndon B. Johnson Space Center

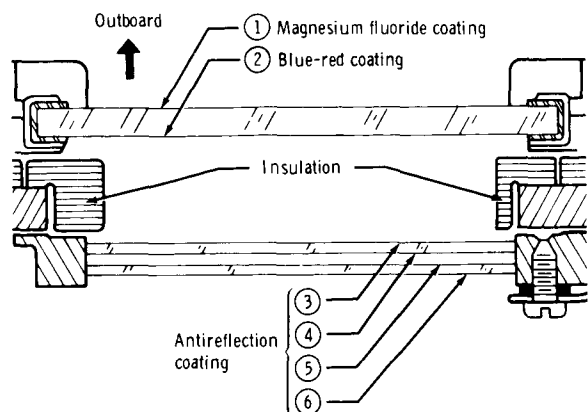
Figure 5. - Command module window-surface notation.

As previously stated, an initial assumption was made that the optical coatings applied to the windows did not degrade their structural capability; therefore, the window qualification tests were conducted using uncoated, abraded windows. This assumption was proved invalid during coating crazing anomaly, and additional qualification testing of the coated windows was required to verify their flightworthiness.

To improve the optical properties of the CM heat-shield hatch window for the lunar multispectral photography experiment (S-158) on Apollo missions 13, 14, and 15, the available hatch windows were surveyed to find those with acceptable optical properties. Two heat-shield side windows with acceptable properties were found, and it was decided to remove the coatings and cut hatch windows from these side windows. At that time, the hatch scientific window could have no coatings because of the S-158 experiment optical requirements. The "no coating" requirement was removed later for the Apollo 14 mission because the S-158 experiment on that flight was rescheduled to the Apollo 15 mission. The first side window was damaged during the polishing procedure to remove the coatings. The second window was cut to size, and both the magnesium fluoride and the blue-red (BR) coatings were left on the window. In the thermal-shock test, the window was heated in air to 1200° F for 45 minutes and immediately immersed in room-temperature tapwater. The BR coating crazed and cracks propagated through the tension layer developed by the thermal gradient of the glass on the underside of the BR coating. Later, an entire side window from spacecraft 014 was tested in a similar manner to verify that the cutting of the window had not caused the crazing; similar results were obtained.

1. The BR coating crazing is temperature dependent.
2. The BR coating crazing is independent of window size or cooling rate.
3. The BR coating crazing occurs during cooling.
4. Window glass fracture sometimes occurs when the BR coating crazes, but does not occur without it.

To determine the minimum temperature at which the heat-shield window coating crazes, a series of tests was conducted on 2- by 7-inch samples cut from a spacecraft 017 heat-shield side window. The results of these tests indicated that the threshold temperature for BR coating crazing is 450° to 500° F. A separate series of tests was conducted on 3- by 3-inch samples cut from a spacecraft 014 heat-shield rendezvous window and also determined that BR coating crazing occurs at approximately 500° F.

The decision was made to continue using the coated windows and to conduct a delta qualification test program to verify the adequacy of these windows at newly predicted flight temperatures. The maximum flight temperature on the inner surface of the heat-shield window was predicted to be 362° F. Because the coating crazing was

determined to be caused by peak temperature and not thermal gradient, it was proposed that the heat-shield windows be tested to a maximum temperature of 462° F to account for variations in oven temperature and the temperature at which the coating was deposited. Three heat-shield side windows were heated in an oven to 462° F to represent worst-case flight temperatures, and the windows were then pressure tested on both sides to verify adequate structural capability for the remaining flight loads. The program was completed successfully and the coated heat-shield windows were considered flight qualified.

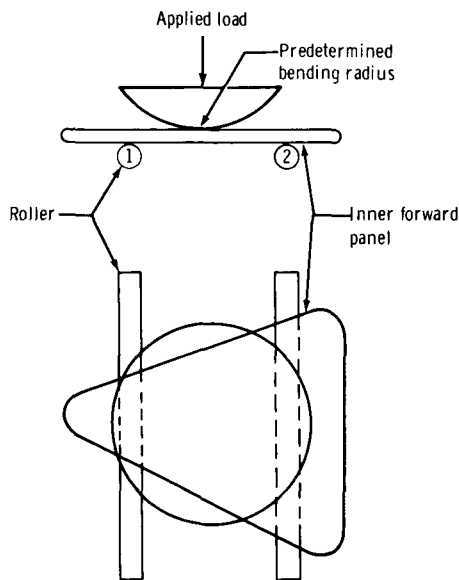
Figure 10. - Lunar module window flexure tests.

Forward window test failure. - In December 1967 during a factory checkout pressure test on the LM-5 ascent stage cabin, a forward window failed at a cabin pressure of 5.1 psid. The pane was completely destroyed, which is consistent with the failure mode of tempered glass. The subsequent investigation revealed no abnormal conditions; it was concluded that the most likely cause of the failure was an undetected flaw in the glass. This pressure test of LM-5 was the first time the window glass had been exposed to the correct stress distribution. Previous structural acceptance tests on the windows consisted of a mechanical flexure test (fig. 10) on the forward windows and a thermal-shock test on the docking window. The mechanical flexure test was accomplished three times on both sides of each panel (each corner on roller 1). The flexure test stressed the pane to a maximum of approximately 30 000 psi, which demonstrated a factor of safety of approximately 5 over normal operating stress. However, this test did not

stress the corners of the pane, which were the areas of maximum stress in the vehicle. Because the docking window was curved, a thermal-shock acceptance test was required instead of a mechanical flexure test. The stress level experienced during thermal shock was approximately 20 000 psi, which demonstrated a factor of safety of approximately 7. To reestablish confidence in the structural integrity of the LM windows, many engineering evaluation tests were conducted. A summary of the tests conducted, including the purpose, condition, and results, is given in table I. These tests showed the structural integrity of the window glass and the window-support structure. The structural integrity was sufficient if glass with critical defects was not used in the spacecraft. Two steps were taken to guarantee that defective glass was not installed. The first step was to modify the acceptance test to include a pressure test on each structural pane in a test fixture simulating the

spacecraft installation. The acceptance test pressure imposed on the panes was 25 psid for the forward windows and 15 psid for the docking window. These pressures correspond to proof factors of 5 and 3 above operating pressure for the two windows, and these proof factors are consistent with requirements based on fracture mechanics techniques. The docking window test pressure was restricted to 15 psid to prevent yielding of the metallic edge member. In addition to the improved acceptance tests, the second step taken was to redesign the window glass protective covers to provide maximum protection from acceptance until launch. Before the acceptance tests were conducted, a polycarbonate protective cover, retainer, and glass pane were installed as a subassembly in the pressure-test fixture. The pressure test was then performed to the proper pressure for 2 to 5 minutes. After the pressure test, the subassembly was removed from the fixture and an additional protective cover was installed on the opposite side to provide a handling and transportation protective cover assembly. The outer covers remained on each pane until the outer pane was installed. The two covers were not removed from the vehicle until just before launch, which provided maximum protection against inadvertent damage from workmen in and around the vehicle.

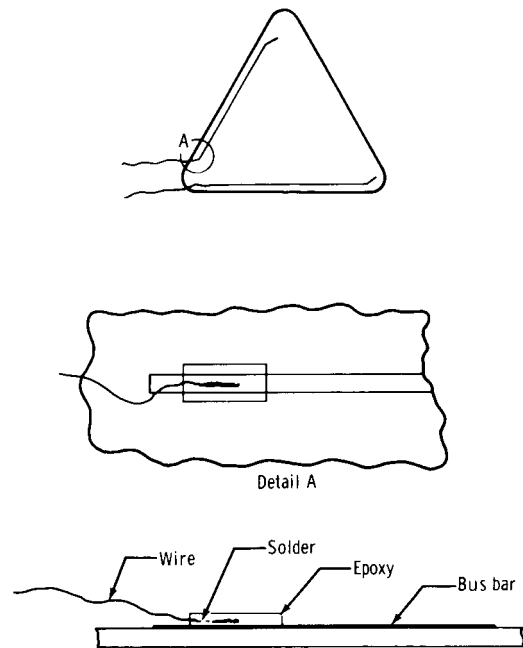
Figure 11. - Lunar module window heater electrical connection.

Window heater electrical connection. - A forward window bus bar arced during the factory checkout test of the electrical heater on LM-8. Failure analysis revealed the glass was spalled under the bus bar, causing the arc when electrical power was applied. A detailed inspection conducted on other LM windows revealed discolorations that indicated spalling.

The configuration of the electrical connection to the bus bar for the window heater is shown in figure 11. The bus bar was a strip of silver paste fused into the glass along the edge of two sides of each window. The electrical wire was subsequently soldered to the bus bar. To provide strain relief to the solder connection, an overlay of epoxy was applied. After the addition of the solder and epoxy to the windows, the window was exposed to various manufacturing processes that elevated the window temperature. Because of the difference in the thermal coefficient of expansion between the glass, solder, and epoxy, residual stresses were induced into the glass. Analysis indicated that the magnitude of thermal stress was sufficient to relieve the compressive stresses in the outer layer of the chemically tempered glass, thereby reducing the strength of the glass. An extensive test program was conducted to verify the cause of the spalling. The MOR test matrix is presented in table II.

program included specimens with solder and epoxy applied that were exposed to the flexure and temperature environment and then the solder and epoxy were removed. These specimens showed that the original strength was reestablished if the solder and epoxy were removed.

The electrical connection to the bus bar was redesigned to eliminate the solder and epoxy. The new electrical connection was achieved by a beryllium copper spring-loaded electrical contact as shown in figures 12 and 13. The window panes in LM-7 and subsequent vehicles were removed from the vehicles and the solder and epoxy were removed from the panes. Following the rework, the panes were proof-pressure tested and reinstalled in the vehicles.
