## New Tire Fill Alert System Pumps Up Tire Inflation

New Tire Fill Alert System Pumps Up Tire Inflation . . . . .	1
Download the Latest AFIT Software Update . . . . .	2
Camaro Convertible Folding Top Front Latch Rebalance . . . . .	3
Camaro Convertible Rear Quarter Glass Wind Noise . . . . .	4
Using the Correct AFIT Power Adapter . . . . .	5

GM TechLink is published for all GM retail technicians and service consultants to provide timely information to help increase knowledge about GM products and improve the performance of the service department.

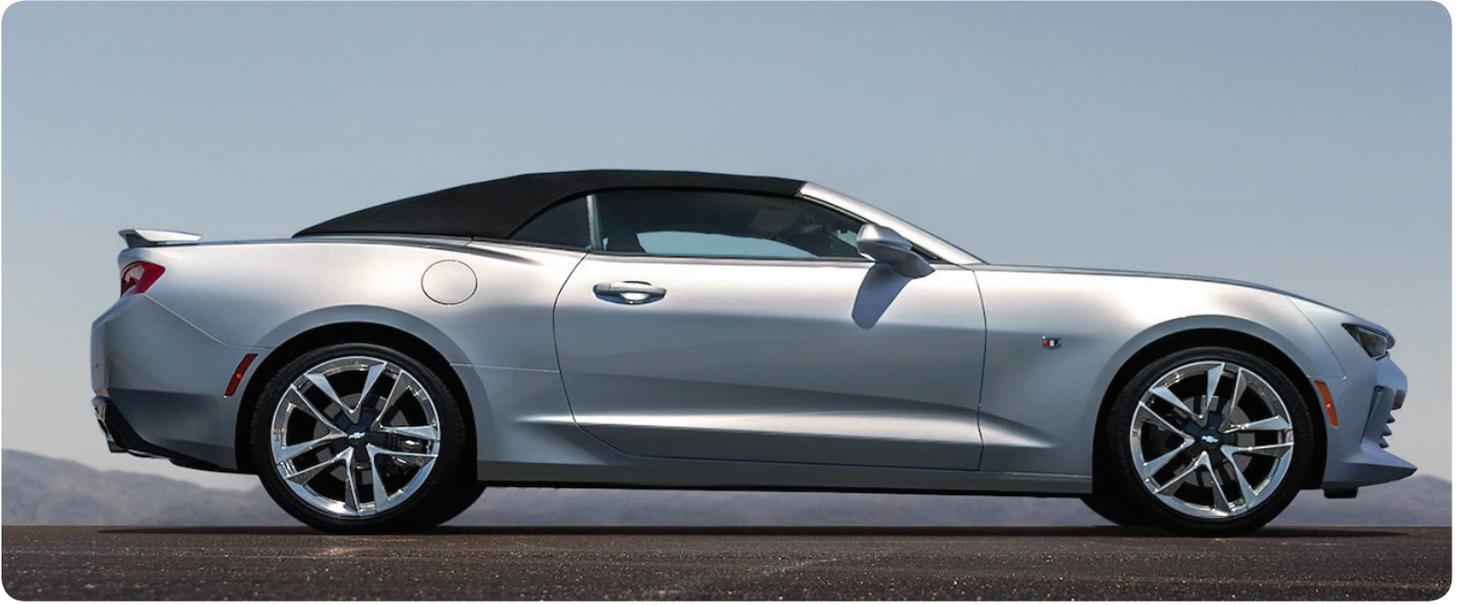
2016-2018 Camaro convertible models may have a “Top Not Secure” message display on the Driver Information Center and the rear compartment lid may not open. During diagnosis, it may be found that the folding top latch actuator is latching, but the magnet is not aligned with the position sensor. These conditions may be caused by the amount of time the folding top control module drives the latches, possibly causing them to bounce back past the sensor.

To correct the condition, reprogram the K23 Folding Top Control Module with the latest calibrations, and complete the rebalance procedure for the folding top front latch actuator motor and the front latching mechanism (based on build date).

The rebalancing procedure involves loosening the three bolts that retain the folding top front latch actuator motor so that the motor can be moved freely side-to-side, turning the Allen key until the latch hooks are completely open, and then turning the Allen key until the latch hooks are completely closed. Refer to Bulletin #16-NA-257 for complete instructions.

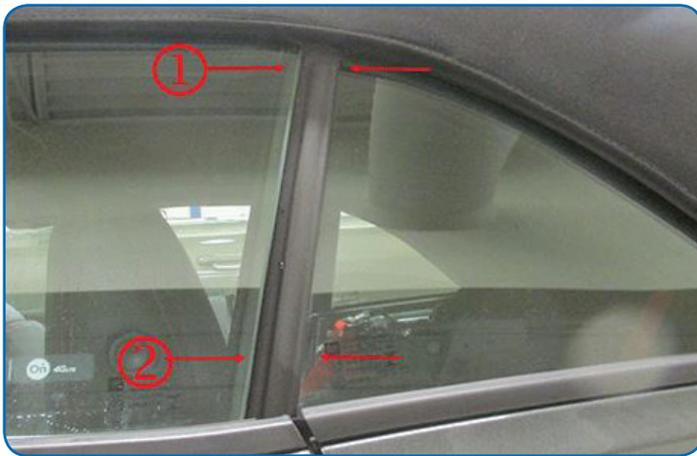
Some 2016-2017 Camaro convertible models may have a noticeable wind noise condition at the rear quarter window area. The wind noise may be due to a misalignment between the front side window and the rear quarter window on either side of the vehicle.

Even 10 mm gap between the two windows

The first two measurements are related to the vertical gap between the front side window and the rear quarter window. This gap is V-shaped by design. When the folding top is lowered, the gap between the two windows is 12 mm wide at the top and 10 mm wide at the bottom.

When adjusting the vertical gap, the folding top must be in the stowed or lowered position. After adjustment, when the top is closed and latched, the rear quarter glass window will be pushed forward slightly. The result will be an even 10 mm gap between the two windows from top to bottom.

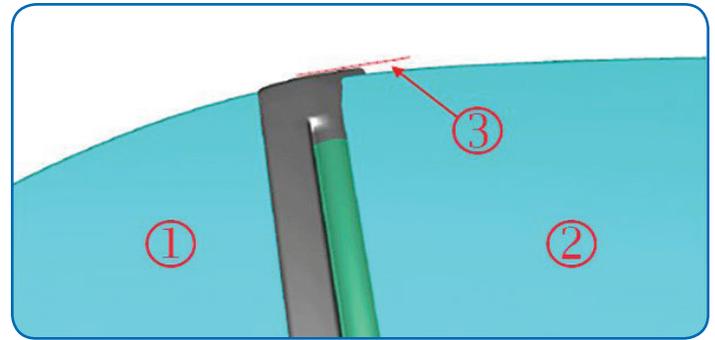
1. Rear quarter glass
2. Front side glass
3. 4 mm difference in height

The third adjustment to the height of the rear quarter glass will change the location of the glass so that it sits 4 mm higher than the front side window glass.

Once the quarter window is adjusted, compare the two panes of glass at the base. They should be flush with each other (inboard vs. outboard). If the difference between the front and rear windows is more than 1.5 mm, or if there is a visible gap that can be seen between the seals, the rear quarter glass will need to be adjusted further.

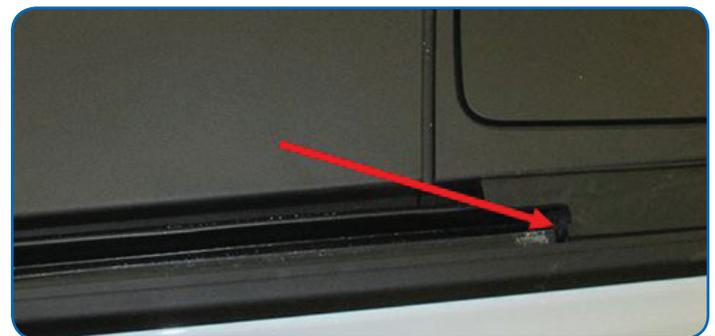
Foam in the rear of the window channel

If the glass adjustments have been made and wind noise is still present, inspect for the presence of a foam piece in the rear of the window channel. If the foam is missing, insert a foam piece into the window channel. If the foam is in the window channel, installing a slightly larger foam piece will put more outward tension on the window seal, helping to reduce any lingering wind noise.

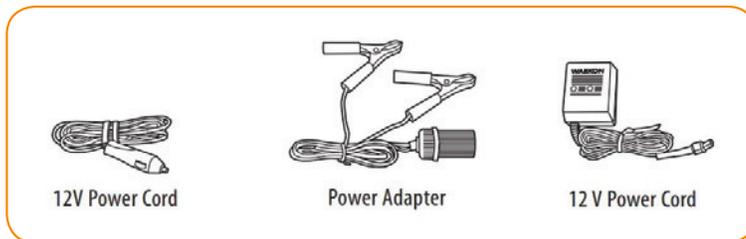
The wall adapter will power up the MCU but does not provide sufficient power to test the fuel injection system.

Power adapters for the accessory power outlet, vehicle battery, and wall outlet.

The 12V power adapter that plugs into a wall outlet only should be used to supply power to the MCU when connected to a computer when it's necessary to update the tool or upload test records.

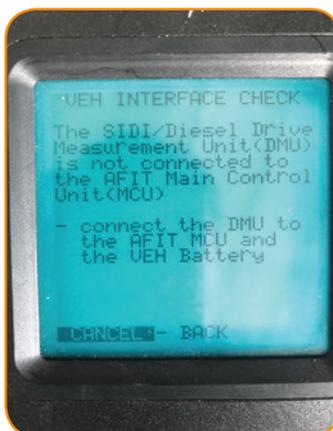
Error message

If the correct power connections are not made, an error message may be displayed that the MCU is not communicating with the DMU.
