# NEWTON PAVILION AT BOSTON MEDICAL CENTER

88 East Newton Street  
Boston, Massachusetts 02118

Report of Property Condition Assessment

Reference: Report of Property Condition Assessment  
Newton Pavilion at Boston Medical Center  
88 East Newton Street  
Boston, Massachusetts 02118  
Faithful+Gould Project No. 100056092

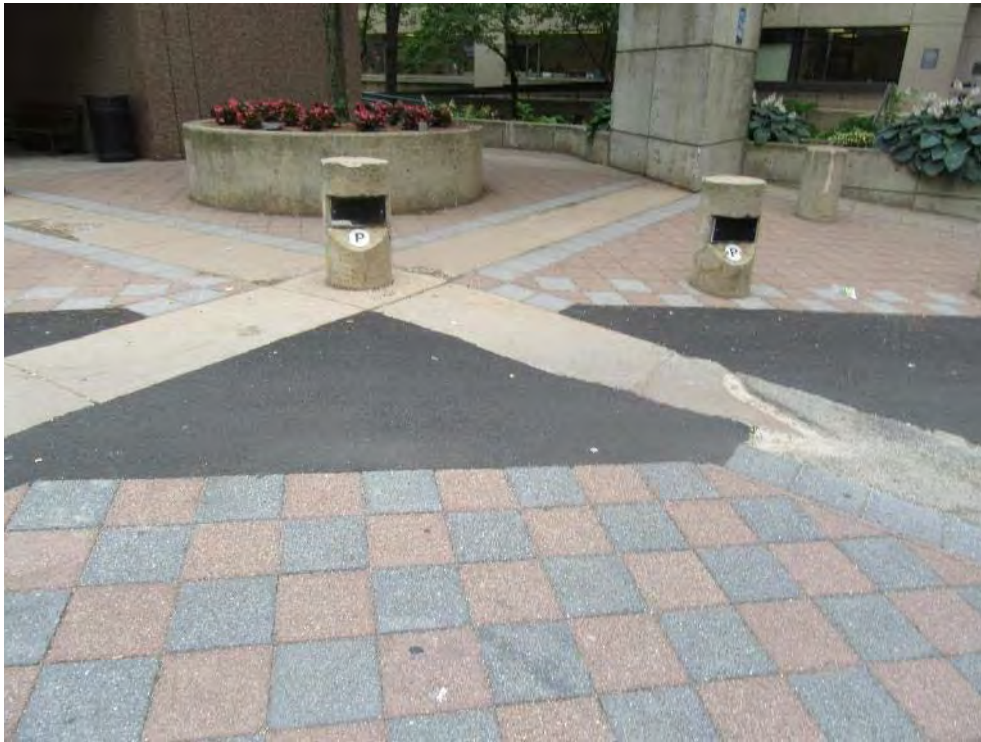
**Photograph No. S-01**

Entrance Plaza  
Concrete, Bollards,  
Pavers and Asphalt

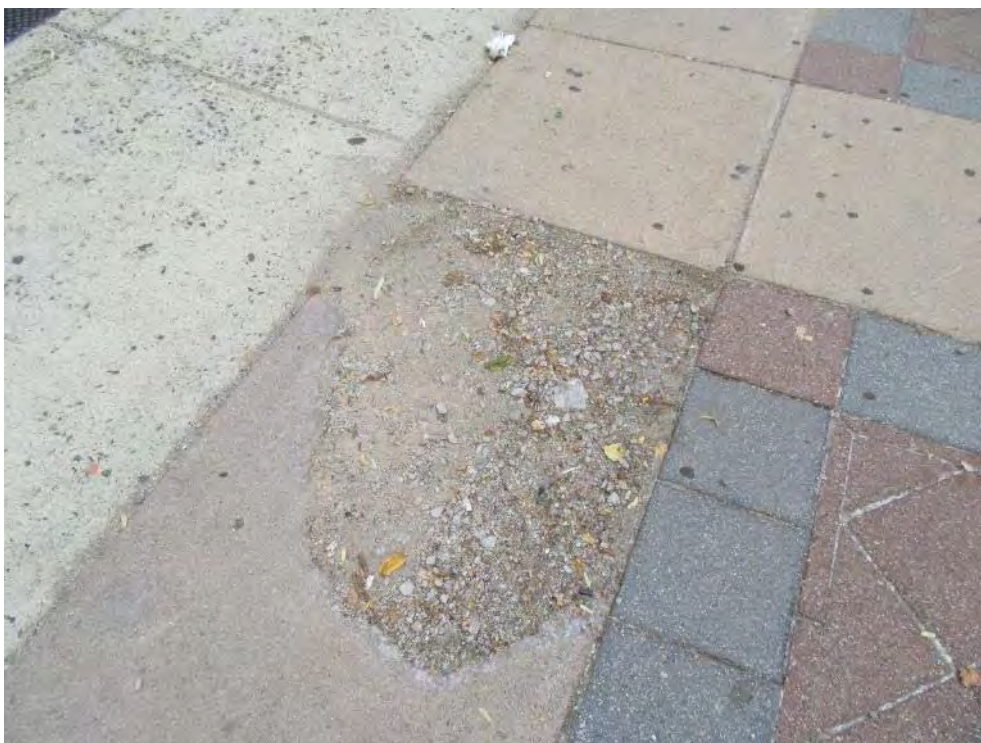
**Photograph No. S-02**

Across the site, the condition of the cast-in-place concrete ranged from fair to poor. In many areas, the concrete bands had degraded from salt spreading in winter along with general weathering, traffic and freeze-thaw damage resulting in areas of cracked, broken and loose concrete. If left, these areas will continue to degrade and in their current state represent a trip hazard. We recommend that the defective concrete is replaced in the near-term, and that an annual allowance be budgeted for replacement of failed concrete throughout the study period.

Damaged Concrete at  
Entrance Plaza

1. We recommend budgeting for replacement of the failed concrete site elements in 2019. Our opinion of cost for this work is \$13,356.
2. We recommend budgeting for replacement of the failed concrete site elements, as a 10% annual allowance per year from 2019 through 2028. Our opinion of cost for this work is \$1,330 per year for a total cost of \$13,300 over the study period.
3. We recommend budgeting for the currently failed bollards at the entrance plaza in 2019. Our opinion of cost for this work is \$10,500.

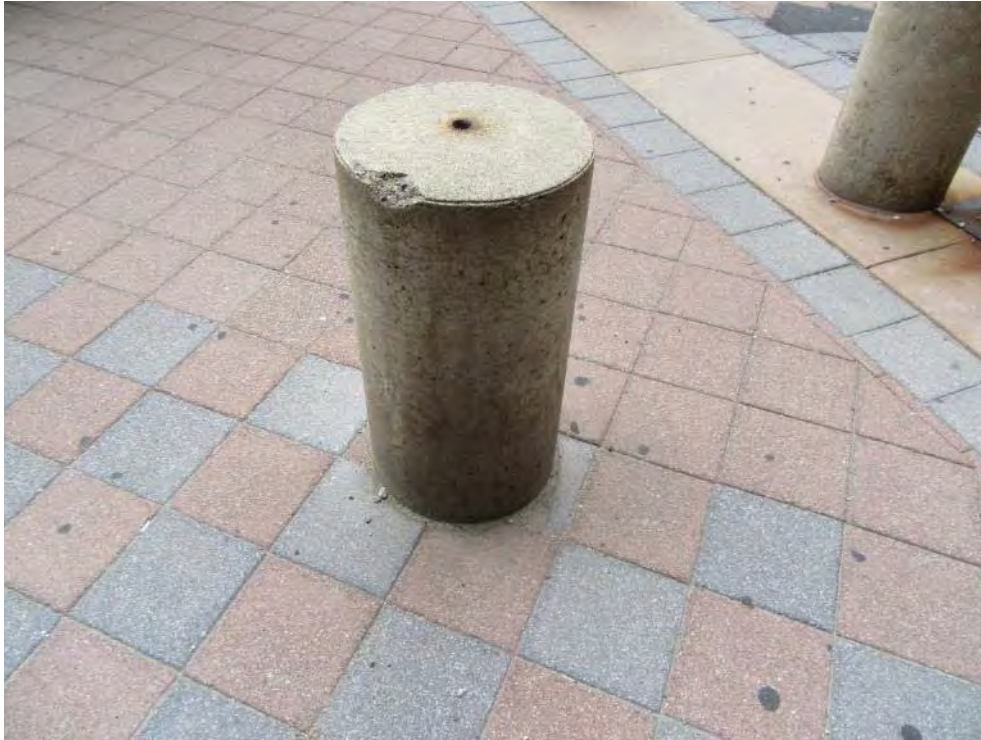
**Photograph No. S-03**

Column (Fair Condition) at Entrance Plaza

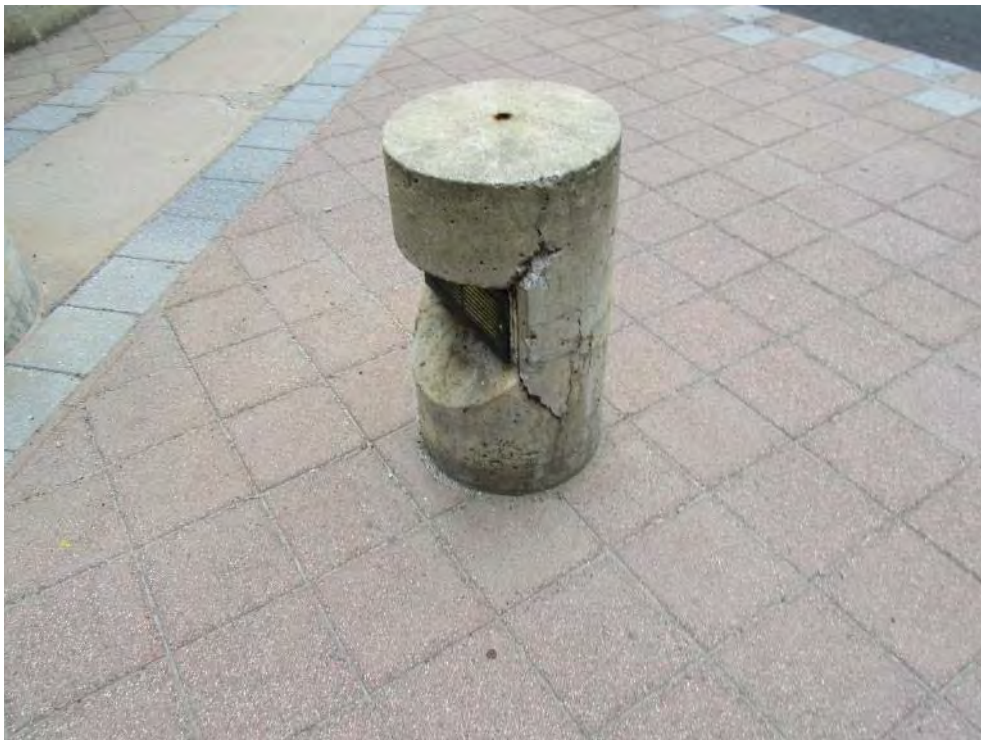
**Photograph No. S-04**

Several of the bollards in the drop-off area have failed and are in a poor condition, with areas of cracked and loose concrete visible. The remainder of the bollards are in a fair condition, but are starting to degrade. We anticipate that all bollards will fail over the course of the 10-year study period. We therefore recommend that the bollards in poor condition are replaced in the near-term, the degrading bollards replaced in the mid-term and the remainder of the bollards replaced in the late-term.

Column (Poor Condition) at Entrance Plaza

4. We recommend budgeting for the future failed bollards (mid-term) at the entrance plaza in 2023. Our opinion of cost for this work is \$23,100.
5. We recommend budgeting for the future failed bollards (late-term) at the entrance plaza in 2028. Our opinion of cost for this work is \$13,300.

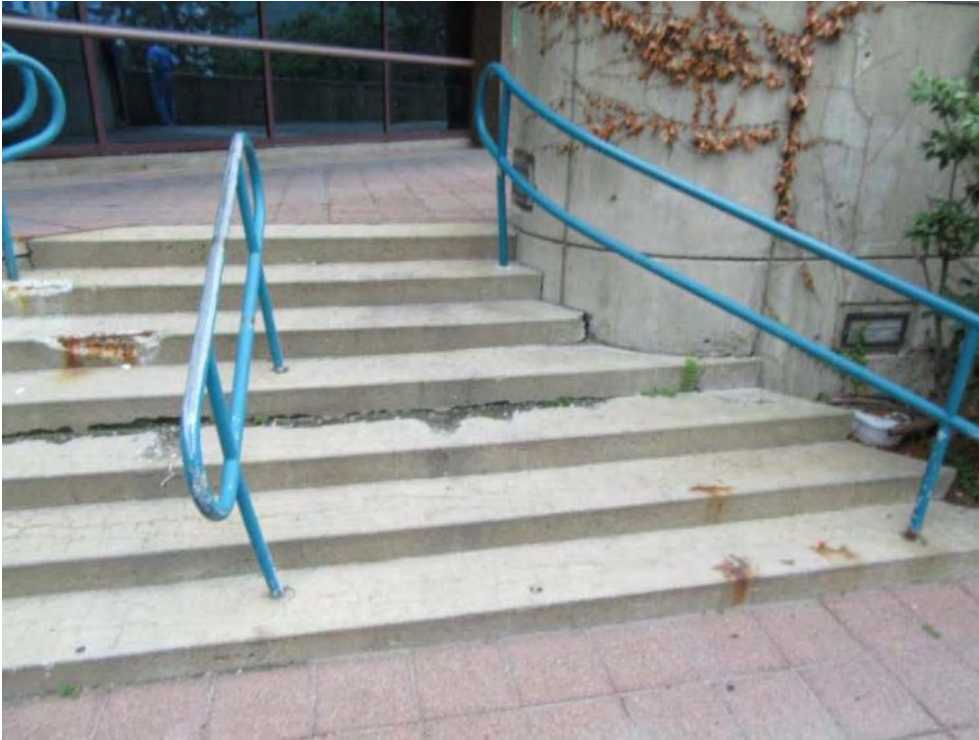
**Photograph No. S-05**

The concrete steps at the northeast facing elevation are in poor condition and require remedial works in the near-term. At this location, the concrete has degraded badly, most likely as a result of salt-spreading in the winter months attacking the steel reinforcement and repeated freeze-thaw weathering which has broken off several areas of concrete across the steps. The handrails are in

poor condition, with the metal handrails bent in places and in poor decorative condition and these should also be broken out and renewed when works to the steps is undertaken. In addition, it was noted during our assessment, that while other steps further towards the main drop-off area were in fair condition, the handrails were in poor decorative order and were poorly fitting; however, given the value of rectifying this, repairs to this item are considered an operational maintenance expense.

Damage to Cast-In-Place Concrete Steps and Handrails

6. We recommend budgeting for replacement of the failed concrete steps at the northeast facing elevation in 2019. Our opinion of cost for this work is \$4,410.

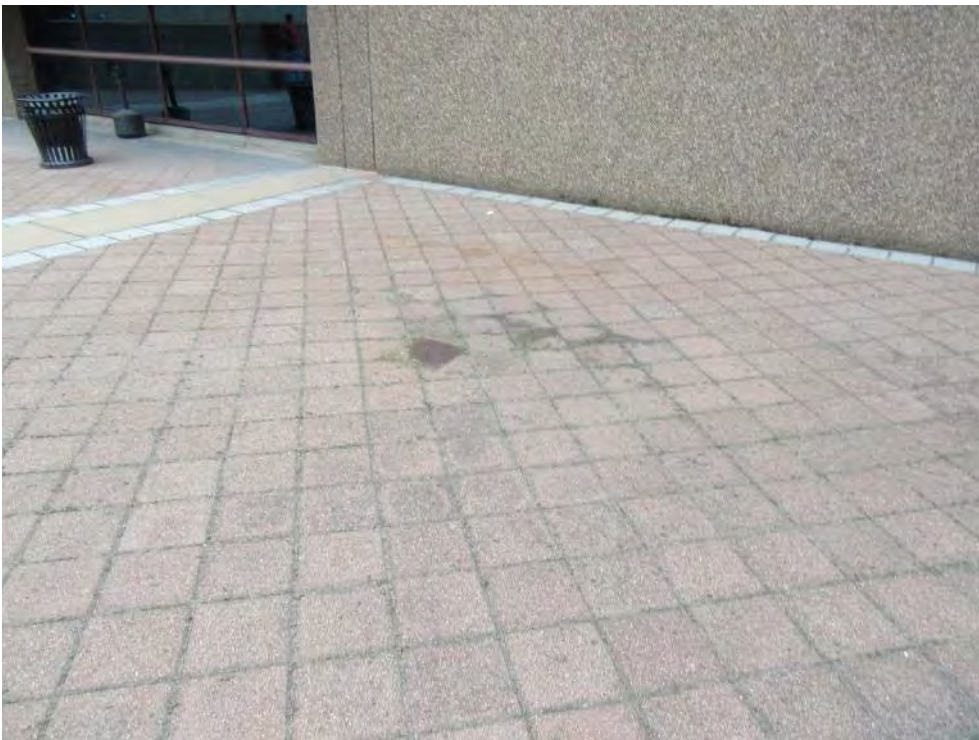
**Photograph No. S-06**

Pavers Above Loading Dock Area

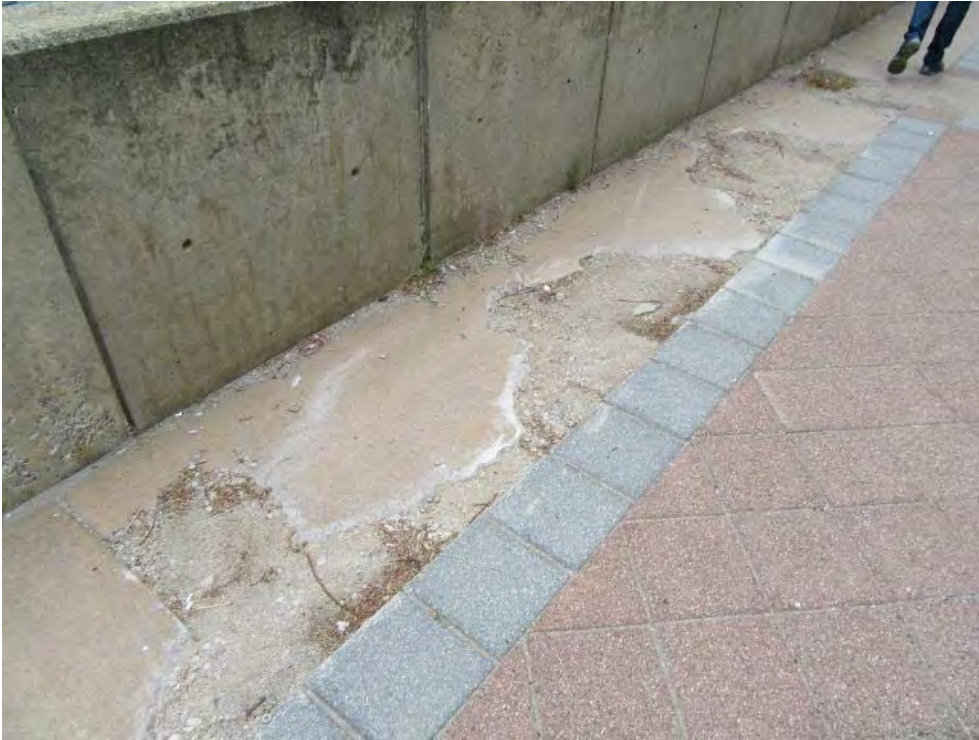
**Photograph No. S-07**

Damaged Concrete at Area Above Loading Dock

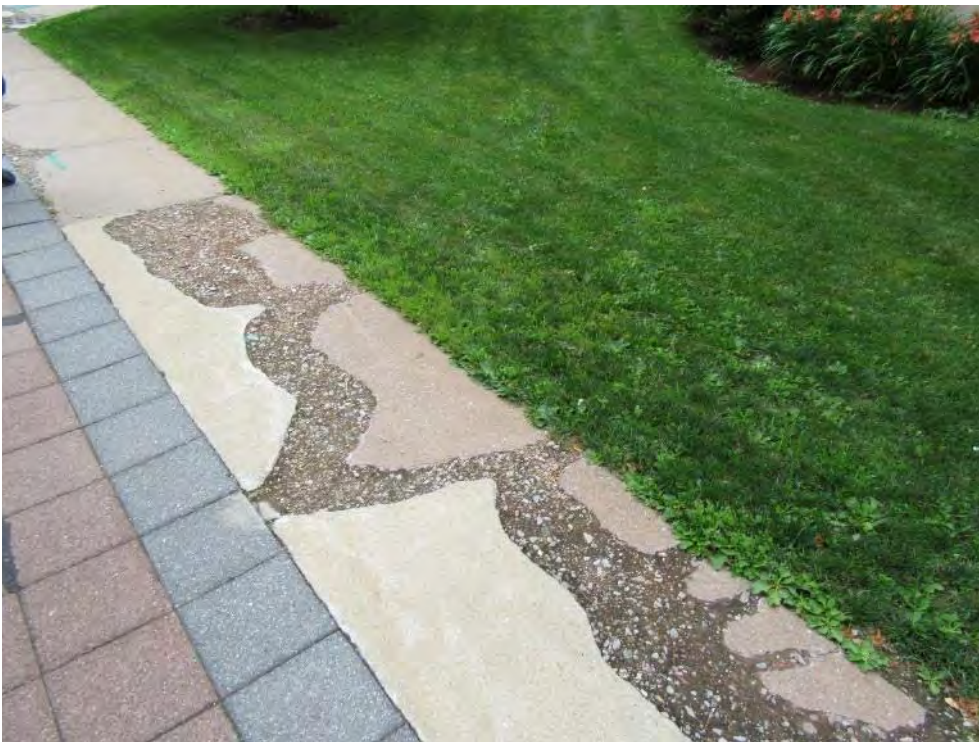
**Photograph No. S-08**

Damaged Cast-In-Place Concrete at Path (East of Site)

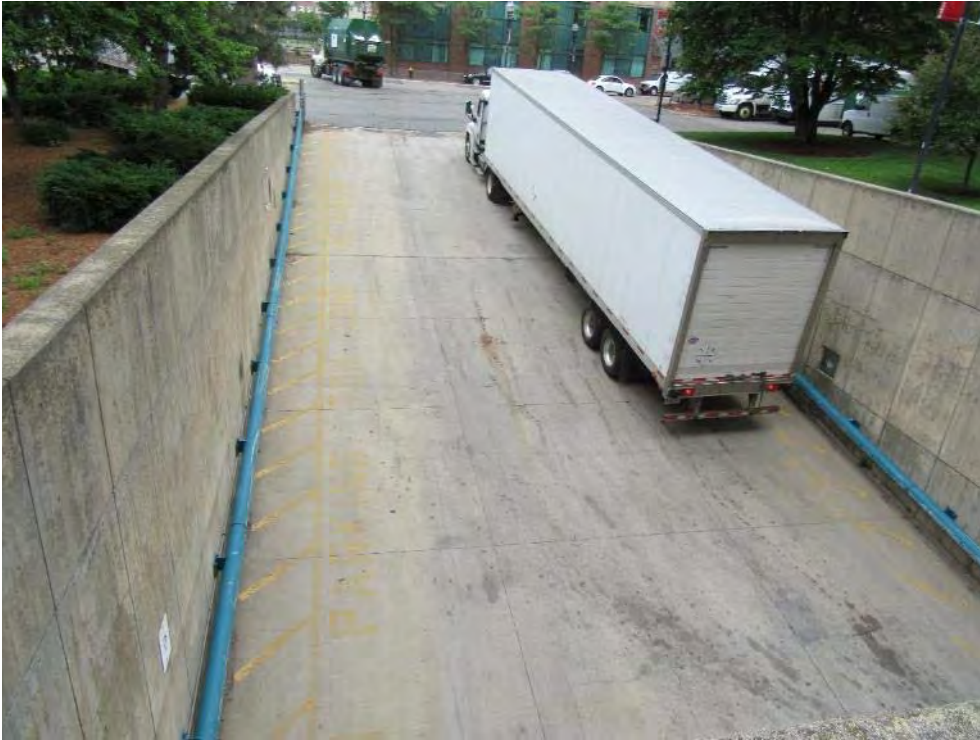
**Photograph No. S-09**

The concrete loading ramp into the basement area was in fair to poor condition and areas of cracked, loose and missing concrete were noted particularly at the top of the ramp. The concrete has degraded naturally through salt spreading, freeze-thaw weathering and damage from trucks which reverse up and down the ramp several times daily. We recommend that concrete to the top of the ramp is broken out and replaced in the near-term, with a cycle also completed in the mid-term to replace the mid-section of the ramp. Given that this ramp is used frequently for deliveries, consideration should be given in regards to programming of the works to verify that the concrete can be laid and given time to set sufficiently, without compromising the operation of the hospital.

Loading Dock View  
from Above

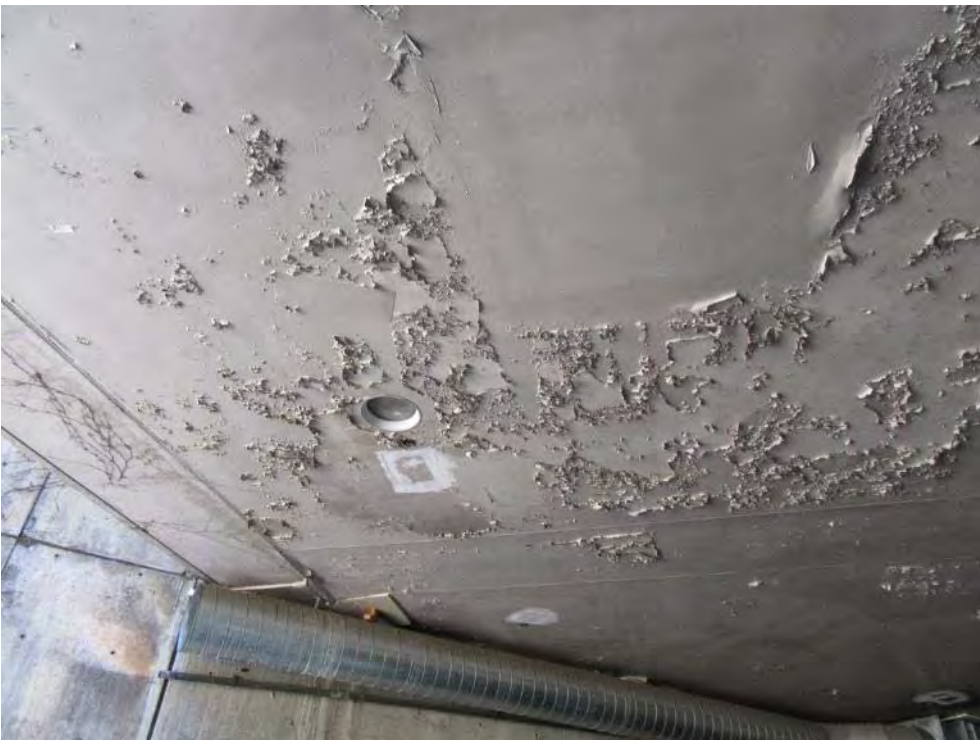
**Photograph No. S-10**

Damage to Soffit of  
Loading Bay

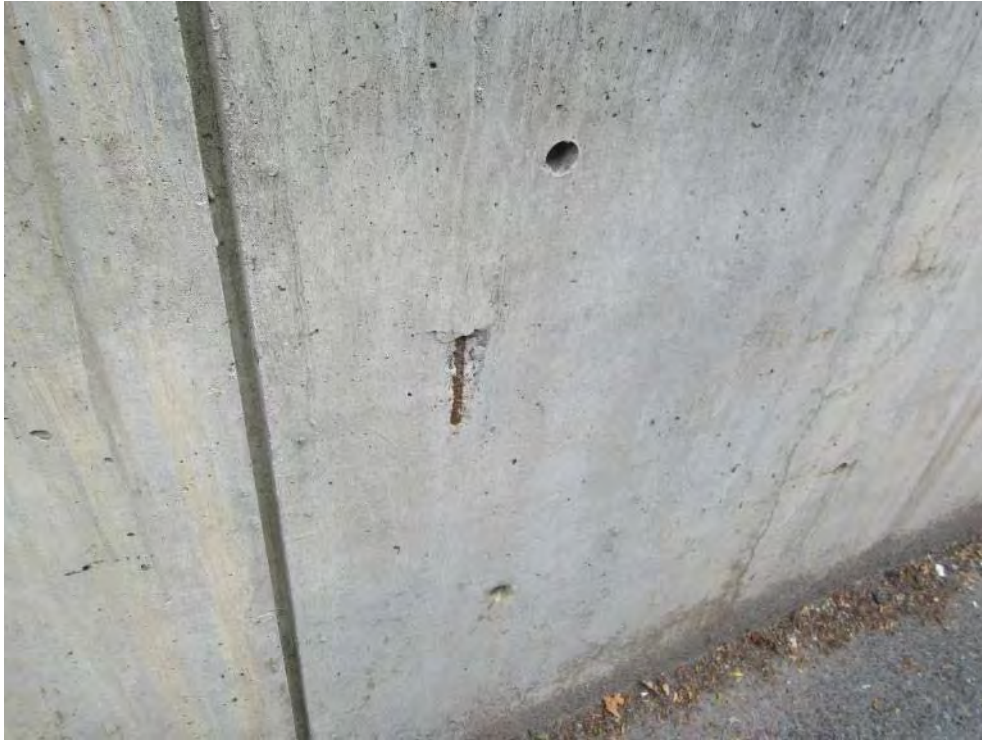
**Photograph No. S-11**

The concrete planter at the southeast of the site was in a fair condition, however the external face of the concrete was exhibiting the same defects as the ramp retaining walls as described above and the issues with the waterproofing membranes are described also in the following section.

The planter is exhibiting the same defects as the walls to the ramp and we believe that the membrane at this location has also failed, water is penetrating from the earth in the planter behind and causing dampness and the associated issues in the concrete. To avoid further deterioration to the concrete, the earth should be removed and the waterproof membrane across all perimeters of the planter renewed in the mid-term. Upon completion and installation of the waterproof membrane, the earth and plants can be reinstated.

Exposed Re-Bar at  
Planter to East of Site

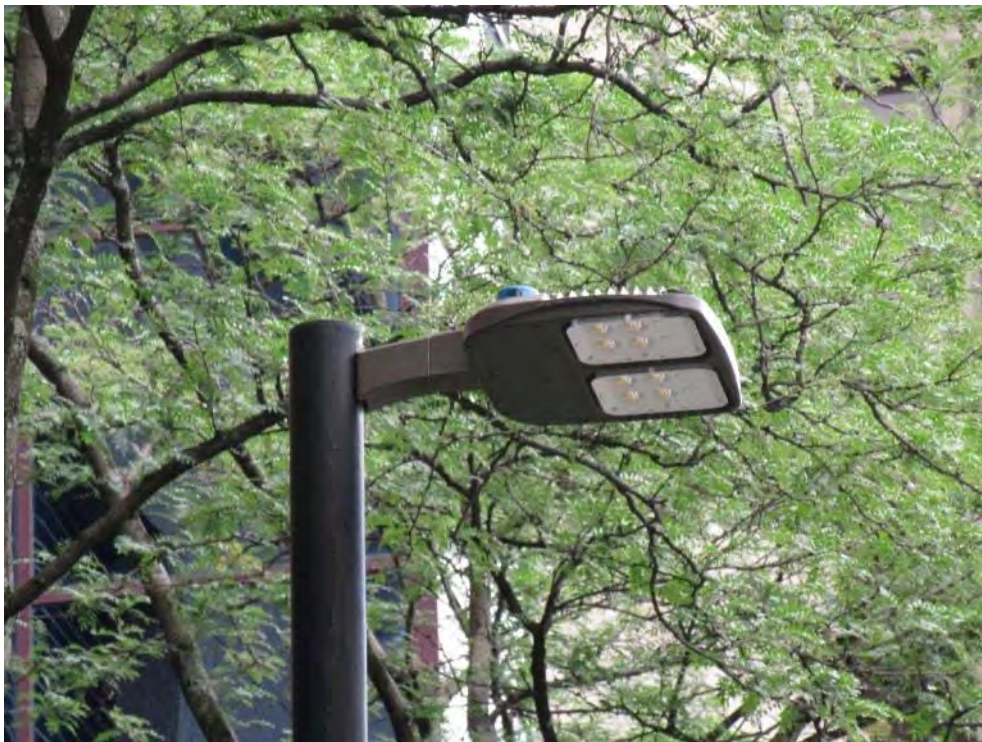
**Photograph No. S-12**

LED Lighting to Site at  
Eastern Alleyway

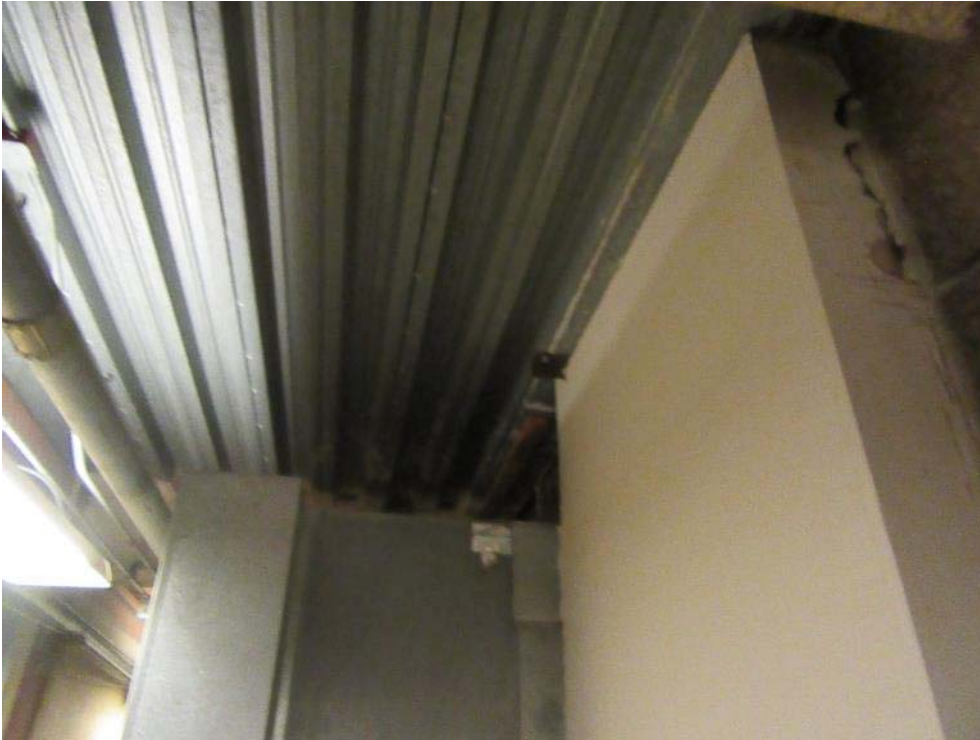
**Photograph No. ST-03**

Soffit of Floor Deck  
Above within Q Building

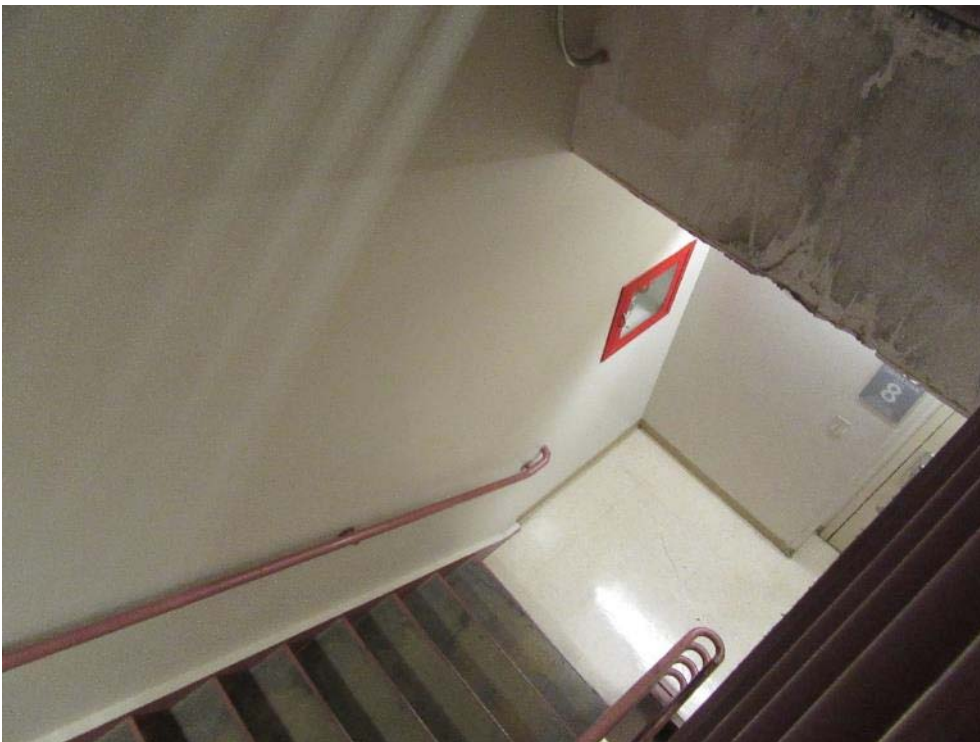
**Photograph No. ST-04**

Interior Stairwell (Q  
Building)

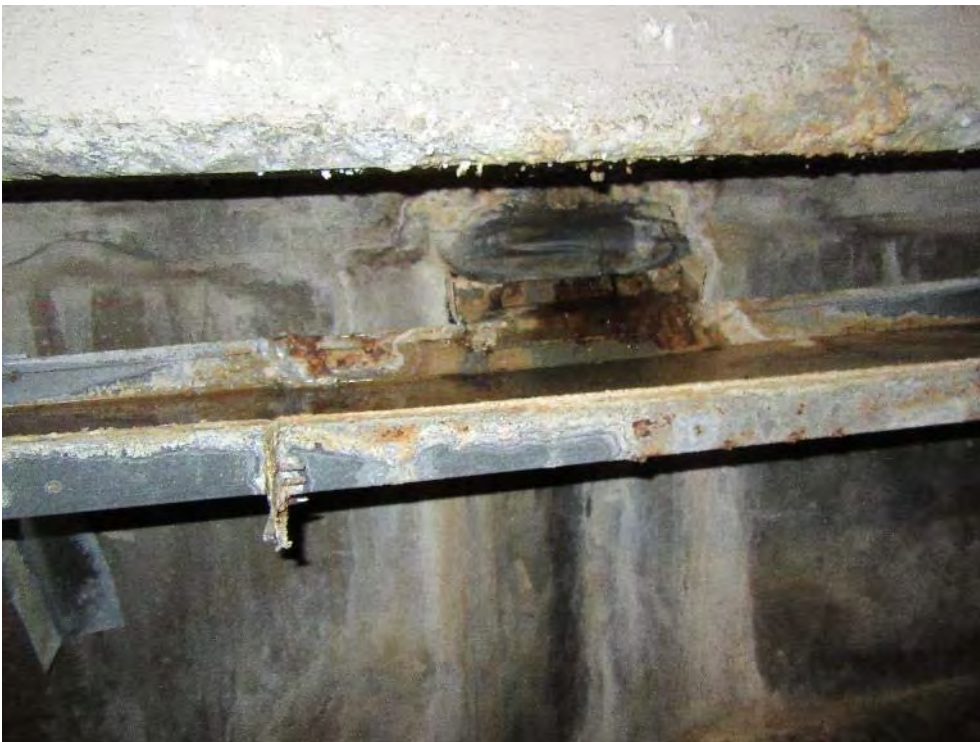
**Photograph No. ST-05**

- We noted water ingress into the basement level. We have included an allowance for evaluation and repair of this condition. Our allowance for repair is a placeholder with the actual cost only known once the aforementioned evaluation is completed.

Water Leak in  
Basement MEP Plant  
Room Collecting in  
Channel and Container

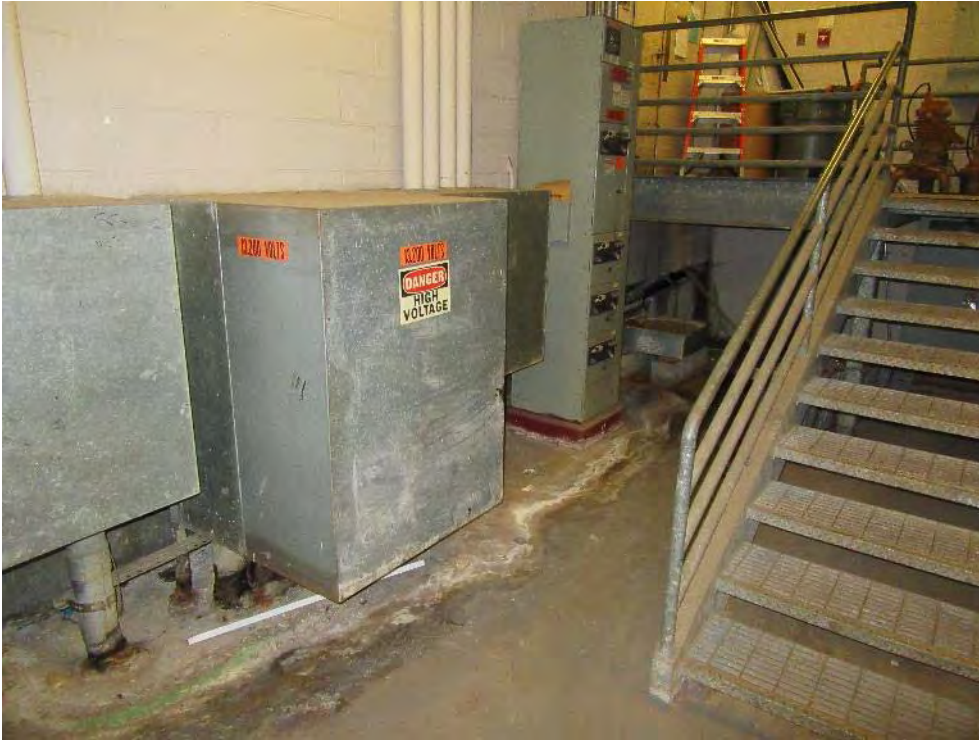
**Photograph No. ST-06**

Water Leak in  
Basement MEP Plant  
Room Collecting in  
Channel

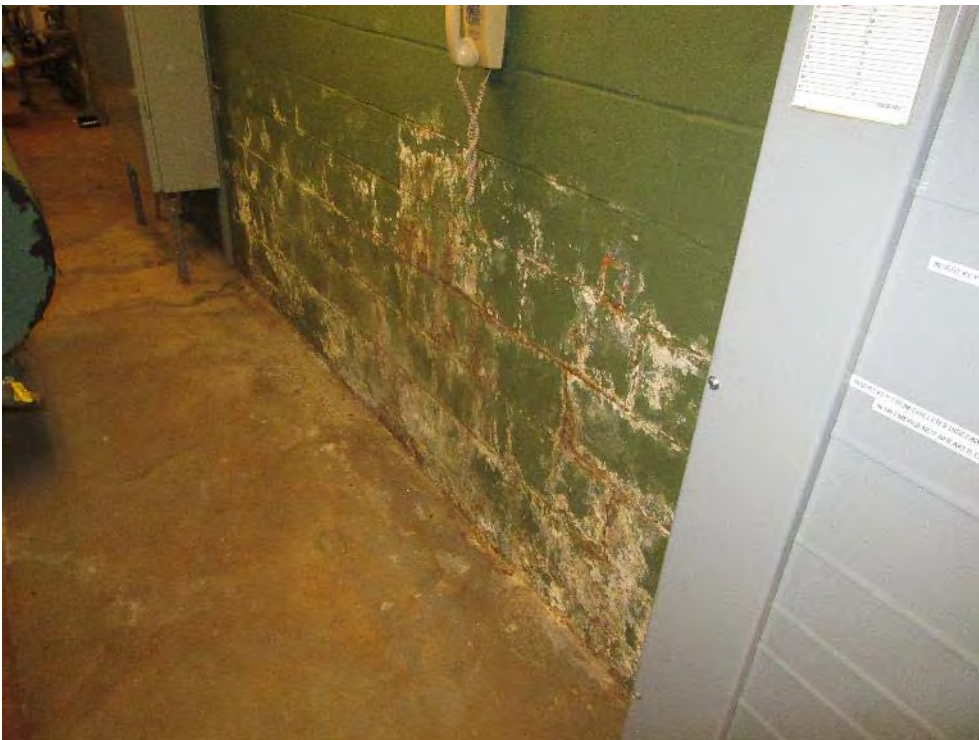
**Photograph No. ST-07**

Damage to Floor  
Surface from Water  
Leak in Basement MEP  
Basement Plant Room

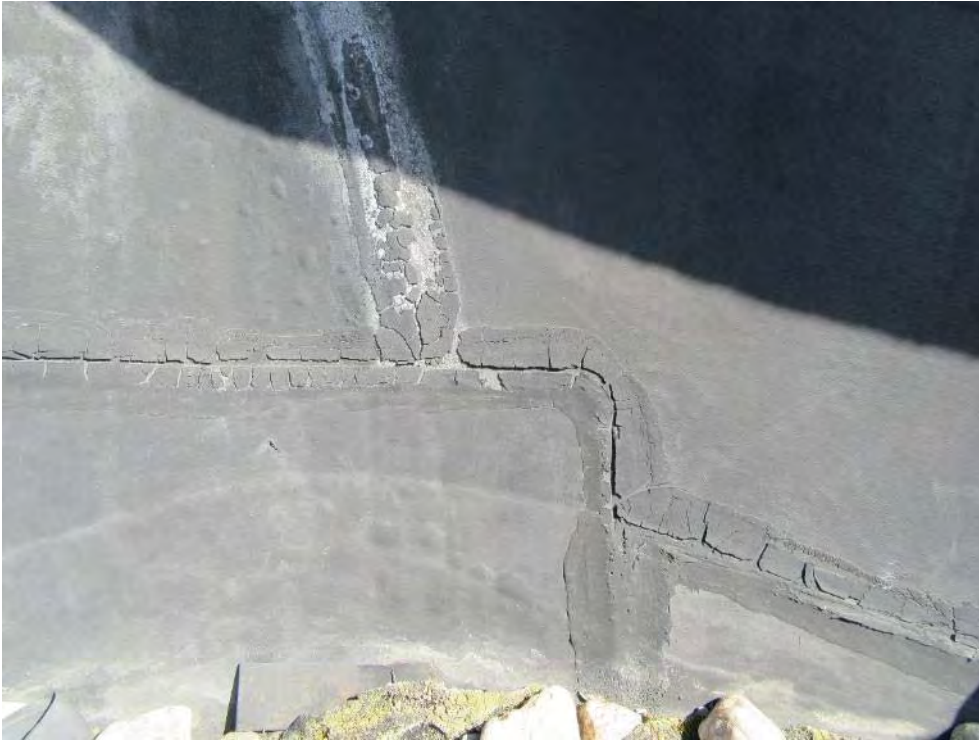
**Photograph No. R-03**

Failure of Joints within  
EPDM Membrane

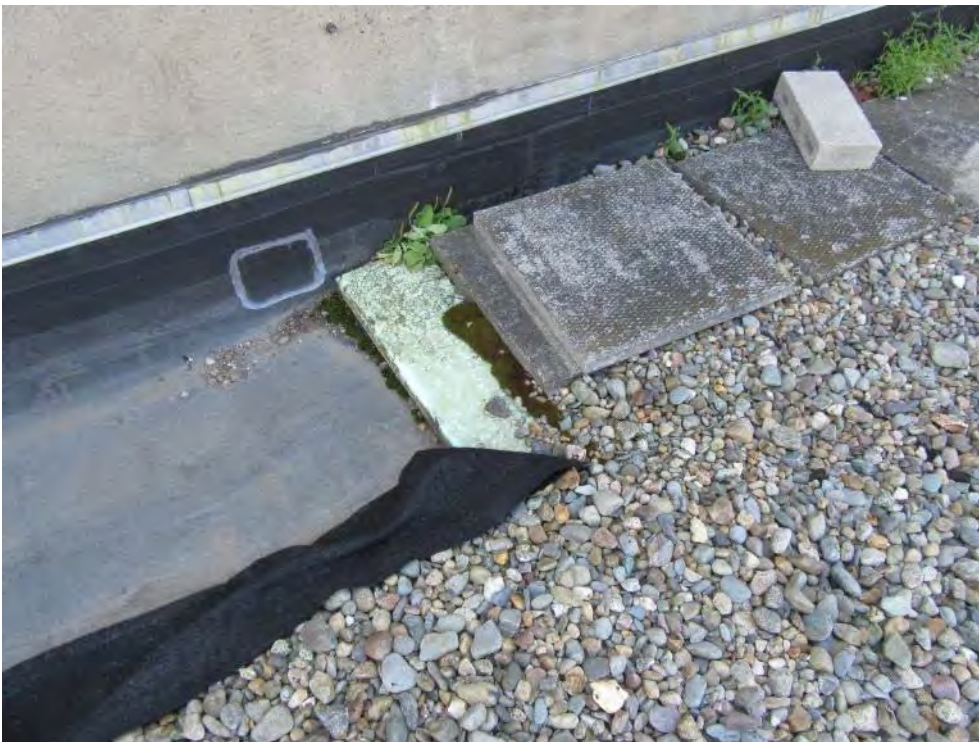
**Photograph No. R-06**

Areas of Exposed  
EPDM Membrane with  
Insulation, Filter Fabric  
and Ballast Removed

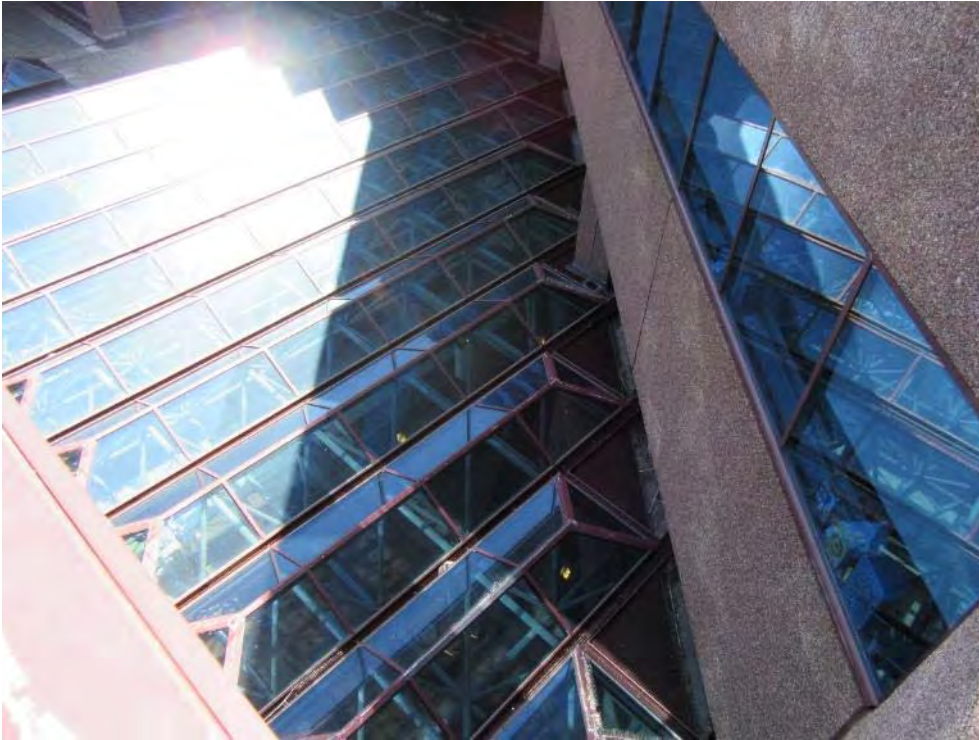
**Photograph No. R-05**

Skylight Atrium at  
Junction of Q and H  
Buildings

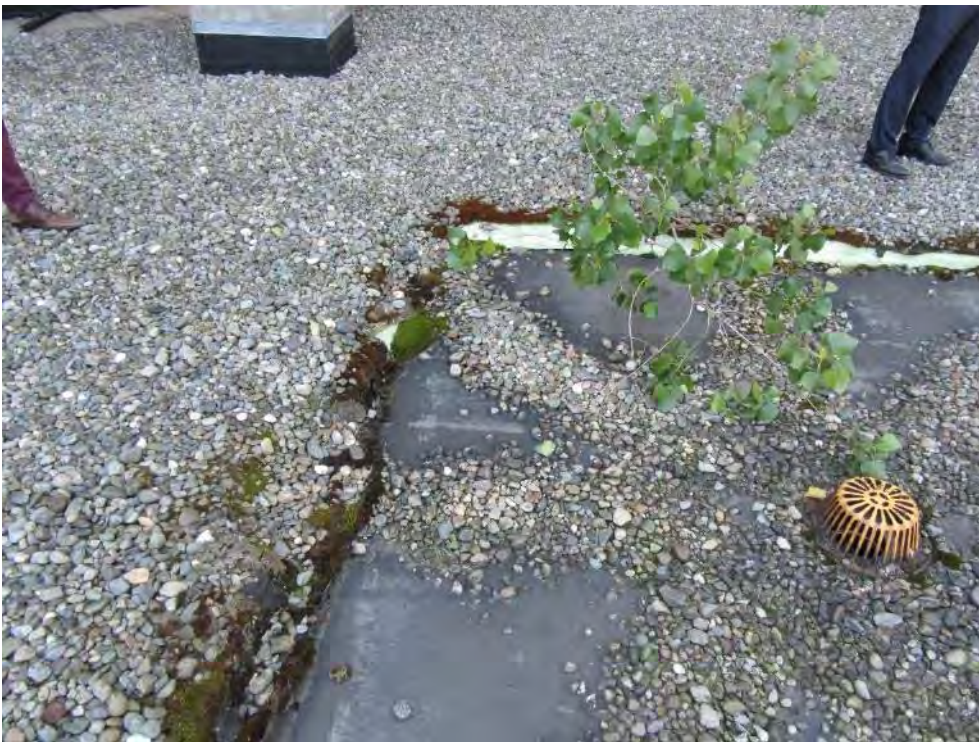
**Photograph No. R-06**

Missing Insulation,  
Filter Fabric and UV  
Ballast and Vegetation  
Growth

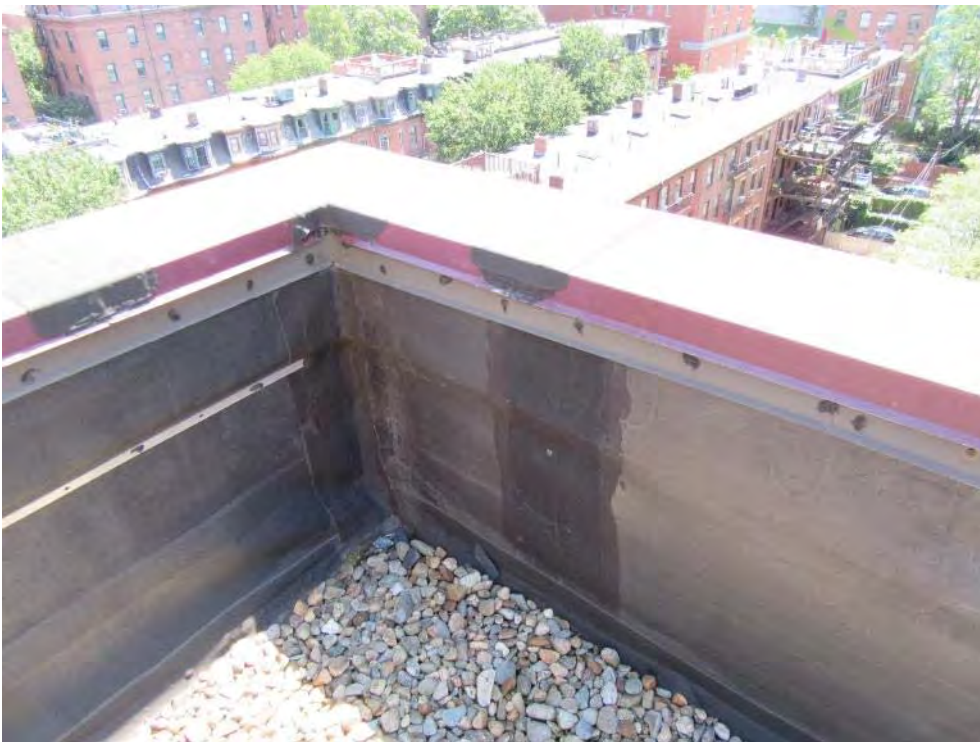
**Photograph No. R-07**

H Building Roof,  
Viewed from Q Building  
Roof

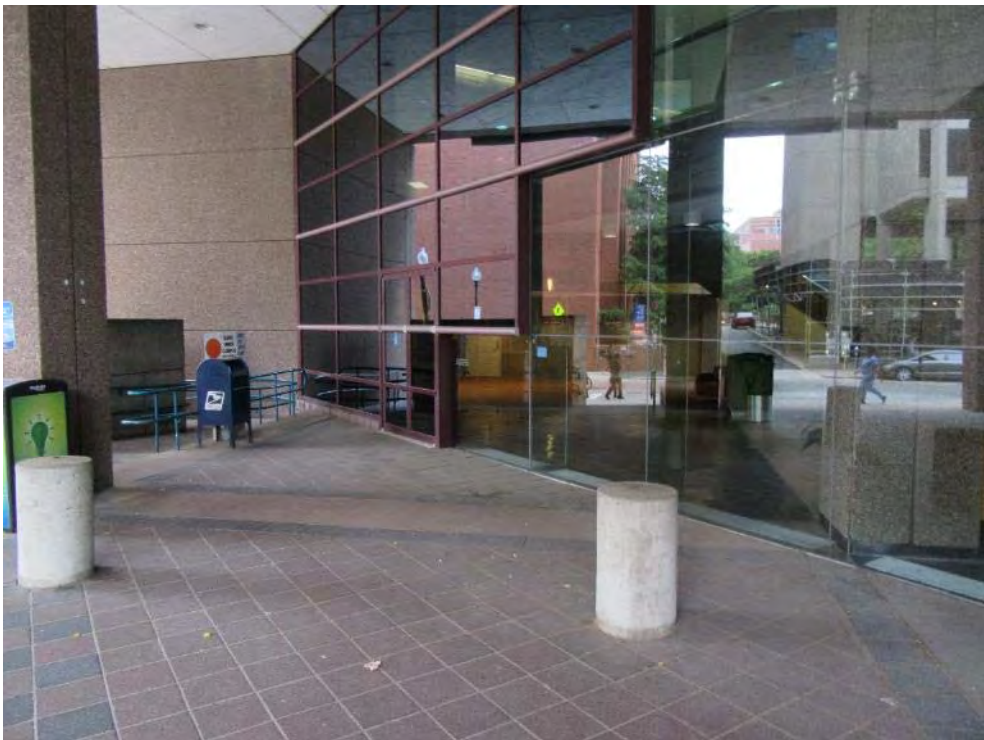
**Photograph No. EXT-01**

Front Elevation of Q Building Showing Exposed-Aggregate Panels, Curtain Walling, Ribbon and Punched Windows

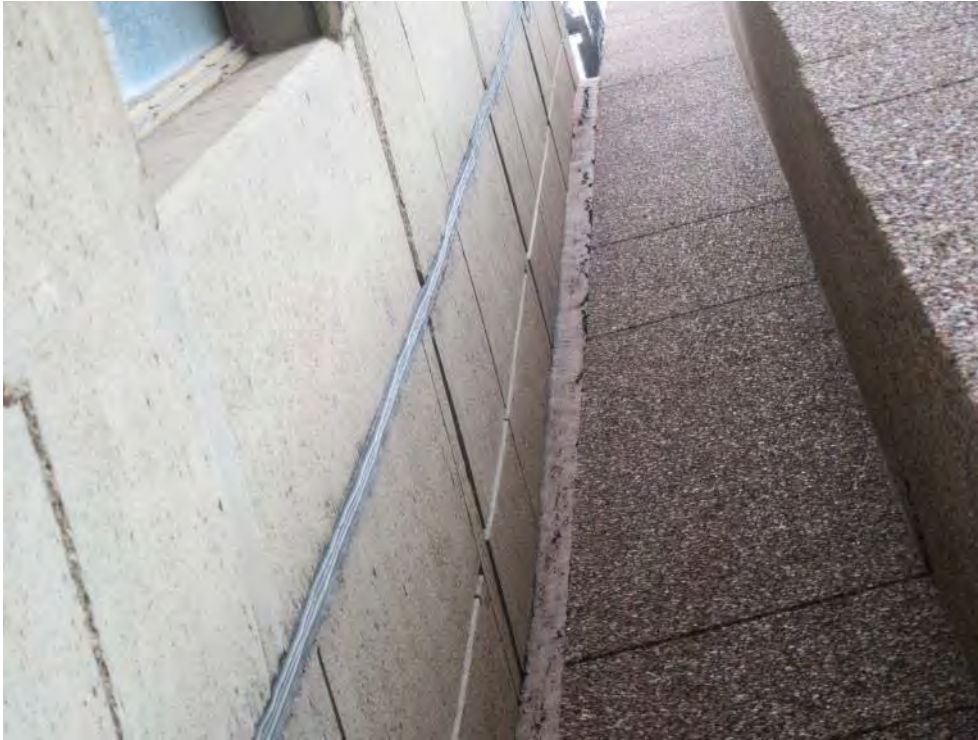
**Photograph No. EXT-02**

Anodized Aluminum Windows and Structural Silicon Glazing

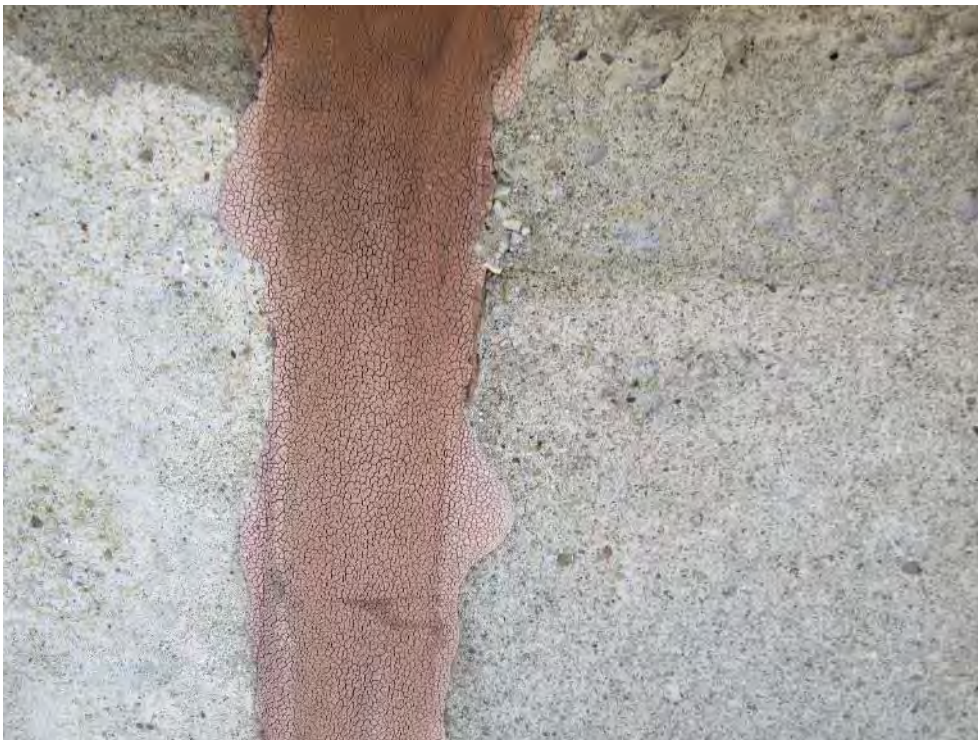
**Photograph No. EXT-03**

Adhesive and Cohesive Failure in Elastomeric Sealant at Junction Between Q and H Buildings

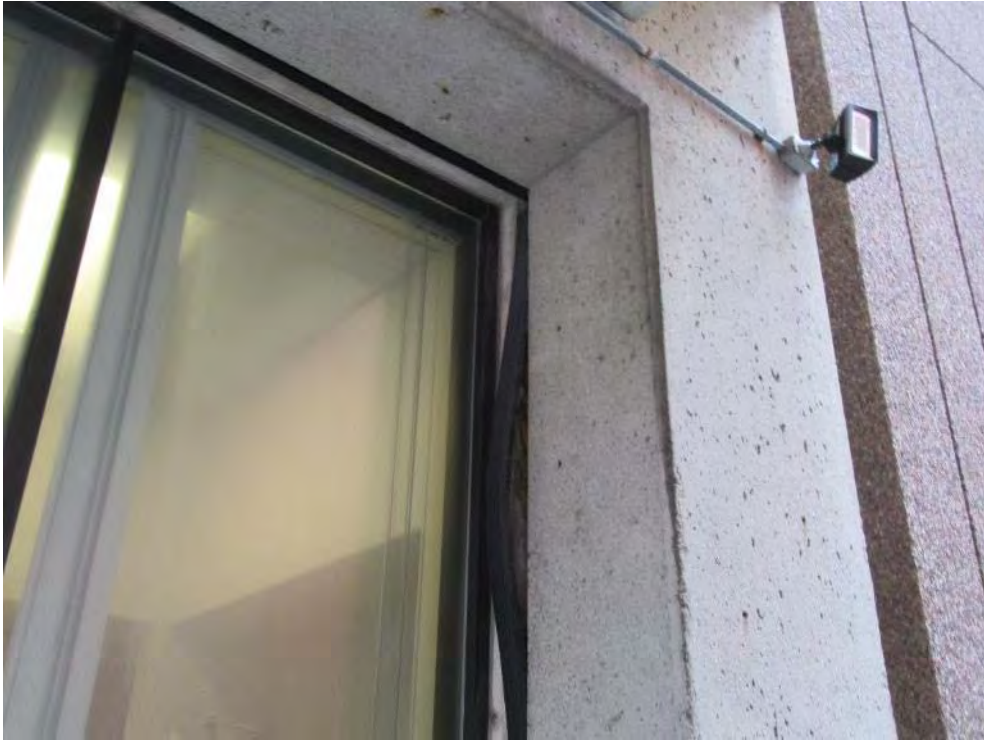
**Photograph No. EXT-04**

Start of Cohesive Failure in Elastomeric Sealant Between Pre-Panels at Roof Level

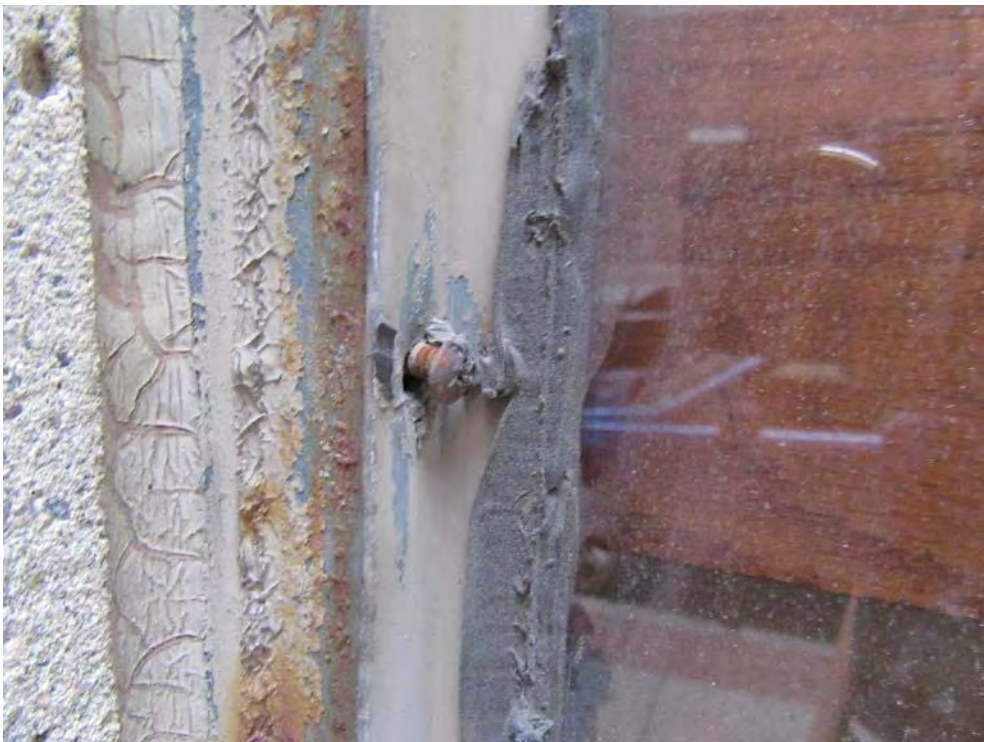
**Photograph No. EXT-05**

Displaced Rubber  
Movement Joint at H  
Building

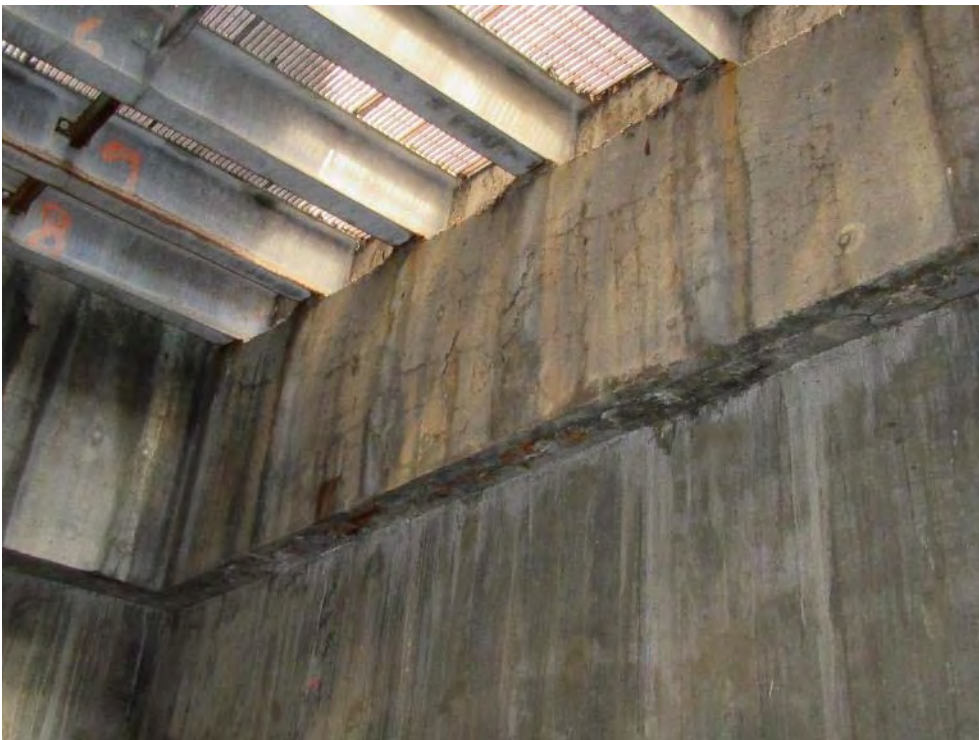
**Photograph No. EXT-09**

Damaged Concrete in  
Basement Vault Area

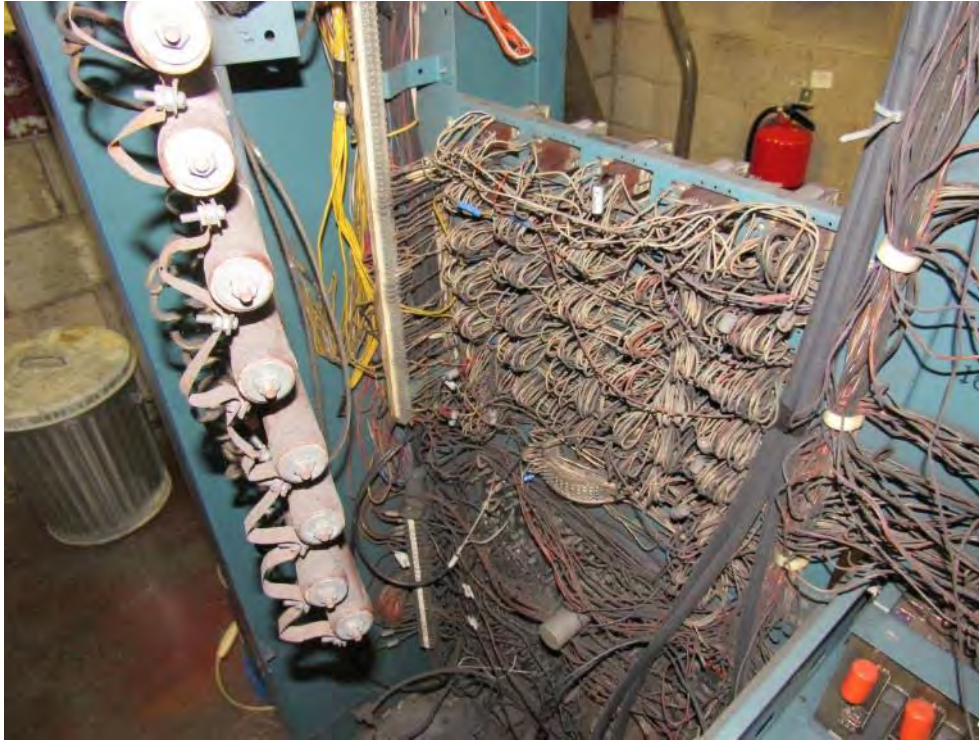
H Building – Older  
Controllers for Cars 1 and  
2
