# NEWTON PAVILION AT BOSTON MEDICAL CENTER

88 East Newton Street  
Boston, Massachusetts 02118

Report of Property Condition Assessment

Reference: Report of Property Condition Assessment  
Newton Pavilion at Boston Medical Center  
88 East Newton Street  
Boston, Massachusetts 02118  
Faithful+Gould Project No. 100056092

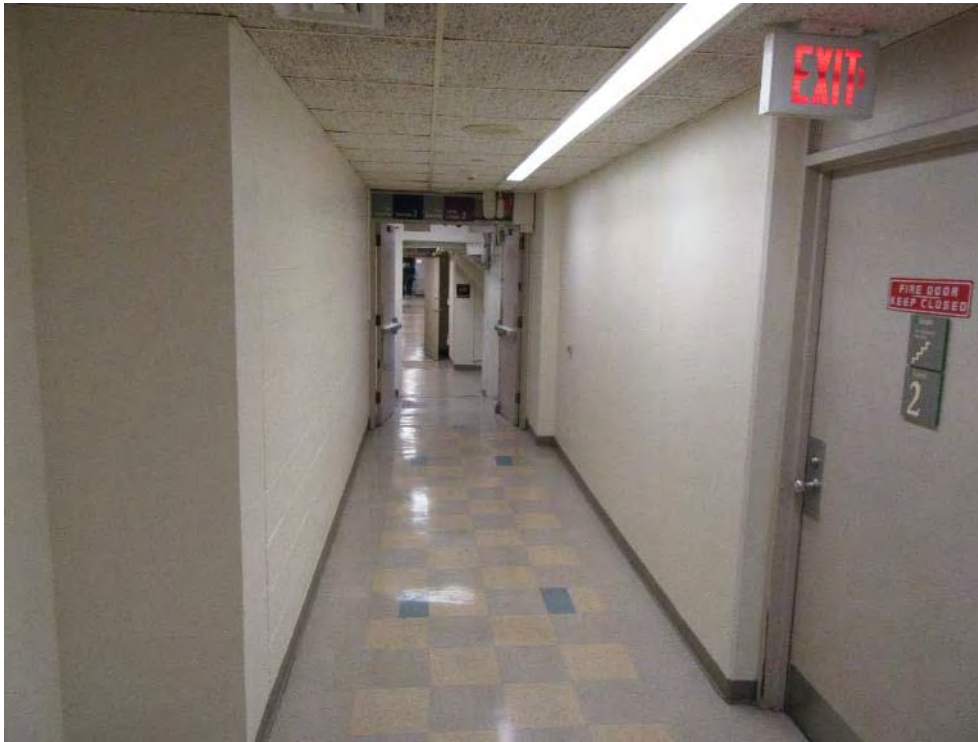
**Photograph No. INT-03**

Typical Corridor Area

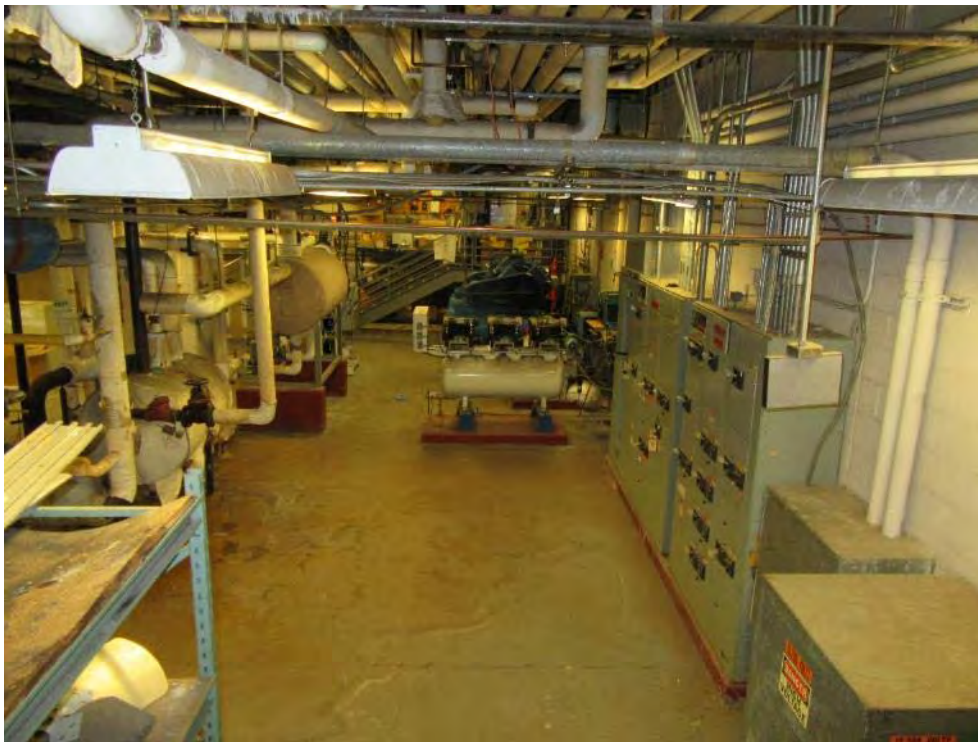
**Photograph No. INT-04**

Basement MEP Room in Q Building

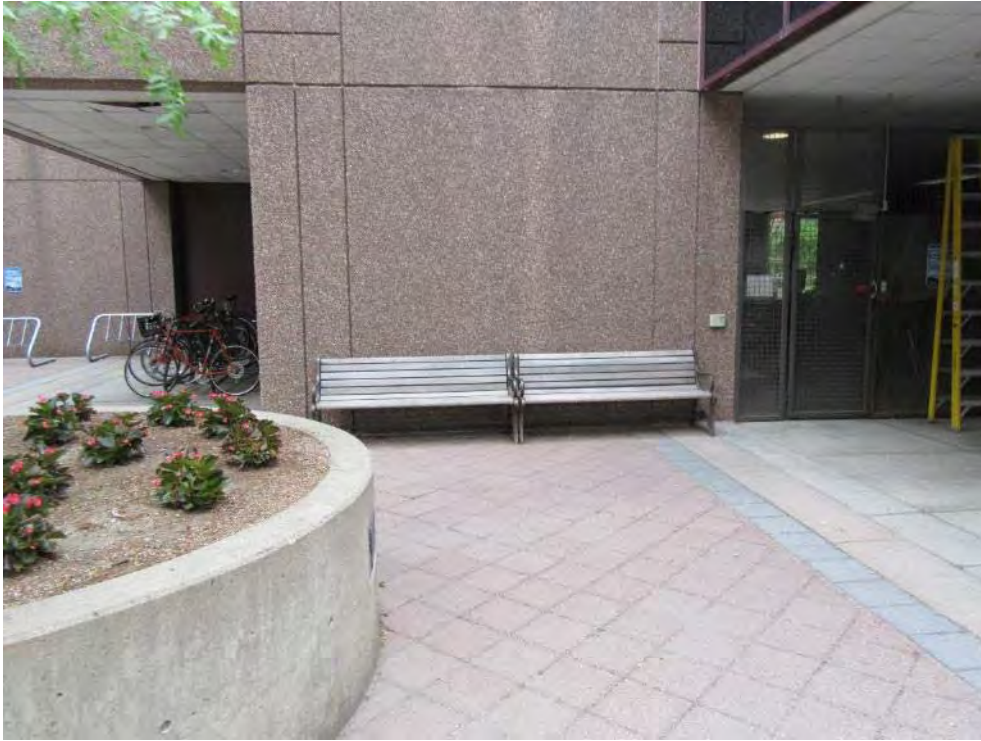
**Photograph No. ADA-01**

Example of Exterior Furniture which is Not Accessible

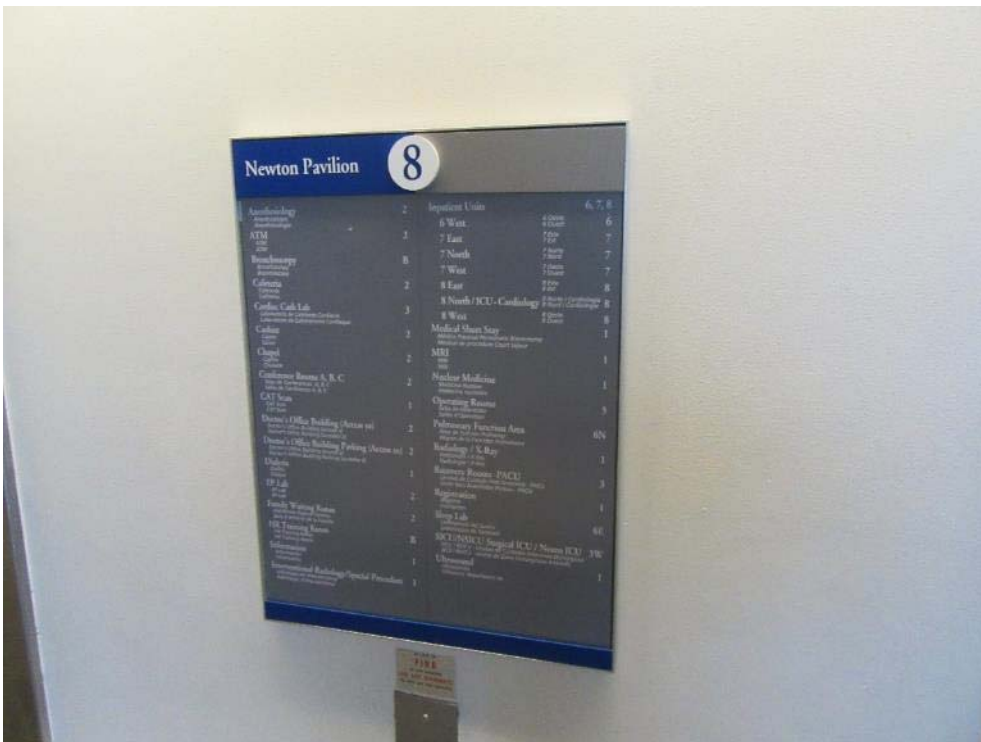
**Photograph No. ADA-02**

Example of Non-Compliant General Information Signage in Q Building
