# SERVICE BULLETIN

Classification: EC16-034b	Reference: NTB17-082b	Date: January 29, 2019
------------------------------	--------------------------	---------------------------

## NISSAN; DTC P0456 CAUSED BY EVAP LEAK AT VENT CONTROL VALVE O-RING

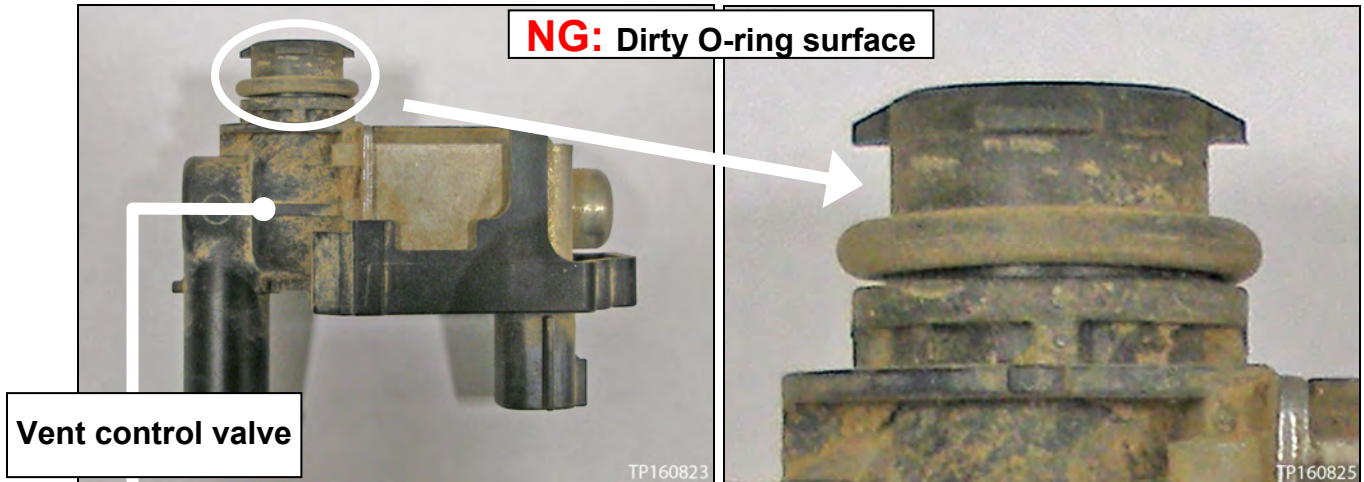
Figure 1

Where vent control valve mounts in canister

Canister

This surface must be clean all around

- Make sure the surfaces that the O-ring comes in contact with are clean.
- When installed, make sure the O-ring is not twisted or rolled over.
- Verify the repair is complete by checking for leaks with a “smoke” leak detection machine or CONSULT-III plus (C-III plus).
  - If a “smoke” leak detection machine is used, follow the manufacturer’s operating instructions.
  - If C-III plus is used:
    1. Confirm the fuel filler cap is secure.
      - Vehicles **with** a service port see page 5.
      - Vehicles **without** a service port see page 6.
    2. Using Active Test, close the vent control valve.
    3. Apply pressure using J-42909 until the bar graph reaches about halfway.
    4. Monitor the bar graph for 10 minutes.

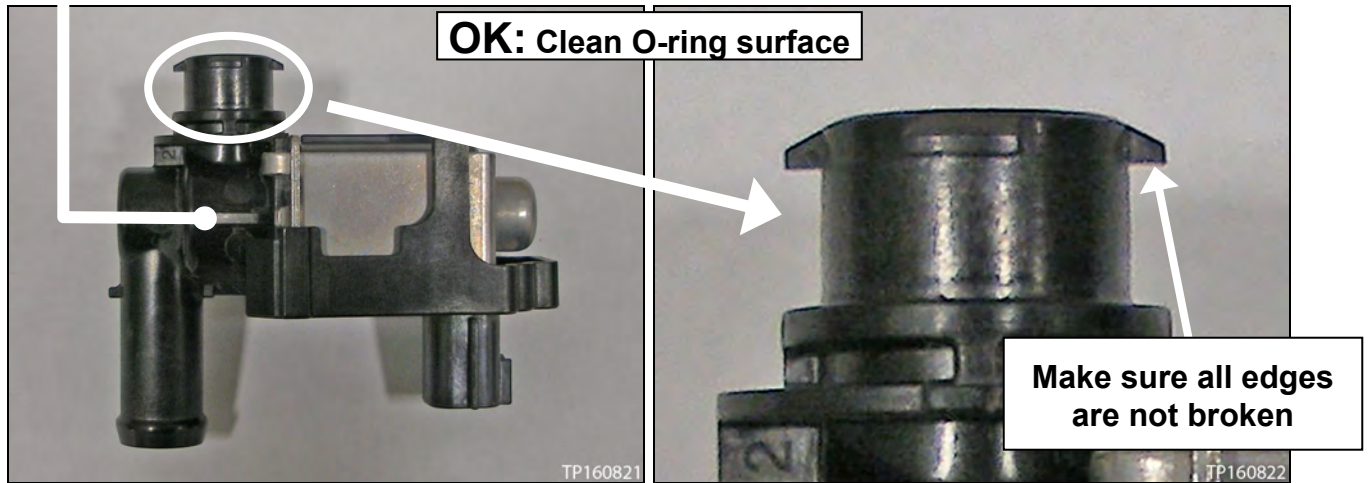
Figure 3

When fully seated (no gaps), O-ring is not twisted or rolled over

O-ring

No gap all around
