WATERSHED SURVEY REPORT

NORTH POND

JANUARY 2017

NORTH POND WATERSHED SURVEY REPORT

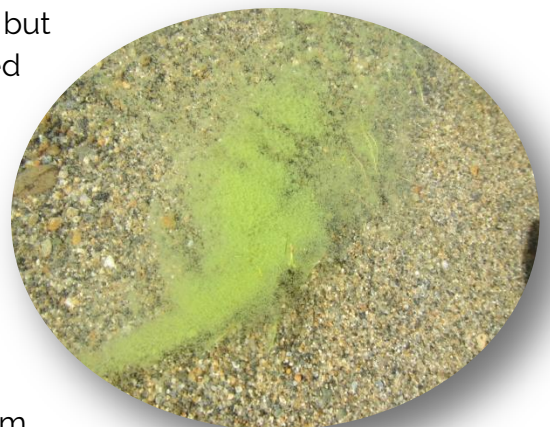
*Algae floating in the shallows of North Pond in the fall of 2016.
(Ecological Instincts)*

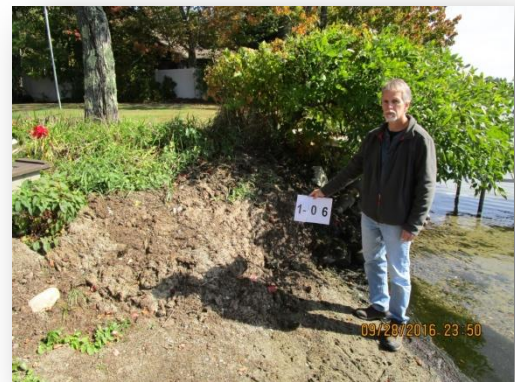
Unstable shorelines result in delivery of sediment and nutrients to the lake.

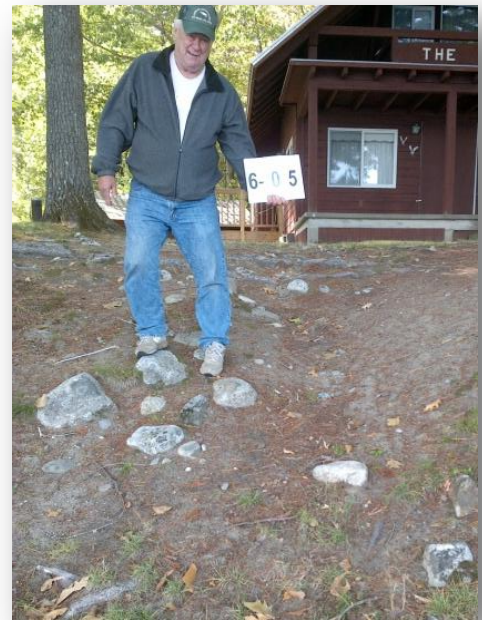
Example of a high impact residential site in Sector 6.

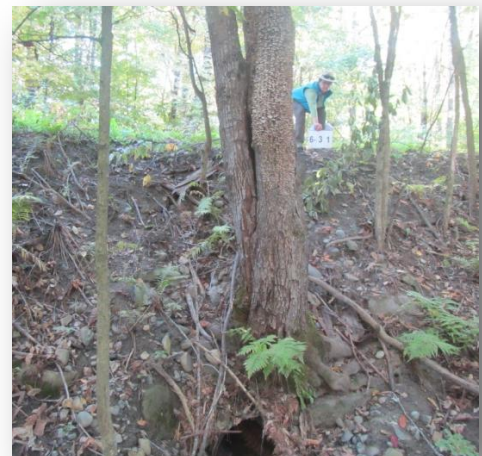
Example of a high impact town road site on Bacon Road in Sector 6.

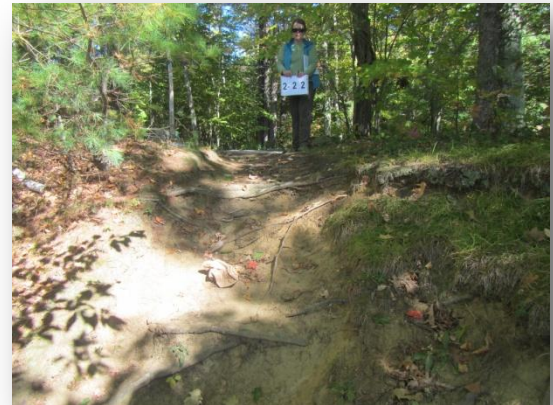
Example of a high impact beach access site in Sector 2.

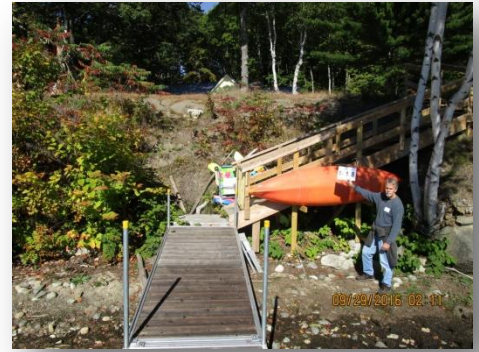
One of many steep eroding beach access sites in Sector 1 on North Shore Drive.

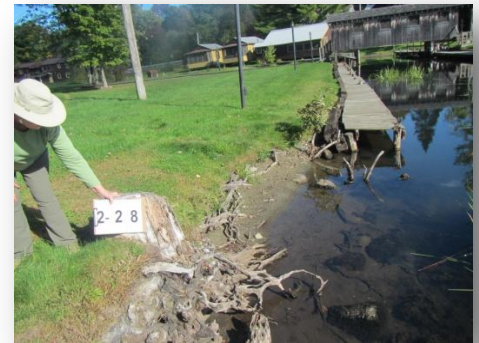
Bank erosion and lack of shoreline vegetation off Mike's Lane where the Serpentine Stream flows into North Pond.

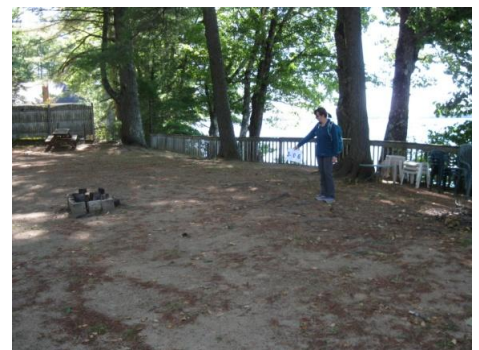
Bare soil in Sector 3 results in sheet and rill erosion into the lake.

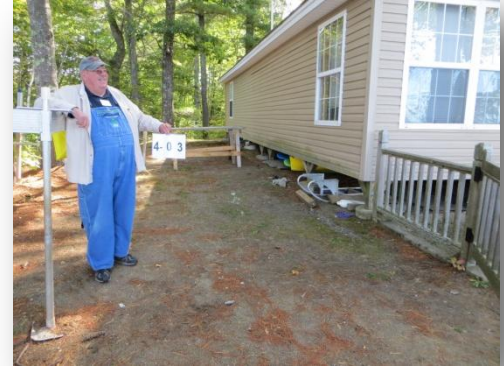
Bare soil & roof runoff in Sector 4.

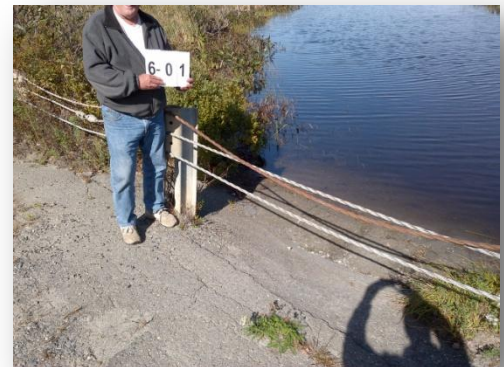
Road shoulder erosion near the boat launch in Sector 6.

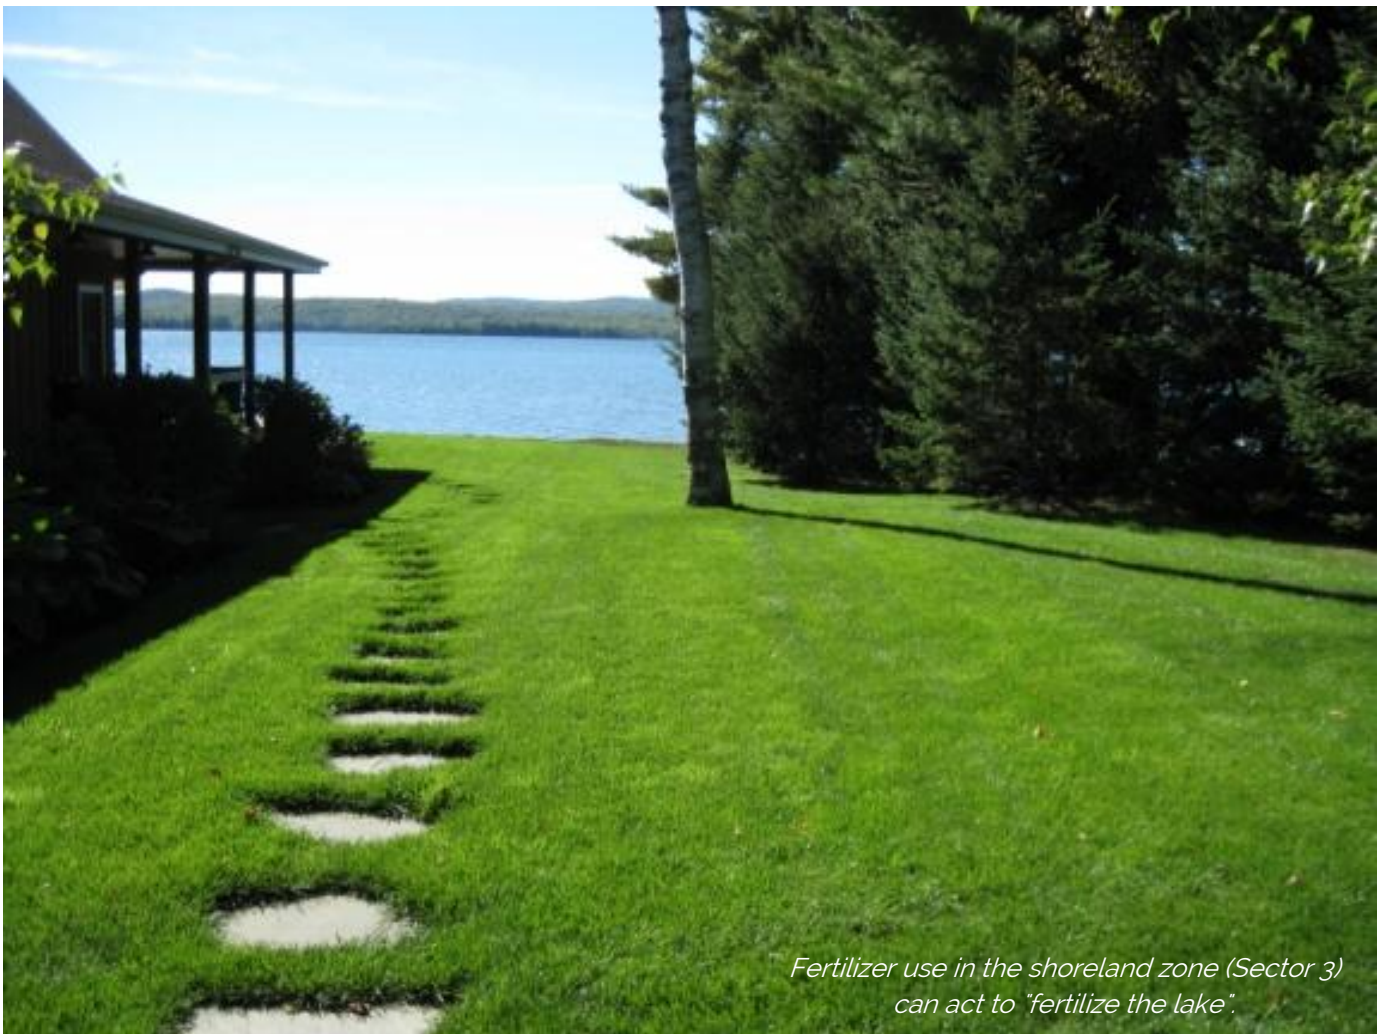
Fertilizer use in the shoreland zone (Sector 3) can act to "fertilize the lake".

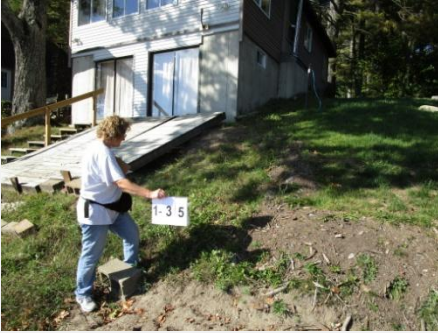
Sector 1: Site 35

Problem: BARE SOIL, SURFACE EROSION, INADEQUATE SHORELINE VEGETATION

Solution: Control runoff from impervious surfaces. Use erosion control mulch in areas with exposed soil, and plant vegetation along the shoreline to stabilize banks and filter runoff. Consider planting vegetation before using rip rap. Or use a combination of both.
