INTERIM REPORT ON THERMOSTATIC VALVE FAILURE ON PALO VERDE EDG

10CFR21 REPORTING OF DEFECTS AND NON-COMPLIANCE

COMPONENT: Amot thermostatic valve element
P/N: 9760X

SYSTEM: Emergency Diesel Generator – lube oil & jacket water system

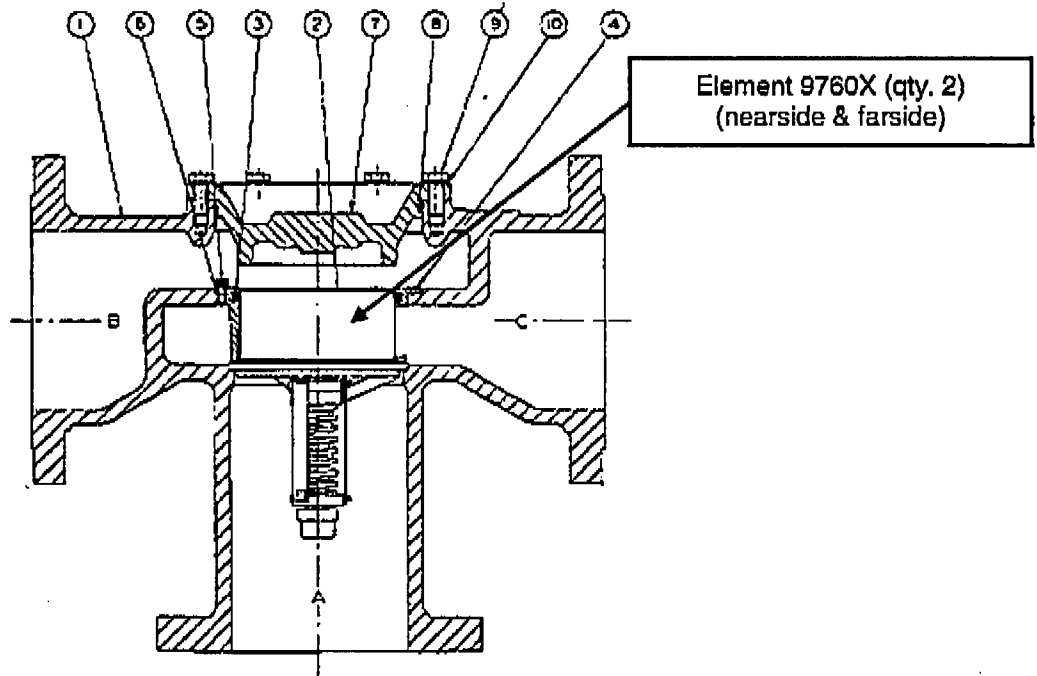
FIGURE 1: AMOT THERMOSTATIC VALVE

Each valve uses 2 thermostatic elements, Amot type 9760X (Figure 1). The elements investigated for the Palo Verde and STP applications have a nominal temperature setting of 160°F and therefore the element part number is 9760X-160.

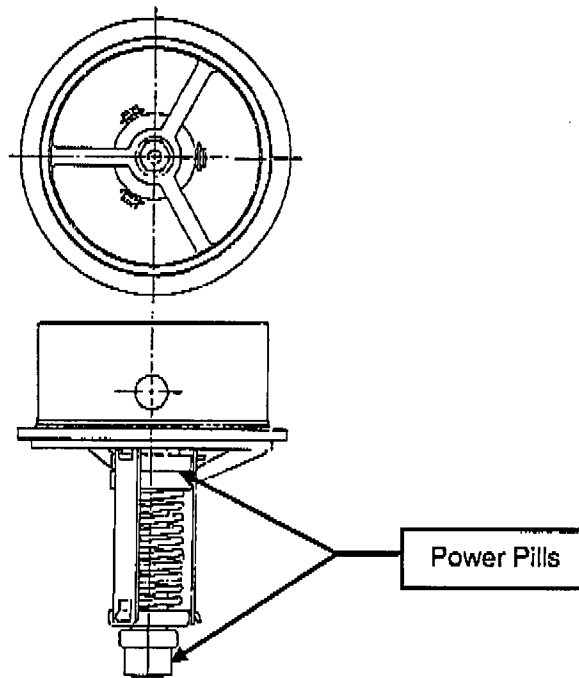
FIGURE 2: VALVE ELEMENT 9760X

The 9760X element contains two power pills (Figure 2). The power pills contain a temperature sensitive wax that expands with increasing temperature and provides the motive force to lift the element off of its seat.
