Ocean Water Desalination Intake Biofouling and Corrosion Study

January 15, 2016

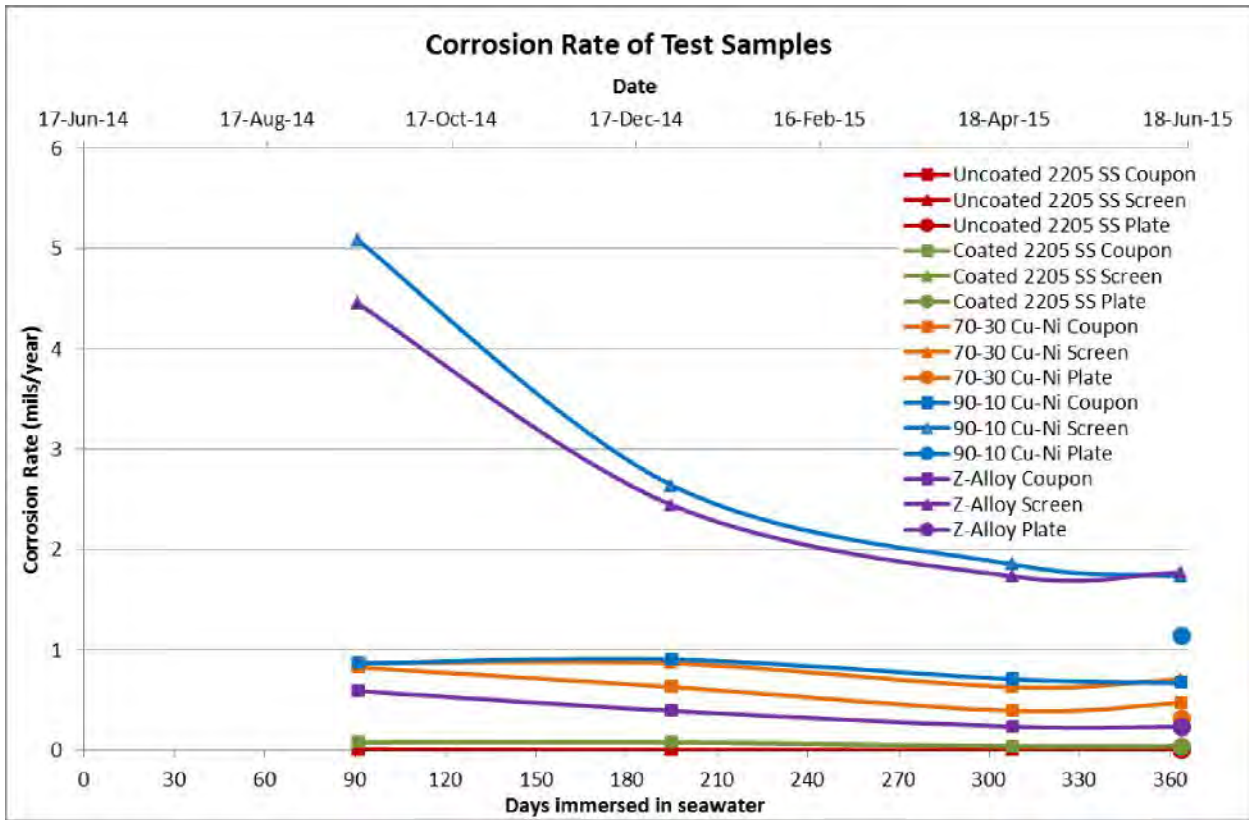
Figure ES-1. Corrosion Rates of Four Alloys after 364 days in Seawater Exposure

Based on the data over 364 days, coated and uncoated 2205 Duplex Stainless Steel has the lowest overall average corrosion rates of the four metal alloys for both the coupons and screens tested in this study. However, the uncoated 2205 Duplex Stainless Steel samples were the most heavily fouled by marine life.

As can be seen in Table ES-2, the highest overall average corrosion rate was observed on the 90-10 Cu-Ni coupon and plate, and the Z Alloy screen. The overall average corrosion rates of the 90-10 Cu-Ni and Z Alloy screens were 3 to 8 times higher than the coupons of the same alloy. The 90-10 Cu-Ni coupons were provided from a different vendor than the screens and they may have a different chemical composition. However the same cannot be said for the Z Alloy samples because they were provided from the same vendor. The 70-30 Cu-Ni samples exhibited slightly more green marine life fouling on the coupons and screens than the Z alloy samples. It is possible that the corrosion rate is reduced by the amount of marine life fouling present on the samples because it limits the exposure of the metal to the seawater. The ability of the metal to create a passivation layer on the surface of each alloy may also affect the corrosion rate.

1. Intake screens should be manufactured with 70-30 Cu-Ni as it would provide the lowest corrosion rate over a long term service life and would not require a foul release coating.
2. Intake screens manufactured in 2205 Duplex Stainless Steel are recommended if they are coated with a foul-release coating.
3. Biofouling results also indicate that the 70-30 Cu-Ni material is superior to the other materials tested to prevent biofouling.
4. If 2205 Duplex Stainless Steel with a foul-release coating is used it will need to be inspected on a regular basis and no longer than 5 year intervals.
5. Long term prevention of biofouling will require either chemical addition, air bursting and/or regular cleaning of the screens.

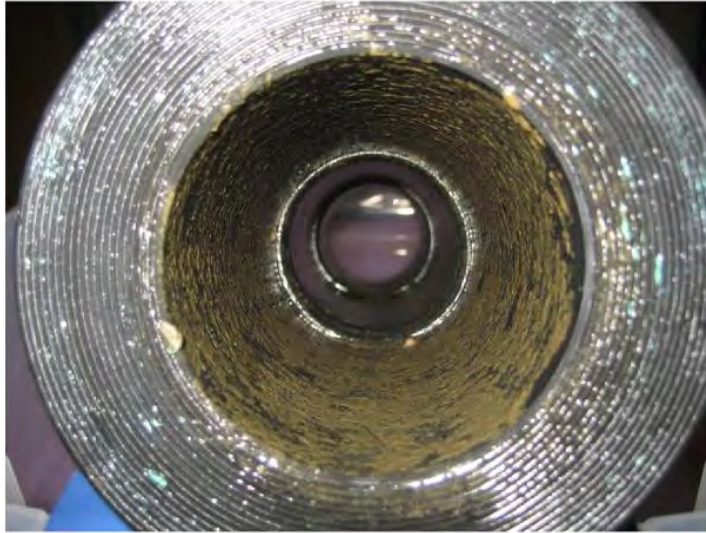
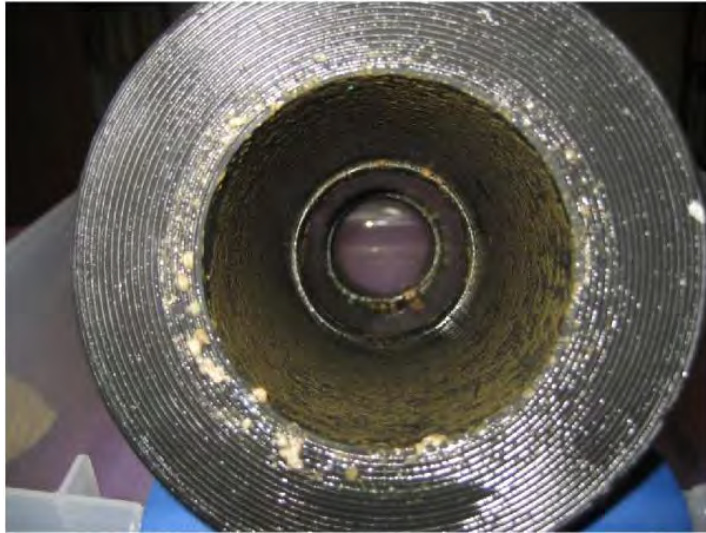
- Inspection with lighted-mirror tools found a total of 18 small acorn barnacles (2 mm to 4 mm basal diameter). The barnacles are located near areas of surface discontinuity or turbulence, such as the inlet to the spool and the ridges that divide the spool into three sections (inlet, middle, and outlet). Barnacles that were large enough to be identified were *Megabalanus californicus*, the others were Balanid barnacles, possibly *Balanus glandula* or *M. californicus*, but it was too early in their development to be sure.
- Six small acorn barnacles (1 mm) were found on the face of the outlet flange – not within the pipe spool (**Figure 3-1**).
- No other macrofouling was found.
- No sand.

Figure 3-1. Pipe spool A3 (Control) October 28, 2014. Inlet (top) and Outlet (bottom).

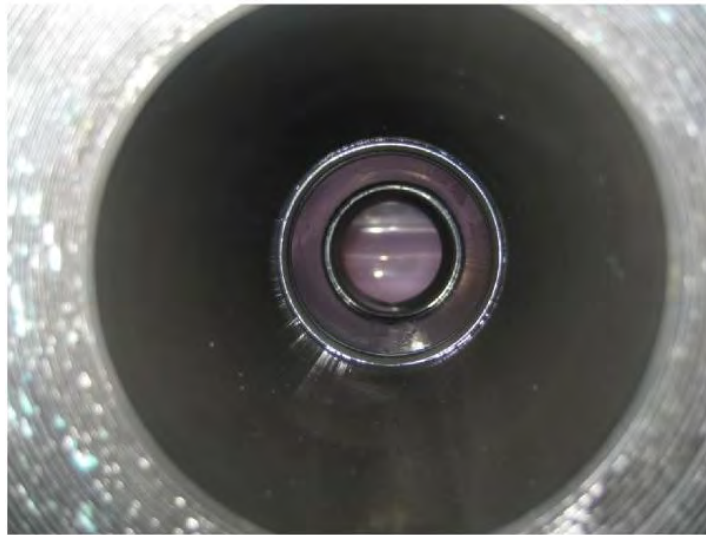
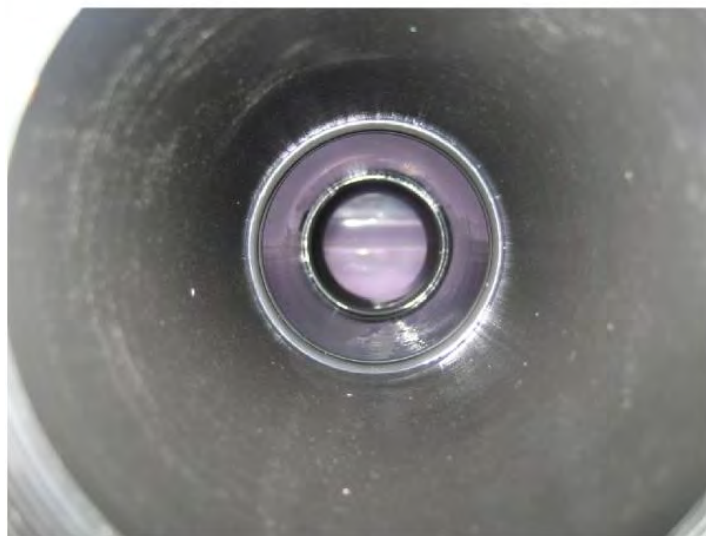
- This is the third pipe spool in spool row B and was treated with continuous injection of a chloramine solution.
- Photos taken from inlet and outlet ends (**Figure 3-2**).
- No macrofouling organisms were found.
- No slime/diatoms detected by touch or tissue wipe.
- No sand

Figure 3-2. Pipe spool B3 (Continuous Chloramine Injection) October 28, 2014. Inlet (top) and Outlet (bottom).

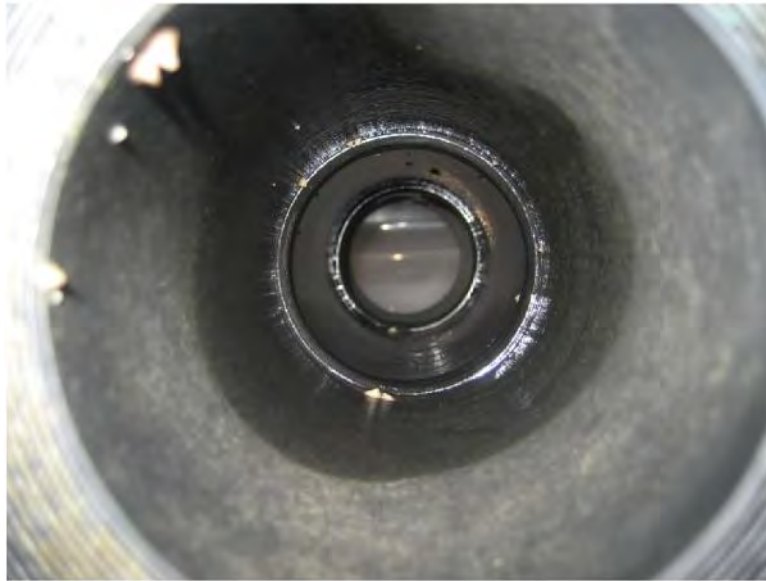
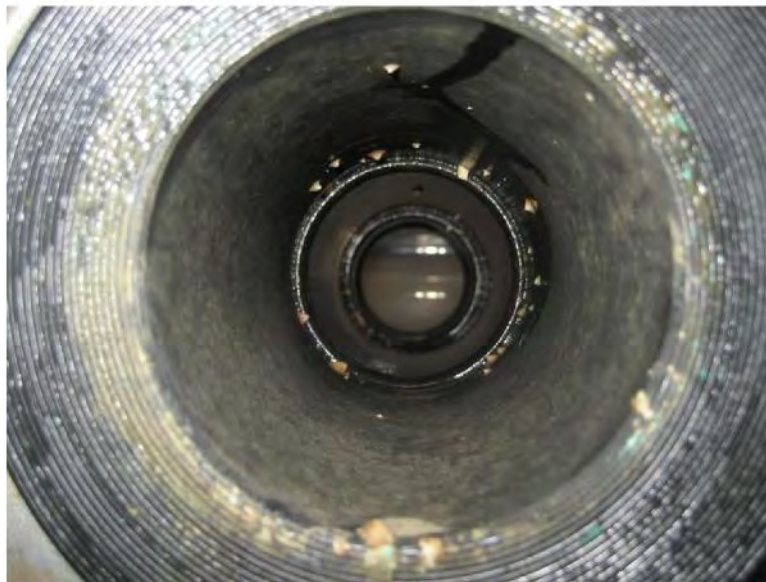
- No other macrofouling was found.
- No sand or debris was observed in the spool.

Figure 3-4. Pipe spool A4 (Control) December 23, 2014. Inlet (top) and Outlet (bottom).

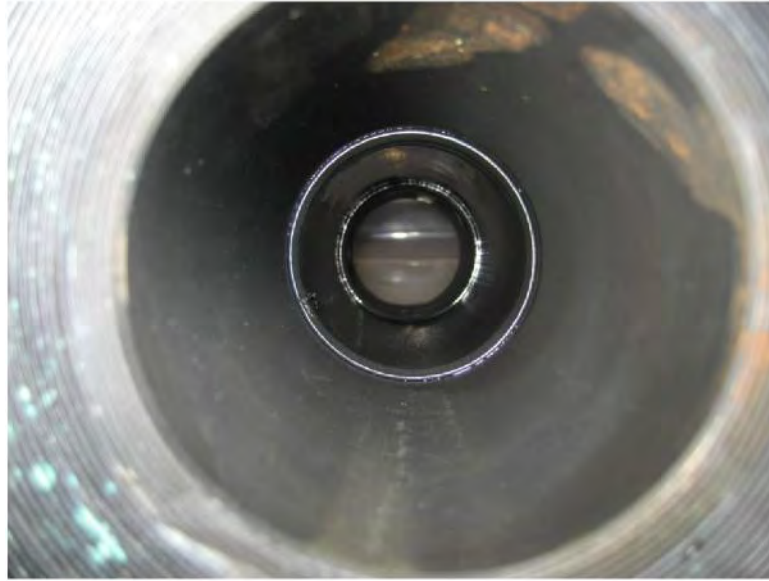
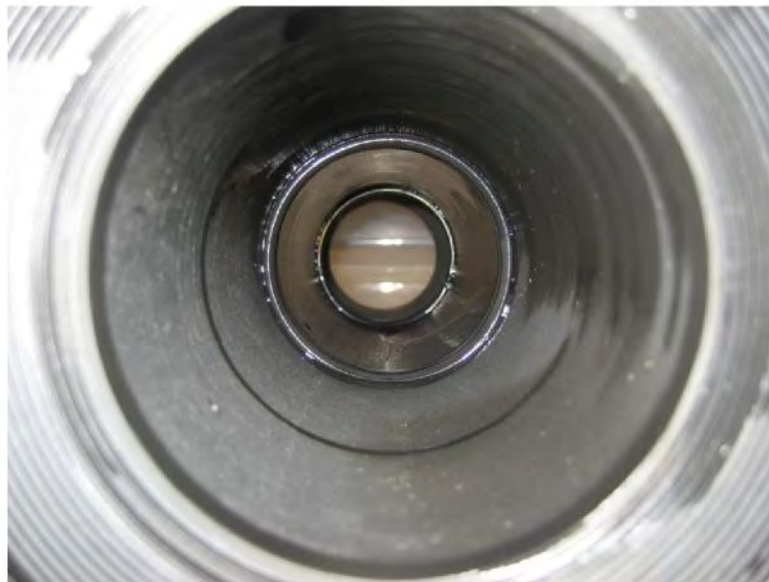
- This is the fourth pipe spool in spool row B and was treated with continuous injection of a chloramine solution.
- Photos taken from inlet and outlet ends (**Figure 3-5**).
- No macrofouling organisms were found.
- No slime/diatoms detected by touch or tissue wipe.
- No sand or debris, although a rust stain was observed in the inlet section (**Figure 3-5**).

Figure 3-5. Pipe spool B4 (Continuous Chloramine Injection) December 23, 2014. Inlet (top) and Outlet (bottom).

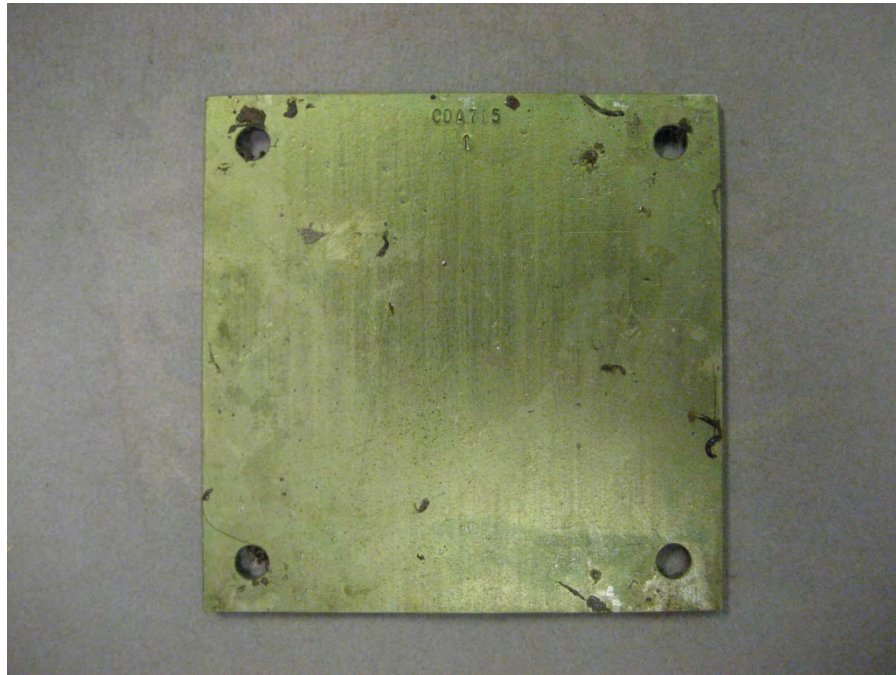
- **CDA 715 (70/30 Copper/Nickel), Plate 2, (Figures 4-12)**
 - The plate is very clean with almost no discoloration or oxidation visible (a very slight, light-green discoloration). The plate looks almost new.
 - No attached macrofouling.
 - No algae.
 - A little debris near the cable tie holes.
 - Motile species: one small polychaete and six small amphipods.
 - A little silt and perhaps some diatoms.

Figure 4-12: 70/30 Cu/Ni (CDA715) test plate (Test Plate 2), photographed 06/18/15 prior to biofouling inspection.

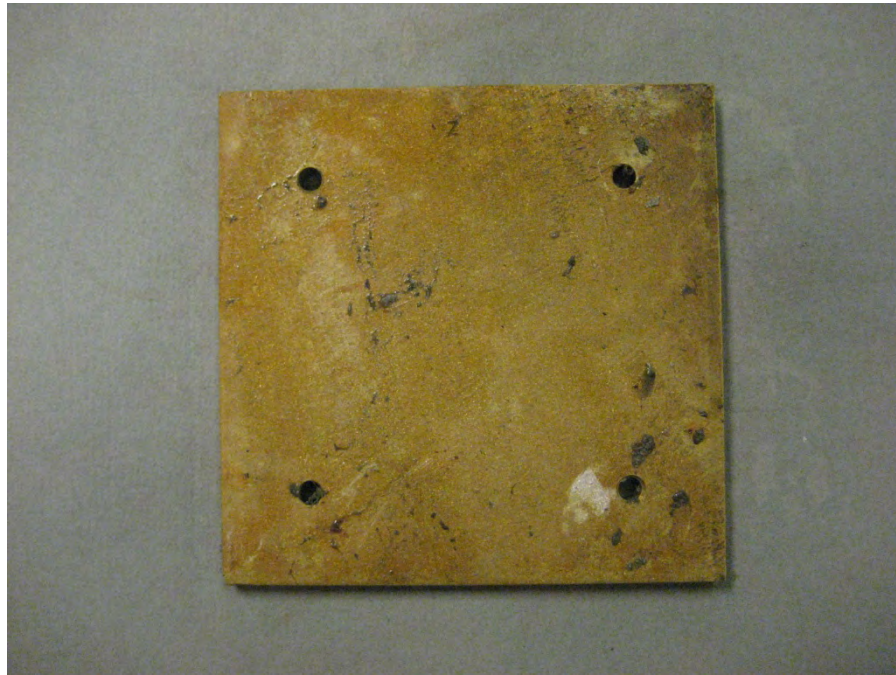
- **Z-alloy, Plate 3, (Figures 4-13)**
 - The plate is very clean, except for a single 19 mm mussel that had been attached to one of the cable ties. When the cable tie was removed, the mussel remained loosely attached to the plate by three byssal threads.
 - No attached macrofouling.
 - The plate has a light brown/gold patina. This is a duller finish than the CDA 715 plate, but does not have the patina of the CDA 706 plate.
 - Motile species: 8 small (3 mm) amphipods stranded on the plate.

**Figure 4-13: Z-alloy test plate (Test Plate 3),
photographed 06/18/15 prior to biofouling inspection.**

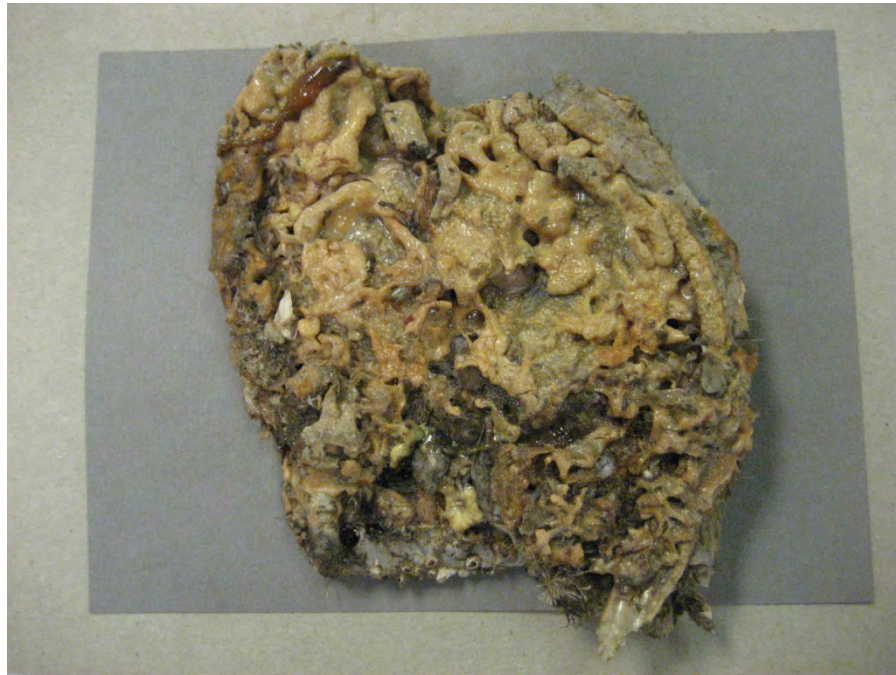
- Erect and encrusting bryozoans.
 - Calcareous worm tubes.
 - C/S tunicate.
 - Hydroids.
 - As with the other plates, a variety of encrusting invertebrates were attached to the PVC frame and the plastic cable ties that secure the plate to the frame. In this case, there is little to differentiate between the stainless steel plate and the plastic components.

**Figure 4-14: 2205 stainless steel test plate (Test Plate 4),
photographed 06/18/15 prior to biofouling inspection.**

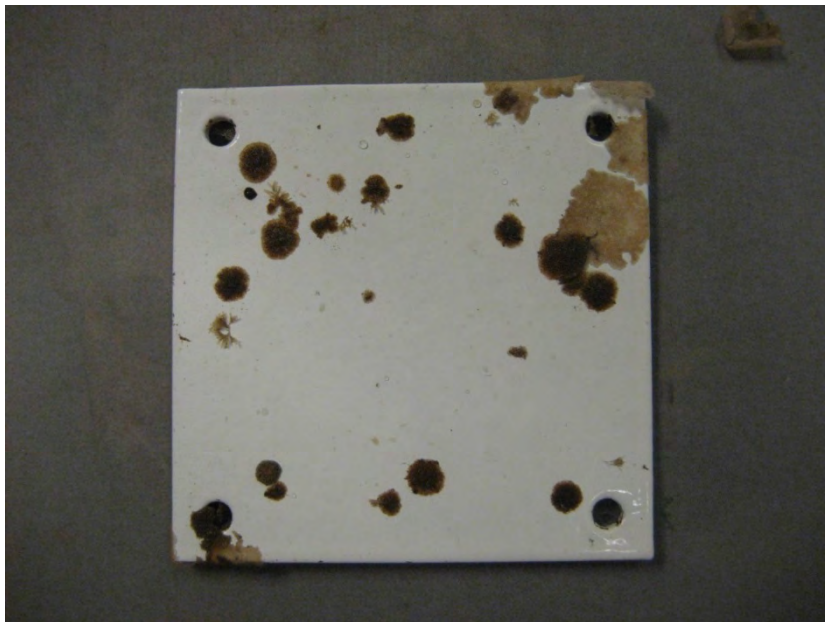
- The PVC frame was still much cleaner (less fouling) than the other four frames that had not dropped into the sediment within the intake structure.

Figure 4-15: 2205 stainless steel test plate with foul release coating (Test Plate 5), photographed 06/18/15 prior to biofouling inspection.

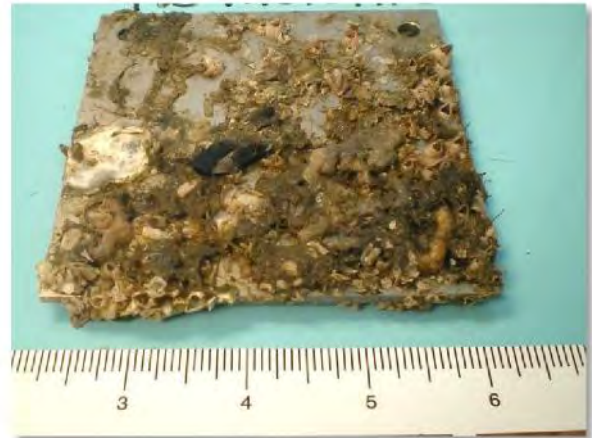
Figure 4-20: Marine life attached to uncoated 2205 Duplex stainless steel flat plate.

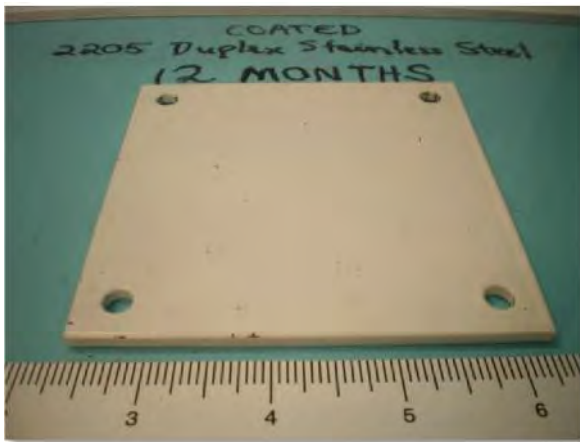
Figure 4-23: Coated 2205 Duplex stainless steel flat plate in good condition.

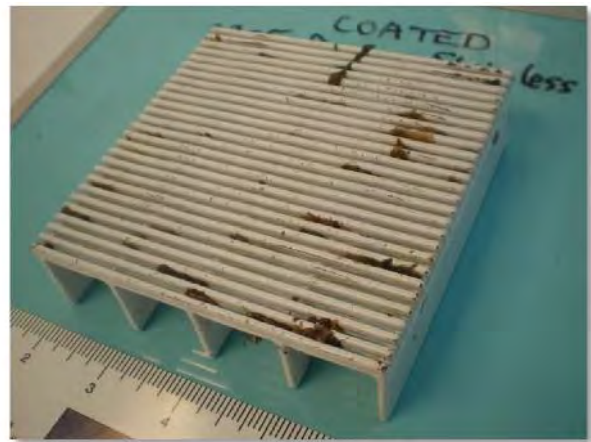
Figure 4-24: Coating damage to coated 2205 Duplex stainless steel wedge wire sample.

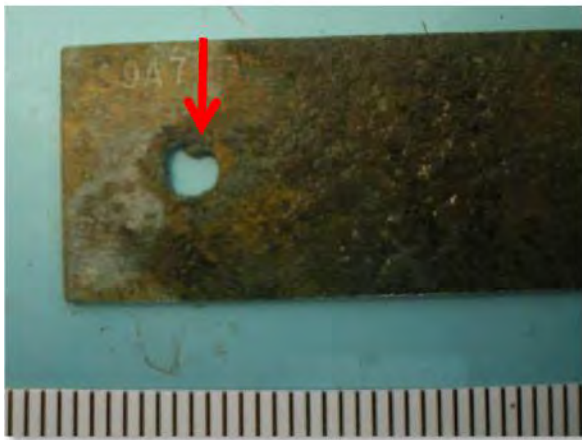
Figure 4-25: Detail view of hole and surface of 70-30 Cu-Ni coupon.

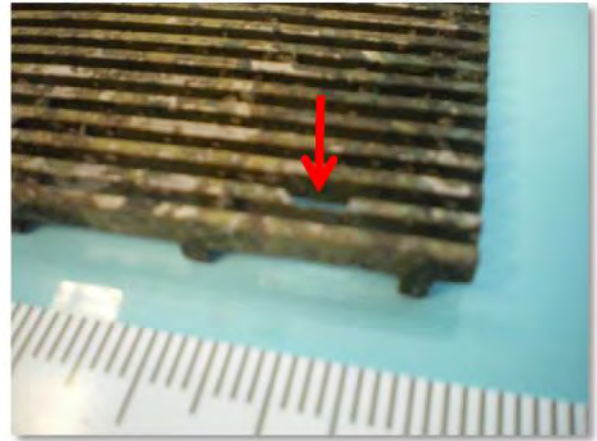
Mechanical damage was observed at each corner of the 70-30 Cu-Ni, 90-10 Cu-Ni, and Z Alloy screens where they were secured to the test rack. The mechanical damage may have been caused by the turbulence in the water and abrasion of the metal by the zip ties that prevented the passivation of the metal at those locations. The exposed metal was corroded and metal loss occurred.

Figure 4-28: Mechanical damage to 70-30 Cu-Ni wedge wire screen.

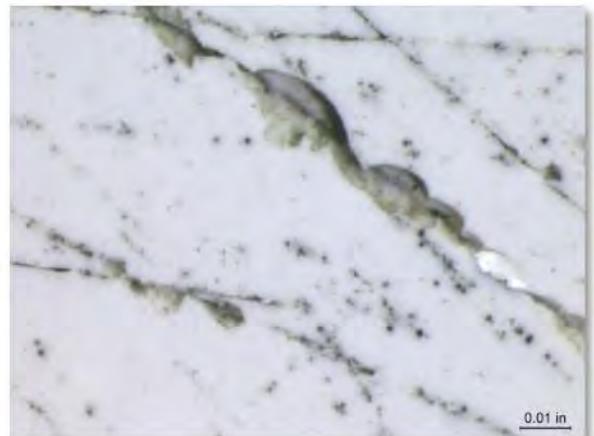
Figure 4-45: 2205 Duplex SS coupon surface at an area of coating damage.

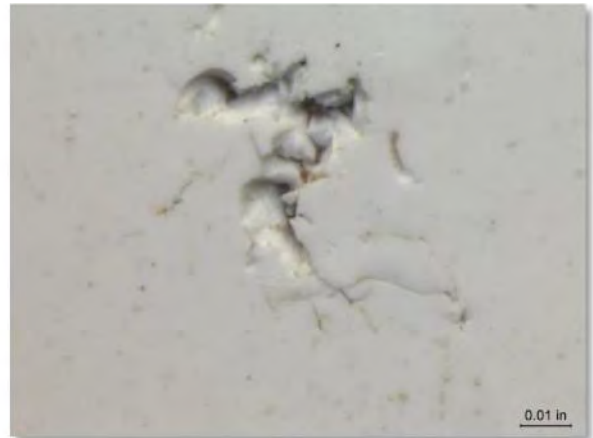
Figure 4-47: 2205 Duplex SS plate surface at an area of coating damage.

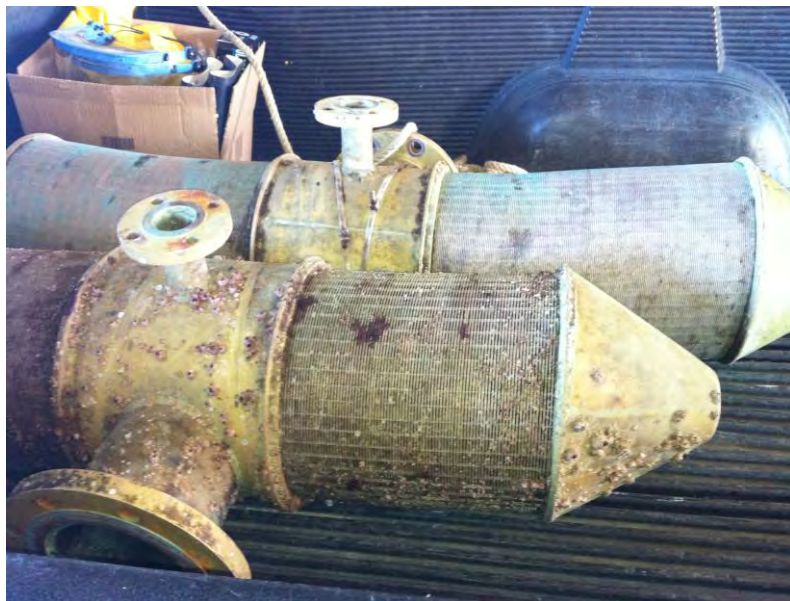
Cook Legacy Screens Removed after Failure

The initial screen installed experienced signs of corrosion within months of installation. After one year of operations mussels were noticed inside the screen. Build-up of mussels, and barnacles inside the screen caused the screens to fail after approximately 15 month of service. Larvae that passed through the screens entered the 6-inch pipelines and caused extensive biofouling, barnacle, and mussel growth. This growth would foul the pipes, become loose, and then damage downstream equipment at the Demonstration Facility.

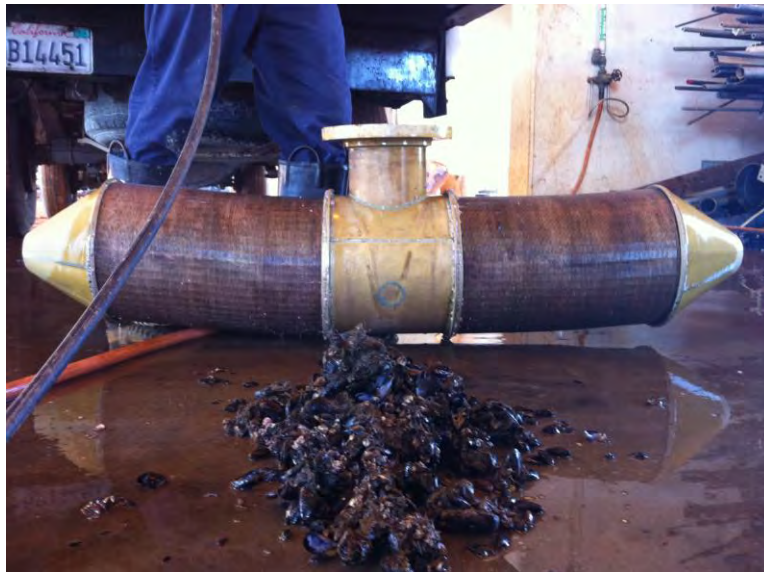
Mussels Removed from the Cook Legacy Screen after Failure

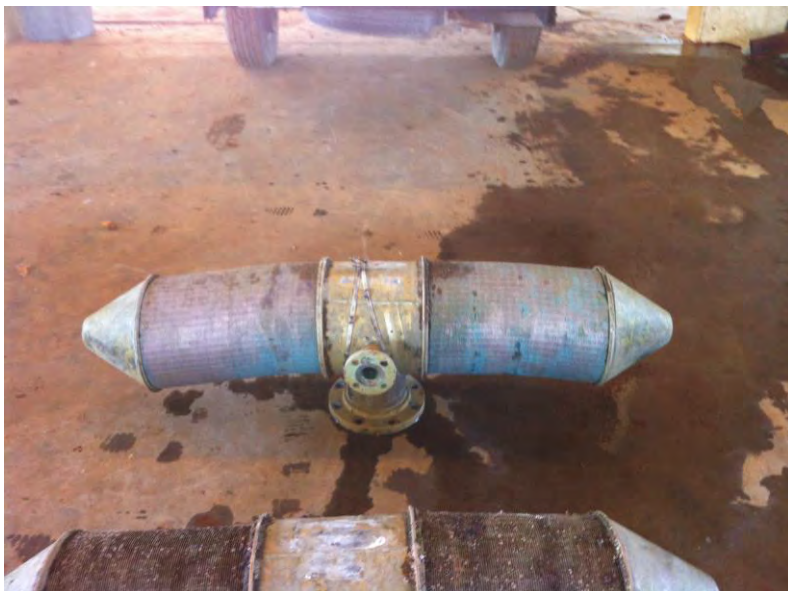
In June 2012 West Basin hired Tetra Tech to investigate the failure of the Cook Legacy screens. A report prepared by Corpro dated August 26, 2012 indicated minor corrosion but not significant enough to cause failure, see copy of Corpro report in Appendix A. However a structural review of the Cook Legacy screens indicated that the screens likely failed due to bending of the support members connected to the wedge wire. The weight of the solid deflection cone coupled with the weight of the interior biofouling caused the support members to bend and fail.

Cook Legacy Screen after Structural Failure

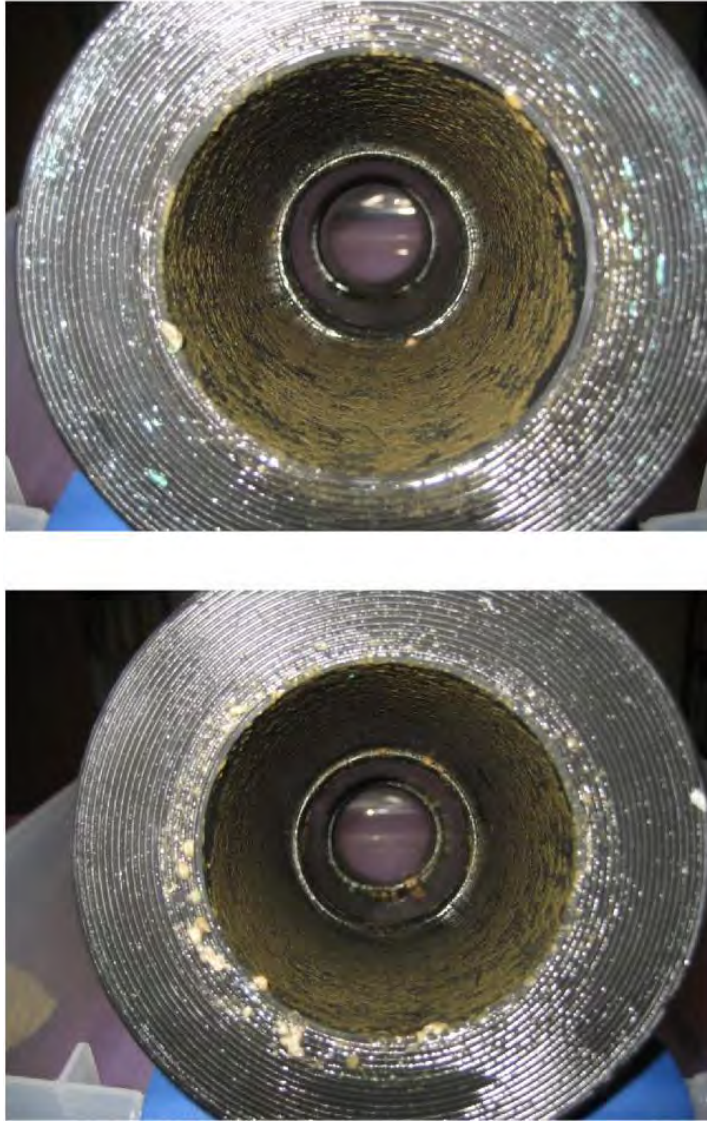
- No sand.

Figure 3-1. Pipe spool A3 (Control) October 28, 2014. Inlet (top) and Outlet (bottom).

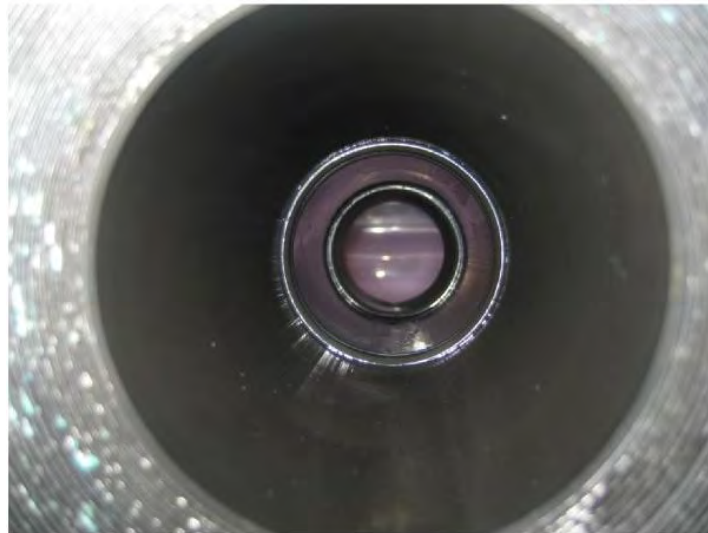
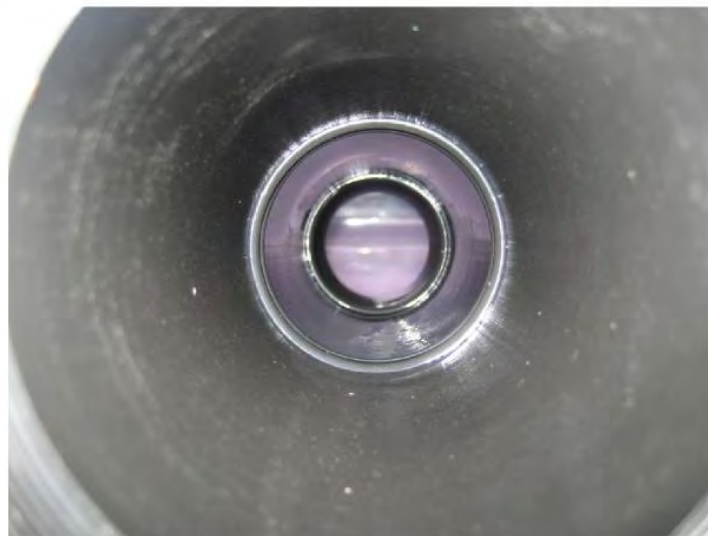
- This is the third pipe spool in spool row B and was treated with continuous injection of a chloramine solution.
- Photos taken from inlet and outlet ends (**Figure 3-2**).
- No macrofouling organisms were found.
- No slime/diatoms detected by touch or tissue wipe.
- No sand

Figure 3-2. Pipe spool B3 (Continuous Chloramine Injection) October 28, 2014. Inlet (top) and Outlet (bottom).

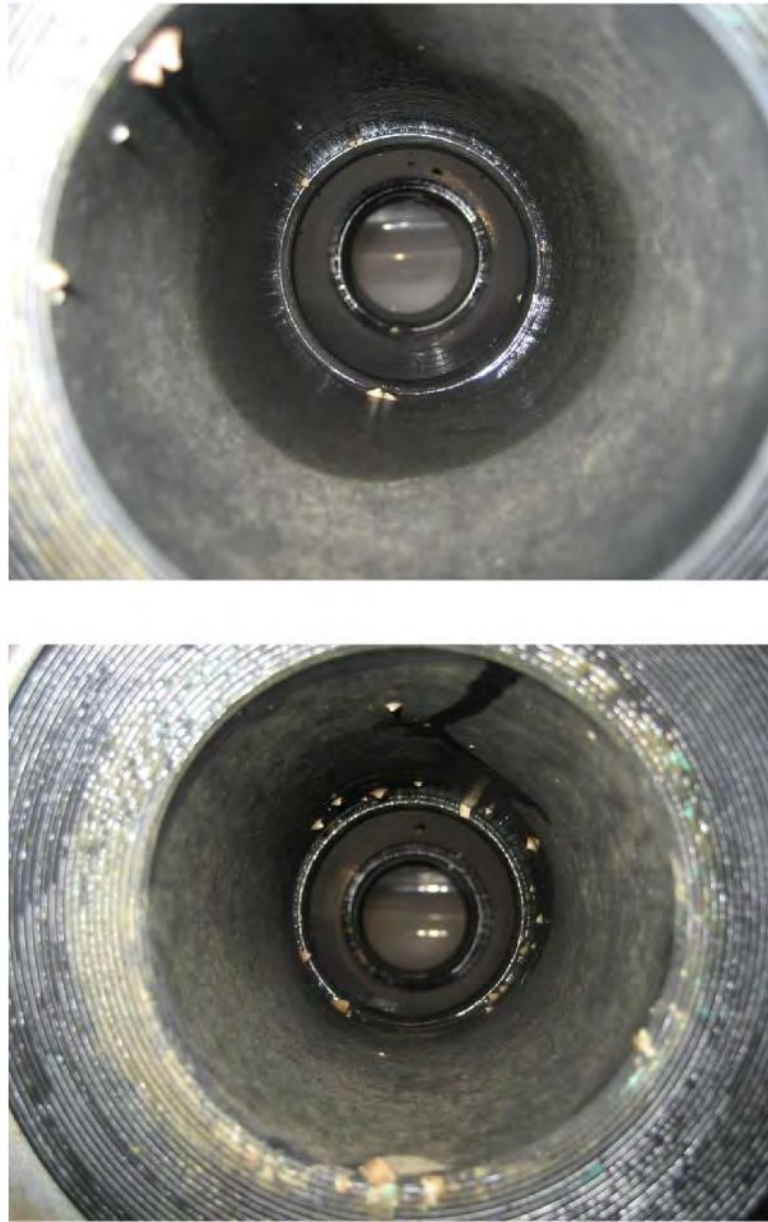
- No other macrofouling was found.
- No sand or debris was observed in the spool.

Figure 3-4. Pipe spool A4 (Control) December 23, 2014. Inlet (top) and Outlet (bottom).

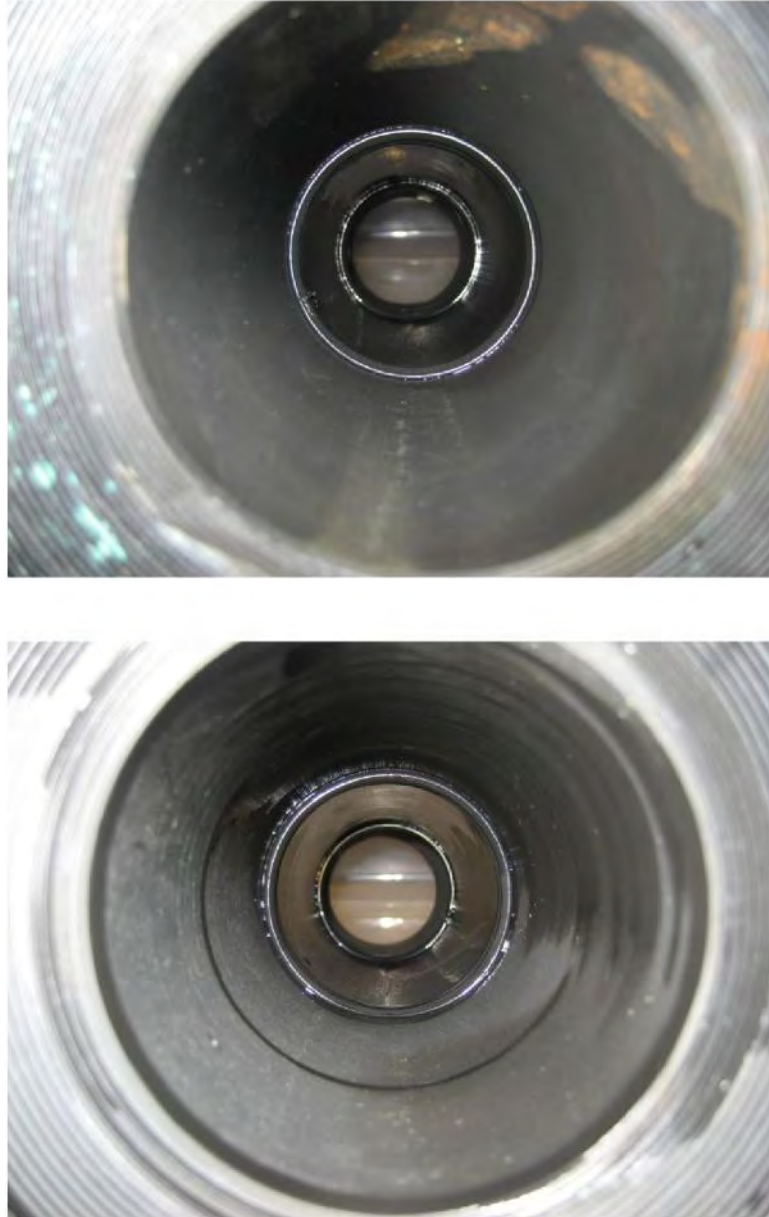
- This is the fourth pipe spool in spool row B and was treated with continuous injection of a chloramine solution.
- Photos taken from inlet and outlet ends (**Figure 3-5**).
- No macrofouling organisms were found.
- No slime/diatoms detected by touch or tissue wipe.
- No sand or debris, although a rust stain was observed in the inlet section (**Figure 3-5**).

Figure 3-5. Pipe spool B4 (Continuous Chloramine Injection) December 23, 2014. Inlet (top) and Outlet (bottom).

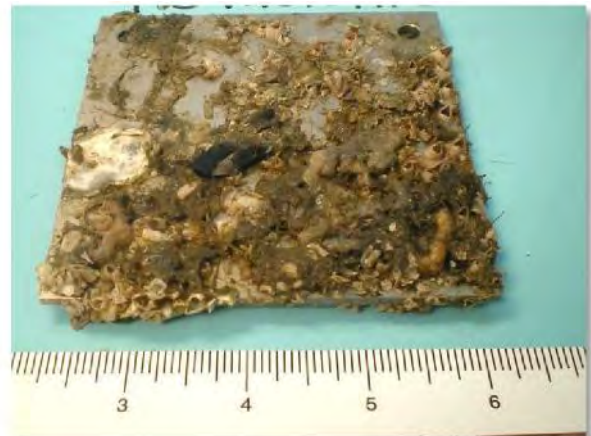
Figure 4-20: Marine life attached to uncoated 2205 Duplex stainless steel flat plate.

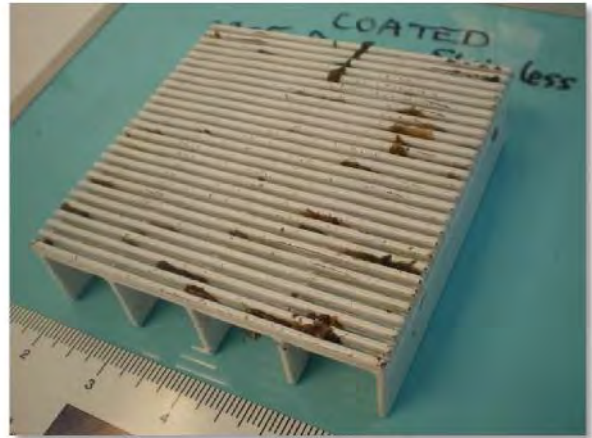
Figure 4-24: Coating damage to coated 2205 Duplex stainless steel wedge wire sample.

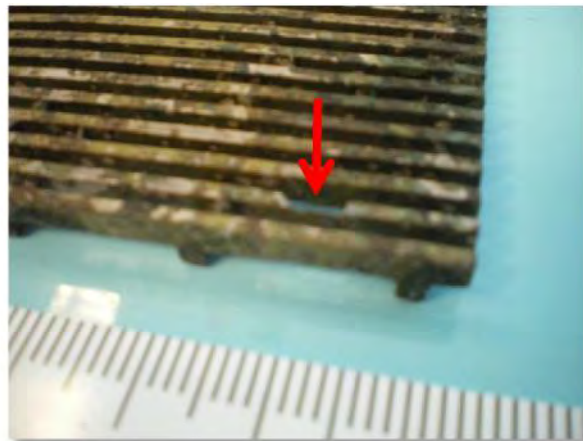
Figure 4-28: Mechanical damage to 70-30 Cu-Ni wedge wire screen.

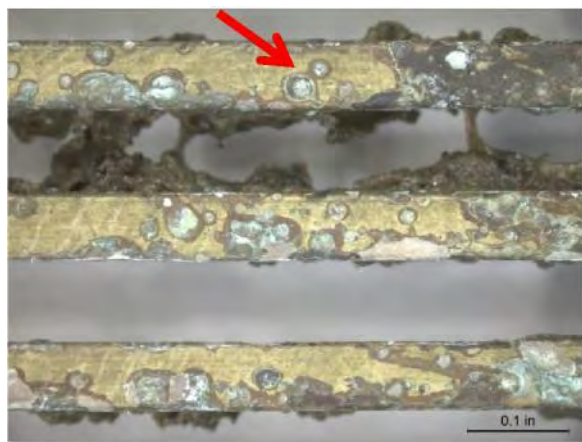
Figure 4-29: 70-30 Cu-Ni wire screen at 10X magnification, pitting and discoloration.

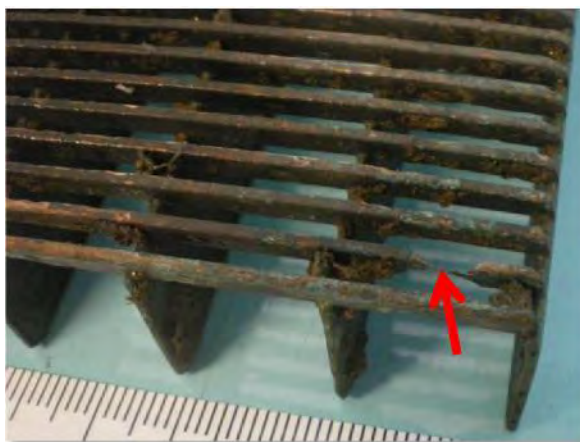
Figure 4-33: Mechanical damage to 90-10 Cu-Ni wedge wire screen.

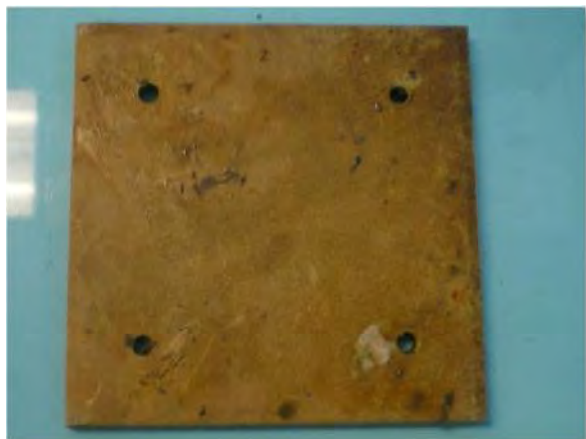
Figure 4-37: Minimal corrosion was observed on the Z alloy flat plate.

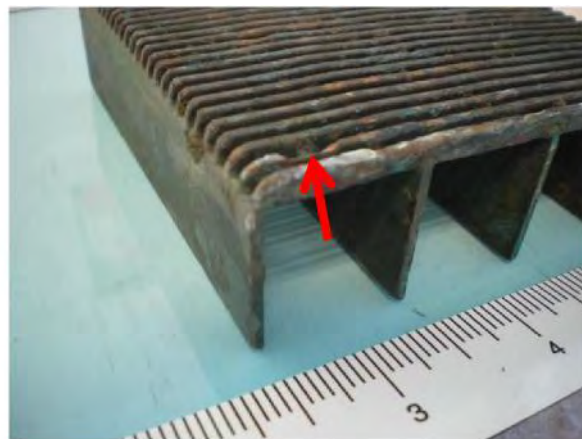
Figure 4-38: Mechanical damage to Z alloy wedge wire screen.

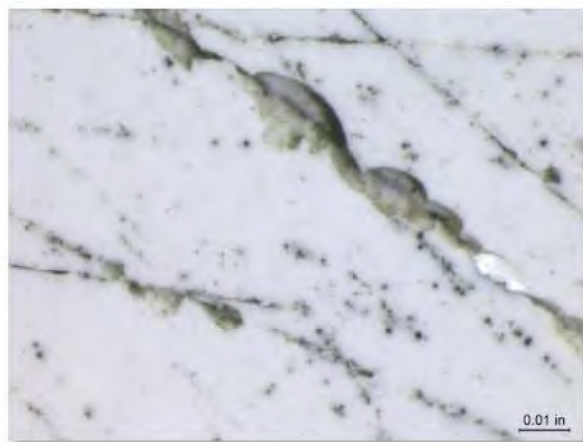
Figure 4-45: 2205 Duplex SS coupon surface at an area of coating damage.

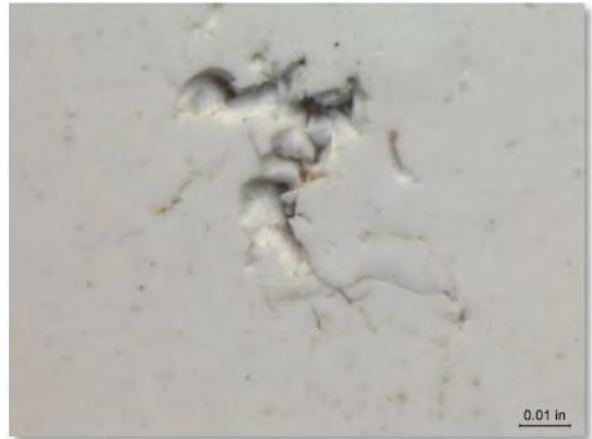
Figure 4-47: 2205 Duplex SS plate surface at an area of coating damage.
