CONSTRUCTION PROGRESS REPORT – 2017 Minor Construction Works

Project:	Cobble Hill Landfill – Closure Plan	Date:	October 15 th , 2017
Subject:	Construction Progress Update		
Location:	Cobble Hill Landfill	File:	17039-2017-03

Cobble Hill Landfill Closure – 2017 Minor Construction Works

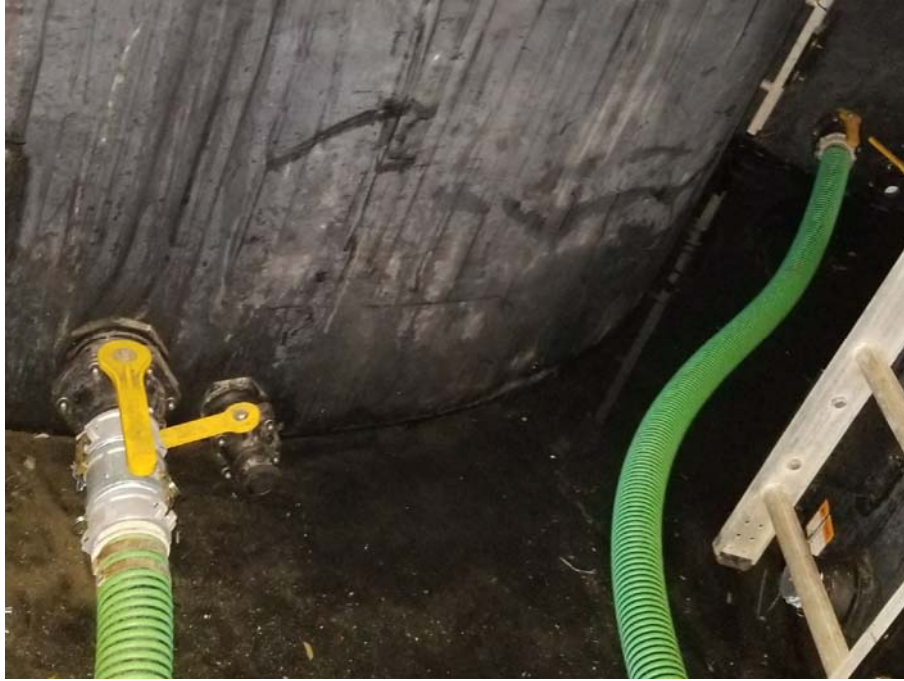
-Interconnecting hose (4” flex hose) between the two leachate storage tanks is installed. Connection were inspected and verified by QP.

Photo 1 – 2x Leachate Tank Interconnecting Pipe Installed.

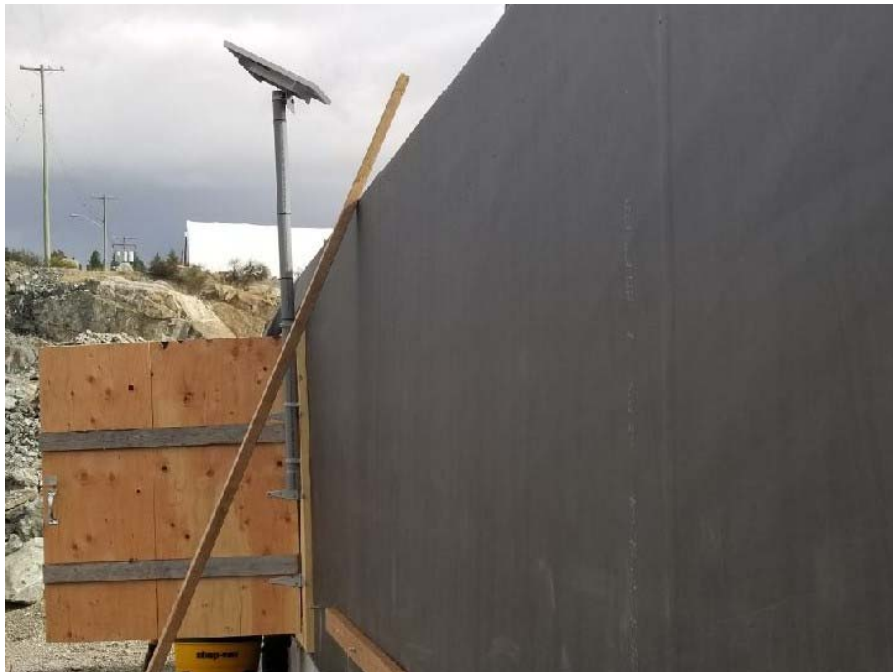
Photo 2 – Solar Panel Installed and Operational at Leachate Storage Facility.

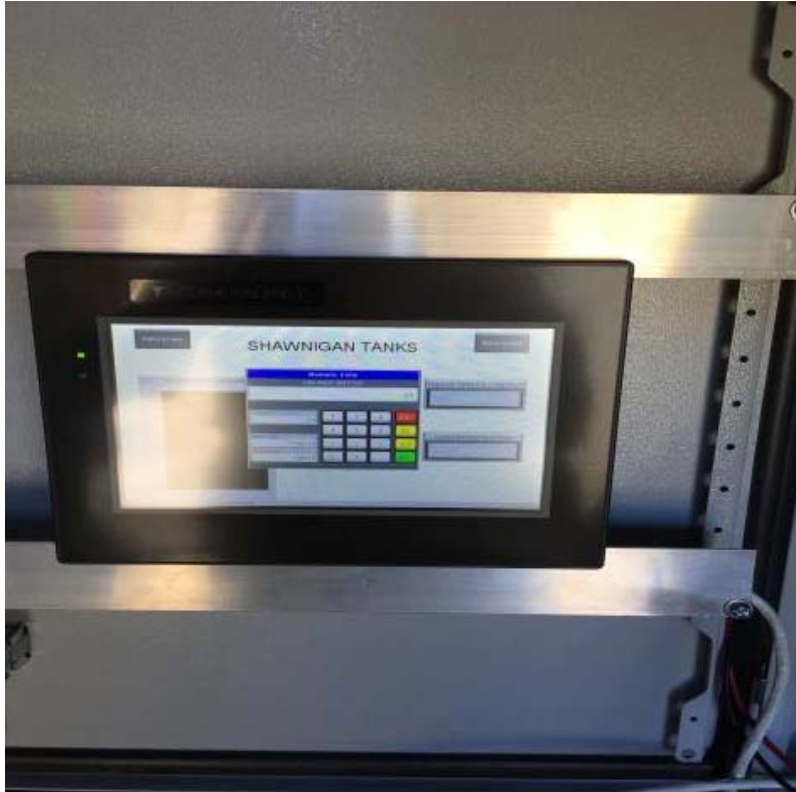
Photo 3 – Digital Readout Screen on Inside Door of Control Panel – for High-level Alarm.

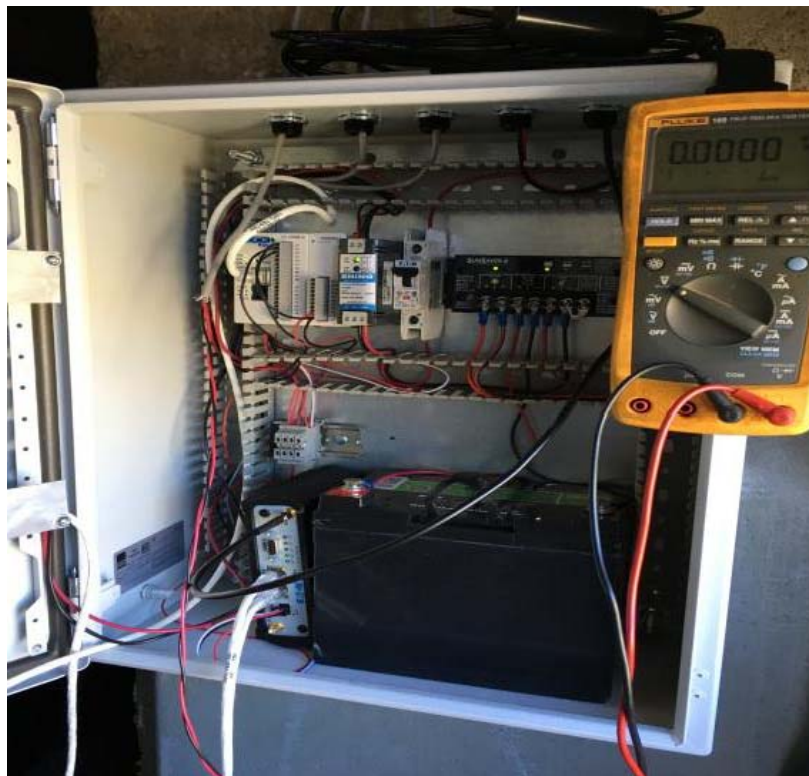
-High level alarm has been installed in the leachate storage facility and is operational. Works included installation of a solar panel, control panel, transducer, floats and fully automated high and low-level alarm system for leachate tanks. Smartphone application was downloaded by the Electrical Contractor during install and functionality of the remote system was explained, tested and verified by the QP. With smartphone, levels in the tanks can be monitored and floats and alarms adjusted. The smartphone application has been downloaded by Allterra and will be used to manage leachate levels with the storage facility.

Photo 4 – Control Panel: PLC, 12V Battery, Router and Wiring – High-Level Alarm

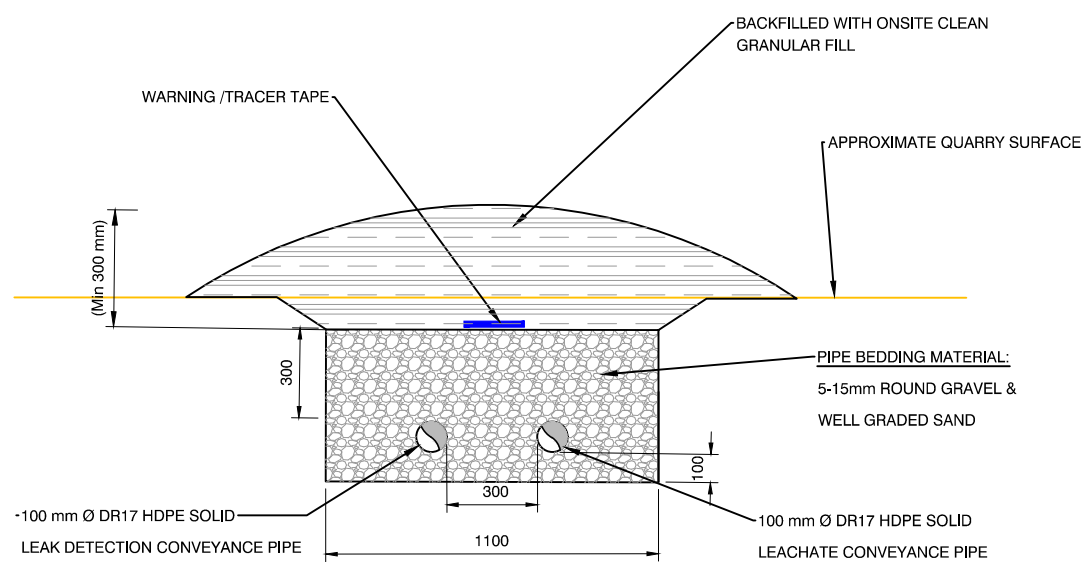
TYPICAL TWIN LEACHATE/LEAK DETECTION CONVEYANCE PIPE TRENCH SECTION B - B'
SCALE 1:20

A. Pipe Bedding Material for ‘New Twin Piping from PEA to New Leachate Storage Facility’: Pipe bedding material was sourced onsite from two stockpiles:

Sieve analysis were conducted on both materials and although they differ from the gradation specification included in the design, both products used are adequate for pipe bedding materials and were approved in the field prior to use by the QP. Sieve Analysis reports are included in Appendix C.

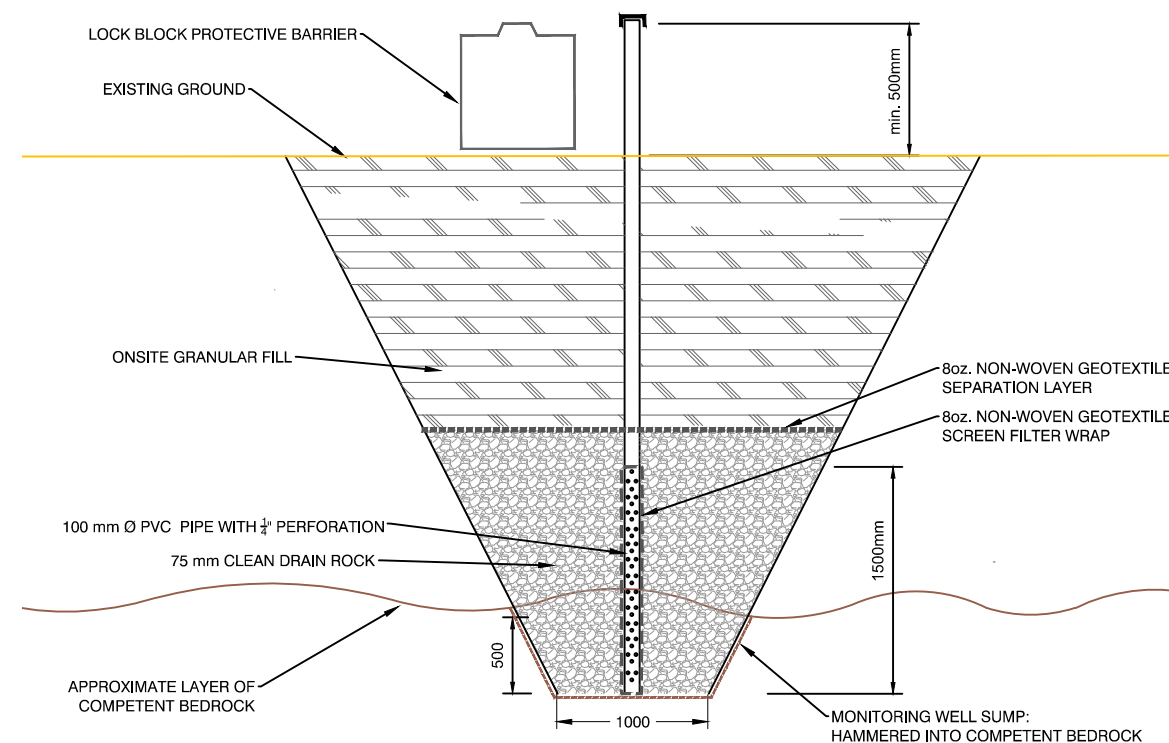
TYPICAL SEEPAGE BLANKET WELL
SCALE 1:50

- D. Seepage Blanket Monitoring Wells at Landfill Toe:
A change to the backfill material was approved in the field by the QP. Original plan specified a 25-50mm clear drain rock be used. In place of the 25-50mm drain rock, 75mm clear drain rock was used.

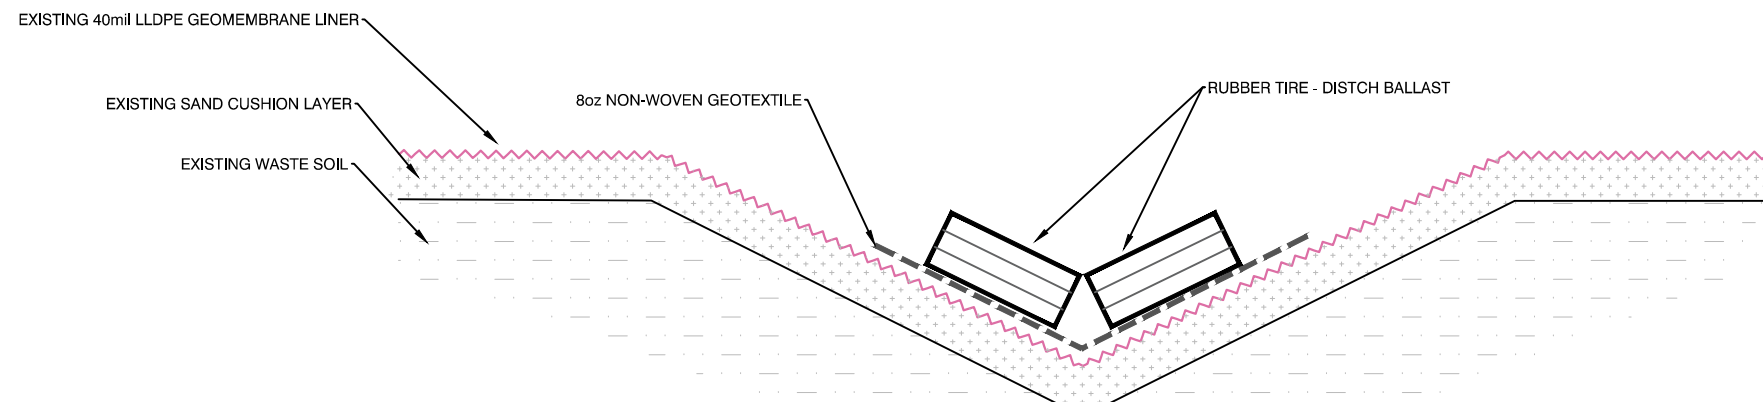
TYPICAL CREST DITCH SECTION
SCALE 1:50

- E. PEA Crest Ditch Ballasting:
A change to the ballast material used in the crest ditch of the PEA was approved in the field by the QP. The design plan specified coarse gravel and sandbags be placed over a layer of 8oz. Non-Woven geotextile. During construction, the ballast material was changed from coarse gravel and sand bags to rubber tires, placed back to back along the entire alignment.
