**U.S. Department of  
Transportation  
Federal Railroad  
Administration**

## **Office of Railroad Safety**

### **Summary Report**

**Obstruction Collision of Amtrak Train 89**

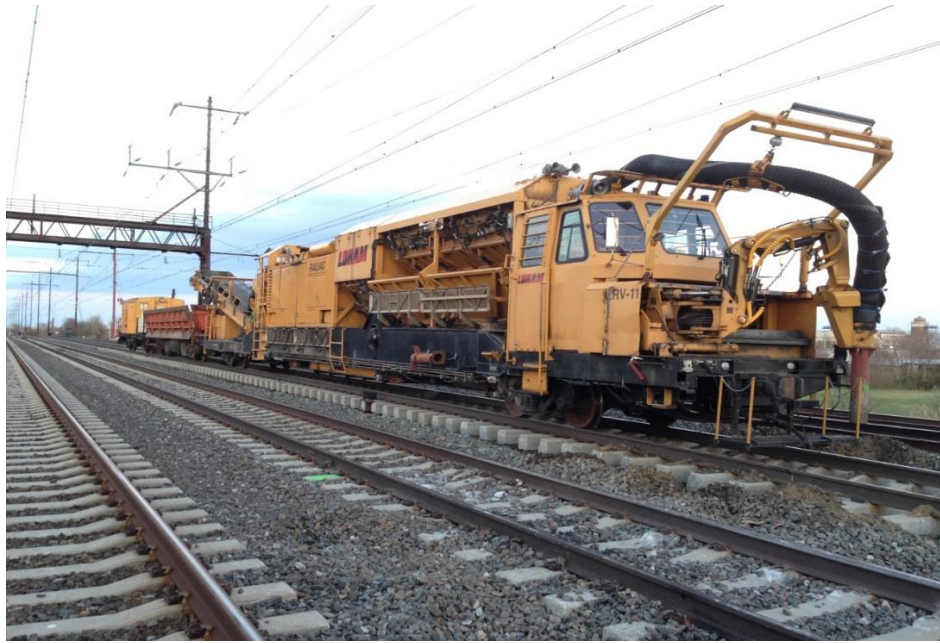
**Figure 1:** *Loram Vacuum Unit*

The MOW gang was working on the north-end of the Booth Street under-grade bridge at MP 15.7 on Track 2. The head-end of the Loram Vacuum Unit (LORA048553) was facing south approximately 138 feet north of the bridge and working in the north direction. There were three Loram contractors working with this Loram Vacuum Unit. Two Loram contractors were inside the cab with the day Foreman, and one Loram contractor was on the ground near the front of the Loram Vacuum Unit. The Amtrak Track Supervisor was standing in front of the Loram Vacuum Unit, facing south between Tracks 2 and 3 on the field side<sup>6</sup> of Track 2. The injured Trackman was standing next to the Track Supervisor, in the gage of Track 2, facing west. The backhoe was facing south on Track 3 with the night Backhoe Operator sitting at the controls also facing south, not actively working. The day Watchman was in front of the Loram Vacuum Unit on the right-of-way next to Track 4.

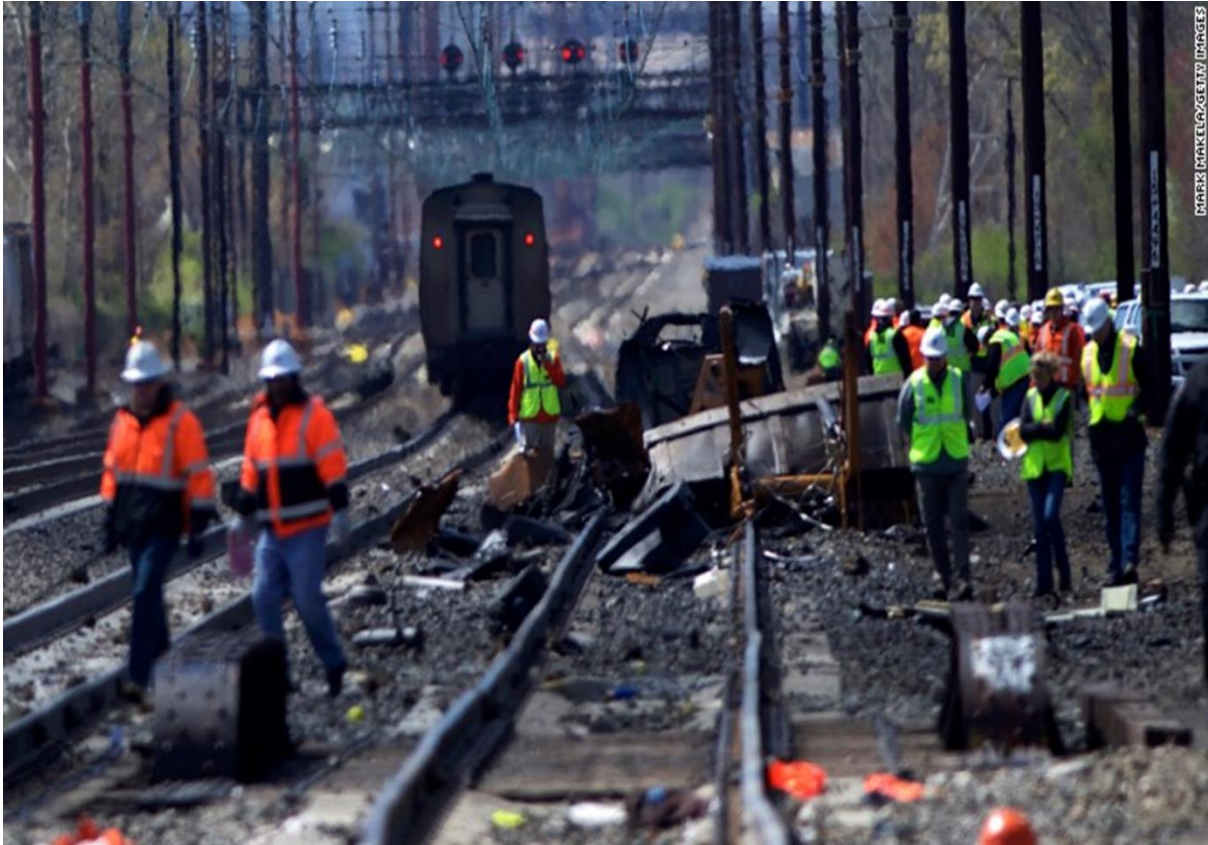
**Figure 2:** *Last Amtrak 89 Collision Site*

At 7:49:15 a.m. EDT, Amtrak 89 approached the accident area, traveling 106 mph. Shadows cast from the Loram Vacuum Unit obstructed the Engineer's view of the work site on Tracks 3 and 4. At 7:49:41 a.m. EDT, the Engineer recognized the MOW backhoe fouling Track 3 and initiated an emergency air brake application 450 feet before impact. The train slowed to 102 mph when the collision occurred at 7:49:44 a.m. EDT based on data collected from the lead locomotive's event recorder (Figure 2).

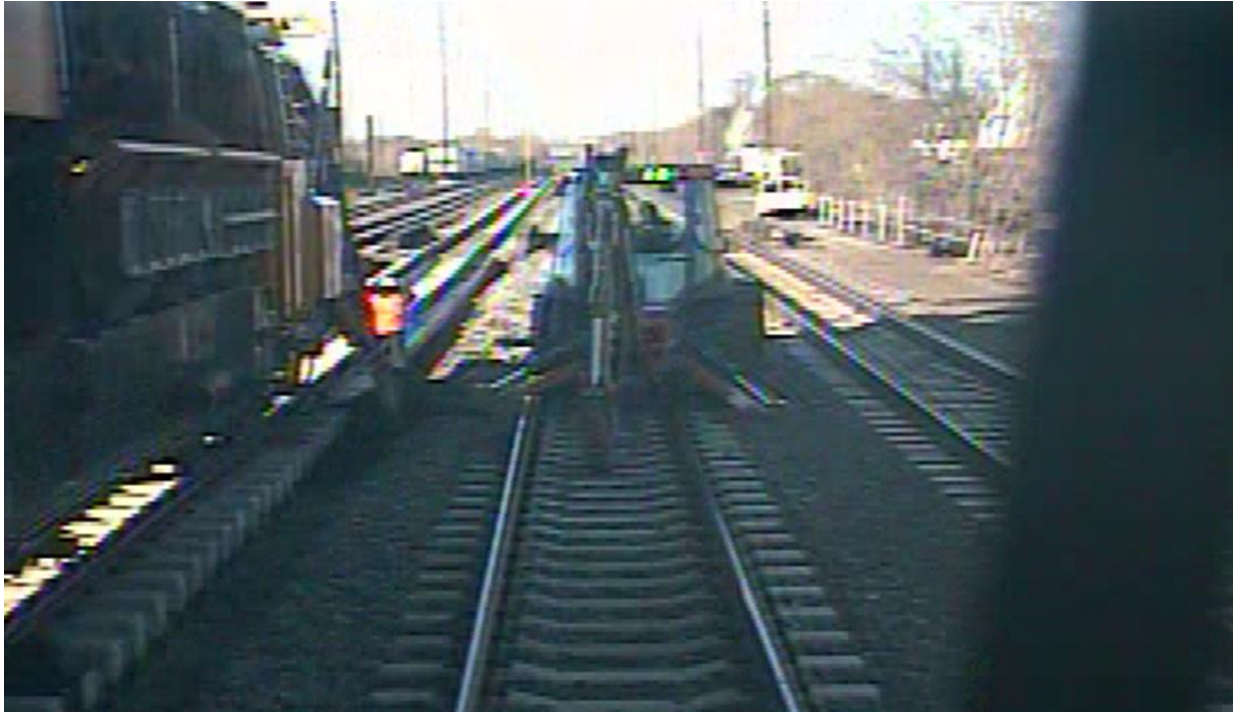
**Figure 3:** *Last Amtrak 89 Outward-Facing Camera Image*

Approximately 138 feet past the point of impact (POI), Amtrak Locomotive 627 derailed its front truck (F-end) due to backhoe debris. Amtrak 89 continued south with the lead truck of the locomotive derailed for 2,510 feet before coming to a stop. After reviewing the outward-facing camera on Amtrak 89's locomotive, it was determined that the MOW backhoe was facing in the south direction with front bucket facing south and resting on the west rail. Both outriggers were down and the rear window was in the open position. The rear boom was also down with the cribbing bucket resting on the ballast between two concrete ties inside the gage of the track, and the rear work lights were on. The night Backhoe Operator was sitting in the Operator's seat and facing south, and the train struck the rear of the backhoe, at the rear boom. The outward-facing camera cut off at the POI due to damage to the locomotive's electrical system after impacting the backhoe (Figure 3).

system includes Automatic Speed Control (ASC)<sup>8</sup> and Automatic Train Supervision (ATS)<sup>9</sup> capabilities. All systems on the locomotive worked as designed, however the event recorders failed to record any data after the initial impact with the backhoe at 7:49:44 a.m. EDT due to damage sustained to the locomotive's electrical system in the collision.

Due to the failure of the event recorder to continue recording/storing data after impact with the backhoe, Amtrak and Siemens engineers are looking for a solution to the failure by connecting the event recorder to another power source or protected circuit to prevent loss of event recorder data in future accidents. The working group developed a plan to rewire the Event Recorder on

ACS-64 Locomotives from the current circuit to a direct battery power circuit to prevent the loss of event recorder data in the future. The modification has been completed on 51 of the 66 ACS-64 locomotives currently in service.

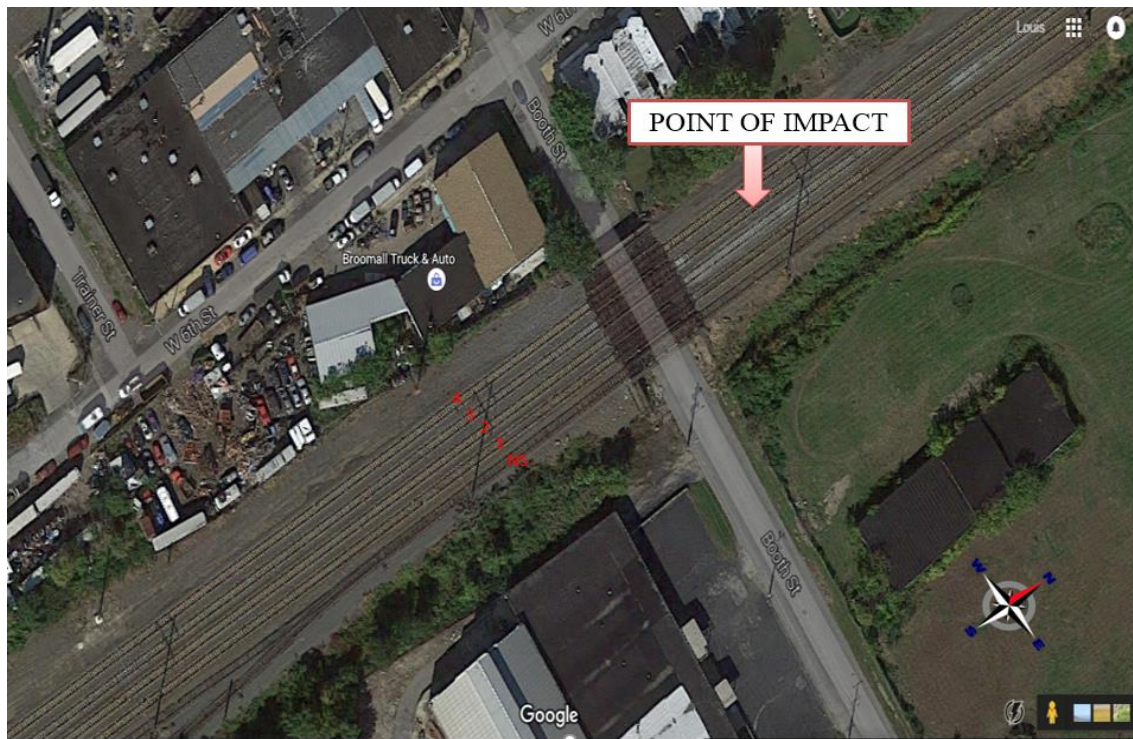
**Figure 4:** *ATK 89 Point of Impact*

Investigators observed wheel flange marks departing the west rail down the gage face of the railhead<sup>7</sup> to the base of the rail and trailing southward as those marks angled towards the center of the concrete crossties. A companion set of marks were observed where flange marks went up and over the east-head of the rail and dropped outside to the field side of the east rail. The marks trailed southward and angled away from the east rail towards the outside edge of the concrete crossties. The Engineering department investigation team established the POD at MP 15.69, or about halfway between the POI and the center of the Booth Street under grade bridge. Amtrak

Locomotive 627 was the only rolling stock derailed and it came to rest upright approximately 2,510 feet from the POD. (Figure 4)

Amtrak found no geometry defects during the post-accident inspection and the prior automated (Geometry Car) and walking inspections did not find an exception near the POD. There are no indications of any rail or track defects that would be a cause or contributing factor in this derailment.
