SYNOPSIS

OPERATOR : AERO SURVEYS LTD
(STARBOW)

MODEL : ATR 72 - 212A

PLACE OF ACCIDENT : KOTOKA INTERNATIONAL AIRPORT
ACCRA, GHANA (DGAA)

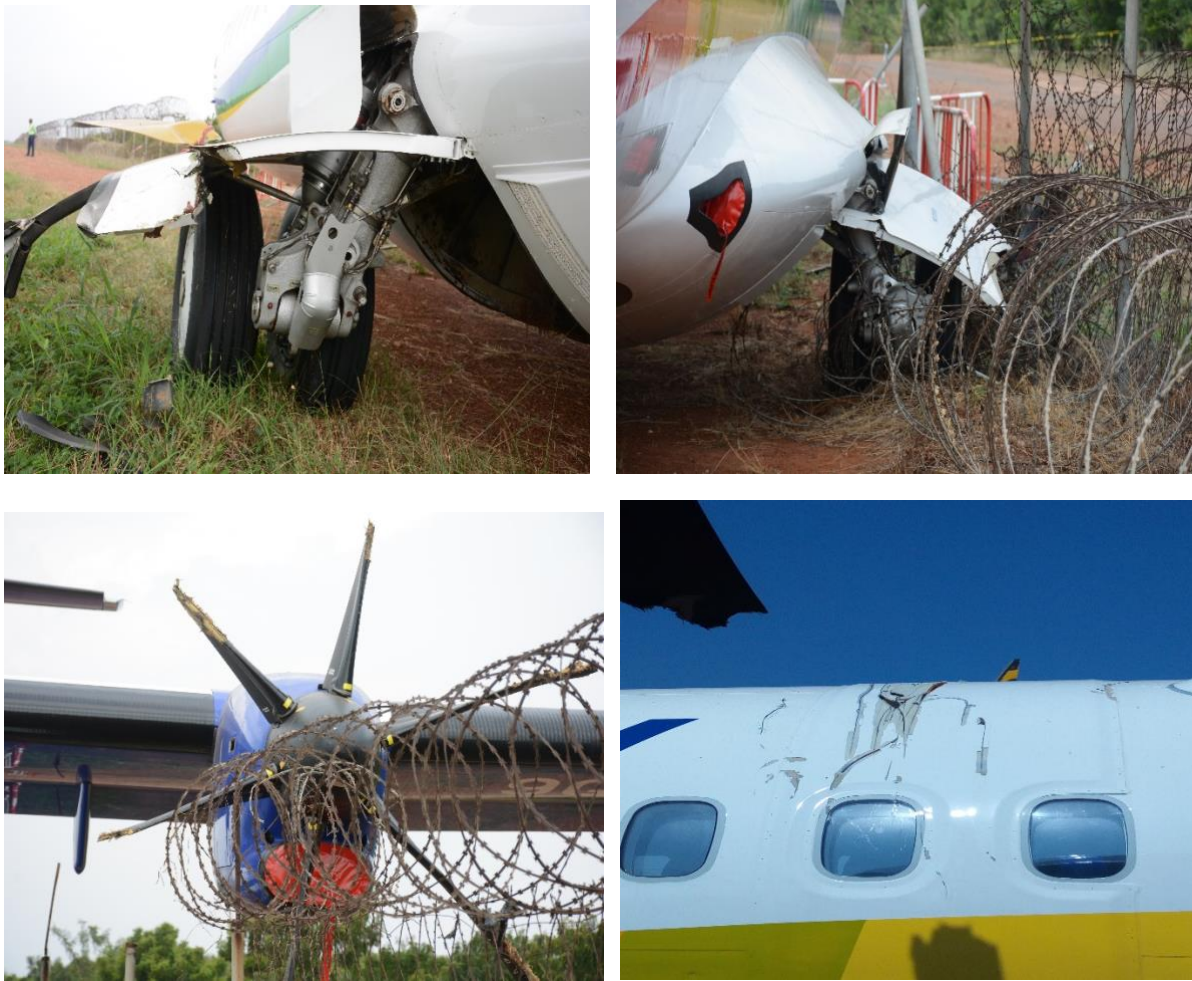
Figure 3: Damages on various parts of Aircraft

The aircraft undercarriage, fuselage, engines and propellers sustained substantial damage.

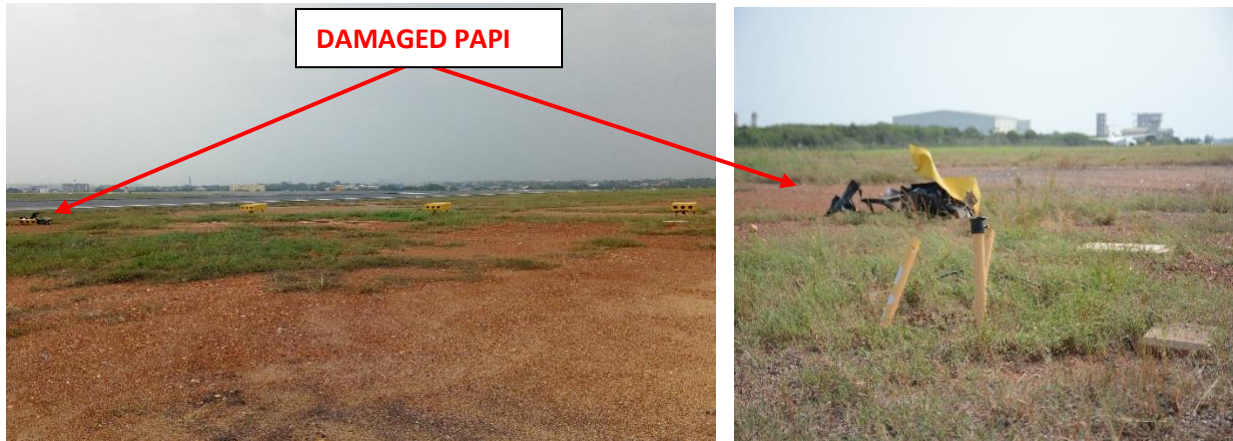
Figure 5: Damaged PAPI

The aircraft's right main landing gear ran over the inner PAPI light (lettered D in figure 4) destroying it completely. In addition, about 30 meters of the aerodrome inner perimeter fence was also damaged.

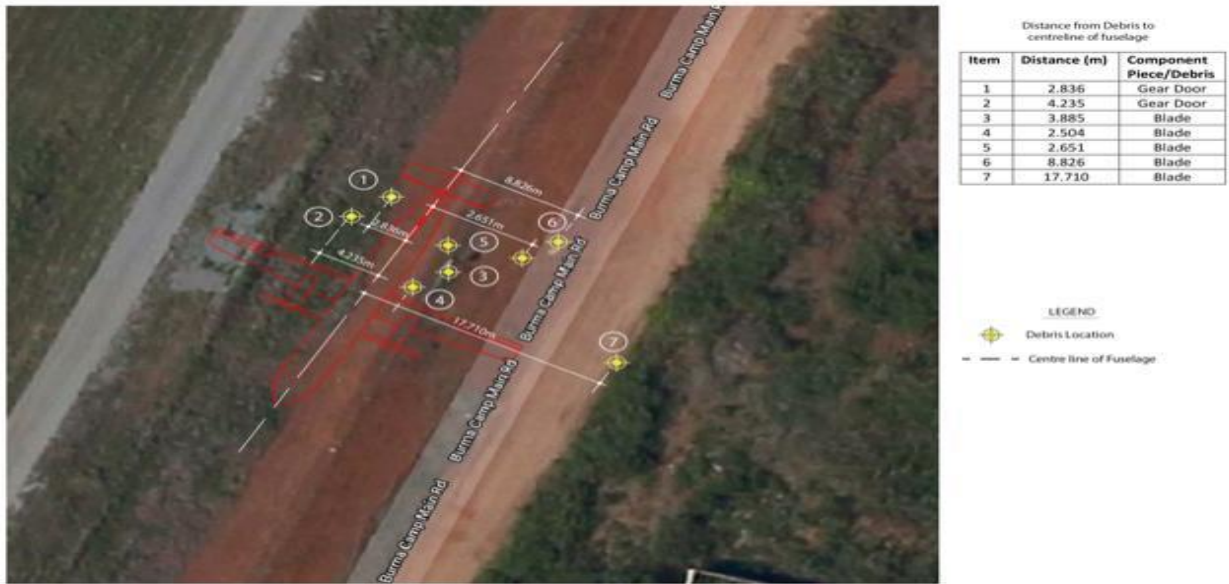
Figure 10: Aircraft impact debris distribution pattern

The accident occurred on latitude N 05° 36'31'' and longitude W 000° 09'51'' approximately 160m east of the centre line of RWY 21 and 600m from the point where the aircraft exited the runway. The aircraft impacted the airport inner perimeter fence with both engines running. Considerable visible damage was done to the propeller blades on both engines with debris scattered within a 100m radius of the aircraft. The undercarriage sustained some damage and part of the inner perimeter fence was also damaged. Aircraft impact debris is illustrated in figure 10.

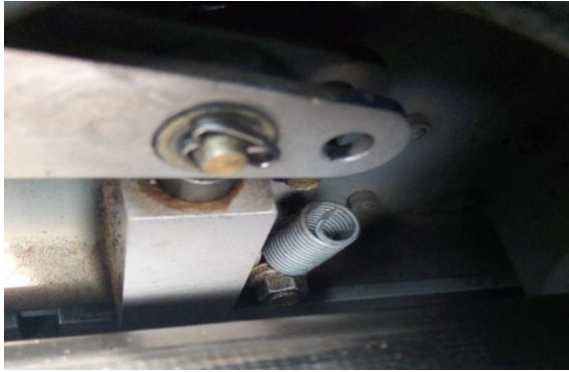
Figure 18: Broken Spring on Captain Seat

3. An initial examination of the seats after the accident revealed the following;
 - a. A broken spring on the right horizontal track locks system of the captain's seat as shown in figure 18.

- c. The cause of the rotational play could not be identified.
 - d. The failure of the right spring may have contributed to the fact that the roll back was not stopped during take-off roll.

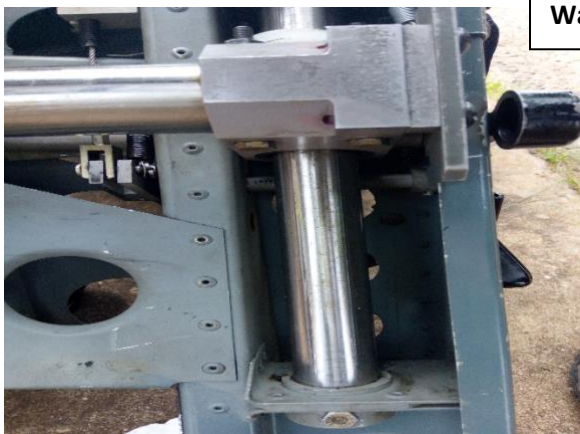
Figure 20: Missing Washer(Packers) on Captains Seat

- b. Both alignment washers (packers) were not in place on the captain's seat. (*Refer to figure 20*)
4. In the case of the co-pilot's seat, all springs and washers were intact. Also, while all other springs looked black (*refer to figure 19*), that on the captain's seat looked ash in colour (*refer to figure 18*), an indication that the broken spring may have been replaced during maintenance.

- e. The incorrect fitting assembly of the spring (missing washers) may have contributed to the failure of the right spring. “

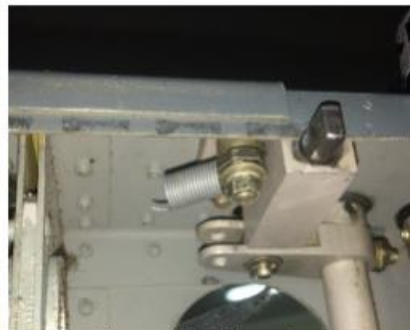
Figure 11 : Right spring

The right spring is broken (Figure 11). Ipeco indicates that the system is designed to function with one spring, though the overall stiffness will be decreased with one spring.

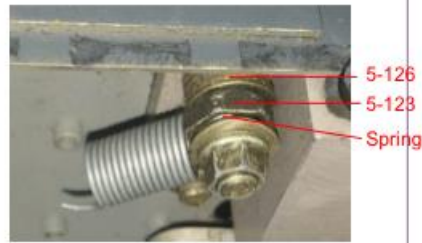
Figure 13 : Right spring assembly

The right spring has been fitted between the hollow nut (5-123) and the thin washer (5-129), with the washer (5-126) on the incorrect side of the hollow nut (Figures 12 & 13).

This incorrect assembly may have contributed to a partial clamping of the spring attachment and thus to its failure.

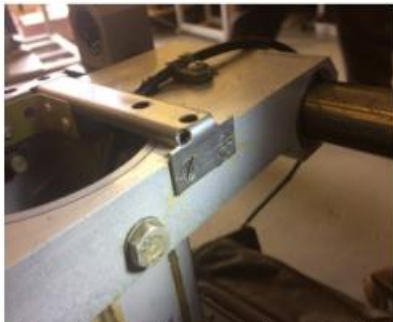
Figure 14 : Fretting on carrier assembly

Traces of interference are observed between carrier assembly and left fore/aft tube guide (Figures 14 & 15).

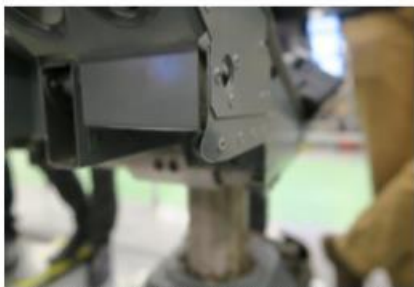
Figure 16 : Bump on seat pan structure

A bump is observed on the bottom front left seat pan structure (Figure 16).

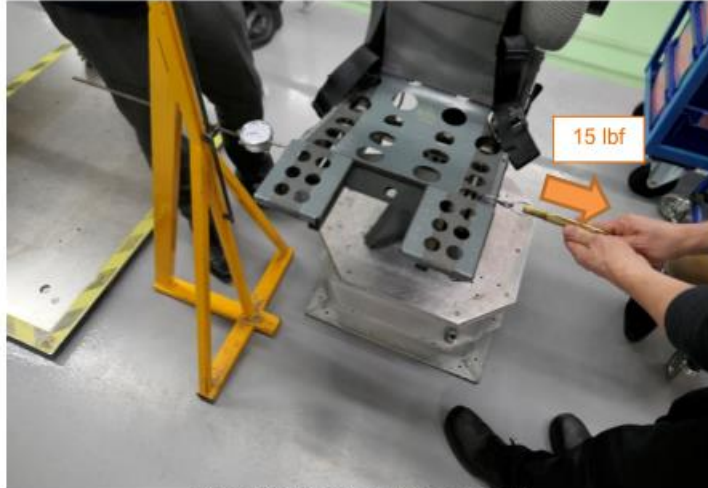
Figure 19 : Rotational measurement

Additional packers are added where they were missing, in accordance with Component Maintenance Manual 25-11-21. Rotational movement is measured with new packers installed : 0.105 inch. The difference with the last measure of 0.119 inch is not significant. The missing packers have thus little impact on the rotational play of this seat.
