OSSA WEST

SERVICE BULLETIN #0-0-1

Ossa Service Bulletin #104

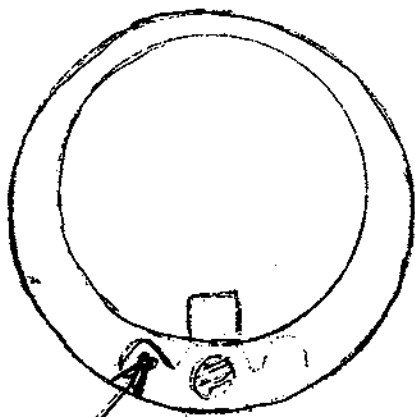
View Looking Into  
Venturi of Carburetor

To increase low RPM performance and improve pulling power out of corners, we recommend the following modifications to be made to the 38 mm Bing carburetors installed on Ossa GP-II and GP-III Motocrossers.

Drill 1/16" hole thru  
to Pilot Air Screw hole.  
It is approx. 5/8" deep.

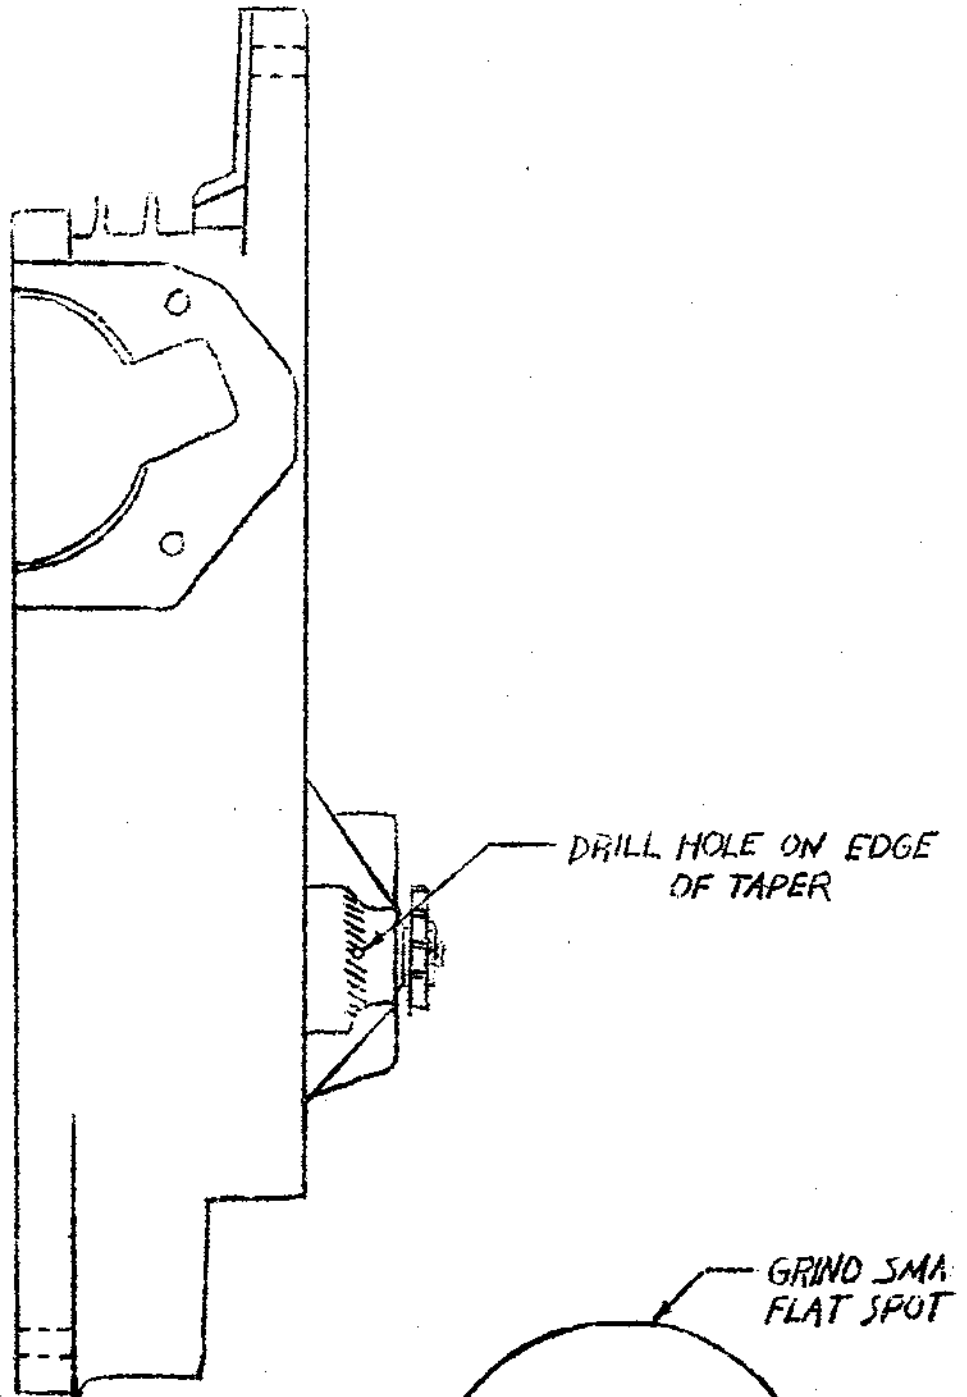
# TOP VIEW OF ENGINE CASES

The following modification will prevent any further problem with transmission failures due to the right side transmission bearing working out of its seat. There has been known to be a lack of interference fit between the 5th gear bearing and the steel sleeve that fits in the right side of the center case. This can be attributed to repeated replacement of the particular bearing or lack of sufficient drive chain slack. In any event, there is an easy and inexpensive solution to the problem.

DRILL HOLE ON EDGE  
OF TAPER

GRIND SMA  
FLAT SPOT
