LTB00445V3

TECHNICAL BULLETIN

SUBJECT/CONCERN:3.0L TDV6 P1247-00 Turbocharger Boost Pressure Low

MODEL:		MODEL YEAR:	VIN:
Discovery 4 / LR4 (LA)	3.0L TDV6 Only	2010 Onwards	AA513326 Onwards
Range Rover Sport (LS)	3.0L TDV6 Only	2010 Onwards	AA215623 Onwards

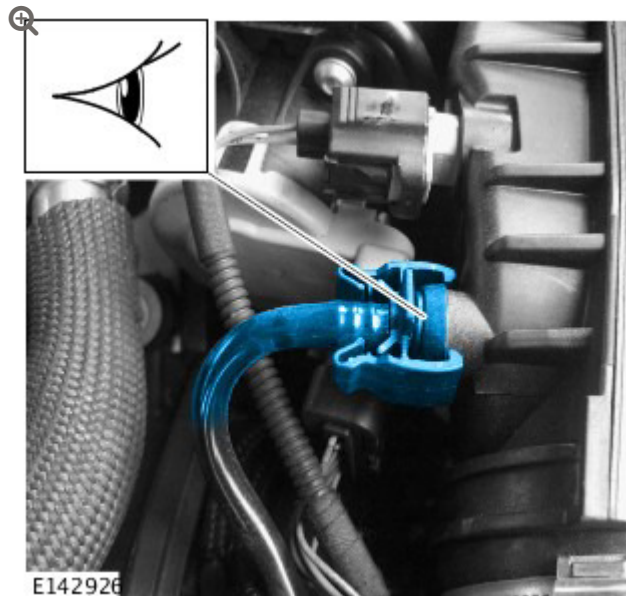
11

Check the secondary turbocharger vent pipe is secure and for signs of oil leakage around the seal area.

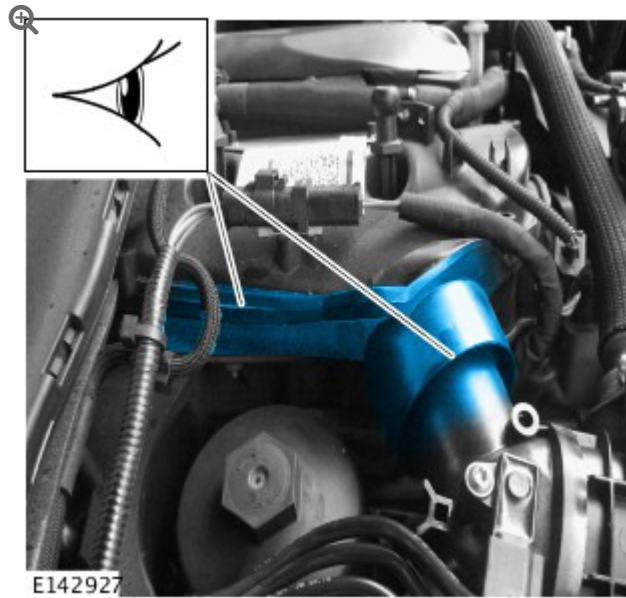
12

Check the intake manifold for signs of oil leakage around the seals and the seam.

- The o-ring seals are available separately.
- Signs of oil leakage around the seam could indicate a seam issue.

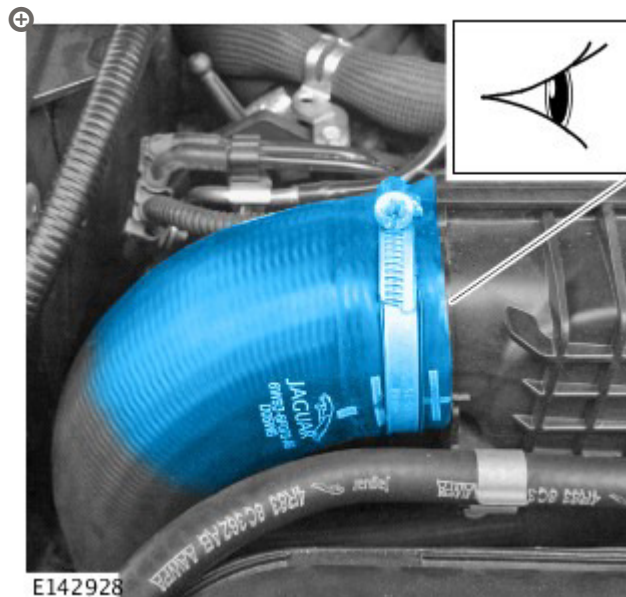
13

Check the charge air cooler to cannister pipe for signs of oil leakage.

- If evidence of oil leakage is found, remove the pipe and clean off the oil.
- Inspect the pipe for damage.
- If no damage is found, install the pipe and secure the clips.

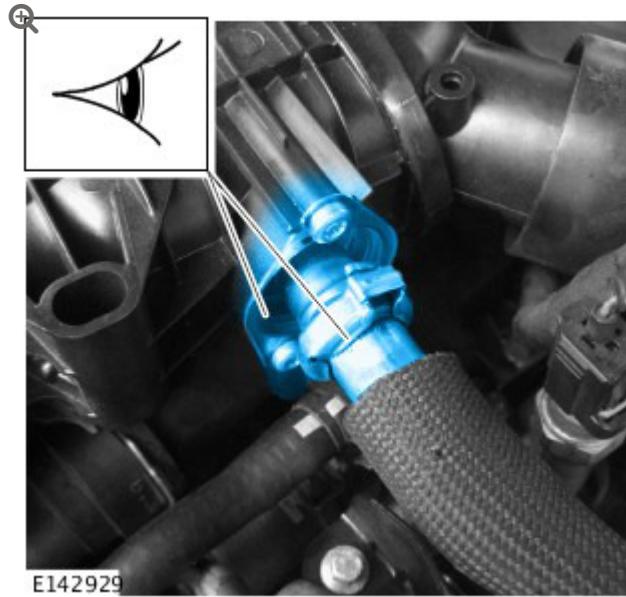
14

Check the throttle intake manifold to EGR pipe for signs of oil leakage and soot in both areas shown.

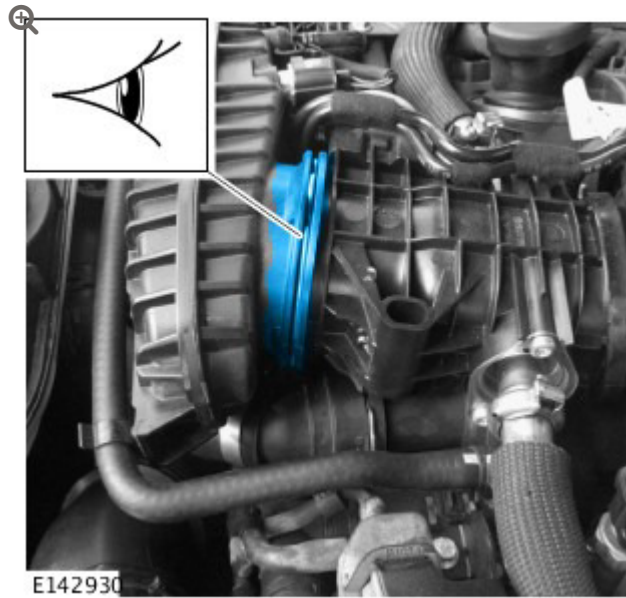
15

Check the throttle intake manifold to cannister seal for signs of oil leakage from the o-ring seal.

- The o-ring seal is available separately.

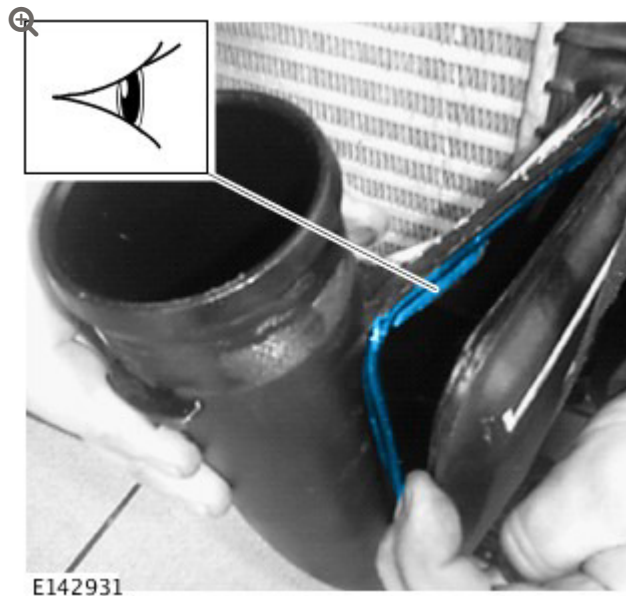
16

Check the charge air cooler plastic end caps for signs of oil leakage or damage. This will be more evident at the joining seams.

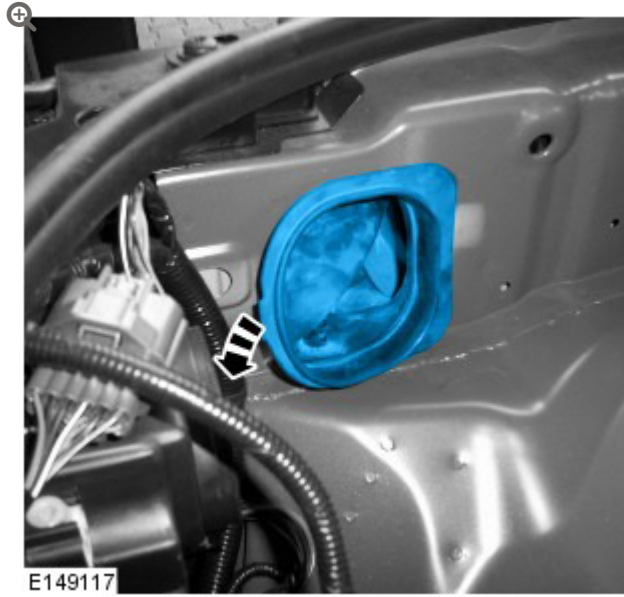
17

Check the air intake rubber to see if it is deformed. This restricts the air flow causing DTC P1247-00 to be stored.
