Client Devon Canada	Date of Inspection 08/13/2012 - 08/17-20'	Report Number RB - 120817 -001
Facility Maple Glen Gas Plant	Time of Inspection 17:00	W.O. Number 20015628
Attention Cam Busby	NDE Procedure UT-0001	P.O. Number NA

Equipment ID Condensate Storage Bullets	Surface Condition Painted, Acceptable
Material Type and Thickness SA 612	Surface Temperature Ambient

We were asked to perform Phased Array inspection of 100% of the welds on the following two Condensate Storage Bullets located at the Maple Glen Gas Plant (16-36-036-16W4). A0151944 and A0151945. This is an in-service client information inspection only.

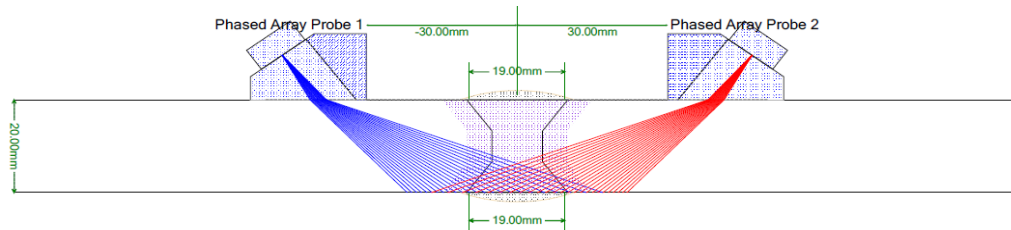
Figure 1 - PAUT Scan Plan

The scan plan shall be built to employ sectorial PAUT to observe the inner 1/3rd of the weld in order to quantify any signs of ID cracking. To note, the weld profile has been built according to available data from the U1-A form. Actual bevel angle may be different.

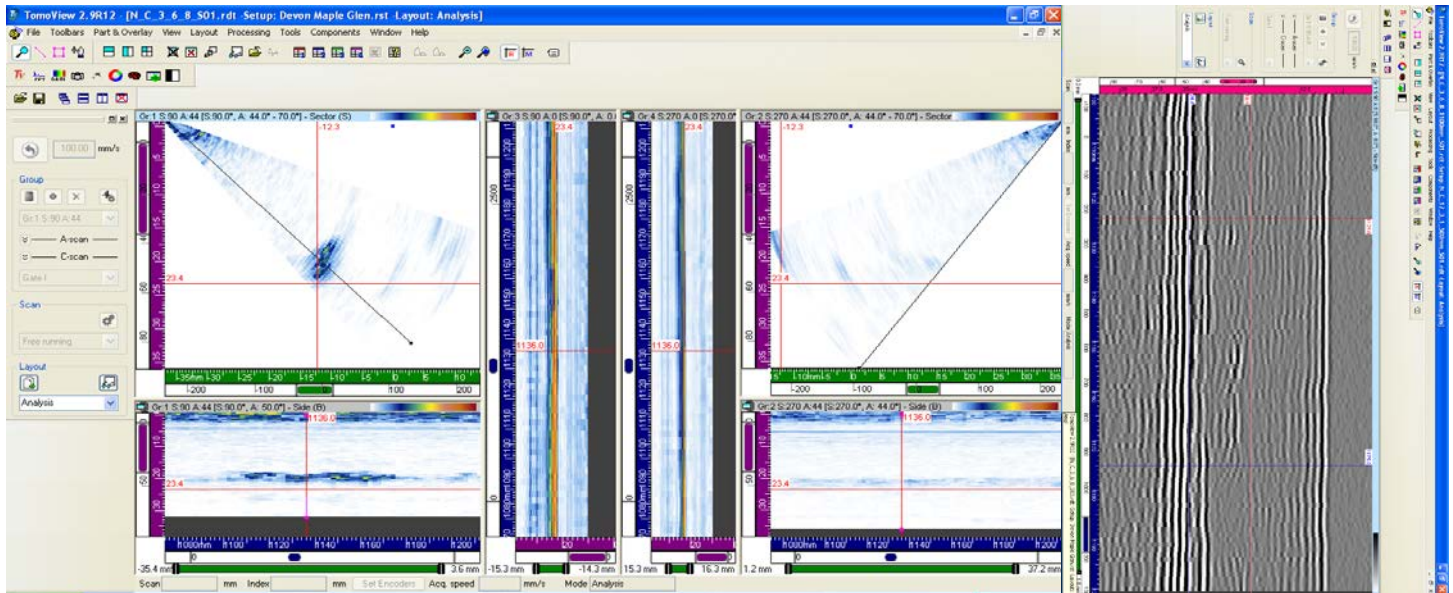
Figure A - Indication number 10

Indication 10 measures Length: 46mm (1129 to 1175) Height: 3mm (17 to 20). Indication 12 measures Length: 103mm (100 to 203) Height: 1.5mm (18.5 to 20). While these indications certainly appear to be ID connected, without full knowledge of the weld bevel and internal weld profile (caps ground flush?) these has to be some caution in analysis. These indications may turn out to be undercut or small areas of cold lap. Future monitoring to look for signs of growth would be prudent, however these indications may be easily classified with the next internal inspection by visual or magnetic particle methods.
