SAFETY RECALL BULLETIN

SUBJECT: 2008–2013 LANCER EVOLUTION CLUTCH MASTER CYLINDER – SAFETY RECALL CAMPAIGN – REVISED			No: SR-13-009REV
			DATE: December, 2013
			MODEL: 2008 – 2013 Lancer Evolution
CIRCULATE TO:	<input checked="" type="checkbox"/> GENERAL MANAGER	<input checked="" type="checkbox"/> PARTS MANAGER	<input checked="" type="checkbox"/> TECHNICIAN
<input checked="" type="checkbox"/> SERVICE ADVISOR	<input checked="" type="checkbox"/> SERVICE MANAGER	<input checked="" type="checkbox"/> WARRANTY PROCESSOR	<input checked="" type="checkbox"/> SALES MANAGER

Due to the insufficient bonding strength of clutch master cylinder components on certain 2008 – 2013 Lancer Evolution vehicles, separation may occur, resulting in fluid leakage. This condition results in the inability to engage or disengage the clutch, limits the ability to shift the transmission into or out of a gear, and can create a no start condition once the vehicle comes to a stop.

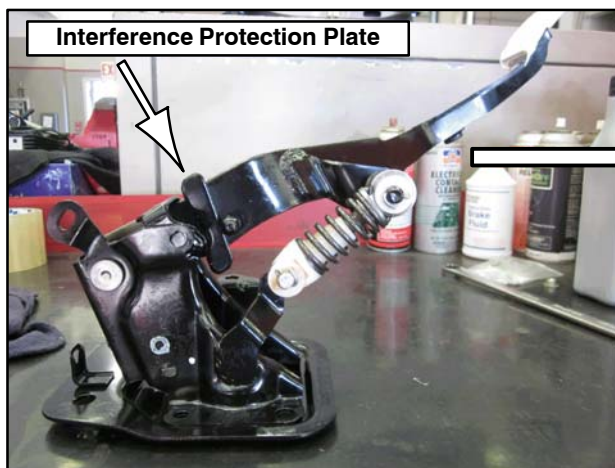
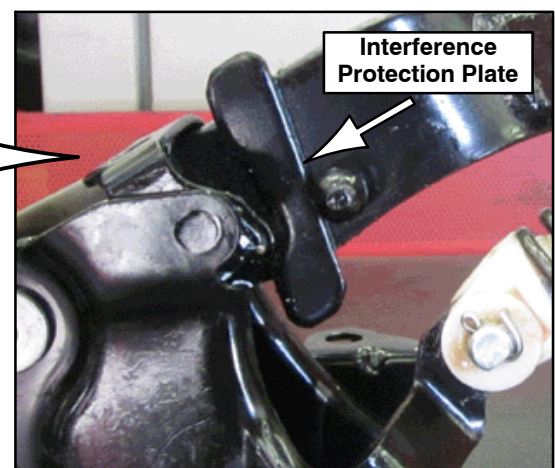
2. Inspect the clutch pedal to determine if an interference protection plate has already been attached to it.

- a. If the interference protection plate is attached to it, proceed directly to the **INSTALLATION PROCEDURE** in the following section.
- b. If the interference protection plate is absent, proceed directly to Step 3 below.

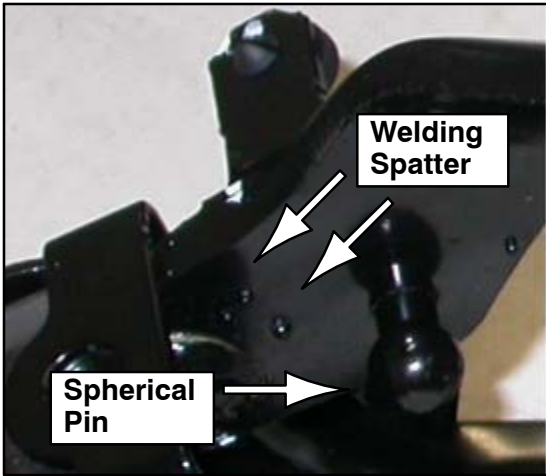
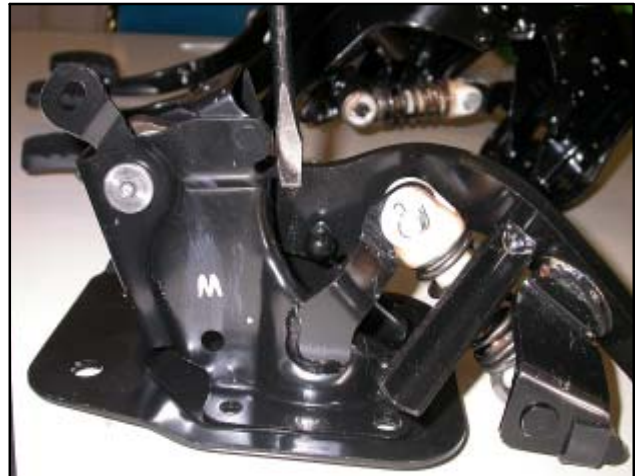
3. Place the clutch pedal flat on a level surface. Visually inspect and touch the area near the spherical pin for welding spatter. If present, remove the welding spatter with a slotted screwdriver or similar tool.
