Performance Assessment of a RECP-Lined Channel 15 Years Following Installation

George L. Armstrong, P.E., PDC Technical Services, USA, garmstrong@pdcare.com

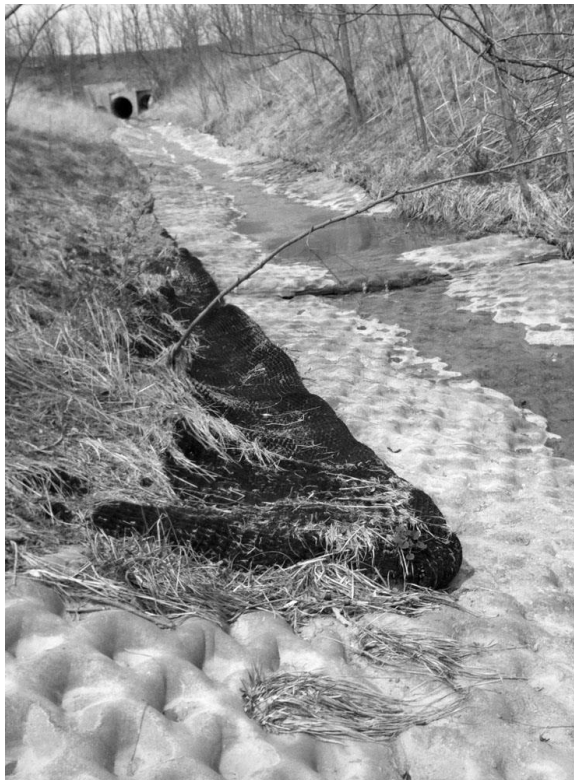
Photo 1. Reaches 1 and 2, looking northeast

As illustrated in Photo 1, the TRM-lined channel banks are well vegetated along Reaches 1 and 2, except near a fabric-formed concrete revetment apron onto which a culvert discharges (Photo 1) near the end of Reach 2. Photos of that area taken in 2000 also show exposed HPTRM, but not the extent found in 2014. Although the HPTRM is not damaged, it appears to have slid toward the channel. Similar conditions were observed along the eastern edge of Reach 3, as illustrated in Photo 2. Note that trees (which were not present along the channel during construction) grew through the HPTRM and conventional TRM and may have helped anchor the lining materials (see Photo 3).

- Careful attention should be paid to the details of the interface between TRMs (particularly bulky HPTRMs such as that used in this project) and rigid concrete, including fabric-formed concrete revetment. The details should ensure that the TRM tightly nests against the concrete, and should minimize the areas where the TRM must be folded over. Smooth transitions between the culvert apron and main fabric-formed concrete revetment (instead of the sharp 90 degree angles used during this project) might have reduced the amount of unvegetated TRM in the area shown in Photo 1.

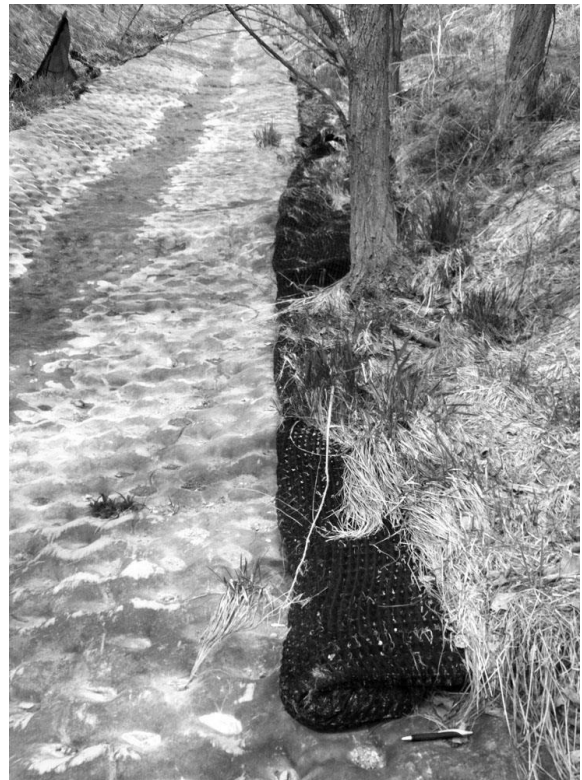
Photo 2. Reach 3, looking north

- TRMs placed on steep banks should be securely anchored using non-degrading materials to prevent long-term downslope slip or creep. Planting of woody vegetation could possibly enhance the anchoring as evidenced by Photos 2 and 3.
- The effects that the lined channel will have on sediment transport and erosion potential at the downstream edge need to be carefully considered to determine the proper terminus details.
- Occasional inspections and, as necessary, maintenance should be conducted. This is particularly important during the first few years following installation.

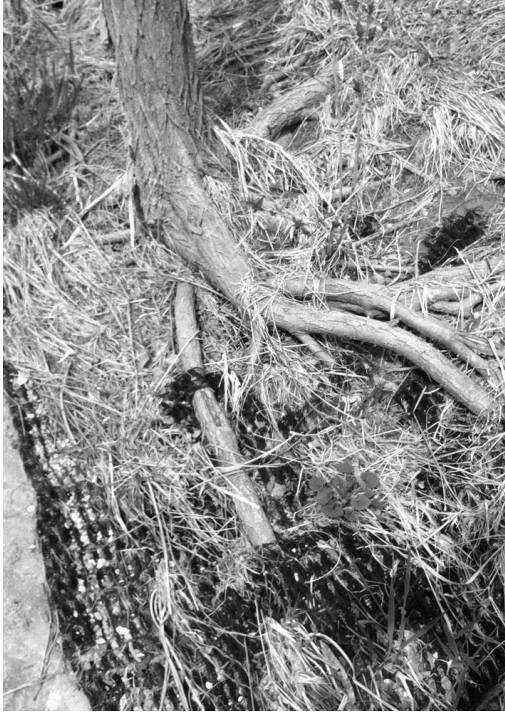
Photo 3. Tree Roots Anchoring HPTRM

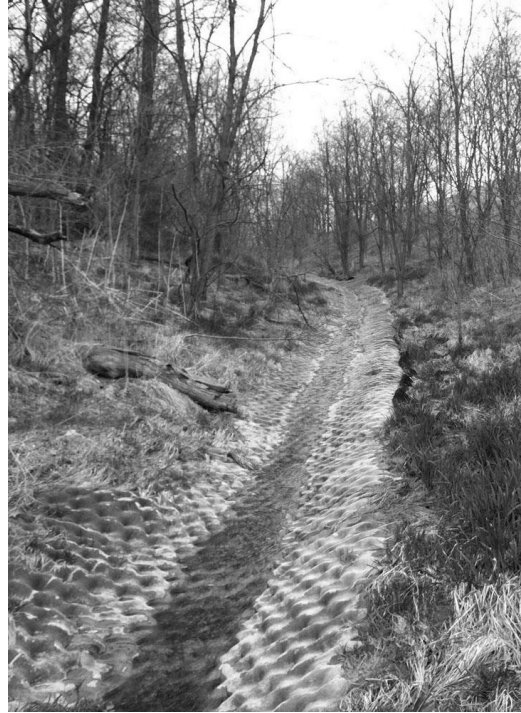
Photo 4 illustrates the trees which have grown adjacent to the channel and through the HPTRM and conventional TRM materials. An approximately 20 feet long strip immediately adjacent to the eastern edge of the fabric-formed concrete revetment (Photos 4 and 5) has settled (or eroded), resulting in exposed HPTRM. The HPTRM itself appears to be in good condition and, although this area has undoubtedly received high flow velocities, significant damage was not observed.

Photo 4. Lower Portion of Reach 3, looking northeast

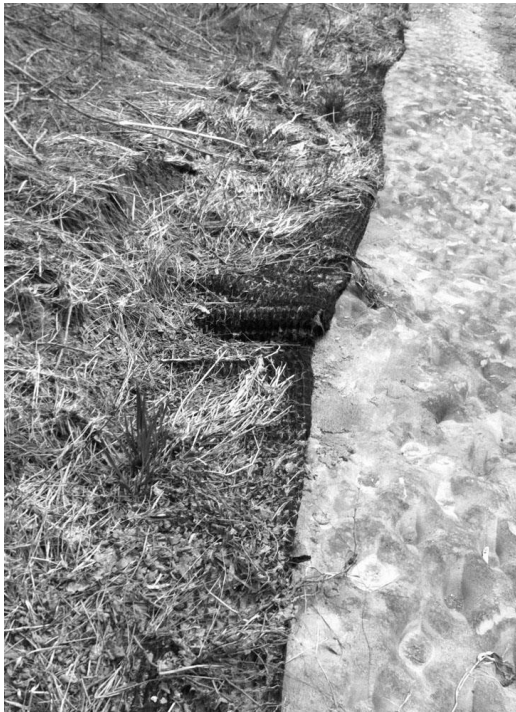
Photo 5. Settled or Eroded Area Along Reach 3

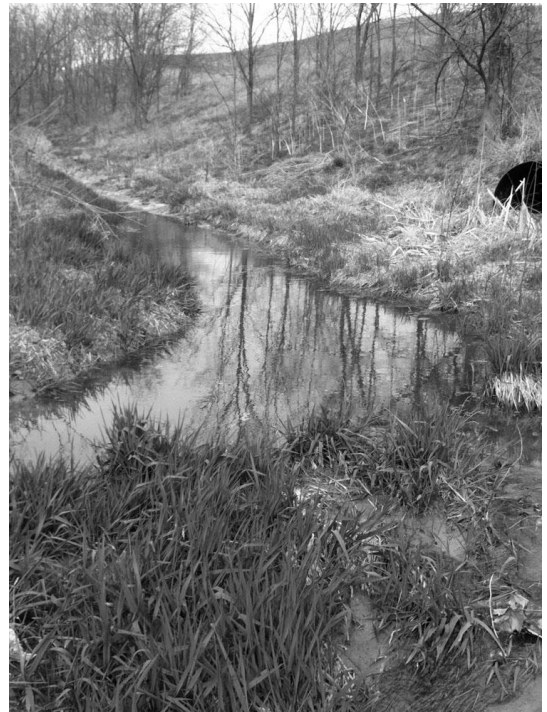
Photo 6. Reach 4, looking northeast

Reaches 4 and 5 are shown in Photos 6 and 7. The 1.5 meter diameter discharge culvert from a sediment basin is visible in both photos. It is apparent that the water velocity is such that a large volume of upstream sediment has been

deposited along these reaches, beginning just upstream of the sediment basin discharge. Approximately 0.75 to 1 meter of sediment has blanketed the area, and the fabric-formed concrete revetment is partially buried.

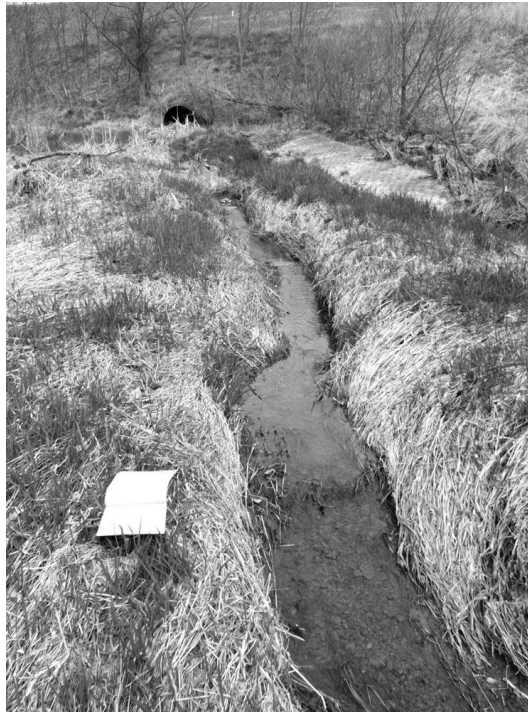
Photo 7. Reach 5, looking northeast

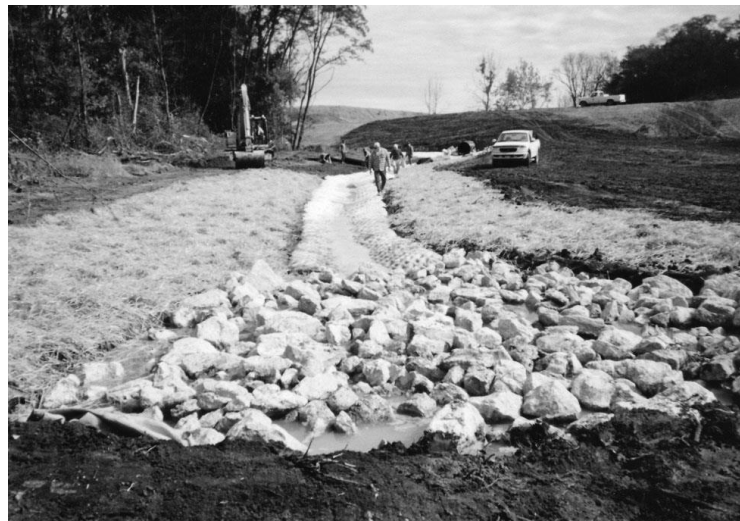
The most significant damage to the RECP lining occurred near the downstream terminus of the lining. In that area, riprap was placed at the end of the fabric-formed concrete revetment, and the conventional TRM was spread along the edges, as illustrated in Photo 8, which was taken during construction. The riprap, however, became completely buried with sediment as of 2014 and, it appears that at some point in the past, the water was diverted approximately 90 degrees and over the southeastern edge of the fabric-formed concrete revetment (see Photo 9). Although the conventional TRM remains in place, the force of the water eroded the underlying soil and formed a new channel.

Photo 8. Downstream Terminus of the RECP Lining During Construction, looking northeast

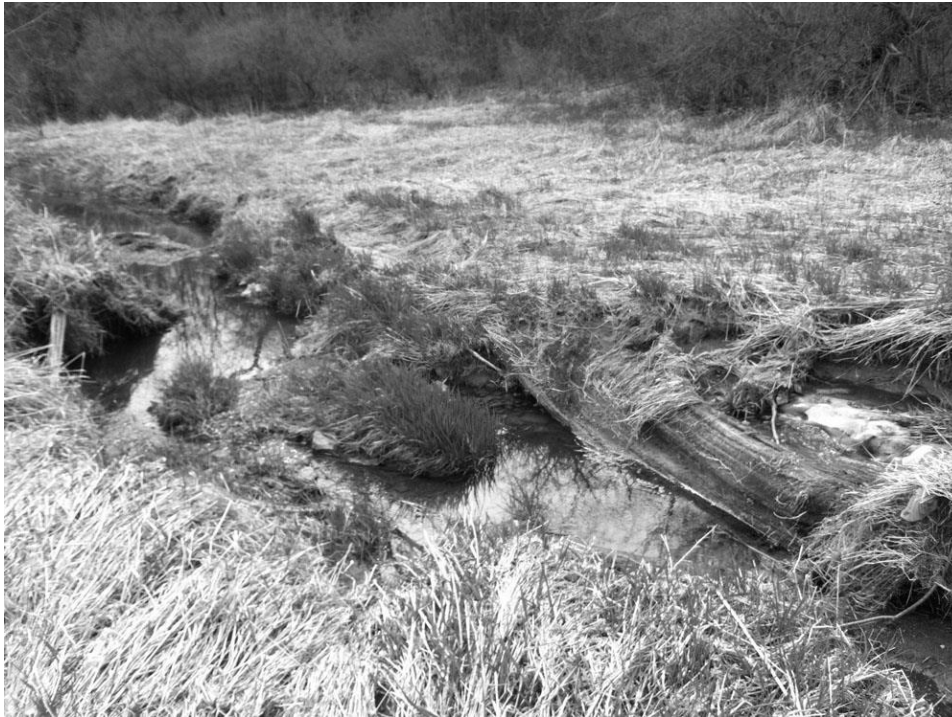
Photo 9. Near Downstream Terminus of RECP Lining, looking southwest

The eastern edge of the fabric-formed concrete revetment and conventional TRM are visible in the right hand side of Photo 9. The riprap is apparently buried beneath sediments in the central portion of Photo 9. As stated above, water was diverted southeasterly approximately 90 degrees to the RECP-lined channel and cut a new channel. In doing so, the soil beneath the conventional TRM has been eroded.

A localized area of significant damage to the lining system has occurred near its downstream terminus. The damage is located in an area of the channel which exhibits a low gradient and does not threaten the overall integrity of the channel nor the nearby landfills.
