Performance of Buildings With Shear Walls in Earthquakes of the Last Thirty Years

Mark Fintel, P.E.

The author describes observations of shear wall performance in severe earthquakes in which modern reinforced concrete buildings stood the test of violent shaking, starting with the Chilean earthquake of May 1960 through most of the subsequent strong earthquakes, up until the Armenian earthquake of December 1988. Despite the excellent behavior of shear wall-type concrete structures as compared to concrete frame-type structures, building codes continued, up until the last decade, to give preference to concrete ductile frame structures (which are subject to higher distortions) while placing a substantial penalty on the use of shear walls. This code approach was due to the lack of experimental and analytical background information on shear wall behavior. While a large body of information on shear walls accumulated during the 1980s, still more experimental and analytical studies are needed to create a solid basis for a rational seismic design approach. The availability of such information should encourage a wider use of shear walls for earthquake resistance.

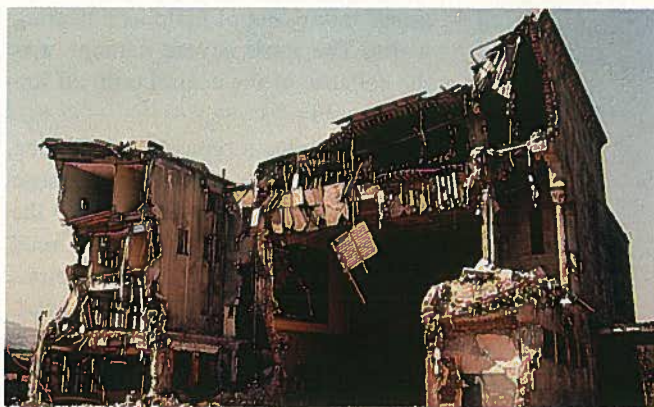
Fig. 1. Collapsed railroad station, Skopje, Macedonia.

times, falling out of peripheral bearing walls. The most severe damage was the collapse of the central railroad station (see Fig. 1).

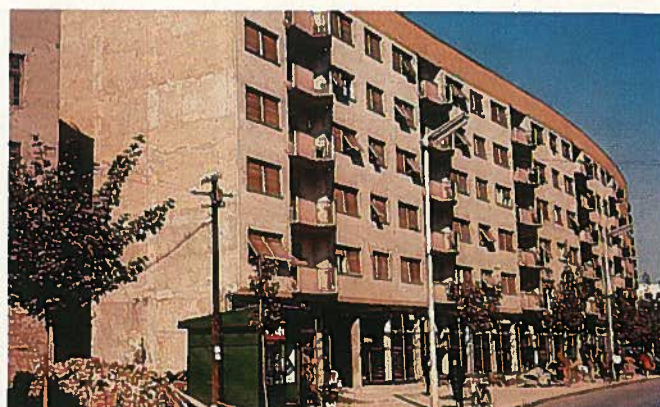
Fig. 2. Building on Central Street, Skopje, Macedonia.

Fig. 2 shows a typical city building in Skopje. The lateral bracing in those buildings was usually provided by the frame supplemented by unreinforced concrete cores into which flue pipes and drainage pipes were embedded. The brittleness of these unreinforced cores caused severe cracking and, sometimes, entire chunks of concrete were falling out (see Fig. 3). However, they succeeded in protecting the structure from collapse and also limited the amount of interstory distortions.

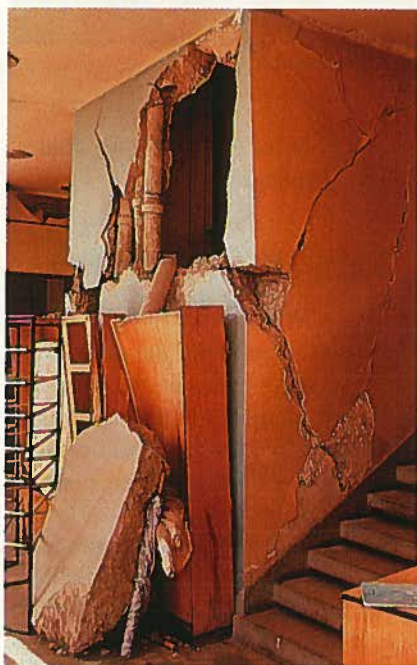
Fig. 3. Chunk of shear wall fallen out, Skopje, Macedonia.

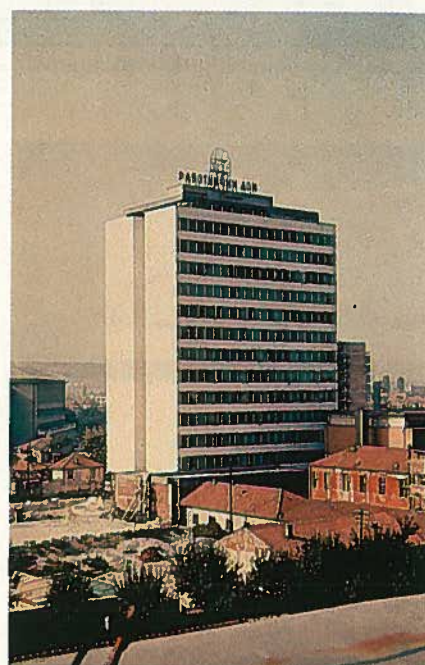
Fig. 4. Party Headquarters, Skopje, Macedonia.

The 14-story Party Headquarters Building (see Fig. 4) had a structural system for lateral resistance consisting of a shear wall frame interaction. The three unreinforced concrete cores interacted with the frame of two-way slabs resting on beams (see Fig. 5). The building swayed considerably during the earthquake; desks were thrown from one end of rooms to the other. However, the building itself withstood the earthquake without damage, not even broken windows. The elevators had jammed but in several days they were repaired and put back into operation.

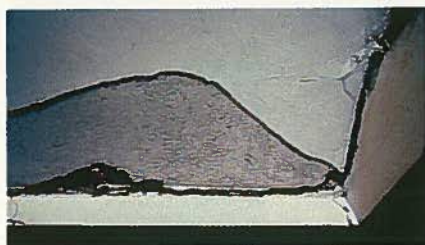
Fig. 6. Monolithic stairs.

Monolithic stairs — Fig. 6 shows the inclined platform carrying the stairs from one story to the next. Those inclined platforms, together with the walls around the staircase, form a vertical truss. Because the truss is much more rigid than the remaining frame of the building, it attracts the bulk of the lateral forces. If the lateral seismic forces exceed the capacity of the truss, distress or failure occurs, usually at the junction of the inclined surfaces to the horizontal surfaces. Only after this failure occurs can the frame take over the resistance of the lateral forces, if any of these forces are left at that point in time.

This characteristic failure of monolithic stairs is seen in many earthquakes. In some cases, observation of the stairwell showed evidence that an outwardly undamaged building was subjected to shaking. Because of its

high rigidity, the vertical stairwell truss cracked at high lateral forces, thus protecting the frame by limiting the interstory distortions.

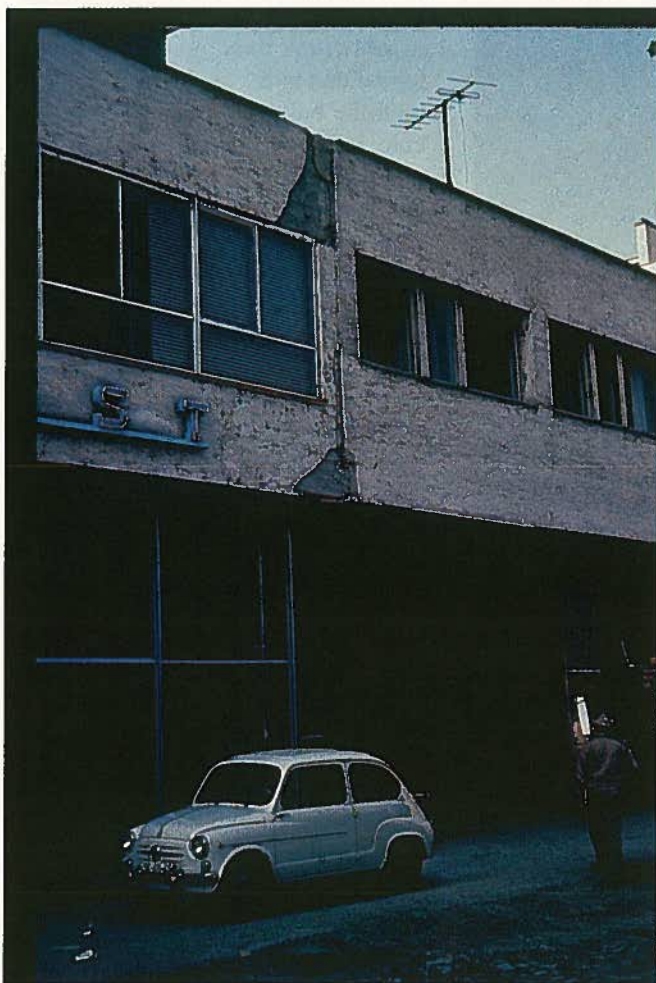
Fig. 7. Hammering of adjacent structures, Skopje, Macedonia.

Hammering of adjacent buildings — Fig. 7 shows spalling and damage at the joint between two adjacent buildings that are not separated by a seismic joint. Each of the adjoining buildings sways during an earthquake according to its dynamic properties and needs sufficient space to deform without hammering and damaging its neighbor. Most modern seismic codes specify the width of seismic joints as a function of building height and seismic intensity.

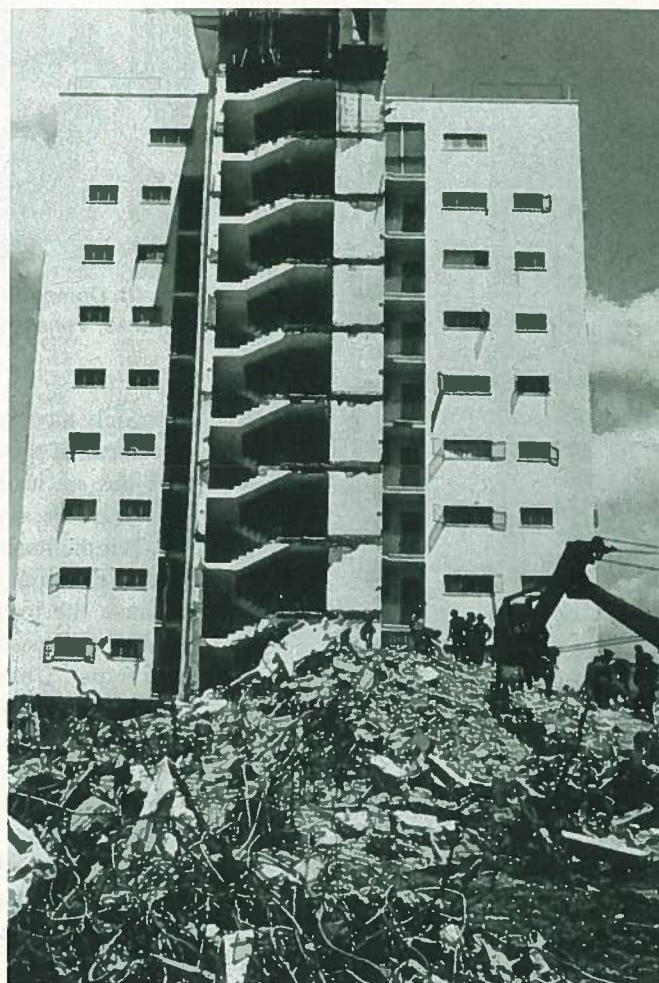
Fig. 8. Collapsed portion of Palace Corbin, Caracas, Venezuela.

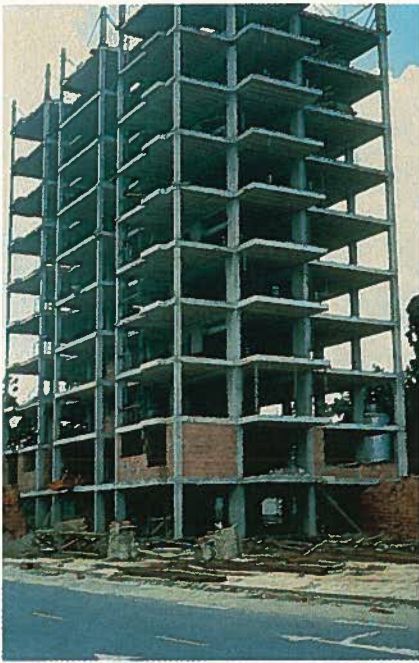
Fig. 9 shows the structural configuration of a typical multistory building design used at the time in Caracas and most of Central and South America. This is the skeleton of an 18-story apartment building under construction. There are several notable characteris-

Fig. 9. Typical building skeleton, Caracas, Venezuela.

tics. First, the columns are very slender for an 18-story building, considering the fact that the concrete strength is only about 2500 psi (17.23 MPa).

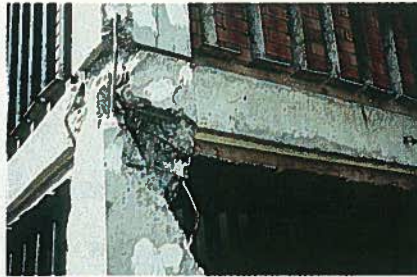
Fig. 10 shows the details of a corner column and of the joint of a 15-story building. The size of the column ap-

Fig. 10. Damaged corner joint, Caracas, Venezuela.

pears only moderate. The vertical reinforcement of the column and the column ties are inadequate by American standards. The importance of the joint between the horizontal beams and the columns cannot be overemphasized because the joints are actually the heart of the resistance to lateral forces of a frame. Unless there is a proper transfer of forces within the joint between the beams and the columns, there is no resistance to lateral forces.

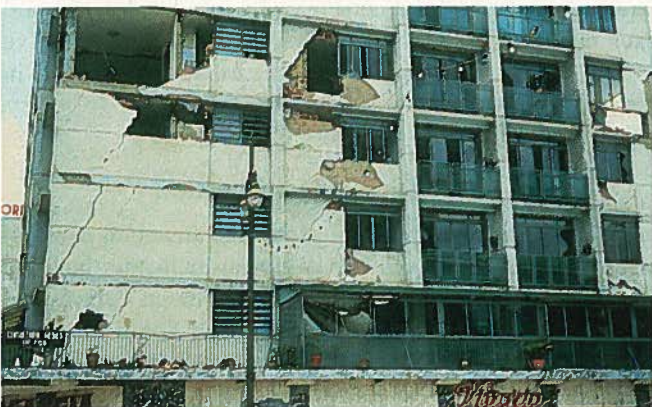
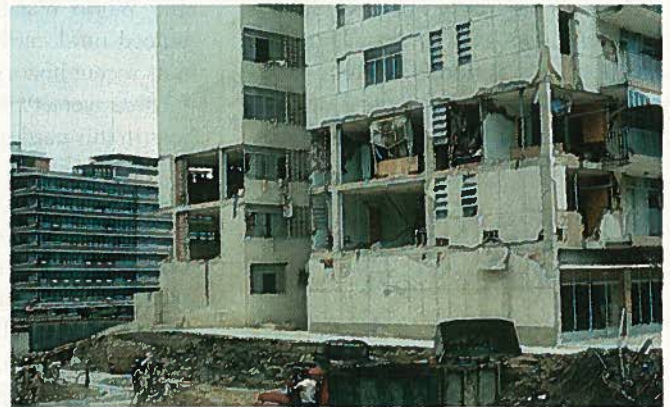
These skeletons were filled in with hollow clay tiles as partitions and as exterior walls. When an earthquake strikes a skeleton of such relatively high flexibility, the skeleton distorts as a result of the ground shaking and, consequently, the partitions are often cracked or damaged due to their brittleness and limited strength. Occasionally, the failure of partitions induces additional explosive forces into the skeleton that further aggravate the response to earthquake forces.

Figs. 11 and 12 show infill partition damages due to frame flexibility, as seen in many buildings in Caracas.

Fig. 11. Damaged partitions, Caracas, Venezuela.

Fig. 12. Damaged partitions, Caracas, Venezuela.

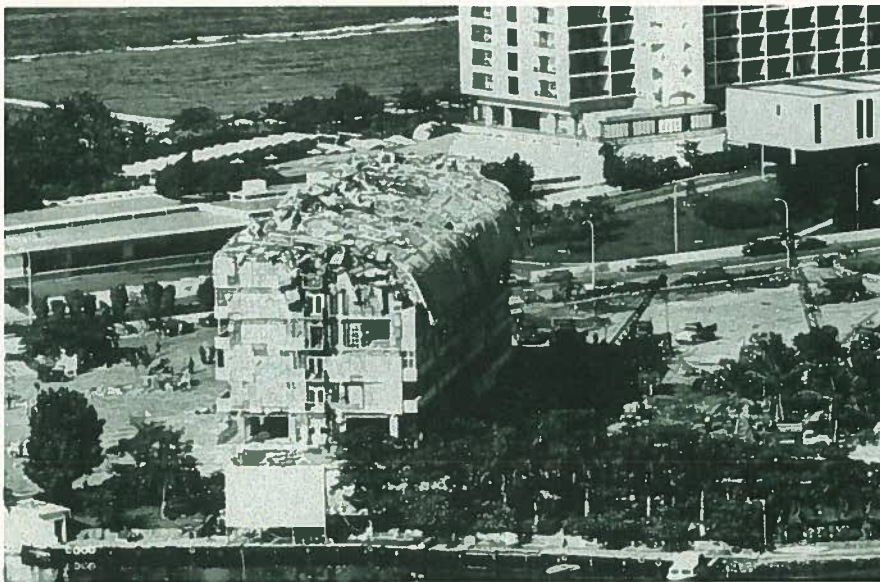
Fig. 13 shows an eight-story building in which the three upper stories collapsed during the earthquake. Seen behind the building is the 10-story Macuto Sheraton, a well designed, well constructed structure. Six typical floors of the Macuto Sheraton had concrete walls separating rooms. To create an open space for the restaurants, lobbies and other public spaces at the mezzanine floor, those wall stacks were omitted and each replaced with two free-standing columns.

Fig. 13. Buildings in Carabolida, Caracas, Venezuela.

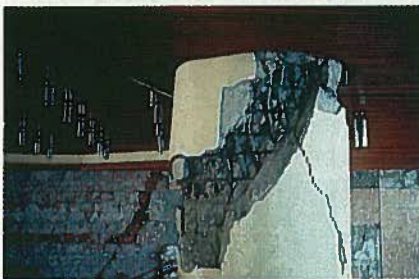
The resulting drastic change in the rigidity between the shear wall-type upper six stories and the flexible, columns-only, mezzanine floor caused a large interstory distortion within the mezzanine floor. These short columns failed in shear (see Fig. 14) despite the fact that they were very well reinforced and of good quality concrete. The conclusion drawn is that most short columns or short stout beams (reinforced for high moment capacity) are more likely to fail in shear, regardless how well they are reinforced.

Fig. 14. Column failed in shear at the Macuto-Sheraton, Caracas, Venezuela.

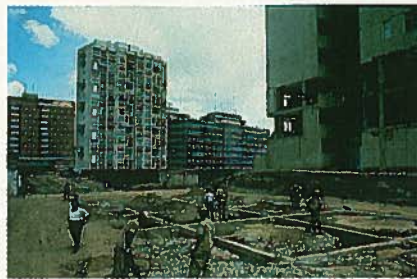
Fig. 15. Plaza One Building, Caracas, Venezuela. Remains of a 10-story collapsed building are seen in front.

The building was located in an area of heavy damage. A 10-story building in front of Plaza One collapsed and most of its neighboring structures suffered heavy non-structural damage. Plaza One went through the earth-

quake without any damage. The presence of the walls provided the carrying capacity for all the gravity loads and, at the same time, provided stiffness for lateral resistance sufficient to limit any interstory distortions.

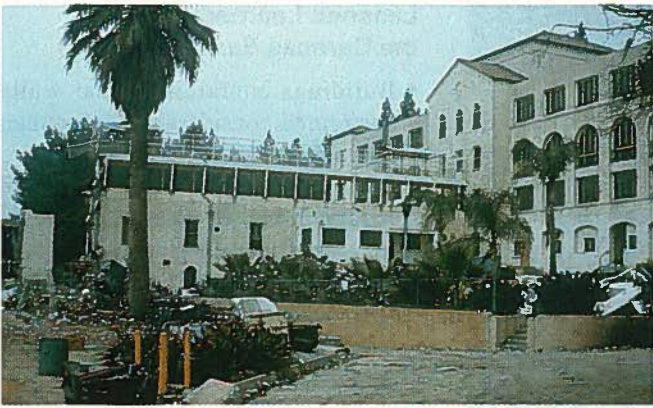
Several hospitals suffered damage, some of which are discussed below. The Veterans Administration Hospital (constructed in 1922) was a four-story building of unreinforced masonry (see Fig. 17). A collapsed wing of the hospital killed 46 patients. Other buildings at the site of the Veterans Administration Hospital fared quite well.

Fig. 17. Veterans Administration Hospital, San Fernando, California.

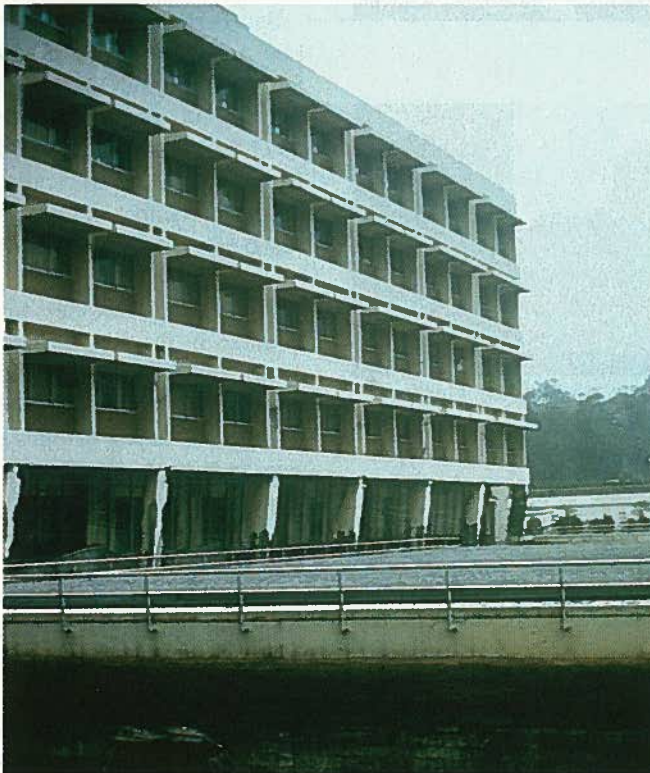
Fig. 19. Olive View Hospital — ground floor distortion.

Structurally, the entire building was a four-story rigid box supported on a soft story of relatively slender columns. During the earthquake, the entire four-story rigid box moved extensively with a large distortion of the ground floor (see Fig. 19). As a result of the large movements, all four stair towers were pushed over and ended up flat on their backs (see Fig. 20). Within the ground floor, there was a very large permanent distortion of

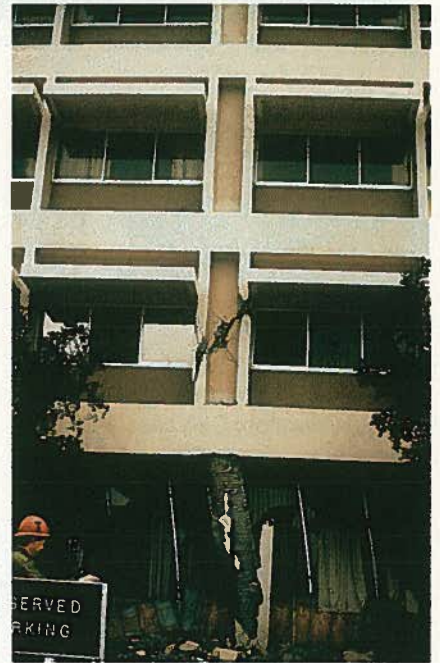
Fig. 21. Olive View Hospital — distorted ground floor column.

21 in. (533 mm) from the tops to the bottoms of the columns of the ground floor (see Fig. 21).

The square columns of the ground floor had circular spiral reinforcement. They had the capacity to distort 21 in. (533 mm) and still retain their load capacity to carry the four stories above it and, thus, prevent collapse of the building and save the lives of the patients. As expected, during such large distortions the shells spalled off. Only the L-shaped corner columns failed because they could not be spirally reinforced due to their shape. They could not withstand large distortions.

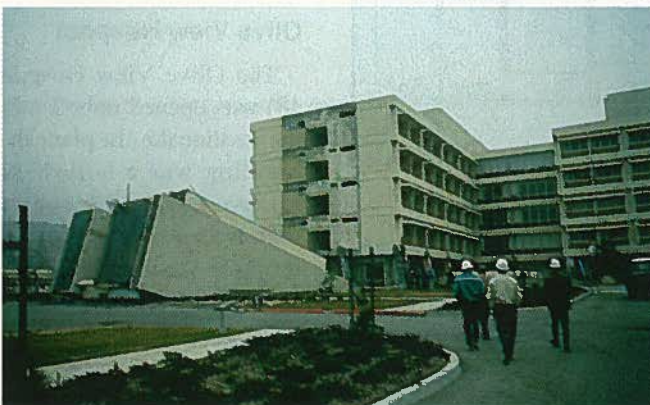
Fig. 20. Olive View Hospital — overturned stair tower.

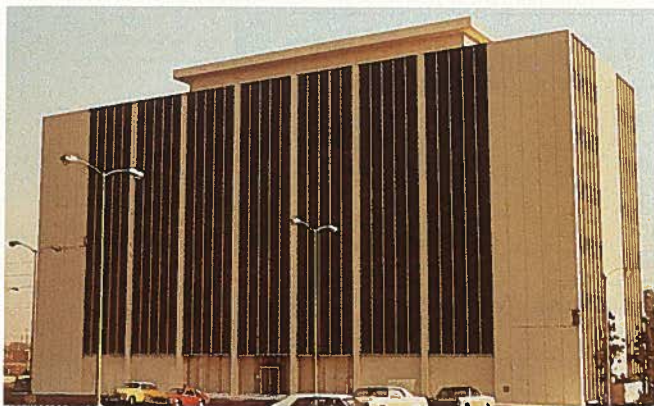
Fig. 22. Indian Hill Medical Center, San Fernando, California.

The six-story Indian Hill Medical Center (see Fig. 22) was located in an area of severe damage. Its structural system contained shear walls around the periphery and also a reinforced concrete core in the center of the structure. The building withstood the earthquake with only minor cracks in the shear walls and was back in operation within a week of the earthquake.

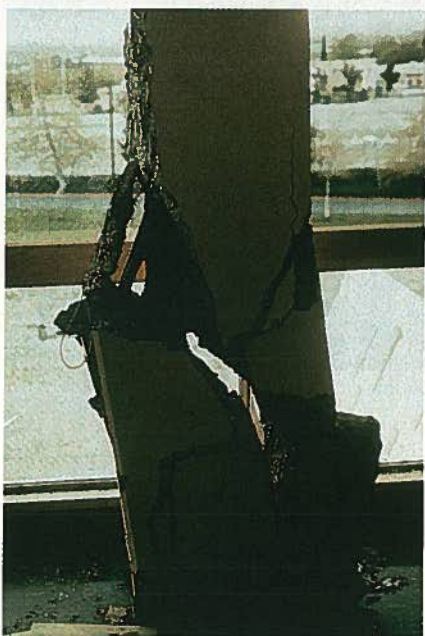
Fig. 24. Holy Cross Hospital — failed column.

The six-story neighboring Holy Cross Hospital (see Fig. 23), which had a concrete frame structural system, suffered severe structural damage (see Fig. 24) and had to be torn down.

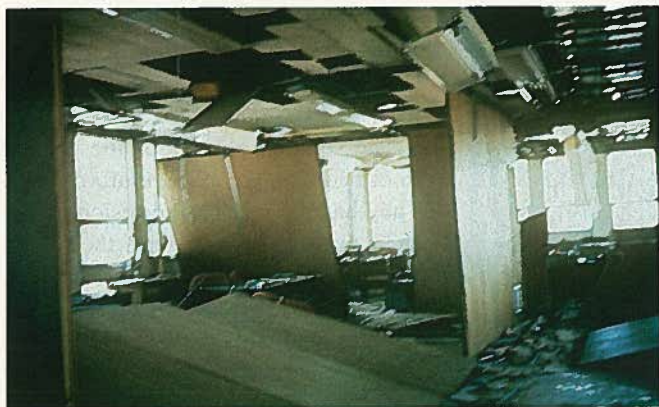
Fig. 28. Inside damage, Banco Central.

cores and the floors. However, the non-structural damage was very severe as a consequence of the intense shaking of the building. The inside of the building was severely damaged (see Fig. 28) on all floors; all of the window sills were cracked. The building was subsequently torn down.

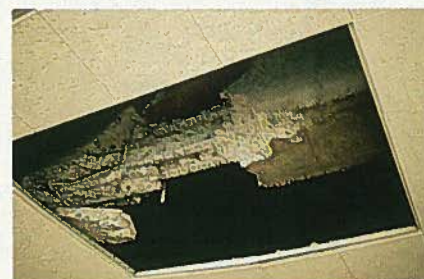
Fig. 31. Failed coupling beam in Banco de America.

The 18-story Banco de America (see Fig. 29) responded to the earthquake in a completely different way. In the plan (see Fig. 30), a closely spaced peripheral column grid interacted with four centrally located elevator and stair cores to resist lateral forces. The cores were tied together with coupling beams on every floor level. The result was a rigid shear wall frame interactive system. There was neither non-structural nor structural damage, except for one coupling beam that failed in shear on the sixth floor (see Fig. 31). This was caused by over reinforcing in flexure of the short coupling beam with a large duct opening.

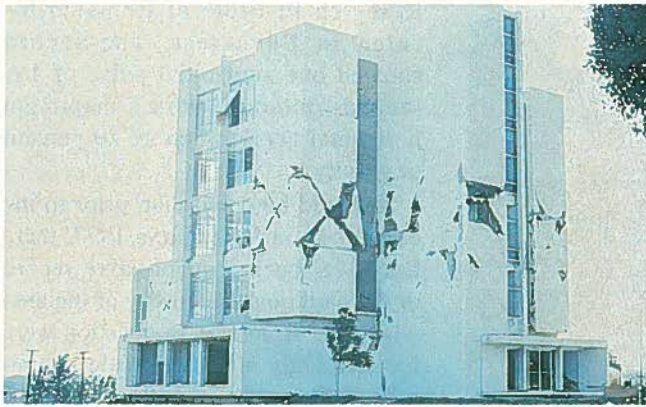
Fig. 32. Five-story Insurance Building, Managua, Nicaragua.

These two buildings were not located close to each other; however, each was in an area of severe damage. The five-story Insurance Building (see Fig. 32) had a structural frame with filled-in hollow clay tile masonry around the periphery and the same clay partitions. There was no structural damage because the flexible structure had the capacity to withstand large distortions; however, there was severe non-structural damage to the exterior and interior partitions.

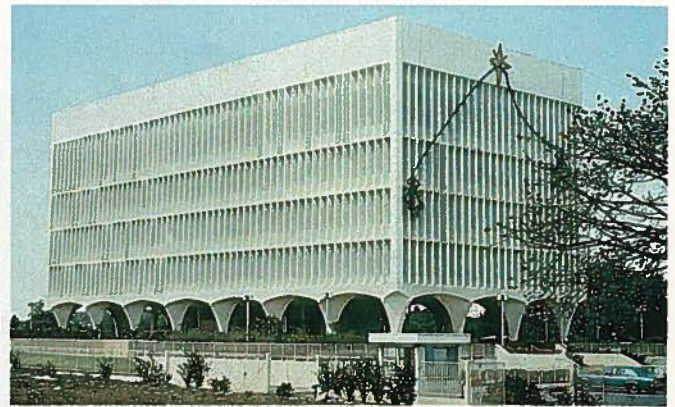
Fig. 33. Five-story Light and Power Building, Managua, Nicaragua.

The five-story Light and Power Building (Fig. 33) had a central reinforced concrete core and an exterior frame of closely spaced delicate columns. There were several cracks in some columns. A corner of the core shear wall was damaged; however, there was no other damage and this structure continued its operations the day after the earthquake occurred.

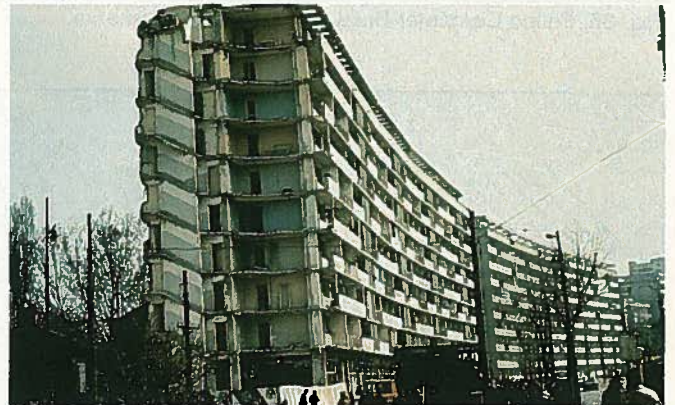
Fig. 35. End of building failure, Bucharest, Romania.

In general, modern construction of all types of buildings behaved very well. There were only three failures of modern type construction. One was an end of a block of a cast-in-place multi-story building (see Fig. 35), the foundation of which was being underpinned at the time of the earthquake.

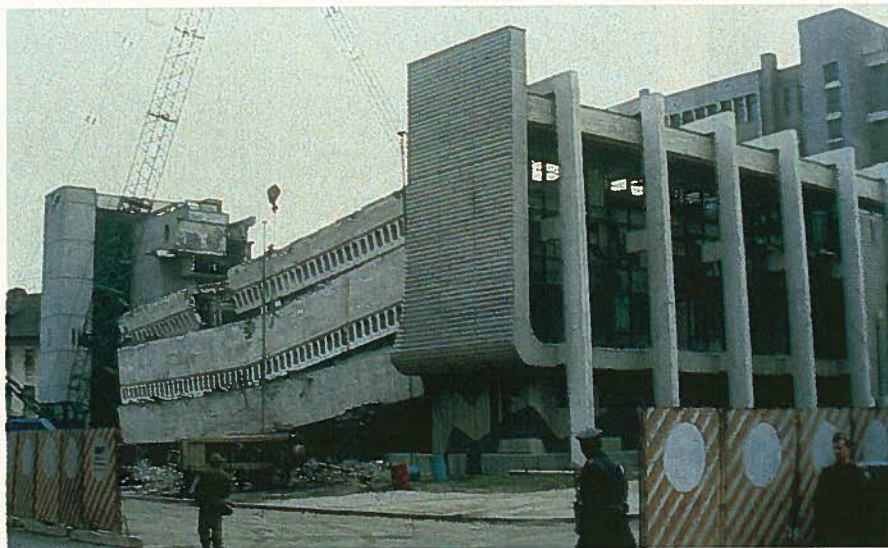
Fig. 36. Failed Computer Building, Bucharest, Romania.

A dramatic failure was the three-story computer facility building of the Romanian Railroads (see Fig. 36). Judging from the debris, the collapse occurred by shear failures of the columns in the lower soft story due to the large interstory distortion.

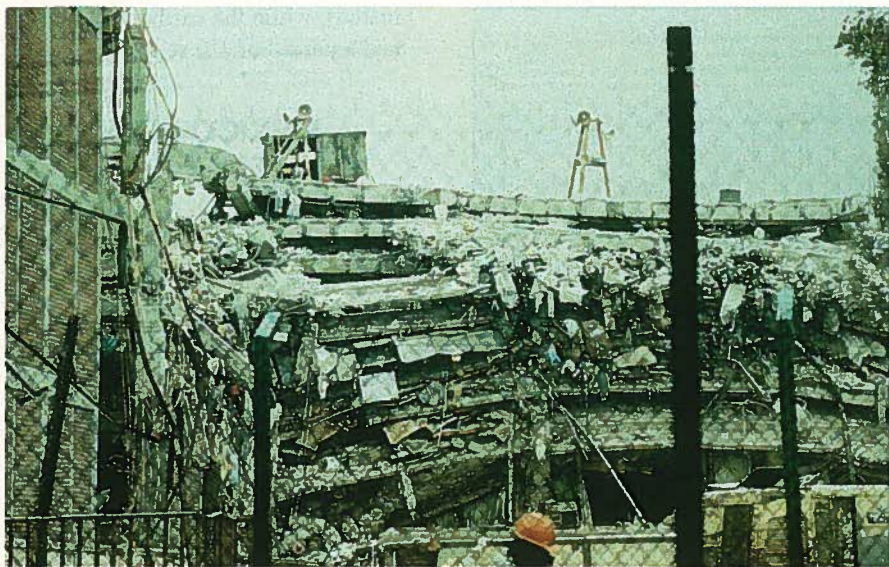
Fig. 41. Typical pancaked building, Mexico City, Mexico.

Fig. 41 shows a typical failure of a concrete frame structure in a pancake fashion. Trying to explain the mode of failure of such structures, one can assume a 10-story concrete building with a period of 1.0 second (a reasonable assumption for a 10-story concrete frame structure). If this building received a jolt during the earthquake, there was some cracking in the partitions and skeleton, causing the period to lengthen to, say, 1.2 seconds.

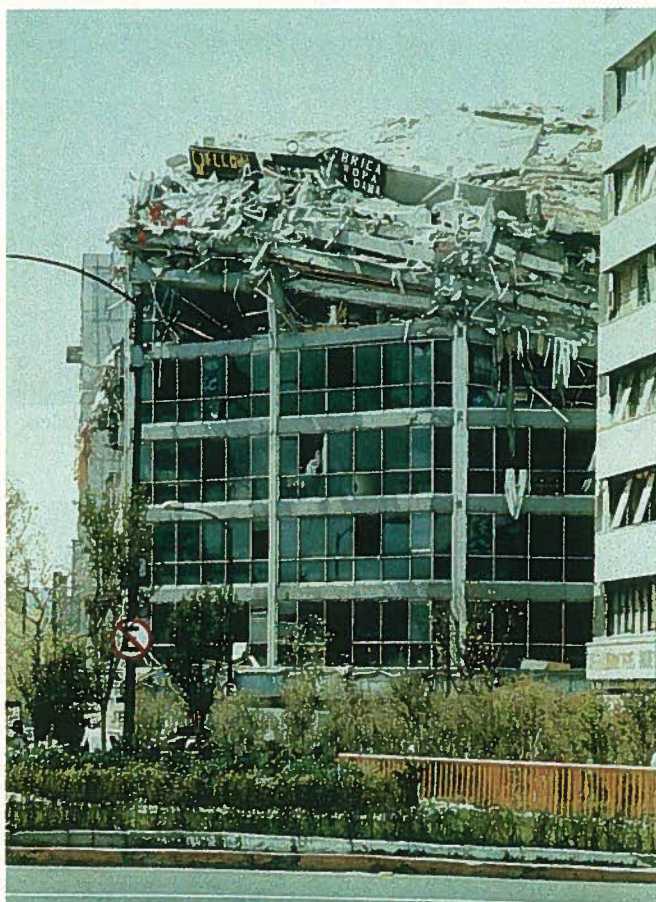
Fig. 42. Failure of upper stories, Mexico City, Mexico.

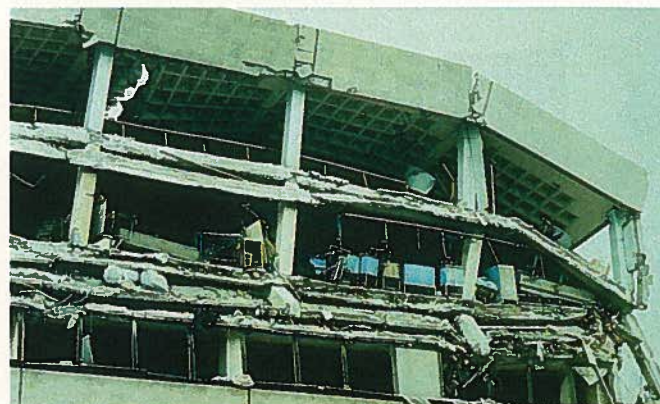
Fig. 43. Collapse of intermediate stories, Mexico City, Mexico.

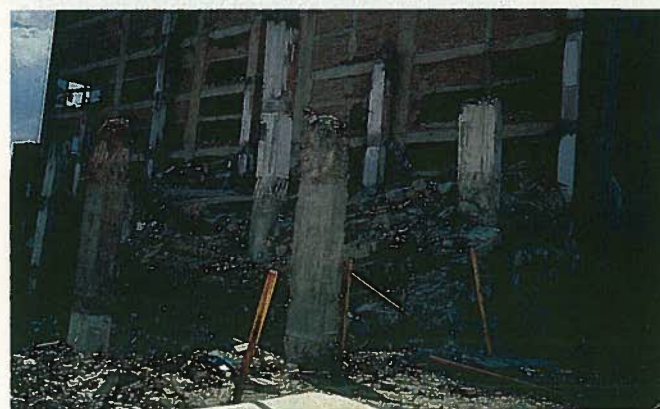
Fig. 44. Failed flat plate building (reticular), Mexico City, Mexico.

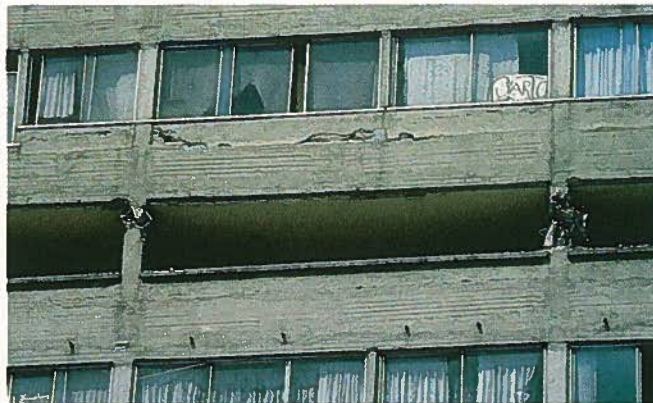
Fig. 46. Remaining section of building, Nuevo Leon, Mexico.

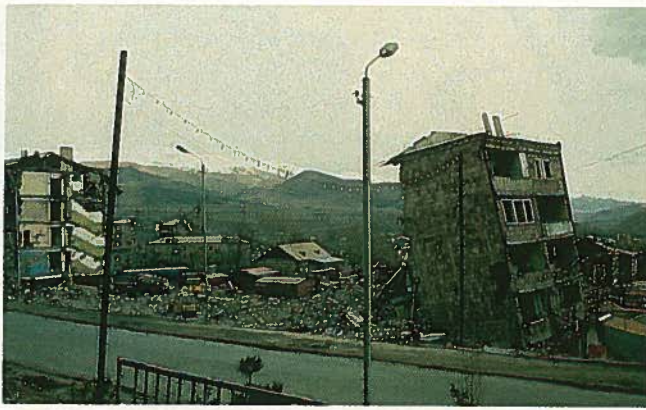
Fig. 49. View of damaged city, Spitak, Armenia.

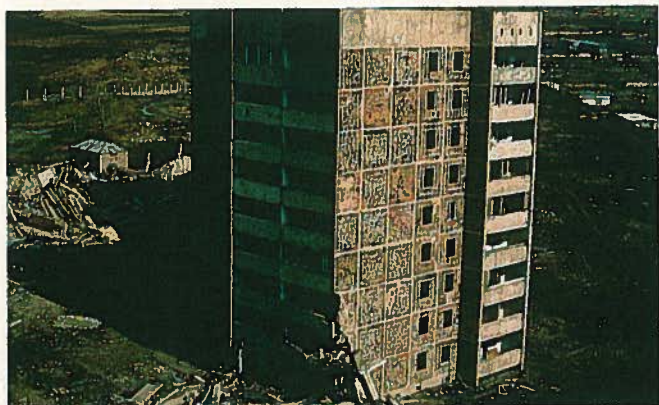
Fig. 53. Nine-story large panel structure damaged by collapsing neighbor, Leninakan, Armenia.
