Revised Work Plan (RWP) for Additional
Characterization of Extent of
RIM in Areas 1 and 2 West Lake Landfill
Operable Unit-1, Bridgeton, Missouri

WESTLAKE LANDFILL PHOTO DOCUMENTATION OU1 10.20.2015

RWP for Additional Characterization of RIM in Areas 1 and 2 in OU-1

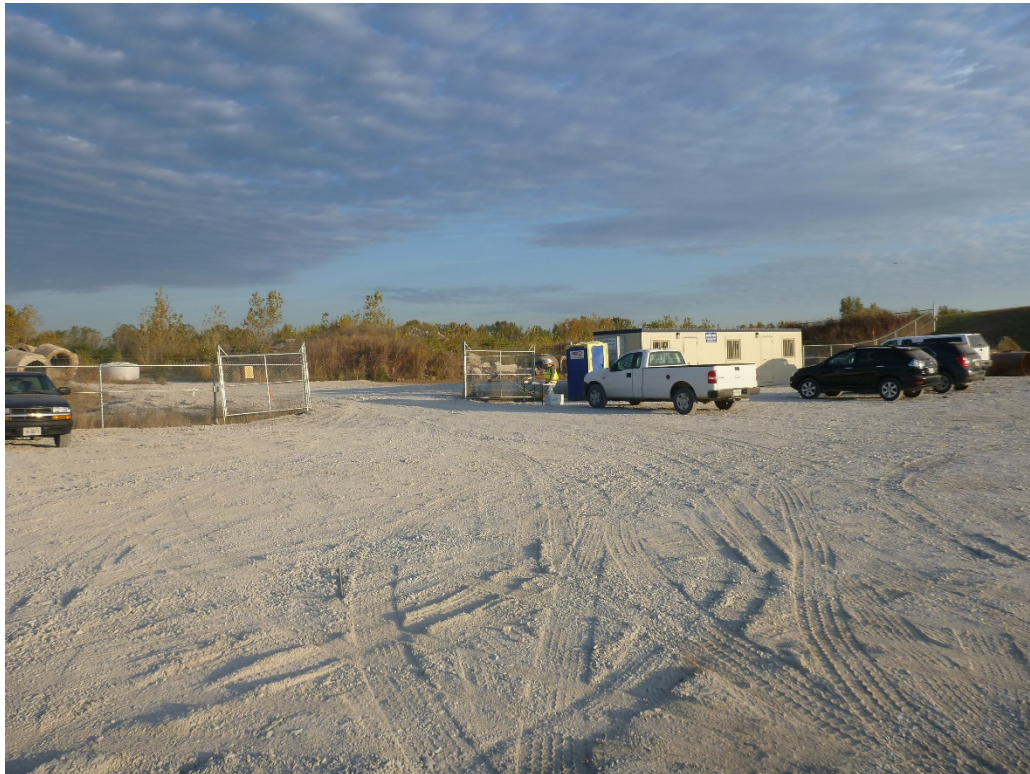
The photo also shows the perimeter gate and fence that surrounds the area. The photo shows that the area is posted with a radiation area sign and trefoil and the gate is locked. This will be the entry / exit point for area operations.

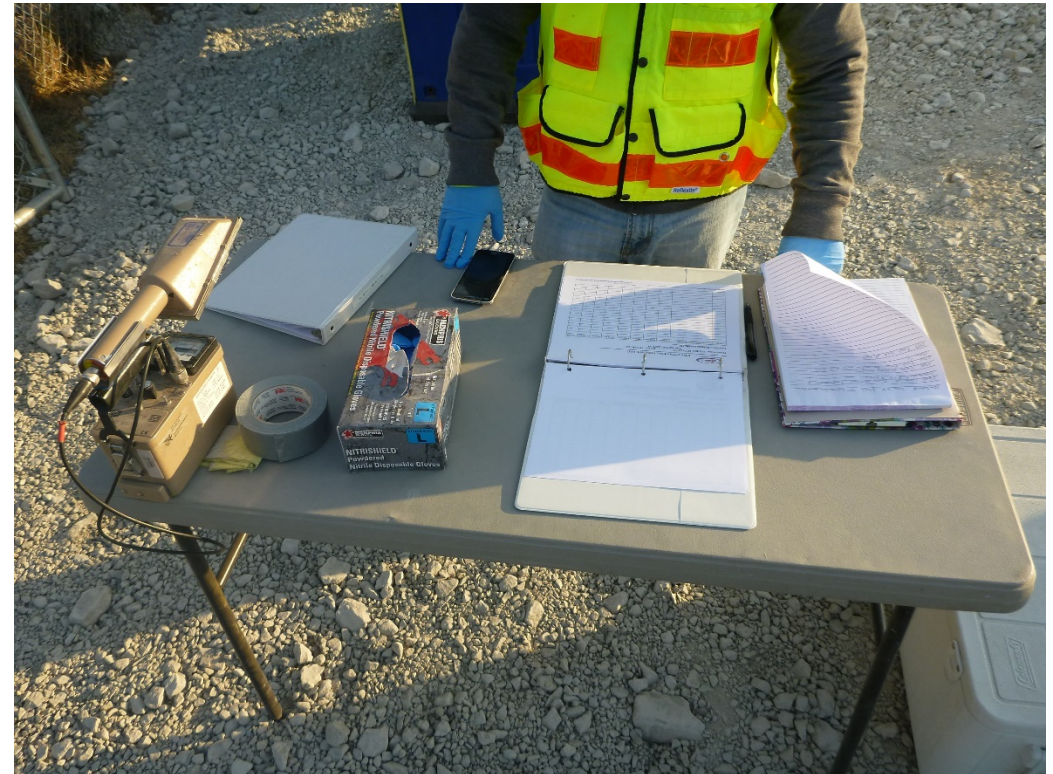
During the site safety briefing, FEI, showed what type of survey meters will be used to conduct measurements on the site as areas are sampled and cleared for the additional work. These were/are used to screen workers and equipment in/out of the area.

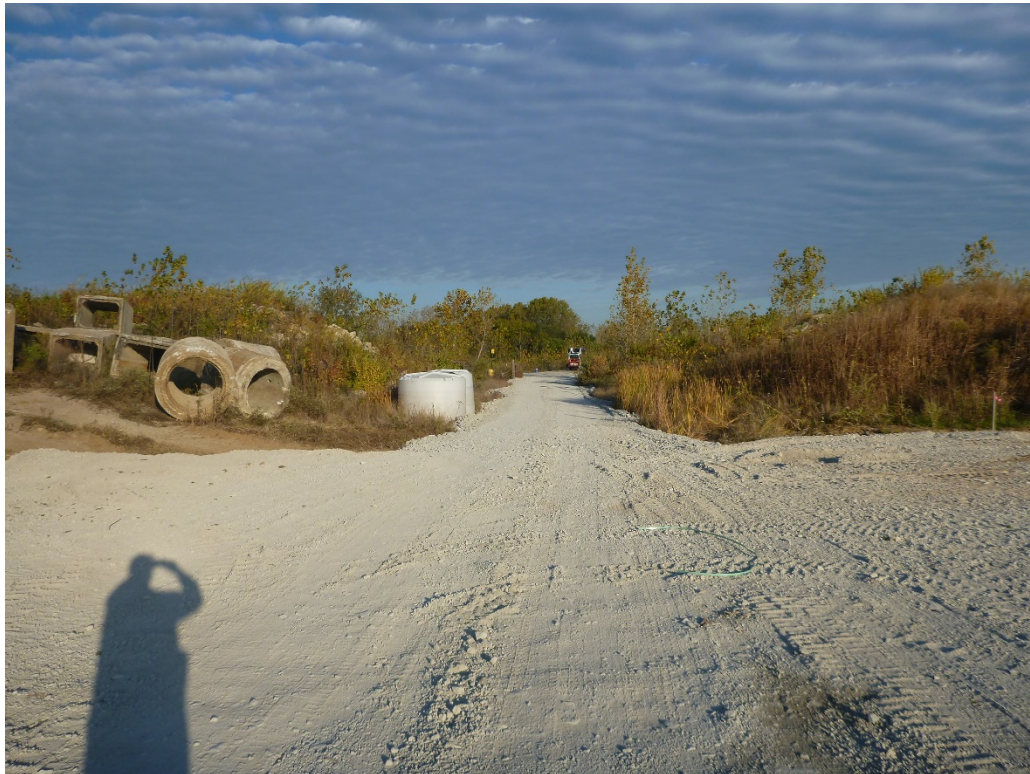
Photo is taken just inside the “hot zone” entrance into OU1 area 2, the view is facing northwest. This is the main alignment pathway and FEI is paving the “finger” pathways 20 – 25 later this week. The photo depicts the pads/roads being built for the additional characterization.

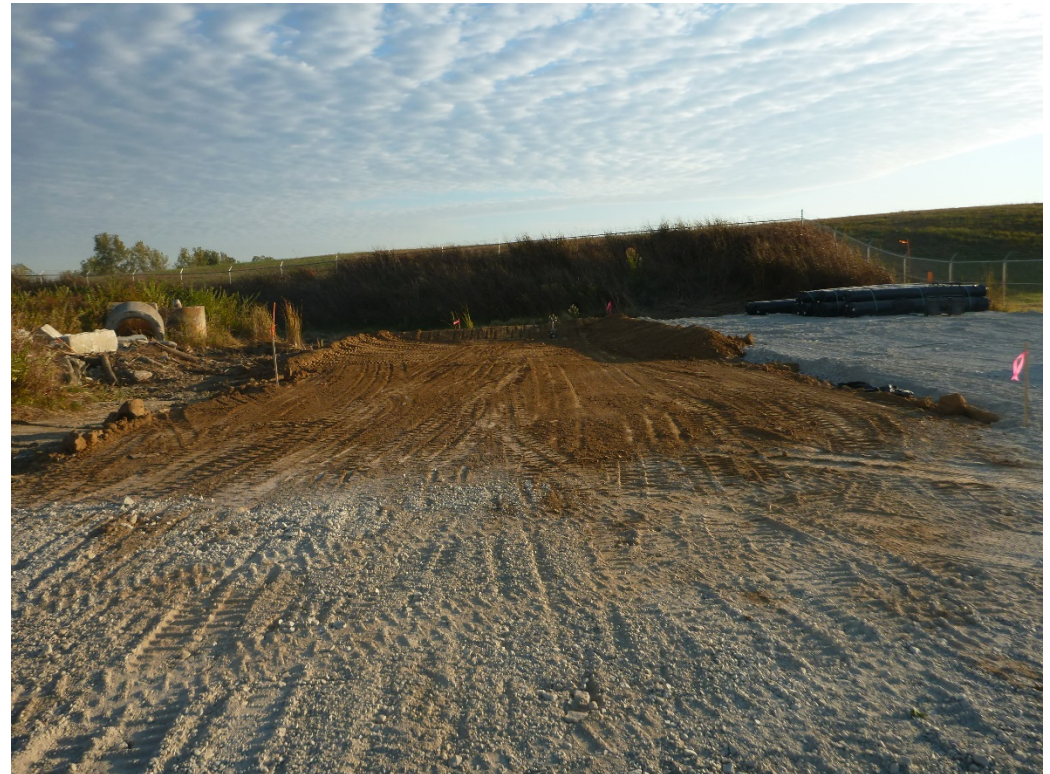
Photo is taken just inside the “hot zone” entrance into OU1 area 2, the view is facing northeast. The photo shows the approximate location where the radiological decontamination pad is being built. The pad will be used to clean and decontaminate vehicles and equipment, if necessary.

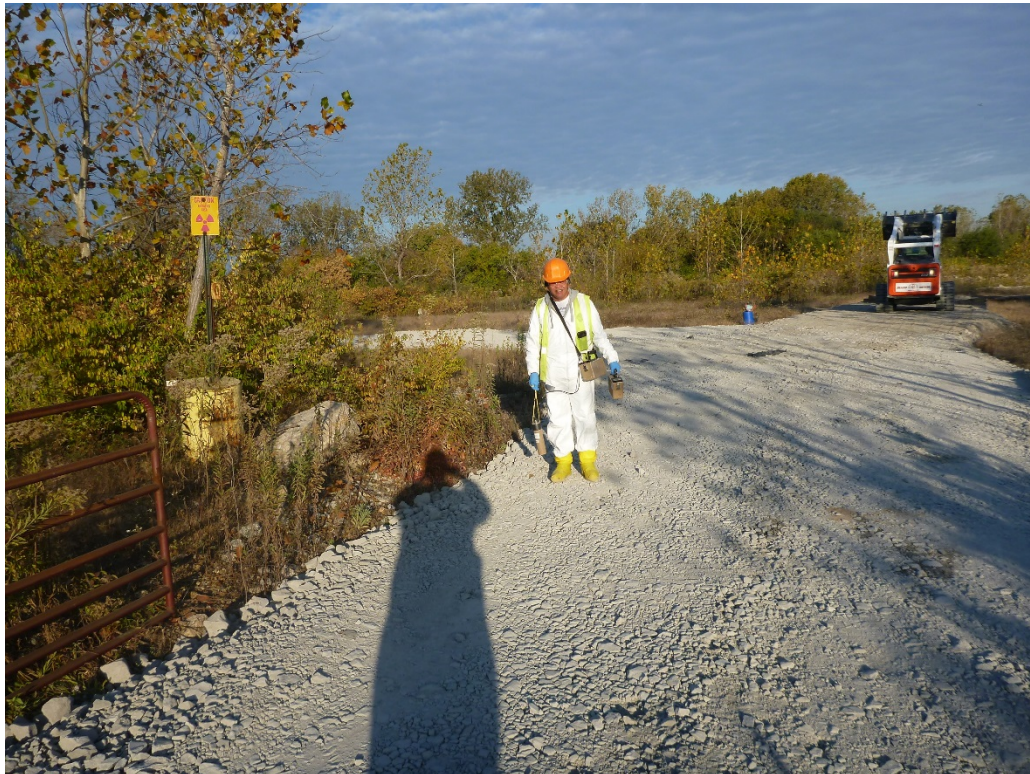
Photo is taken inside OU1, near the reference area #24, the view is facing northeast. The photo is taken approximately 10 yards NE of area 24 and shows the technician performing a survey of the area.

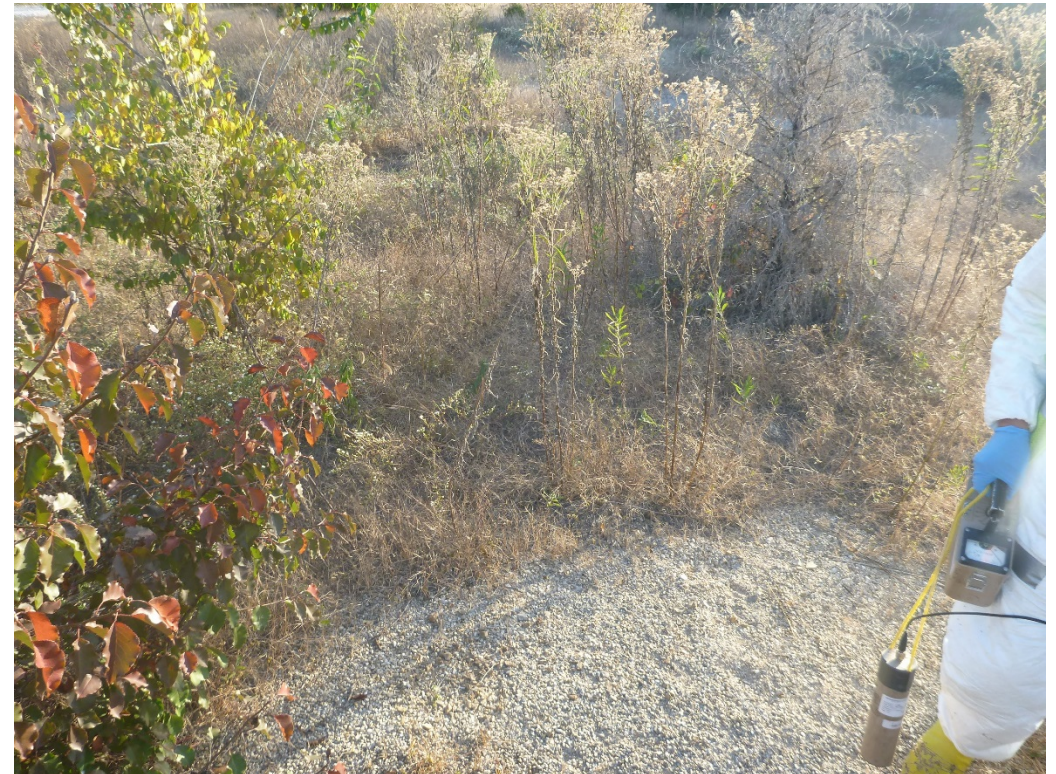
Photo is taken inside OU1, near the reference area #24, the view is facing northeast. The photo is taken approximately 10 yards NE of area 24 and shows the technician performing a survey of the area. This area has been marked for further investigation and will be used as a sampling point for additional characterization.

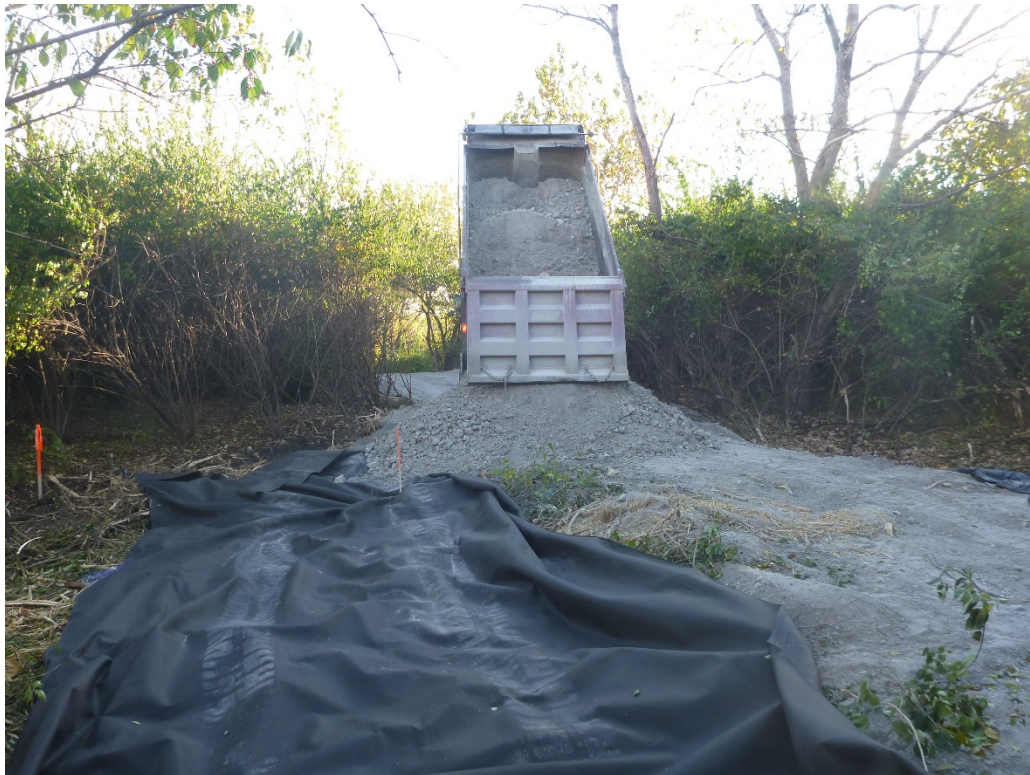
Photo was taken inside OU1; the view is facing east, between paving areas 21-25. The photo shows the progress of the brush cutting/hogging operations in order to have an “alignment line” for the additional characterization. FEI personnel are shown paving and graveling several areas near the reference areas of pathways 23-25.

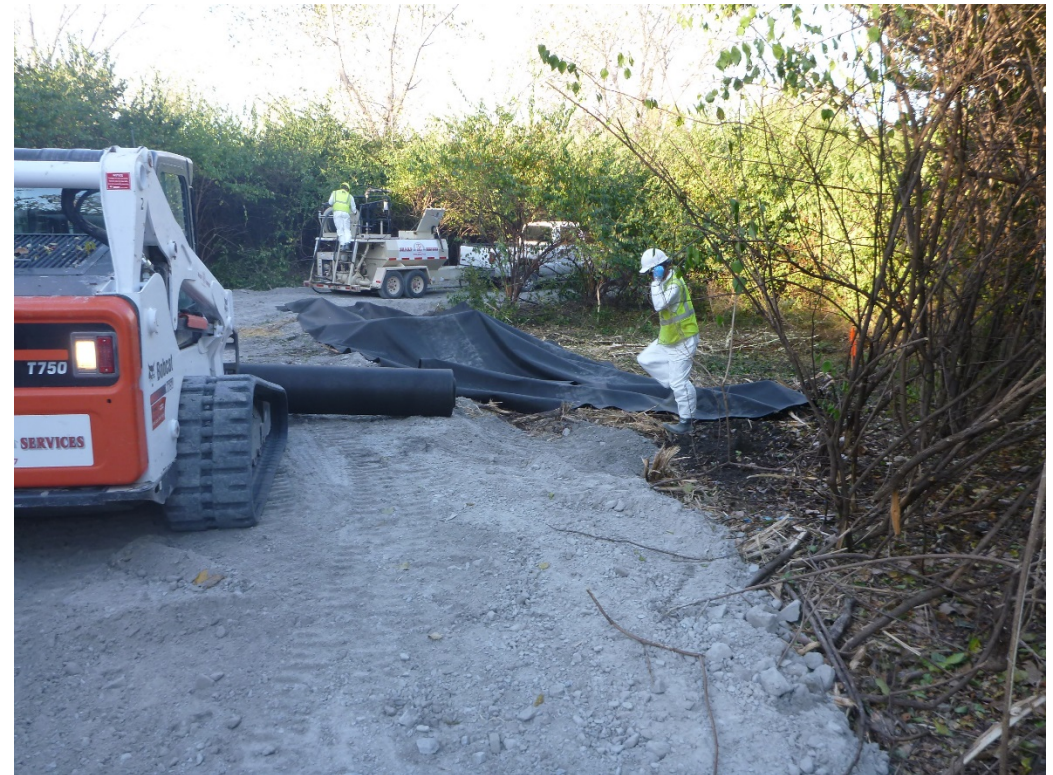
Photo is taken inside the OU1, near the reference area 23, the view is facing west. The pathway is being cleared of debris and vegetation. The photo shows roughly how the area is staked out, the underlayment padding/matting for the path and the crushed gravel used in paving the pathway. The dust suppression method, if necessary, is to lightly wet the material to keep fugitive dust and visible emissions to a minimum in dry and high wind conditions.

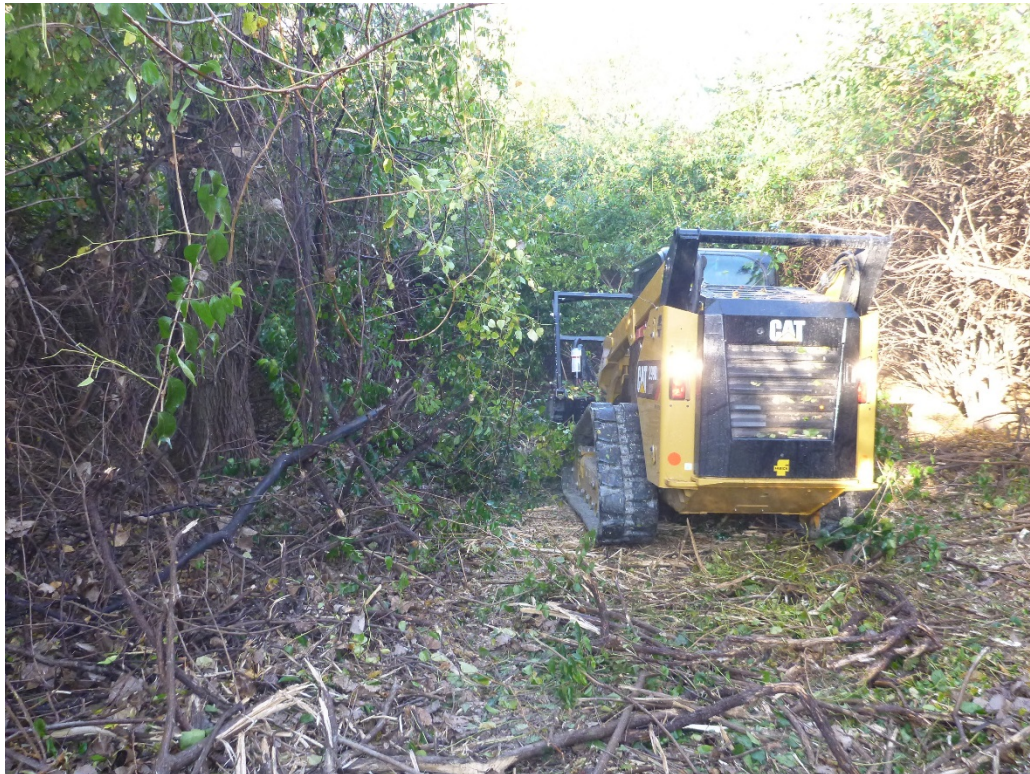
Photo is taken inside the OU1, near the reference area 23, the view is facing west. The pathway is being cleared of debris and vegetation by a forestry mower bobcat. The forestry mower is used to cut small trees and brush.

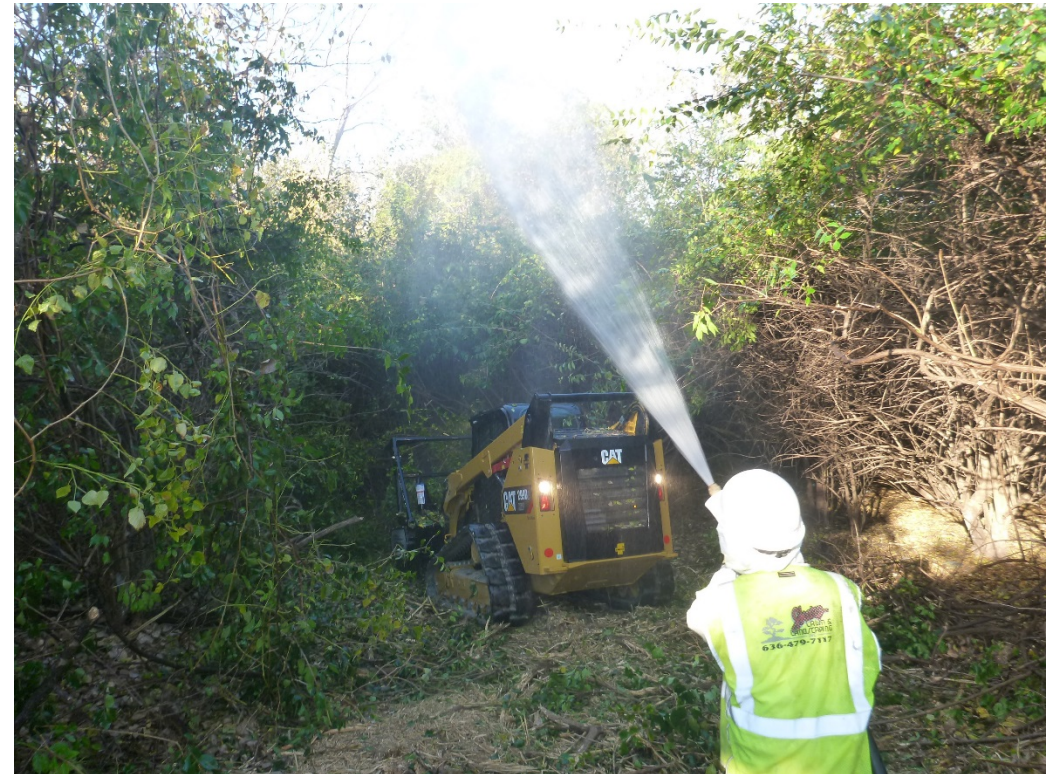
Photo is taken inside the OU1, near the reference area 23, the view is facing west. The pathway is being cleared of debris and vegetation. The dust suppression method, if necessary, is to lightly wet the material to keep fugitive dust and visible emissions to a minimum in dry and high wind conditions. There were no visible dust emissions observed during cutting operations.

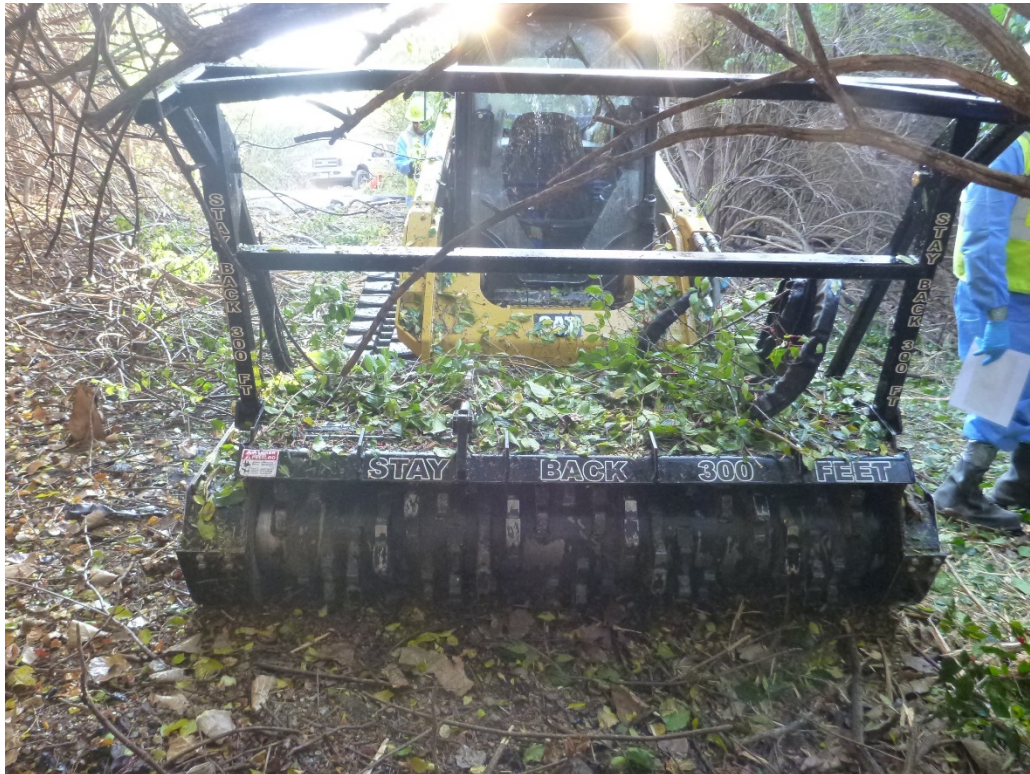
The view is facing southeast and shows what the forestry mower / cutter attachment on the bobcat looks like. The forestry mower is used to cut small trees and brush in preparation for grading a pathway through the site for the additional testing and characterization.

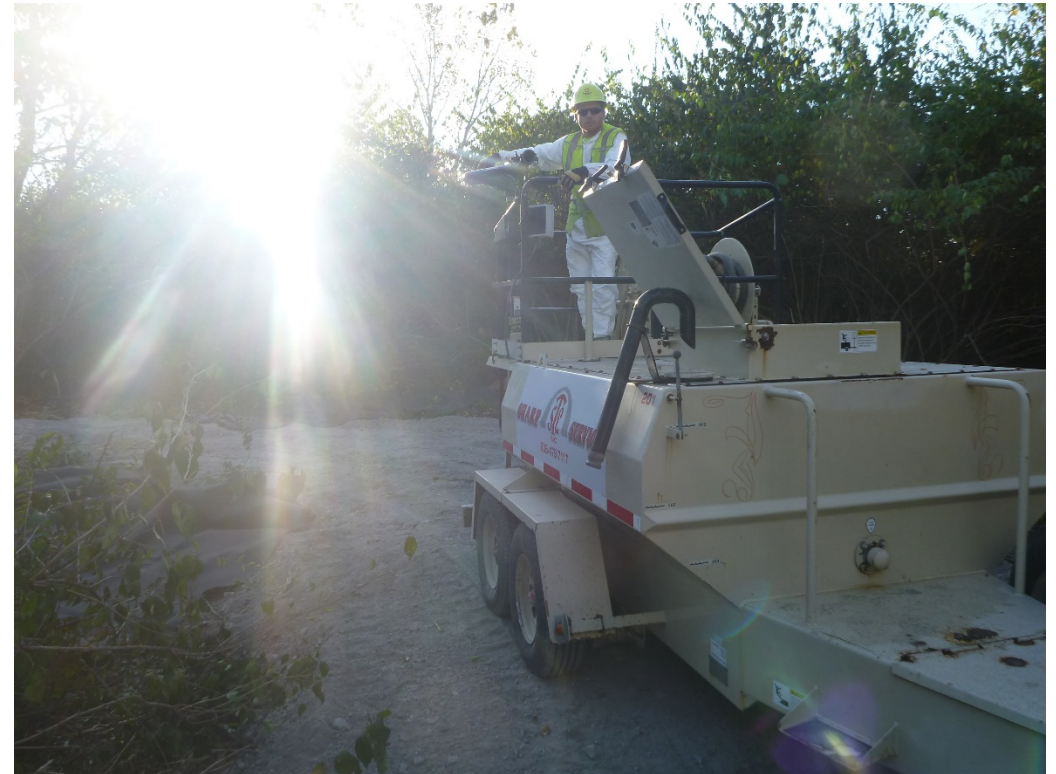
The view is facing south and shows what the water truck looks like. The water truck provides water for the dust suppression mister/hose being used inside the OU1 area.

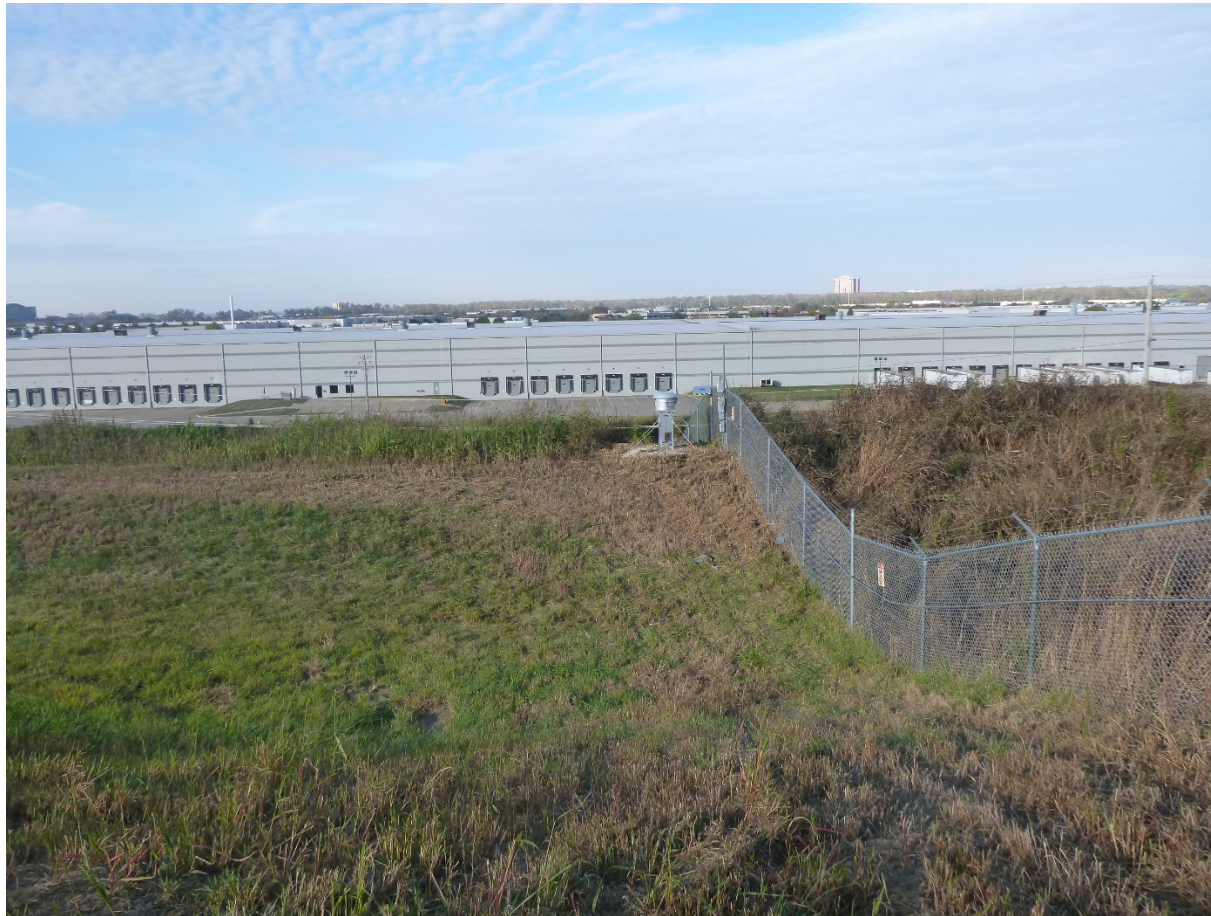
The photo was taken outside the OU1 area, the view is facing west. The photo shows the air monitoring system being used to measure/detect any off-site release at the fence line. The “system” consists of a TLD, Alpha Track Radon detector and a particulate filter. This is 1 of 13 monitors in/around the perimeter of the WLLS.
