#PI0703B: Service Rear Axle Message Displayed on Driver Information Center (DIC), DTC C0407 with Symptom Code 64 or C0403 Symptom Code 62 Set - (Feb 25, 2013)

Models: 2010-2012 Buick LaCrosse
2010-2012 Cadillac SRX
Equipped with All-Wheel Drive (AWD)

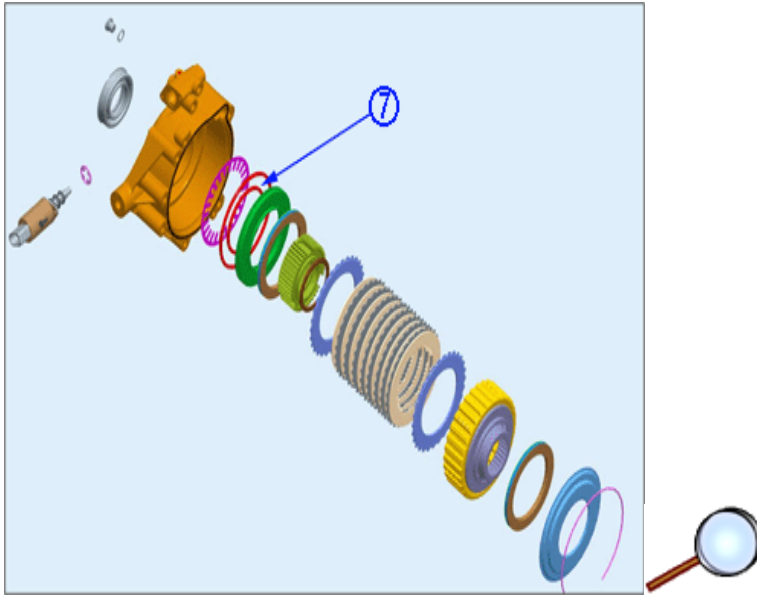
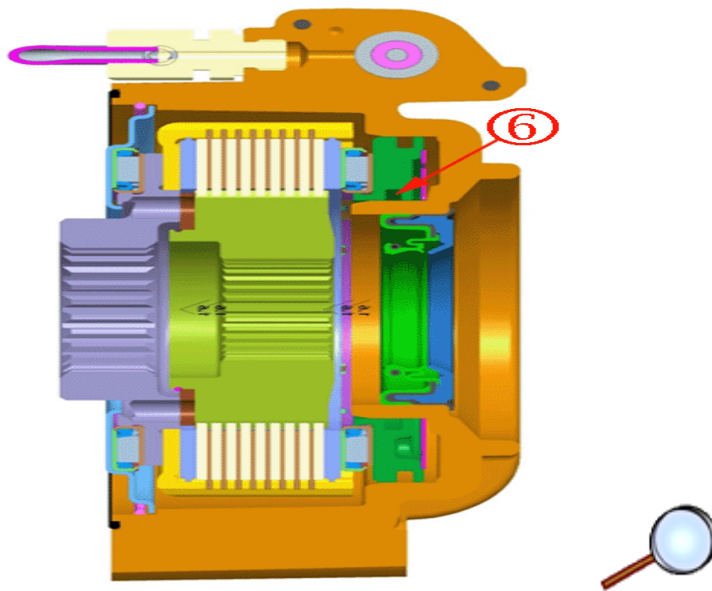
3. If the rear differential fluid level is too high and either a or b exists, then the eLSD clutch oil is leaking past the eLSD clutch internal piston seals (6 or 7) into the rear differential. The service fix is to replace the eLSD clutch piston only using the following procedure.
