# **Pipers Row Car Park, Wolverhampton**

## **Quantitative Study of the Causes of the**

## **Partial Collapse on 20<sup>th</sup> March 1997**

**Jonathan G M Wood**

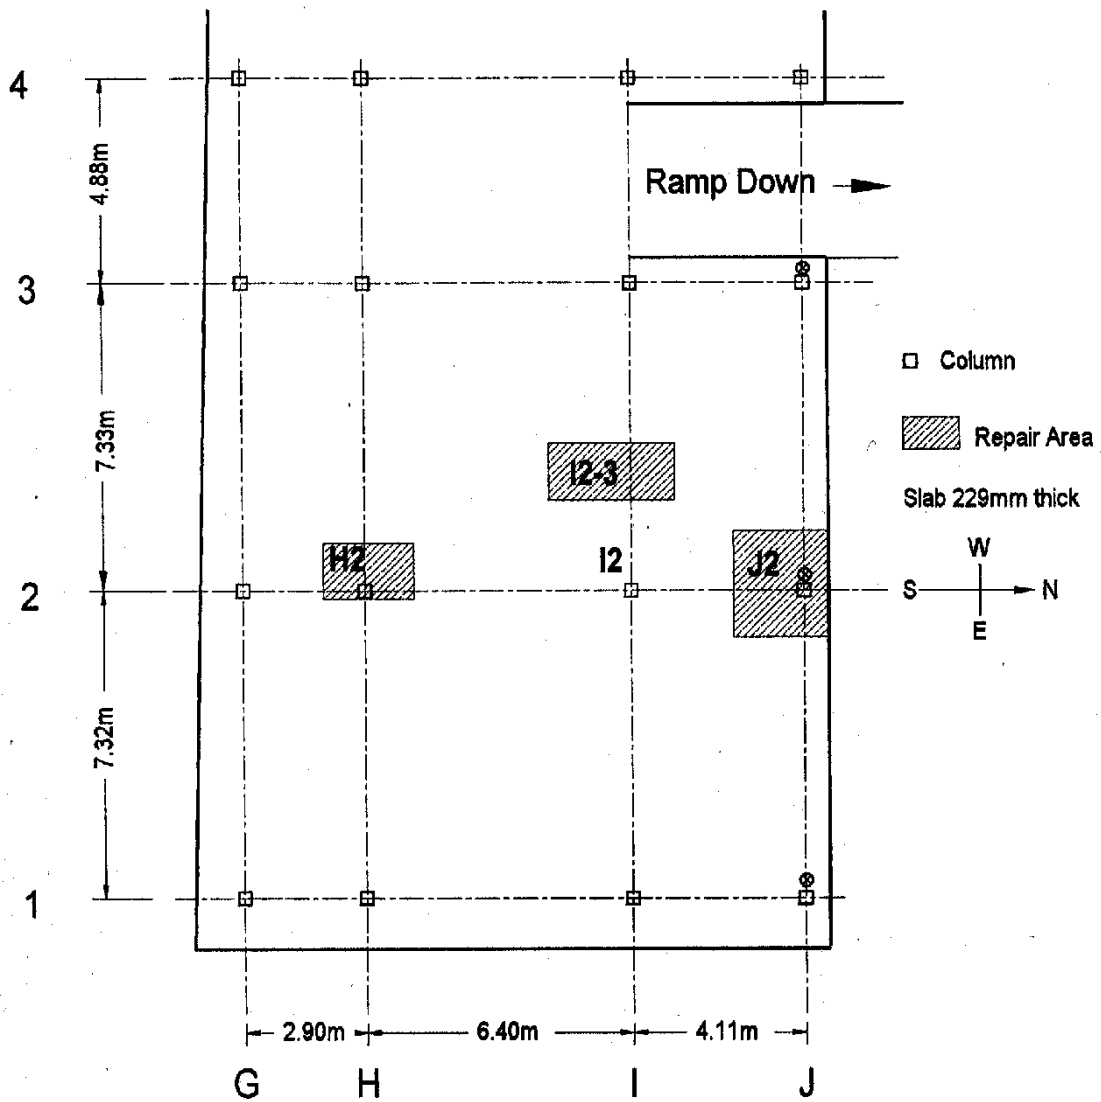
In 1996 parts of the deck slab which collapsed were patch repaired and re-waterproofed by Car Deck Maintenance (CDM) to stop leakage. There was an inspection by Harris & Sutherland (H&S), Structural Engineers for NCP, but there was no proper investigation of deterioration, assessment of the structural effects of the deterioration and repair or specification for a structural repair. The repairs at H2 and J2 were in the punching shear zones adjacent to the columns, see Figure 1.3.1. At both locations a substantial area of concrete had become friable to below the level of the top reinforcement which was corroding. If the drawings had been consulted, the sensitivity of the structure to punching shear with the degradation and with the repair to below the top reinforcement, should have been apparent. The repairs were not taken out to the limits of deterioration leaving substantial areas of friable concrete with corroding reinforcement unrepaired around H2. The area of deep degradation and reinforcement corrosion around I2 was not identified.

Figure 1.3 - 1 Plan of 4<sup>th</sup> floor slab at Pipers Row showing repaired areas

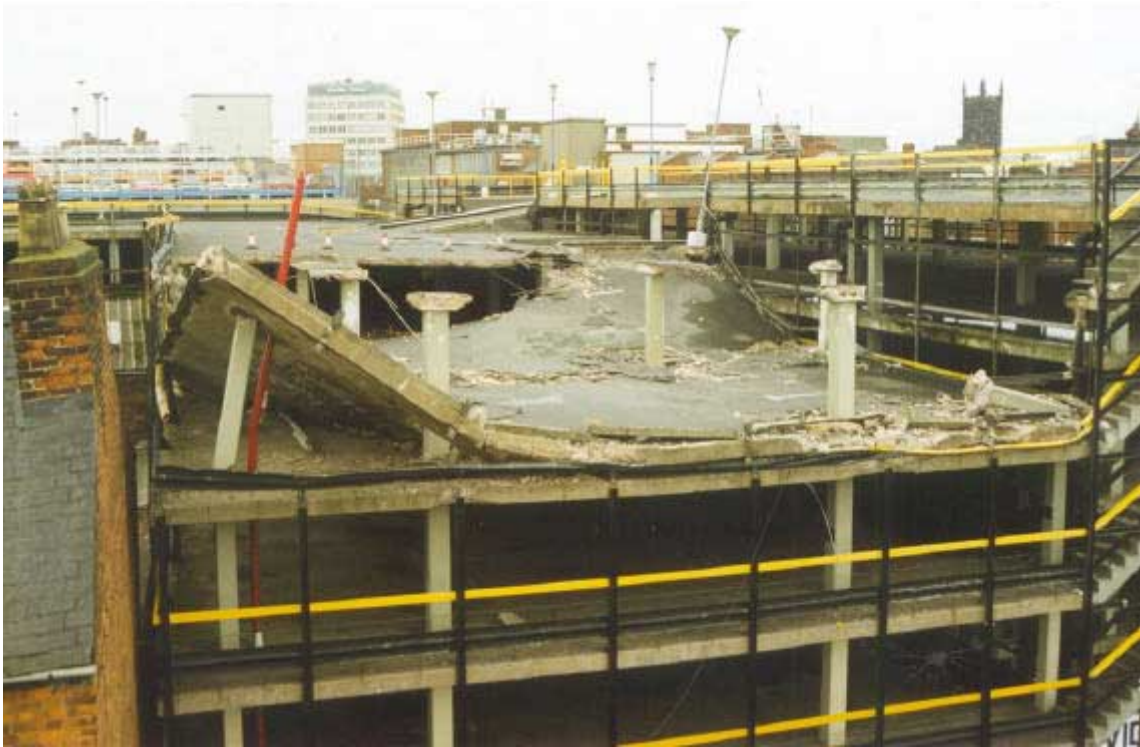
A 120 tonne, 15m by 15m section of the top floor collapsed at about 3am on 20<sup>th</sup> March 1997 when punching shear failure at one column led to a progressive collapse as similar failures followed at eight adjacent columns. Fortunately the car park was empty, so there were no injuries, but the closure and subsequent demolition of the whole 400 space car park caused substantial disruption to Wolverhampton.

**Figure 1.4 - 1 Collapsed 4<sup>th</sup> floor slab at Pipers Row Car Park, Wolverhampton on 25/3/97**

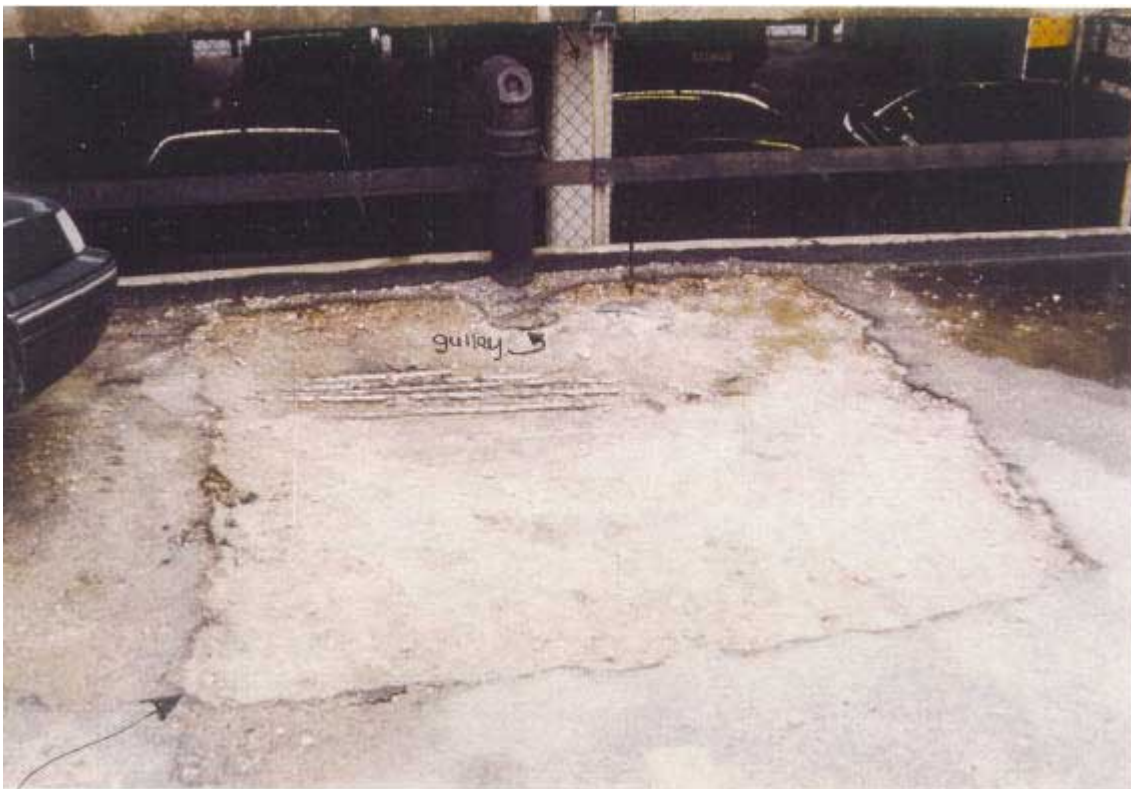
**Figure 6.1 - 1 CDM photo [H126] of initial cutting out at J2, January 1996.**

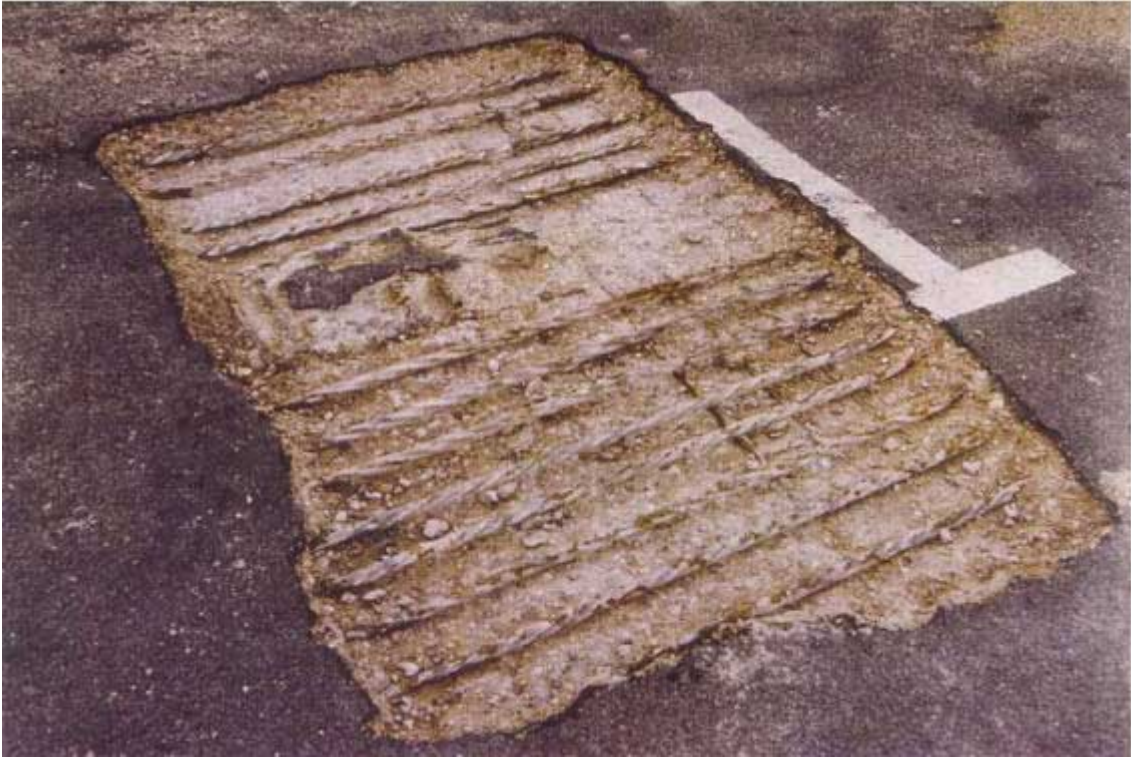
**Figure 6.1 - 2 CDM photo [H128] of initial cutting out at H2, January 1996.**

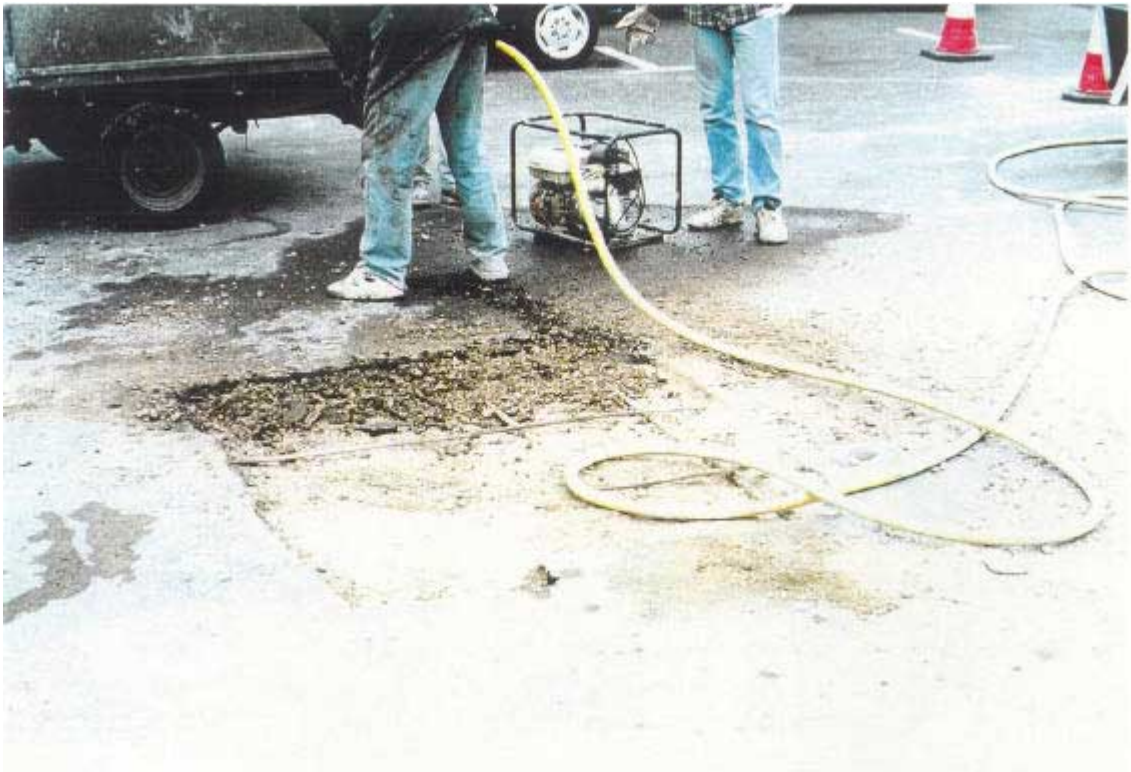
**Figure 6.1 - 3 H&S photo [H132] of cutting out for repairs at I2-3, 20<sup>th</sup> March 1996.**

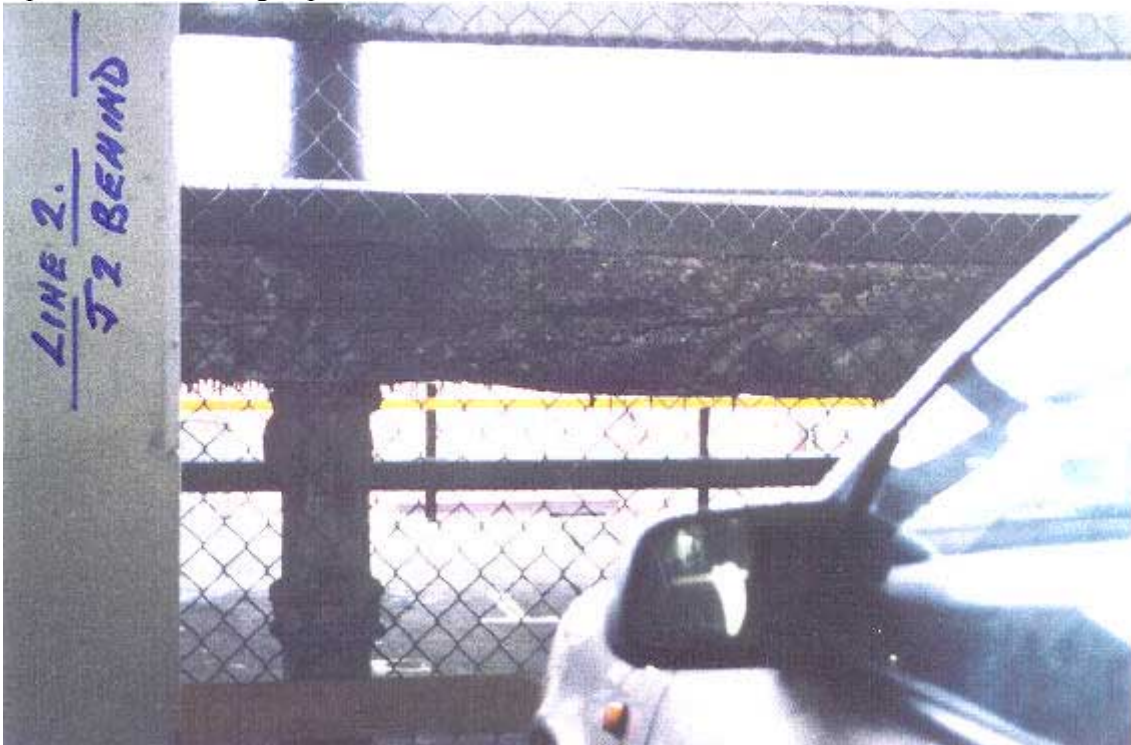
In January 1997 the slab was checked by CDM because of further leakage. A crack adjacent to J2 was found and considered potentially serious. In February NCP and H&S inspected the crack and local propping at J2 was considered appropriate. A full inspection with materials testing and structural assessment of the whole car park was recommended. The propping, detailed inspection and assessment had not started when the collapse occurred on 20<sup>th</sup> March, but the area of slab which collapsed and the slab below were coned off.

**Figure 6.2 - 1 CDM photo [H131] of crack to slab edge at J2, January 1997**

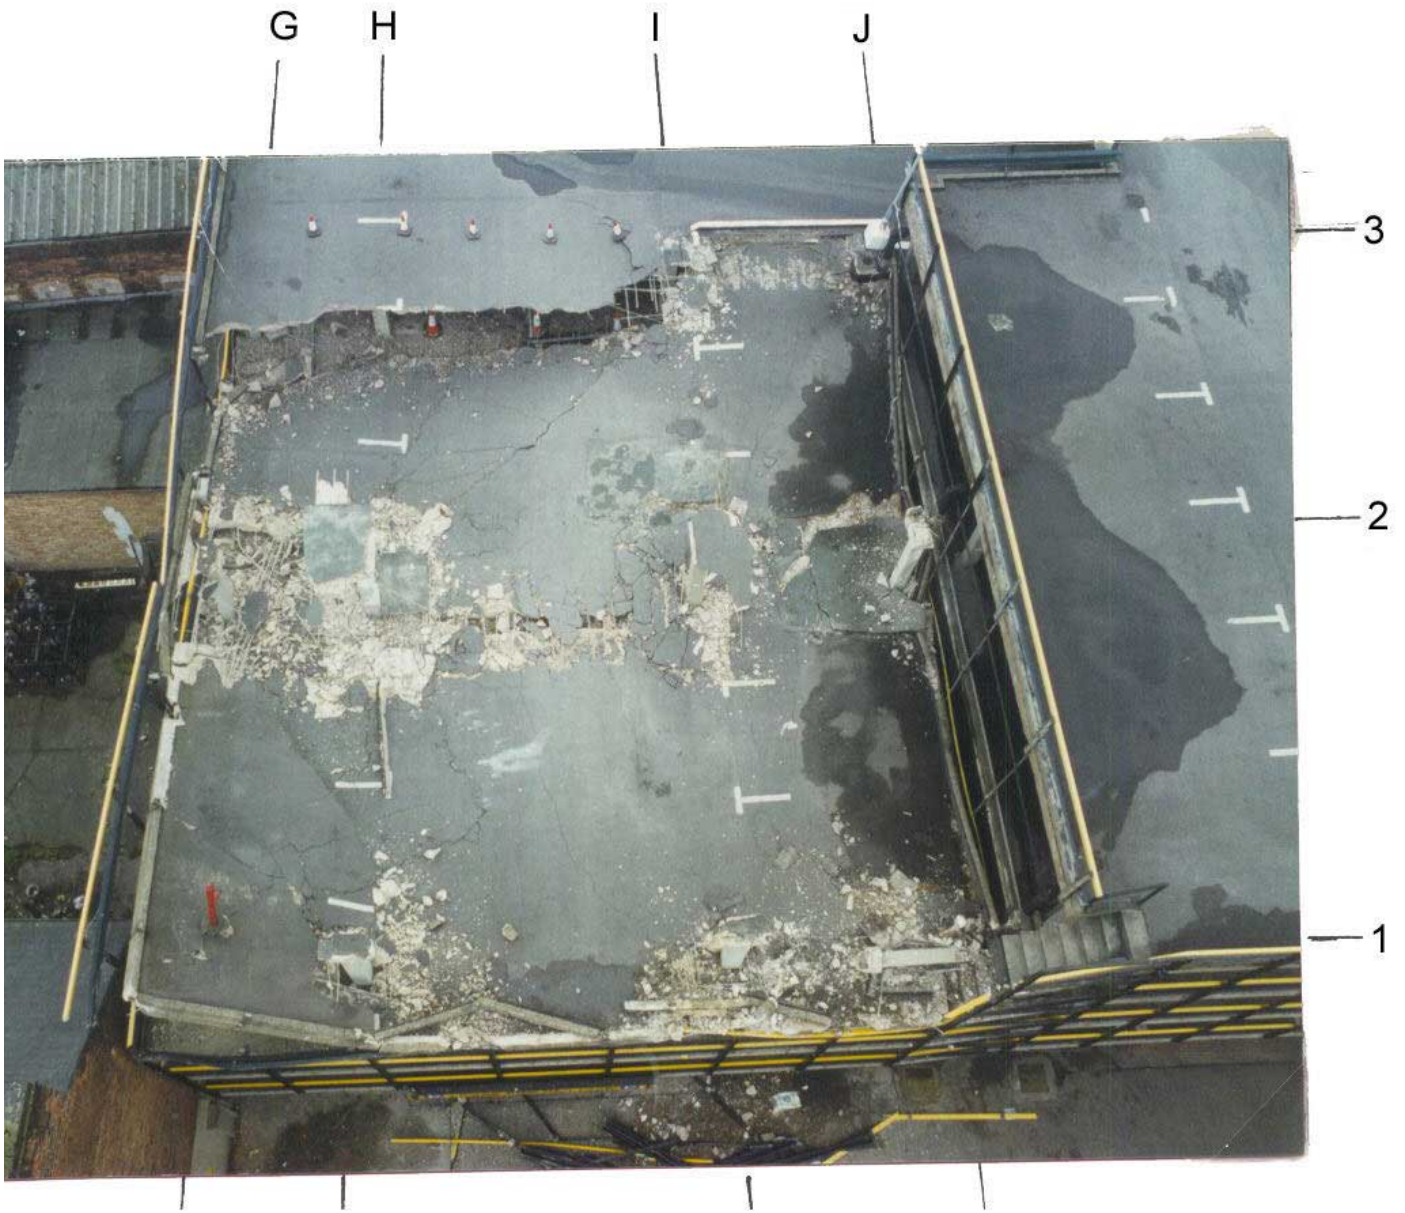
Figure 7.1 - 1 Photo from above the collapsed slab [H17]

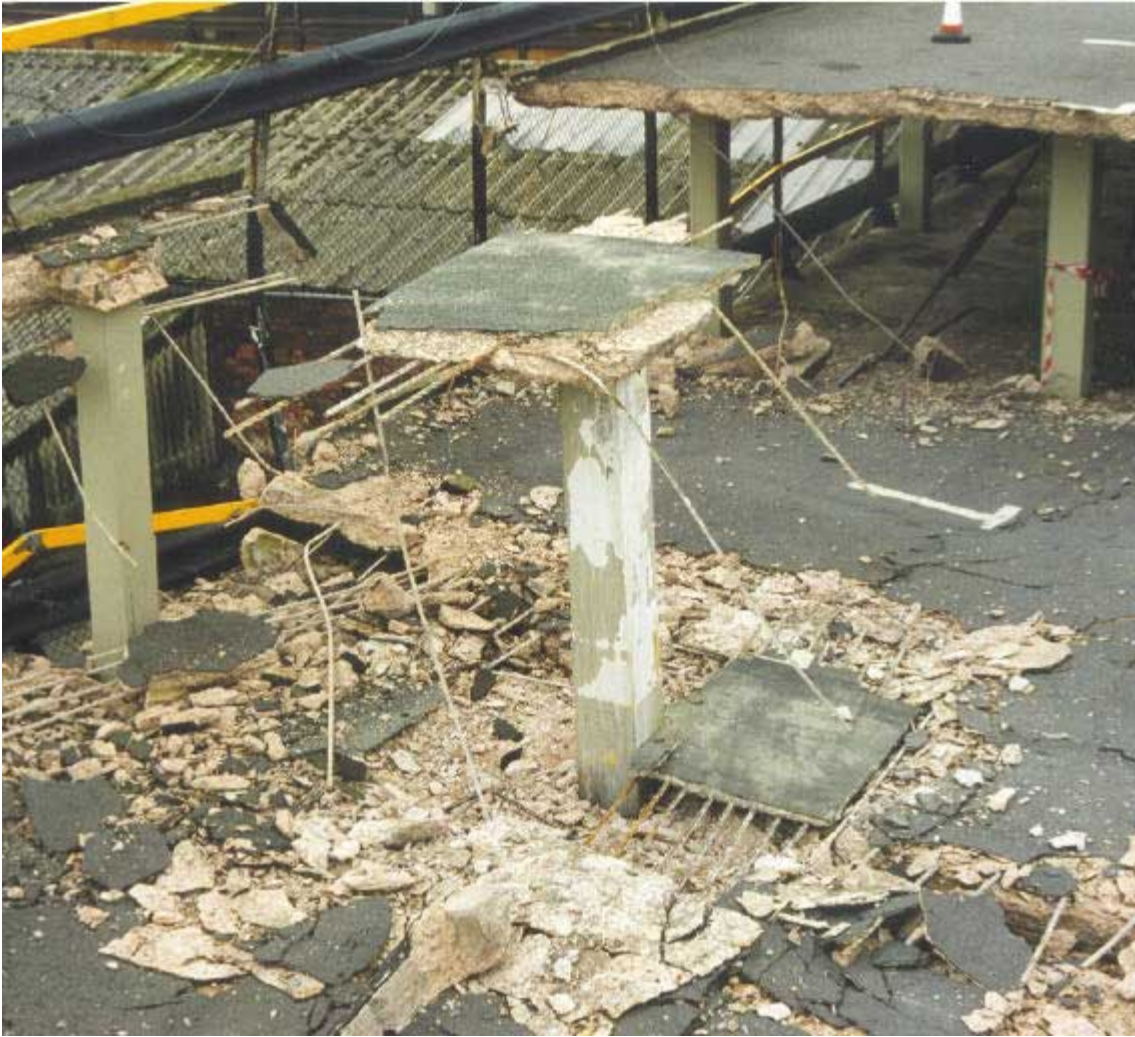
**Figure 7.4 - 1 H2 general view**

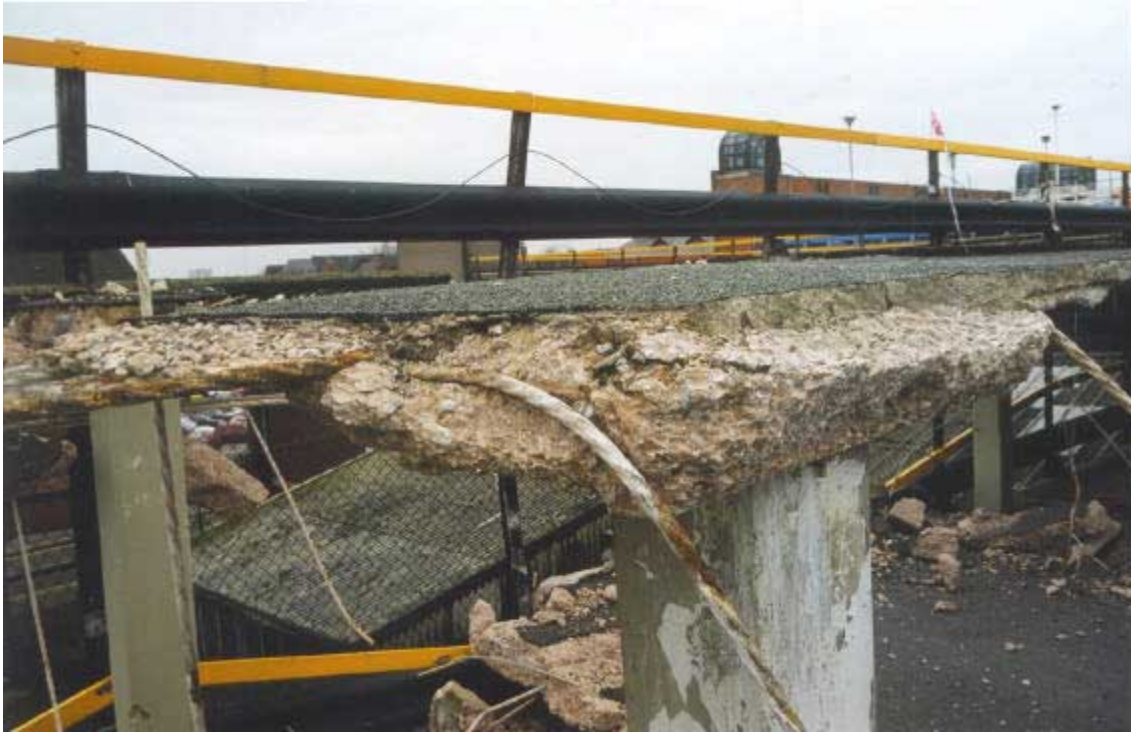
**Figure 7.4 - 2 H2 Close up view showing repair, degradation and corrosion**

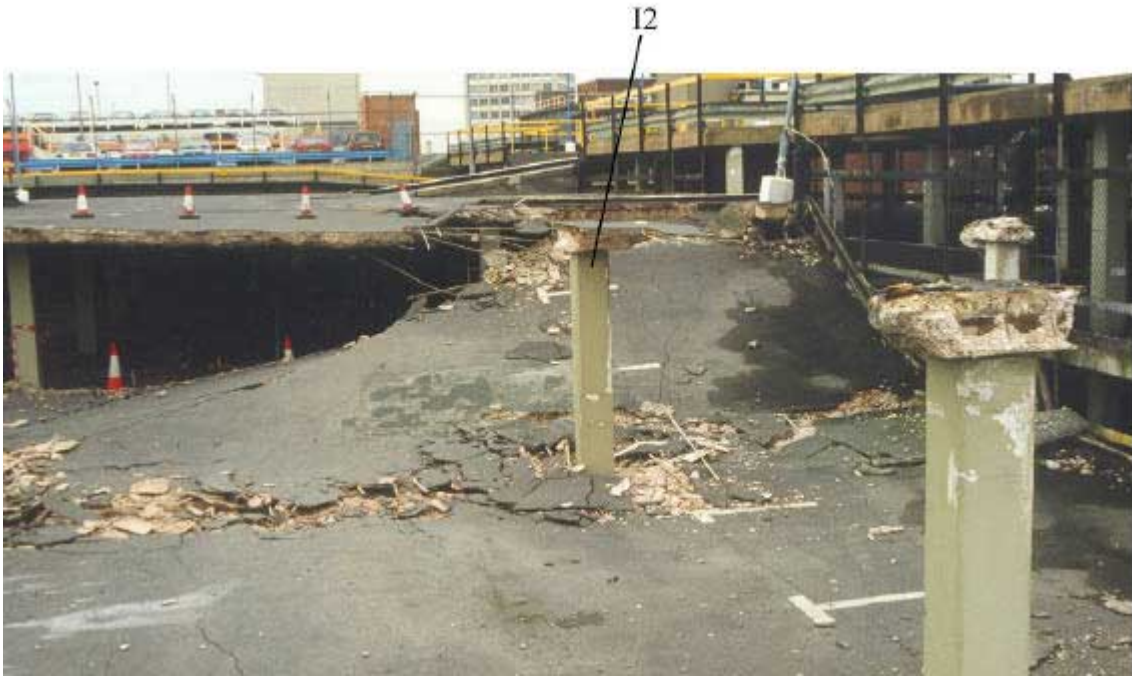
**Figure 7.4 - 3 I2 General view**

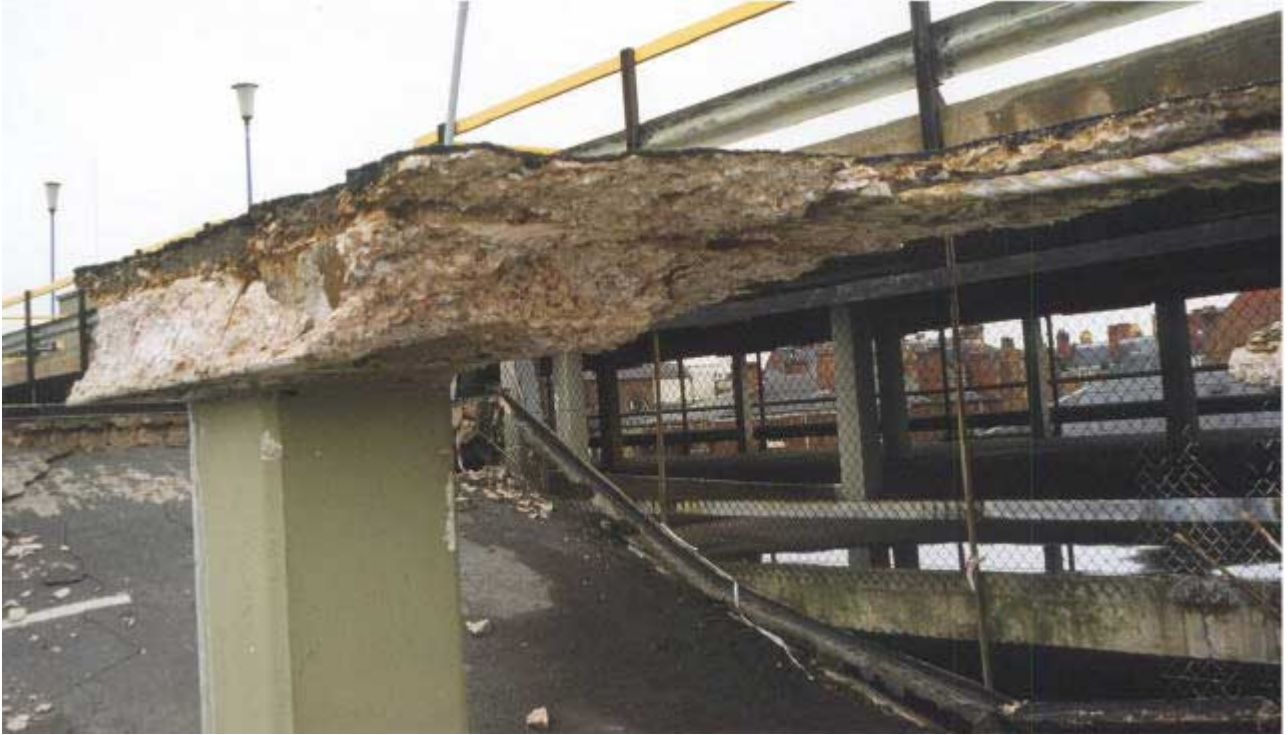
**Figure 7.4 - 4 Close up view of I2 showing degradation, corrosion and fracture surface**

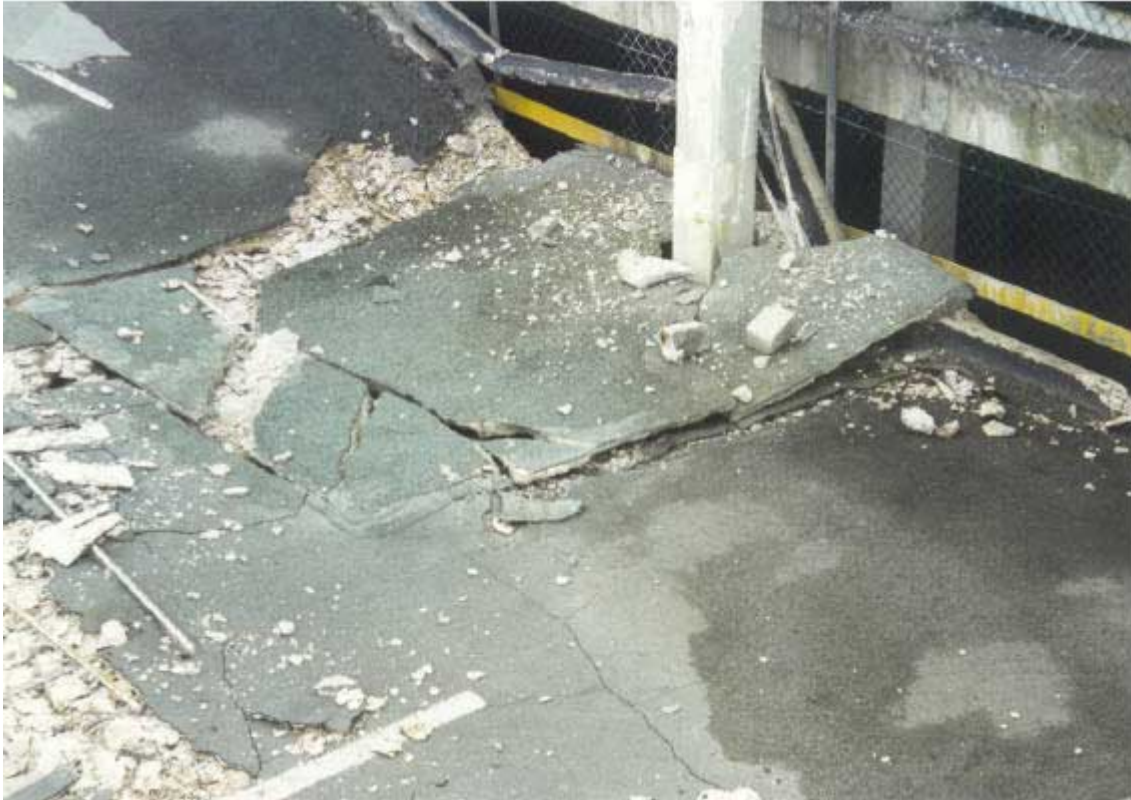
**Figure 7.4 - 5 J2 General view showing delamination of repair**

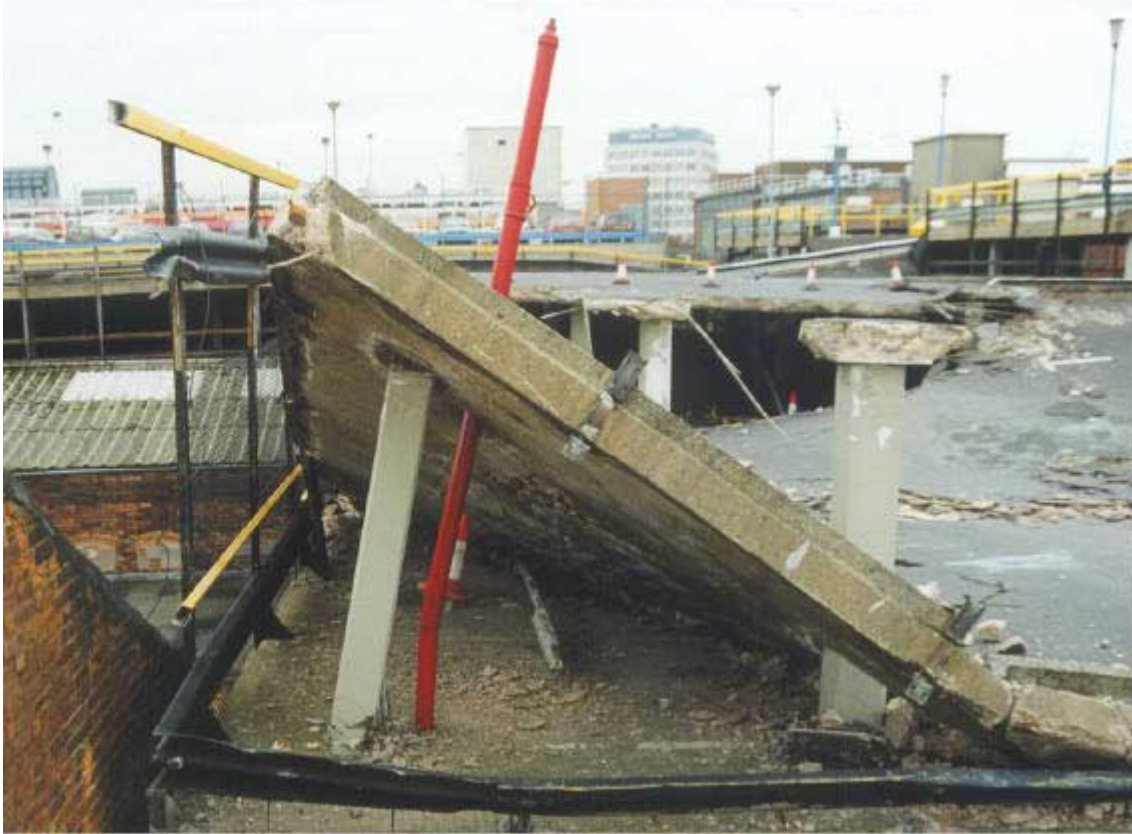
**Figure 7.4 - 6**

**G1 column, with bottom steel welded to shear head, did not fail in punching shear**

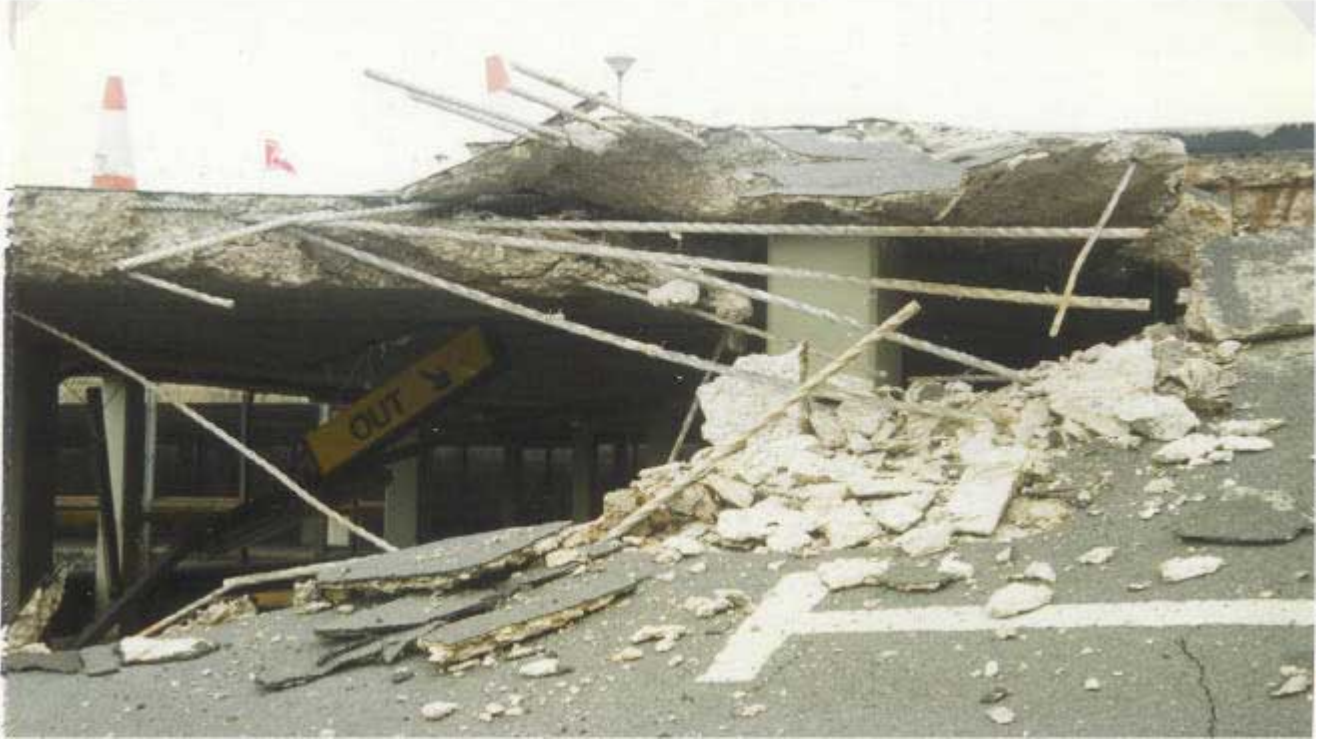
**Figure 7.4 - 7** Punching shear fracture at I3, deformation limited by support from ramp.

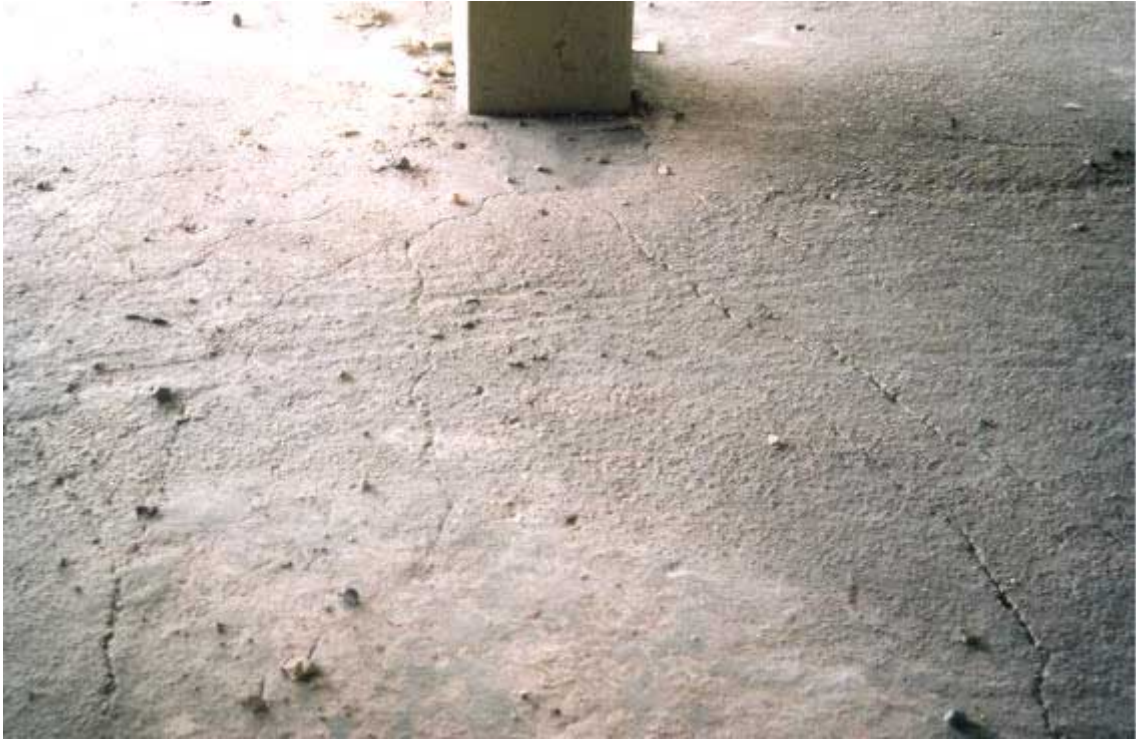
**Figure 7.4 - 8 Typical star cracking around shearhead.**

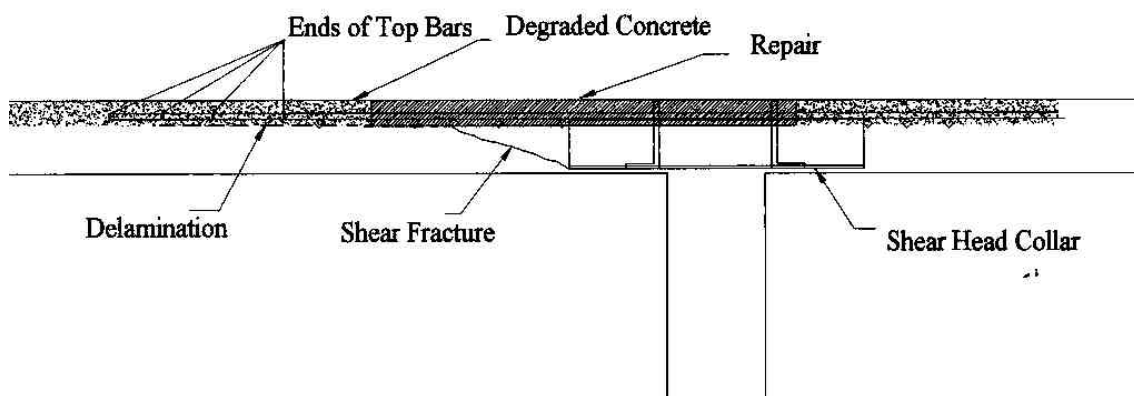
The principal features which were clearly apparent during the inspection and repair work in 1996 were the areas of surfacing breakdown and the underlying friable surface layer to below the level of the T1 and T2 layers of top reinforcement with the associated corrosion of the steel. The major effects of this on bond strength and the punching shear strength are set out in Section 10.4.6. Deterioration to this depth was the largest factor in triggering the collapse. Deterioration around the reinforcement should have alerted a structural engineer to the need for a review of the drawings and a detailed appraisal of strength. The potential vulnerability of the flat slab to this form of deterioration should have been clear from a marking up of the depth and extent of deterioration on to the section of the column slab reinforcement as in Figure 8.2.3 - 1.

**Figure 8.2.3 - 1 Marking of degradation depth and shear fracture plane on Section of H2**

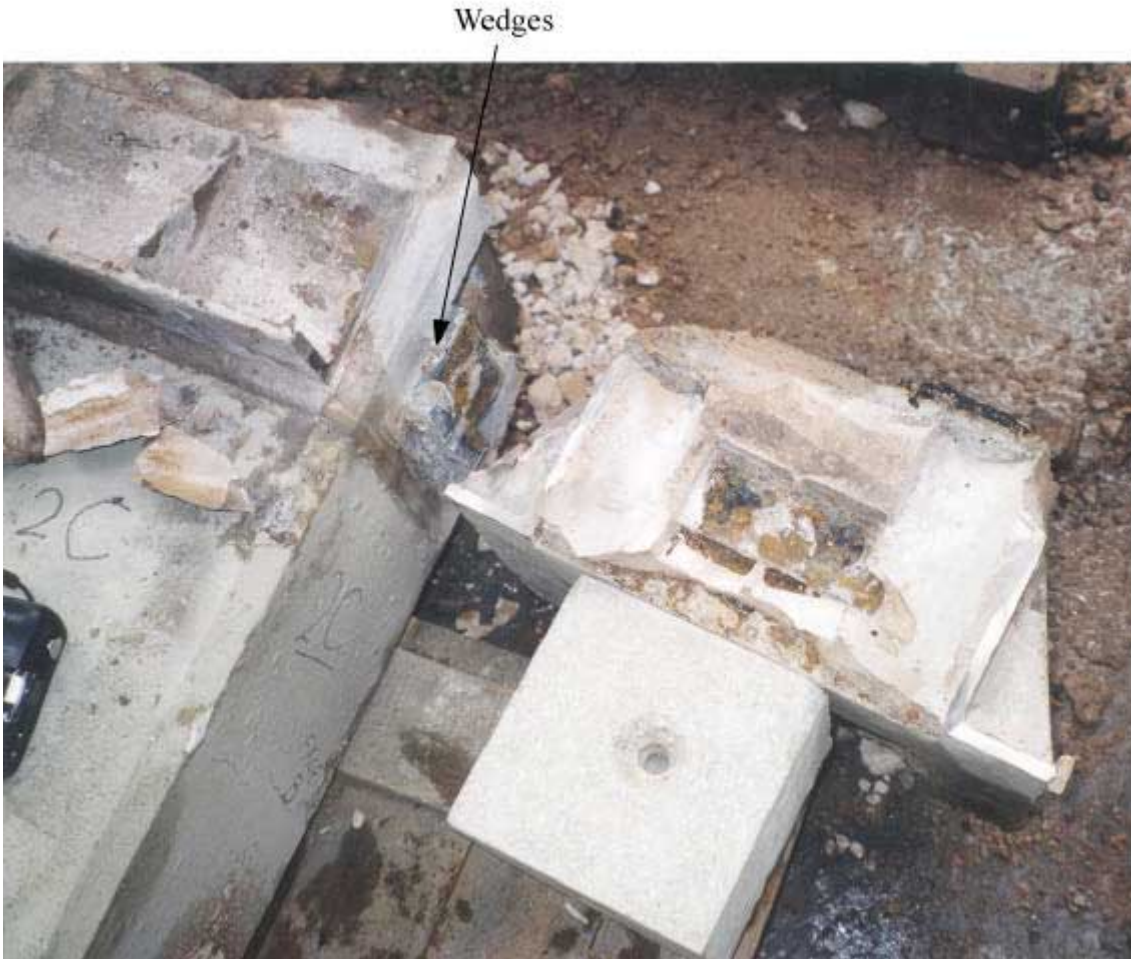
The soffit of the long angle at I2 showed a slight 2mm bow suggesting that it might have distorted under load, but this could also have been the result of fabrication distortion.

Figure 8.2.7 - 1 Sectioning of Column I2 shear head to reveal wedges

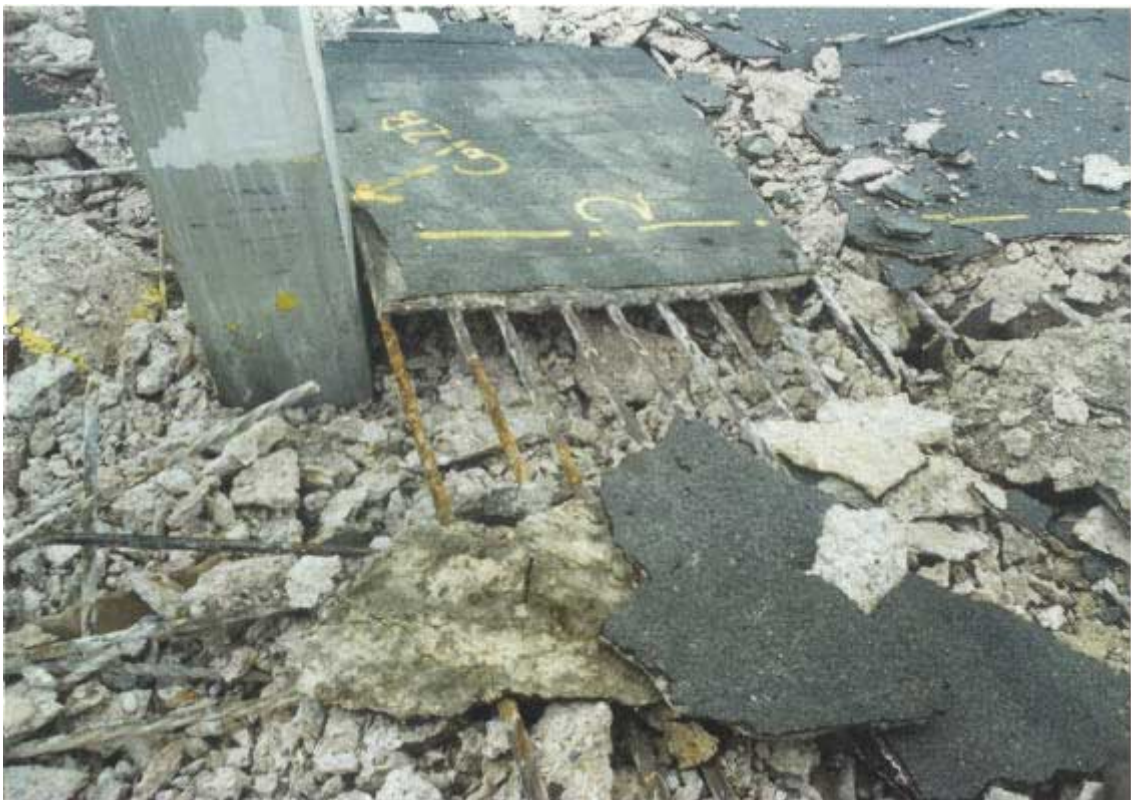
The BRE studies on carbonation and corrosion indicate that it was the fissuring of the degraded concrete which enabled carbonation to develop to initiate corrosion. Corrosion of reinforcement indicates degradation and fissuring at least to the depth of the corrosion. The locations of corrosion on top steel apparent in the photos taken after the collapse therefore give the best indications of the degradation depths and areas where bond strength would have been severely reduced. Figures 7.4 - 2 and 8.4.1 -1 of reinforcement from around H2 and Figure 8.4.1 - 2 of I2 clearly show that this corrosion had developed round the T1 and onto the lower T2 top reinforcement.

**Figure 8.4.1 - 1 Corrosion indicative of fissured and degraded slab at H2**

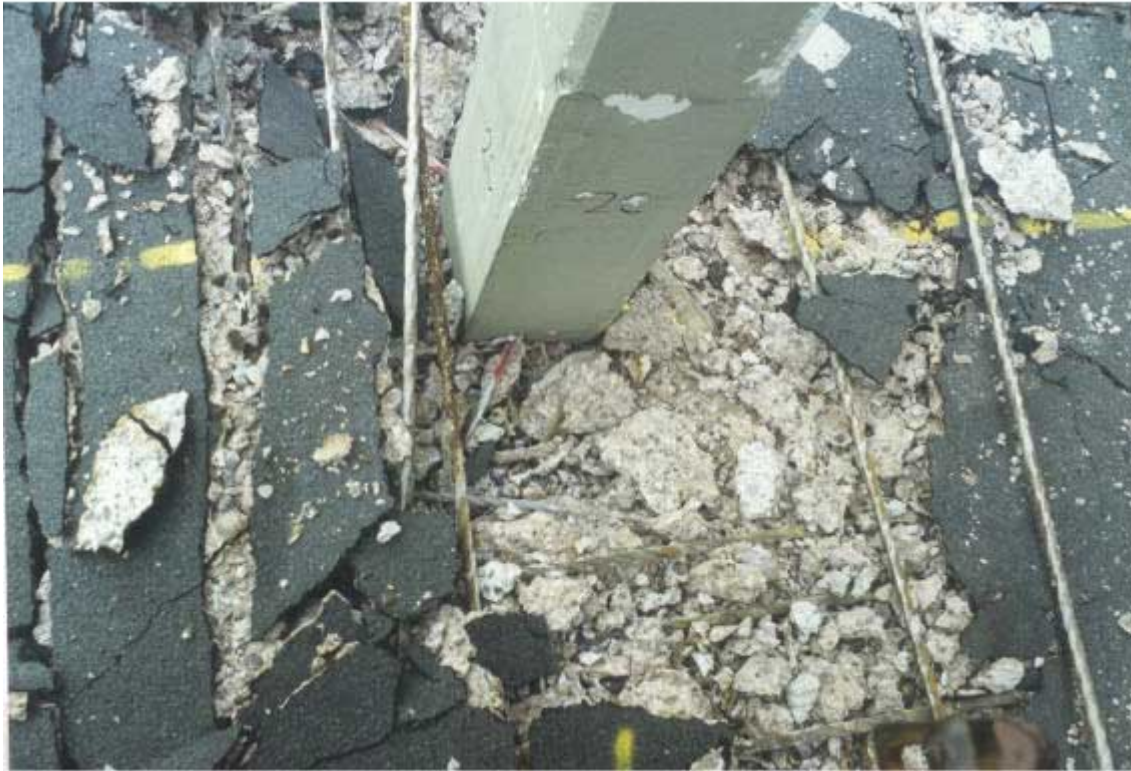
**Figure 8.4.1 - 2 Corrosion indicative of fissured and degraded slab at I2**
