Plank Road/Trail Assessment and Alternatives Report

Date of Assessment: 01/08/2016

Prepared for: Minneapolis Parks and Recreation Board

WSB & Associates, Inc.
701 Xenia Avenue South
Suite 300
Minneapolis, MN 55416

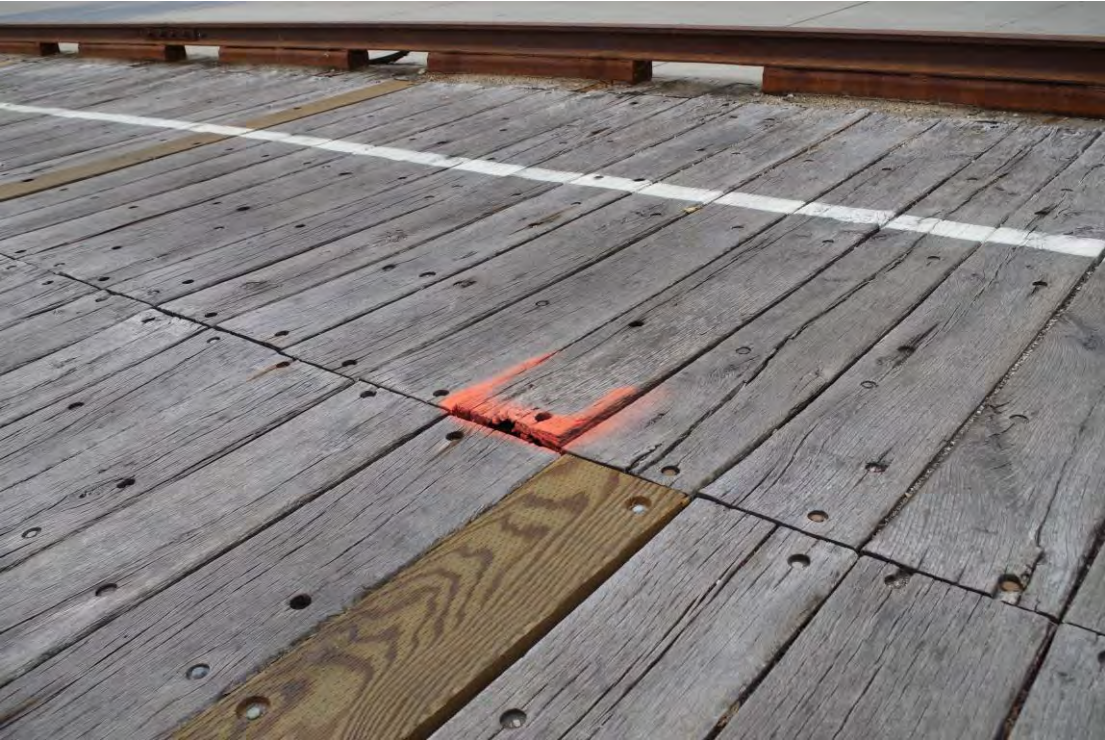
- The original planks have faded in color significantly and cupping/warping was observed in a number of planks.
- It was noted that each plank end attaches to a stringer with one bolt in a corner of the plank. In many locations this has resulted in bowing of the unrestrained corner which has become a tripping hazard. This can be seen in Figure 7.

- The plank seams (butt ends) are warping near the center of the north trail.
- Approximately 66 panels on the north trail have been replaced in the last 3 years.

Figure 7: New Plank and Bowed Existing Plank over Butt Seam on North Trail

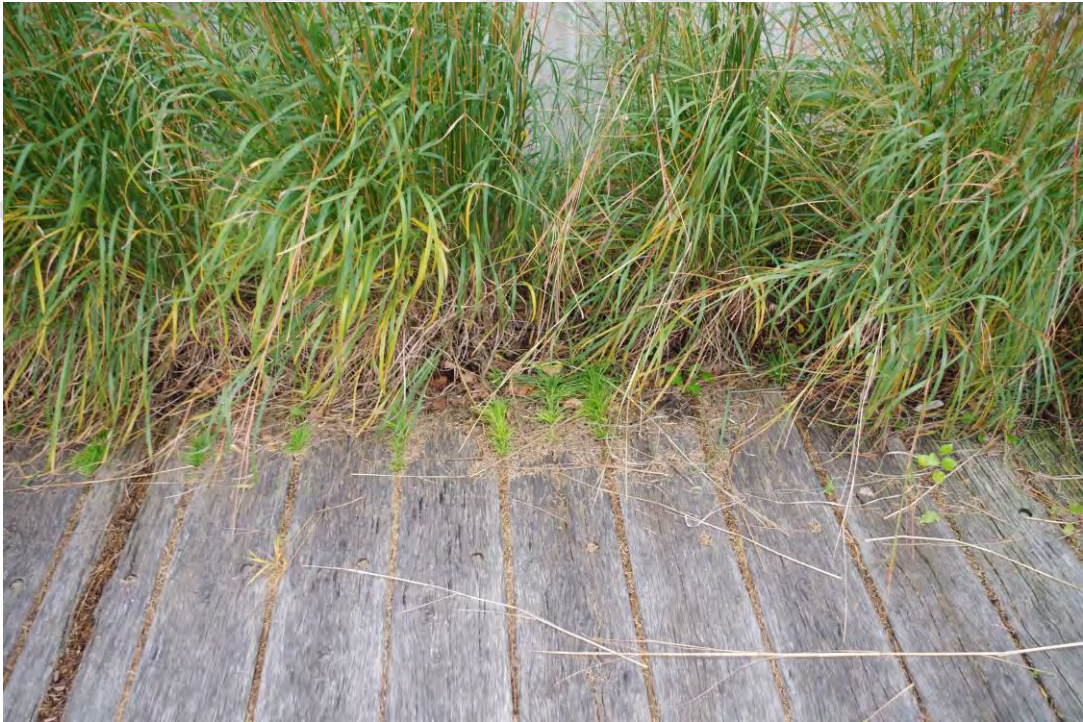
- Vegetation planted on the south side of the parkway between the trail and the adjacent parking ramp, will lead to accelerated deterioration of the timber members. This can be seen in Figure 8. Irrigation in the planted border along the south trail and the adjacent building, will also lead to accelerated deterioration of the timber members.

Figure 8: Plank Rot and Landscape Vegetation on South Trail

Other work anticipated with this option is to remove any landscaping and sprinkler system adjacent to the timber planks. These elements accelerate the deterioration of the timber.

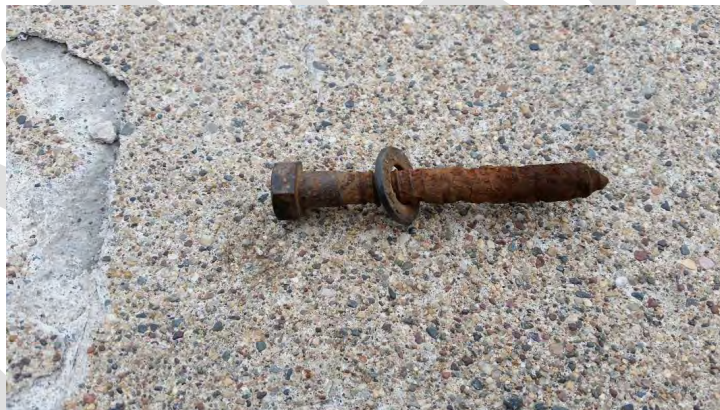
- Corrosion of bolts and loss of threads has occurred and is leading to some loose planks. This corrosion is caused by rain water, treatment chemicals in the timber, and the salt used on the adjacent roadway.

Figure 9: Corroded Bolt that has Lost its Threads

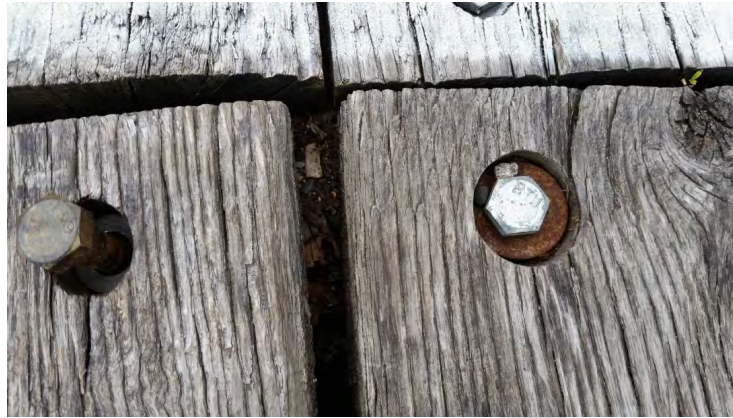
- The planks are difficult to remove and replace because the bolts are countersunk. These countersunk holes fill with dirt and the sock heads MPRB crews have available to fit the bolt heads are too wide for the countersunk holes. Moreover, there is not a consistent bolt size being used throughout the trail. It takes approximately 10 to 15 minutes to remove each plank (or five minutes per bolt).

Each plank end attaches to a stringer with one hex-bolt in a corner of the plank as seen in Figure 10. These bolts are oversized and should be decreased in size. In some cases the unbolted corner has cupped and bowed out of plane, causing a tripping hazard. In addition, bolts that connect the planks to the stringers below have begun to rust and some have lost their threads. Exposure to salt may have accelerated this process. In the future, bolts should be hot dip galvanized or stainless steel. Access to the bolt heads has become limited in some areas due to buildup of dirt and debris in the countersunk holes. WSB has identified that the current anchorage system appears to be tedious and will discuss this system in more detail with the Minneapolis Park Board maintenance crews. It is believed that a stainless steel round head bolts or screws at each corner of the plank may be a better detail. Only galvanized or stainless steel bolts should be used as wood treatments and road salt corrodes steel quickly.

Figure 10: Countersunk Bolts

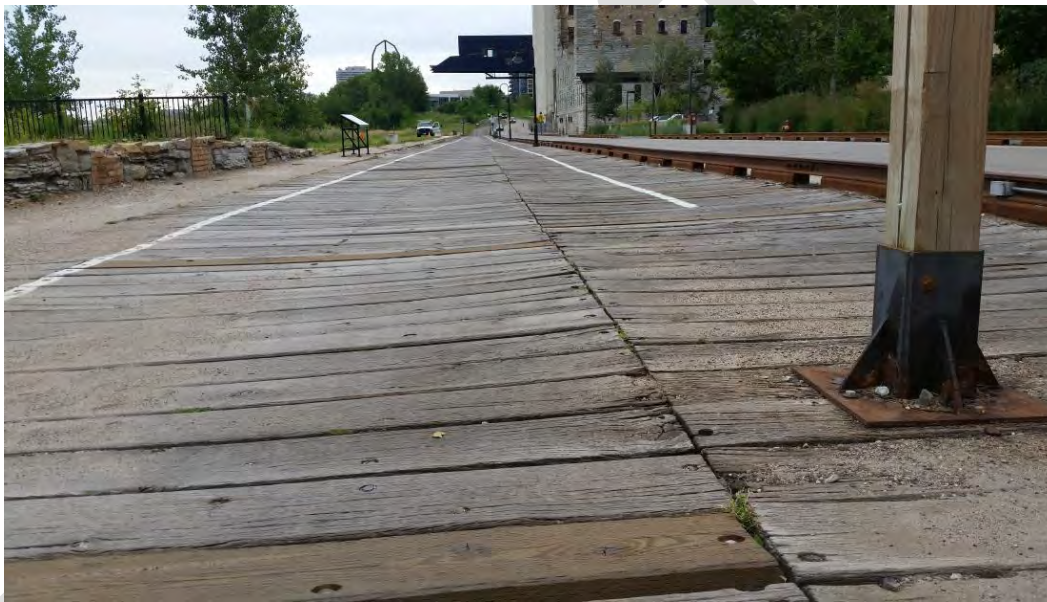
Figure 11: Warping at Butt Seam/Joint in the Center of the North Trail

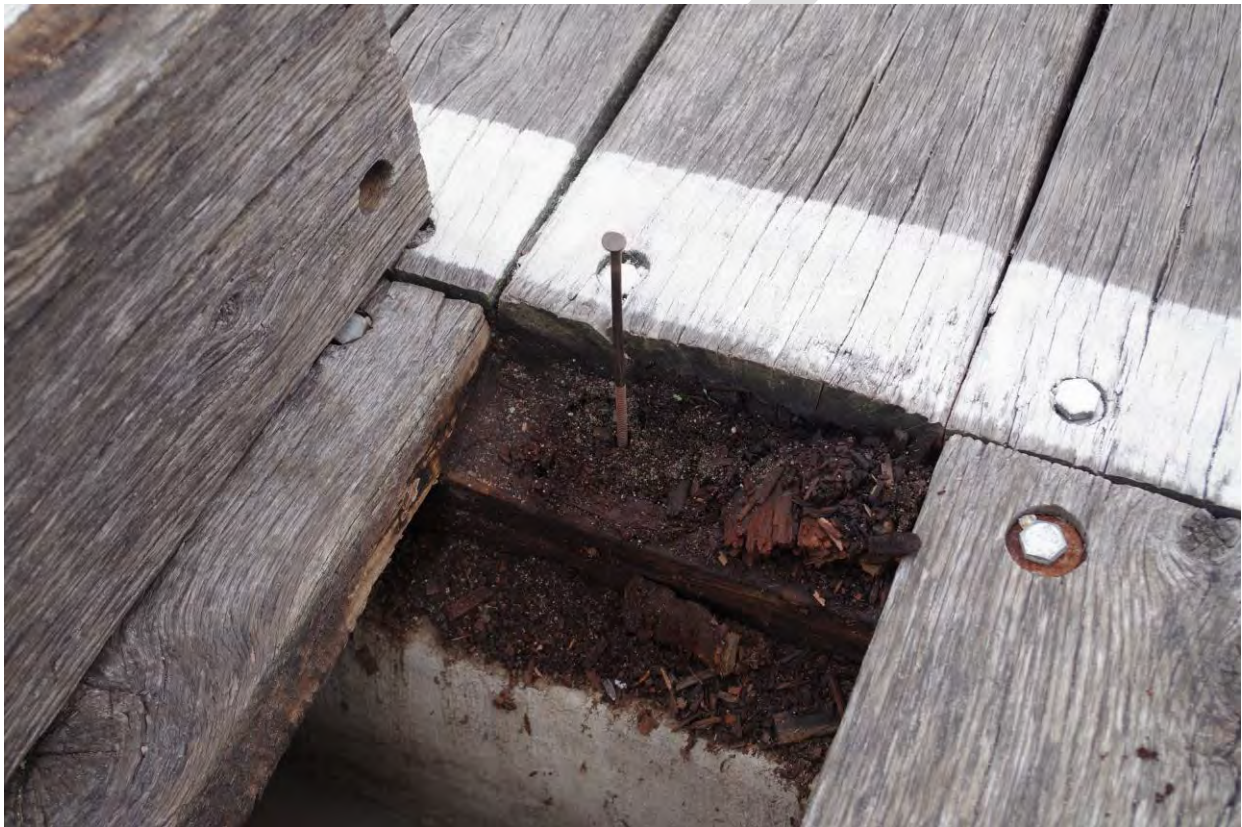
- Some planks have begun to rot and deteriorate, which is not unusual for the age of the untreated lumber.
- Deterioration and rot was noted in a few of the stringers, but this is not seen as a major condition issue with the trail at this time. Over time the rot/decay of the stringers will become a more major issue, as their replacement is a tedious and expensive task.

Figure 12: Deteriorated Stringer at North Trail

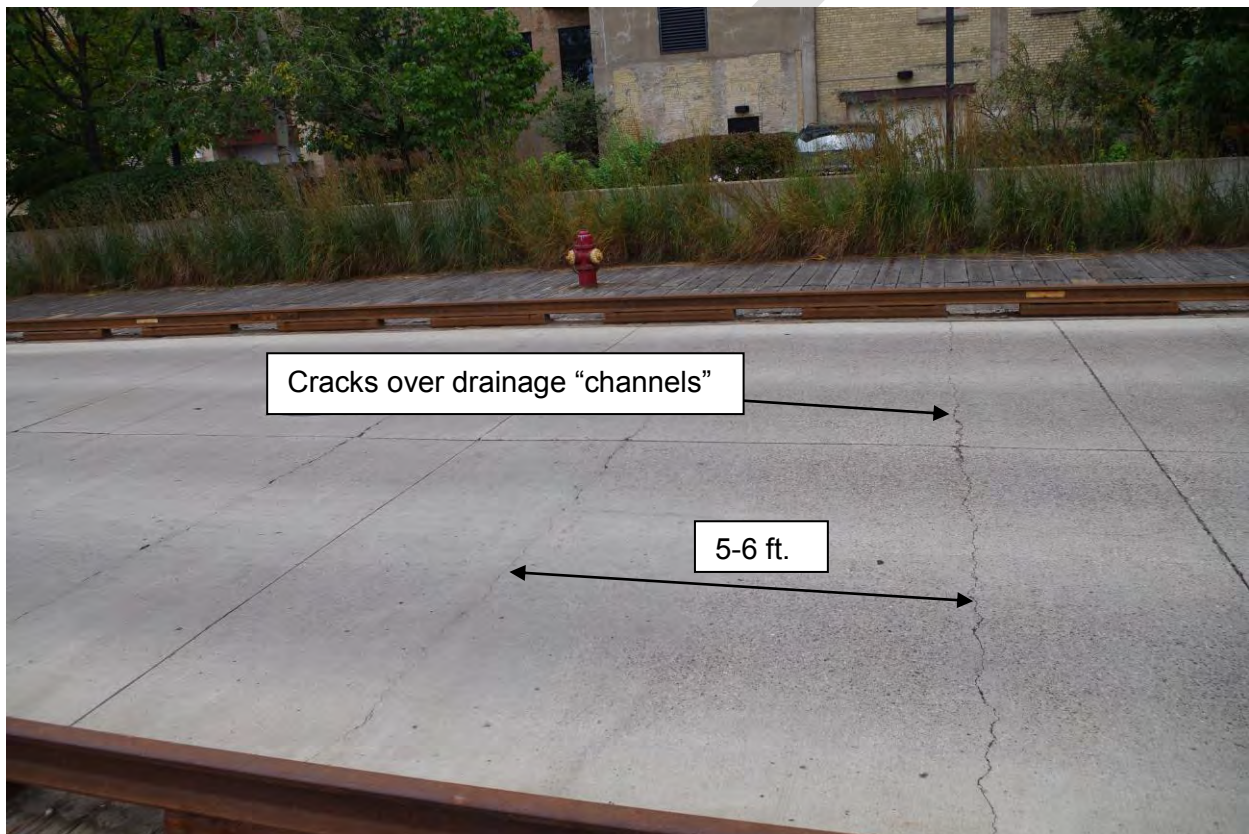
- Visual inspection of the gutter and channel system suggests that very little stormwater is reaching the channels.
- Transverse cracks in the concrete road, corresponding with the drainage “channels” below the roadway, are present every 5 -6 ft.

Figure 13: Transverse Roadway Cracks over "Channels" (Looking South)

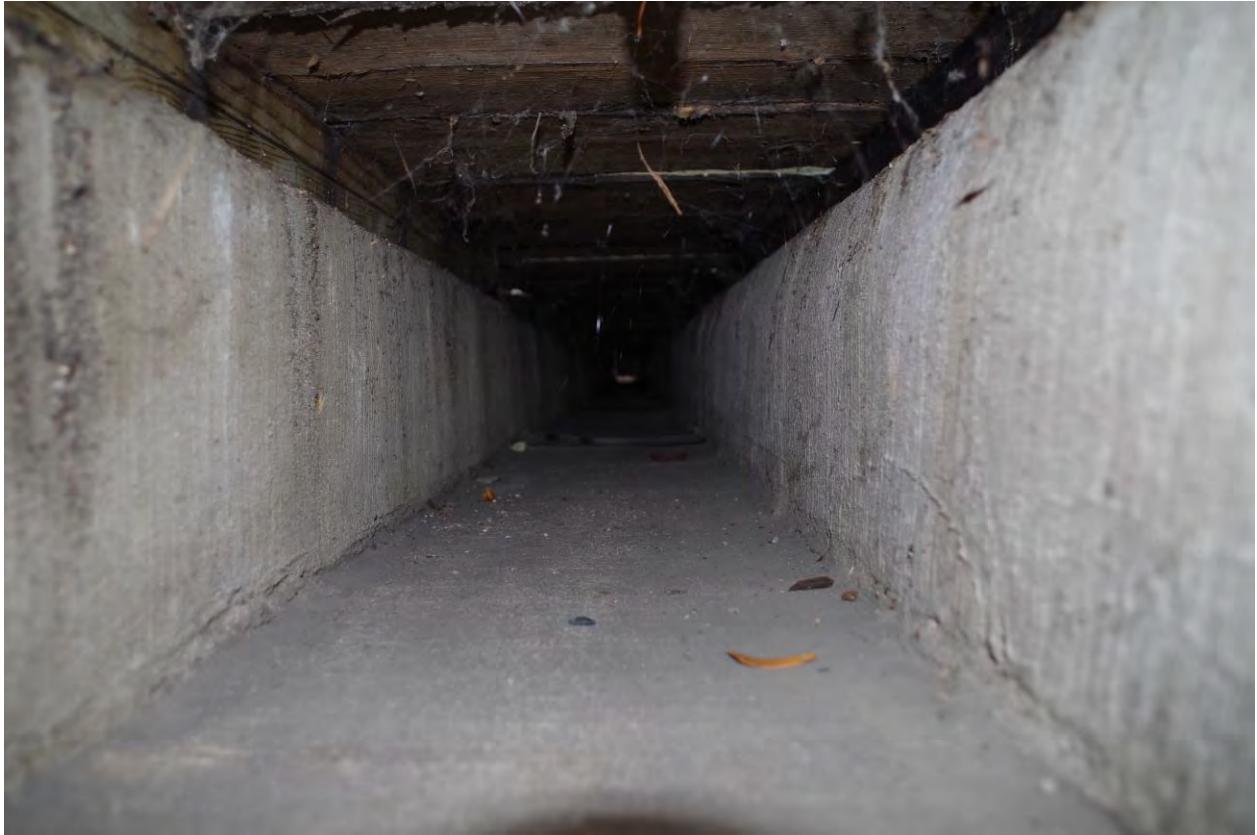
The day after a rain event WSB visited the plank road and observed that the concrete gutter system along the north end of the north trail appeared to be unused. The cleanliness of the concrete gutter after 10 years is evidence that it is not being used. The storm water is likely draining directly into the groundwater through the north trail's aggregate base. Figure 14 shows the gutter one day after a rain event.

Figure 14: Concrete Gutter System on North End of Trail

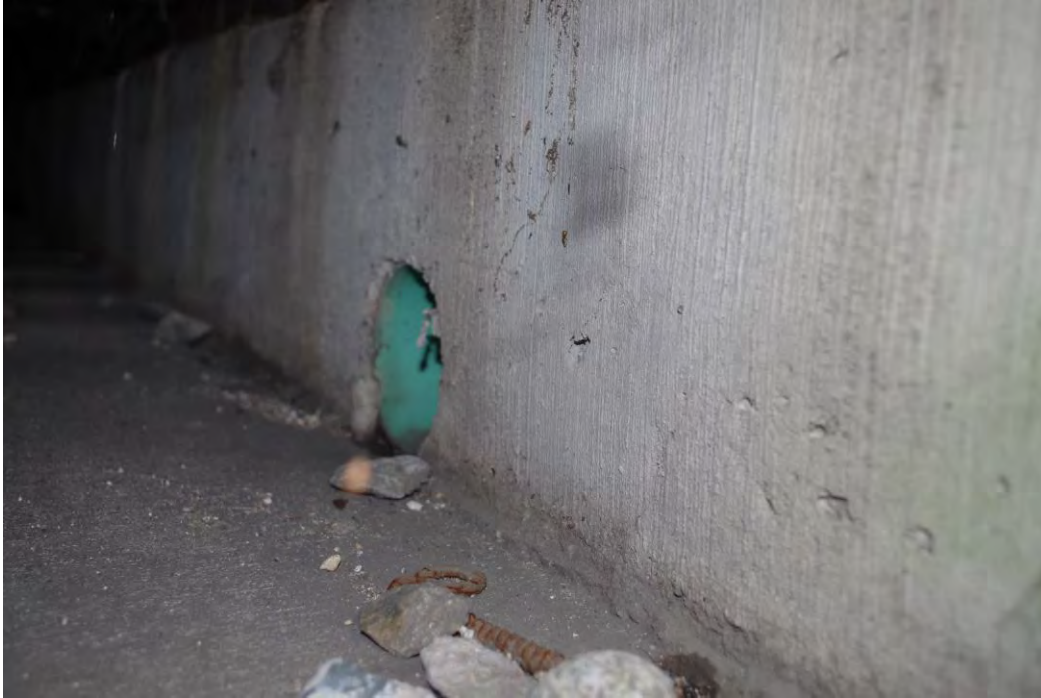
Figure 15: 4-inch Diameter Drain Tile Outlet to Concrete Gutter

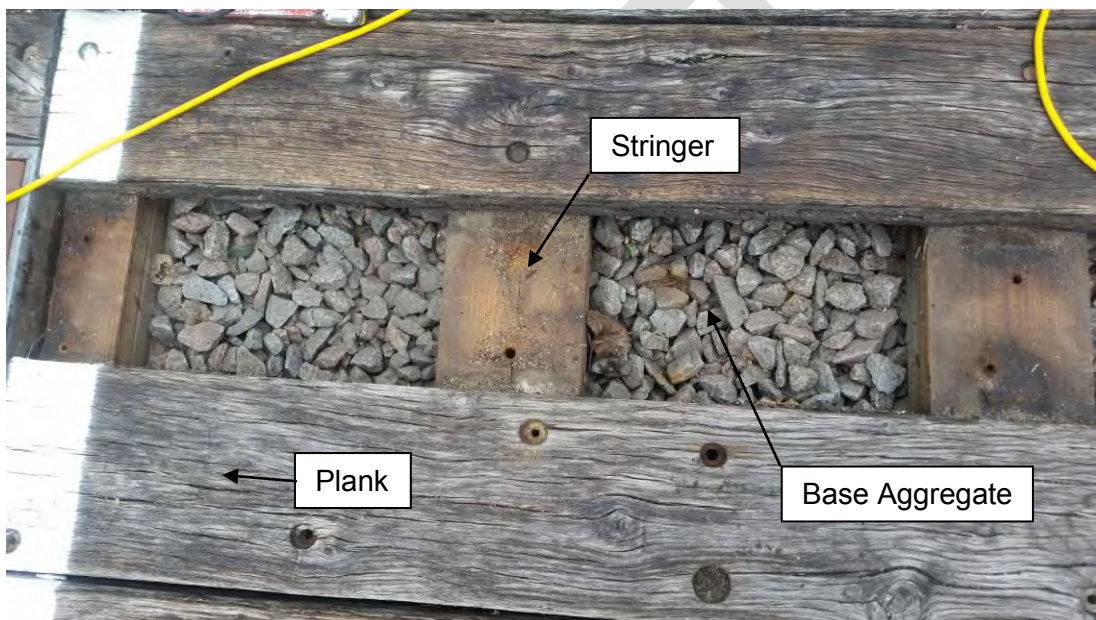
Settling of the base aggregate (under the stringers) has occurred on the north trail. The settling has stabilized and is not anticipated to continue. It is unknown whether or not the aggregate was properly compacted prior to the installation of the timber stringers. Since the trail is at-grade, it is susceptible to freeze/thaw cycles which can cause heaving. WSB performed structural calculations of the bearing requirements of the subgrade and has determined that this is not an issue. If major rework is done on the north trail, it is advised to install a concrete slab subgrade, which is similar to the south trail. This will ensure a more uniform settlement in the future.

Figure 17: Base Aggregate under Stringers on North Trail

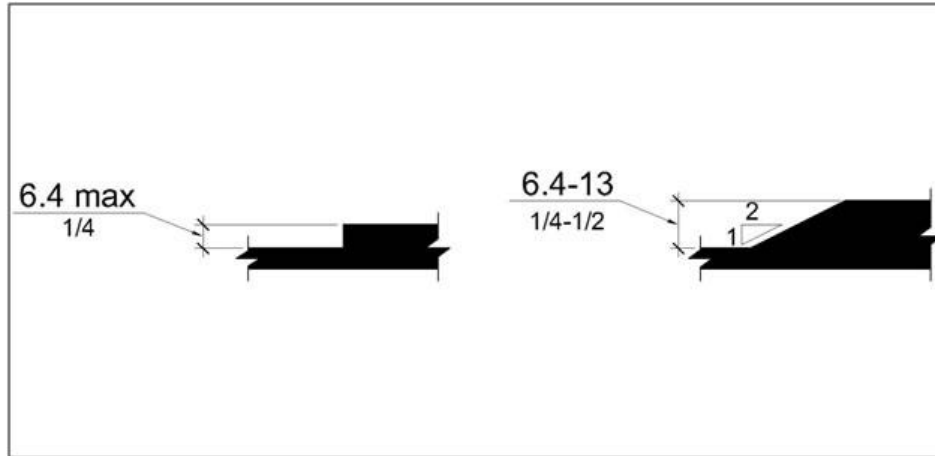
Vertical Surface Discontinuities: Vertical surface discontinuities shall be 13 mm (0.5 in) maximum. Vertical surface discontinuities between 6.4 mm (0.25 in) and 13 mm (0.5 in) shall be beveled with a slope not steeper than 50 percent, as shown in Figure 18. The bevel shall be applied across the entire vertical surface discontinuity. The plank road often violates the vertical surface discontinuities requirements due to the bowed nature of the planks. Figure 7 shows one instance of this. WSB would expect this condition to worsen as the planks continue to age.

Figure 18: ADA Vertical Surface Discontinuities

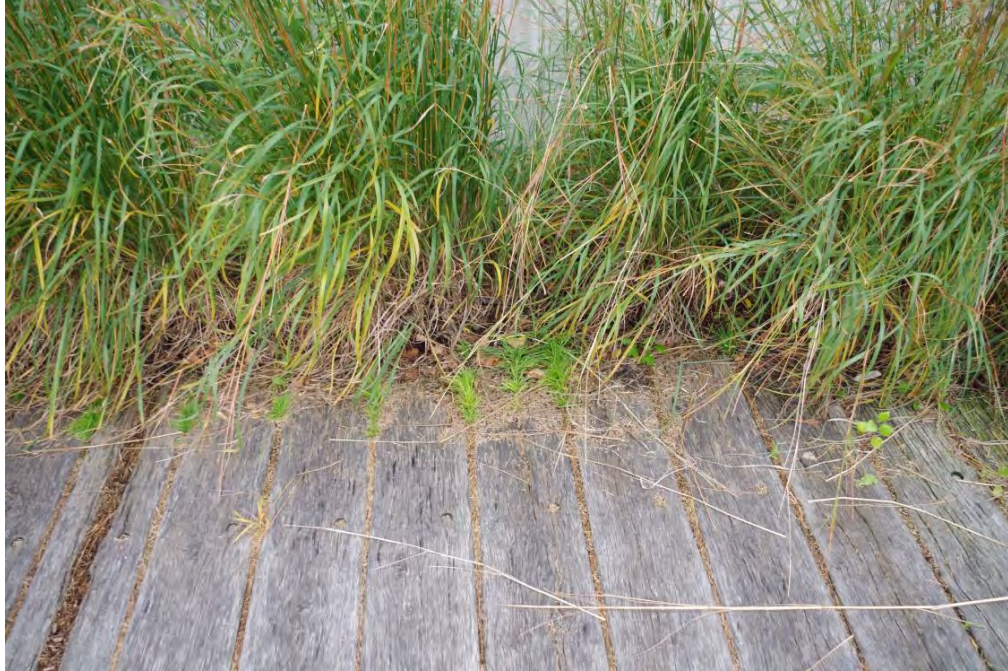
Figure B-3: Plank Rot and Landscape Vegetation on South Trail

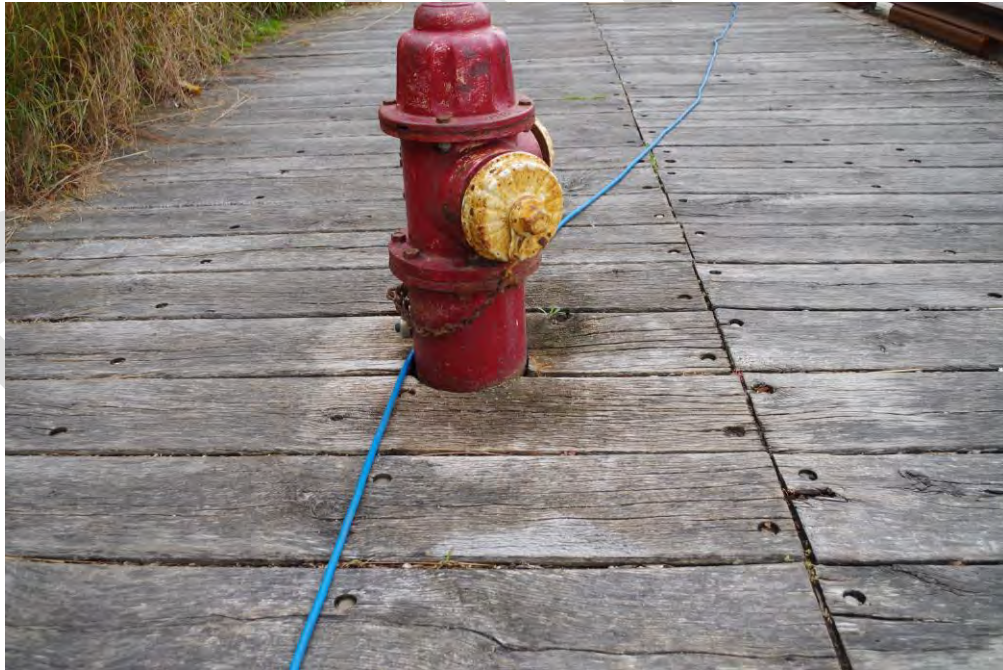
Figure B-4: Wood Rot around Fire Hydrant on South Trail

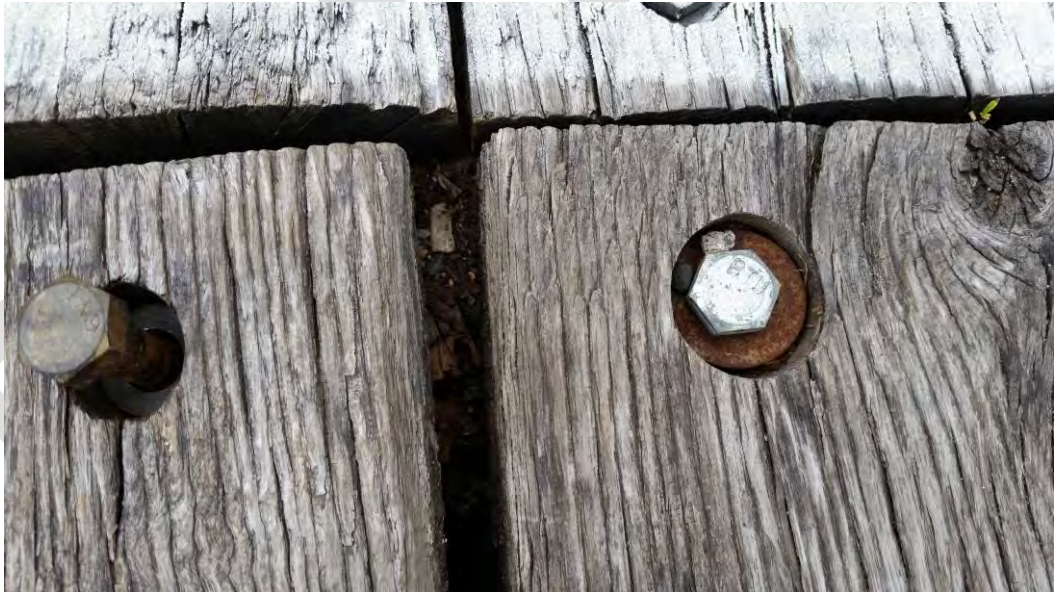
Figure B-6: Loose Countersunk Bolts

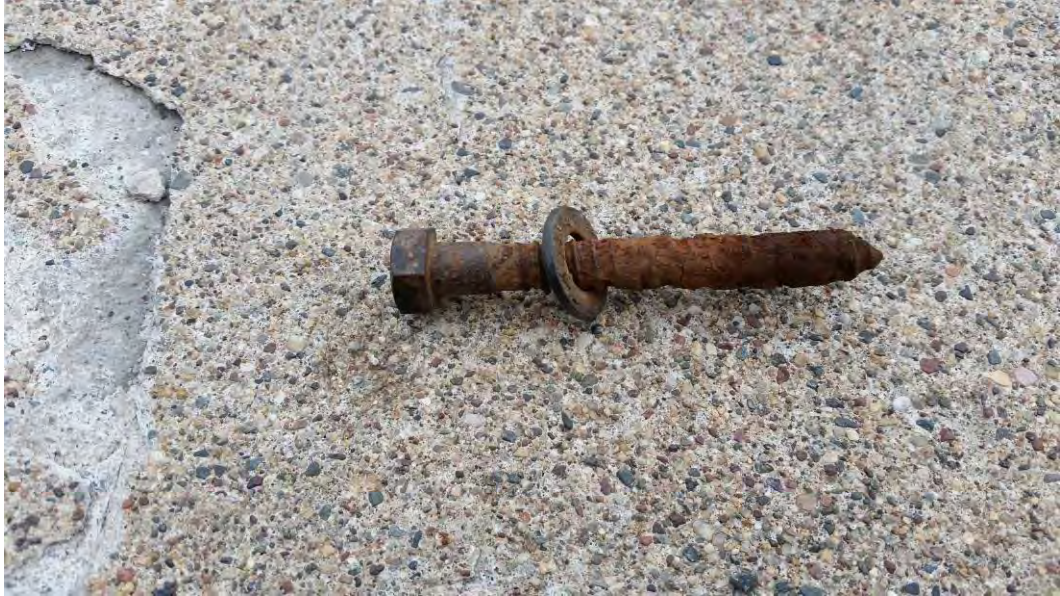
Figure B-6: Corroded Bolt with Thread Loss

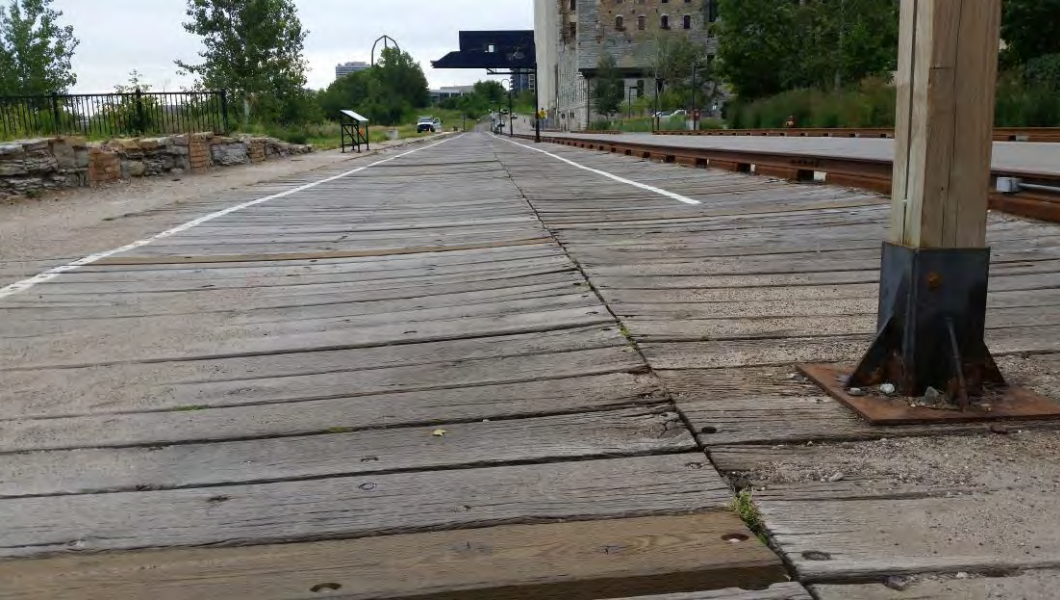
Figure B-7: Warping at Butt Seam/Joint in the Center of the North Trail

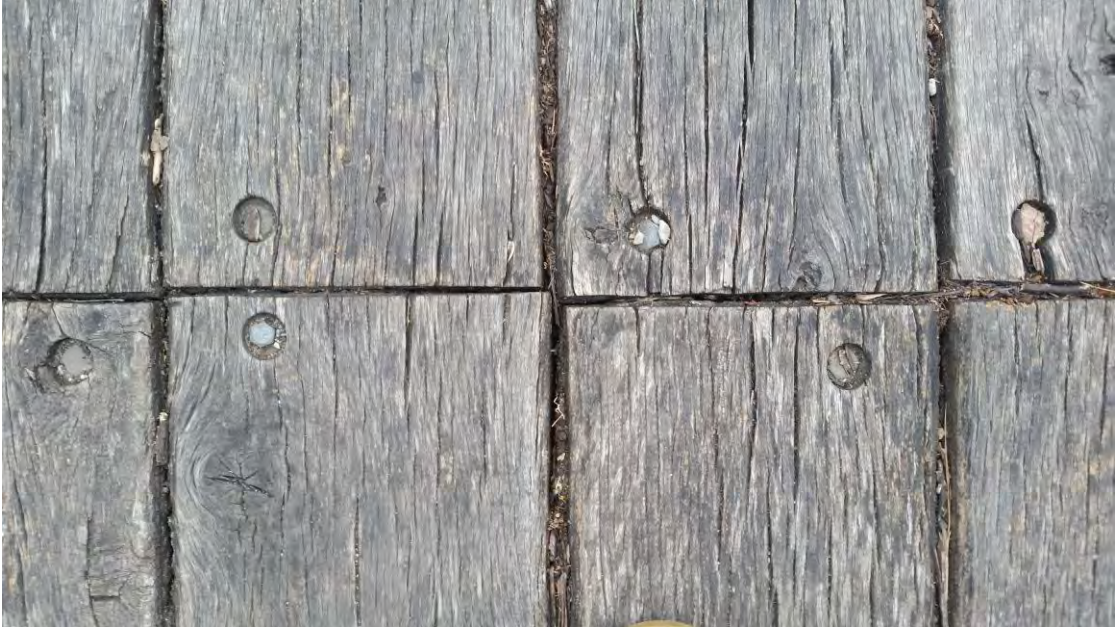
Figure B-8: Countersunk Holes Filled with Debris

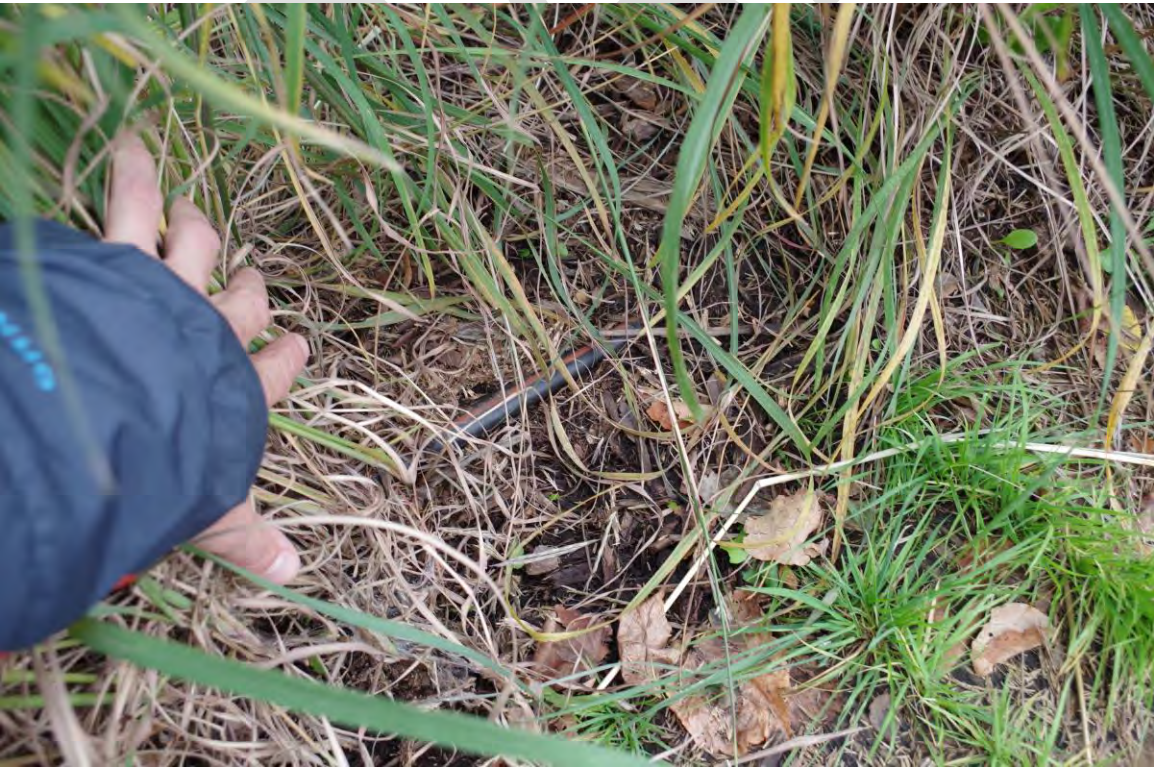
Figure B-11: Sprinkler System on the Border of the South Trail and Adjacent Building
