PREPARATORY SURVEY REPORT
ON
THE PROJECT FOR
REHABILITATION OF METEOROLOGICAL RADAR SYSTEM
IN
GUIUAN
IN
THE REPUBLIC OF THE PHILIPPINES

May 2014

JAPAN INTERNATIONAL COOPERATION AGENCY

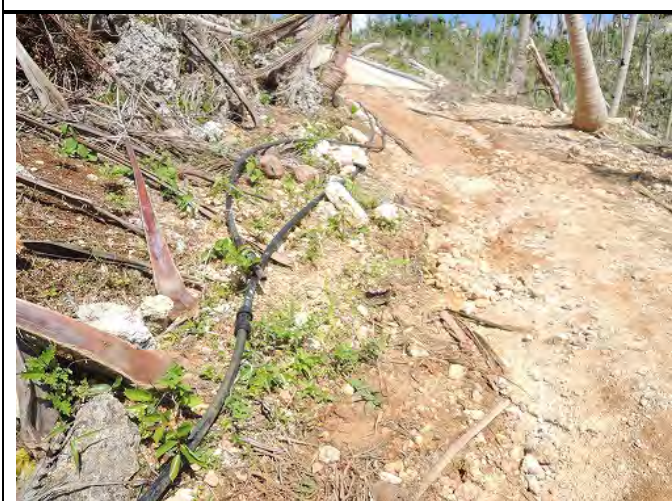
Water Supply Line of the Damaged Well

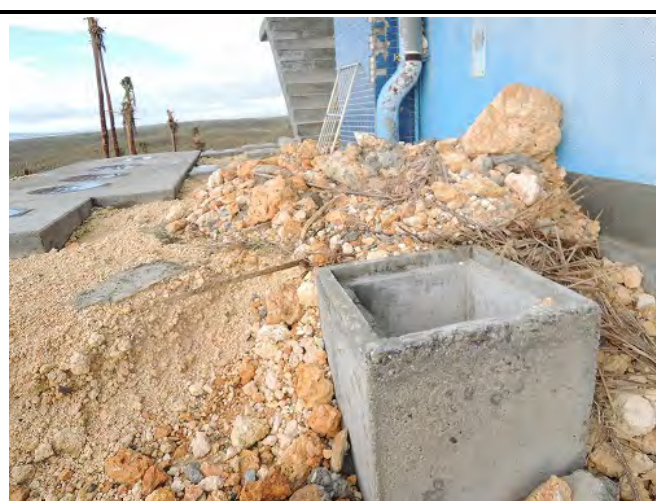
Manhole for Water Discharge (Concrete Cover is damaged)

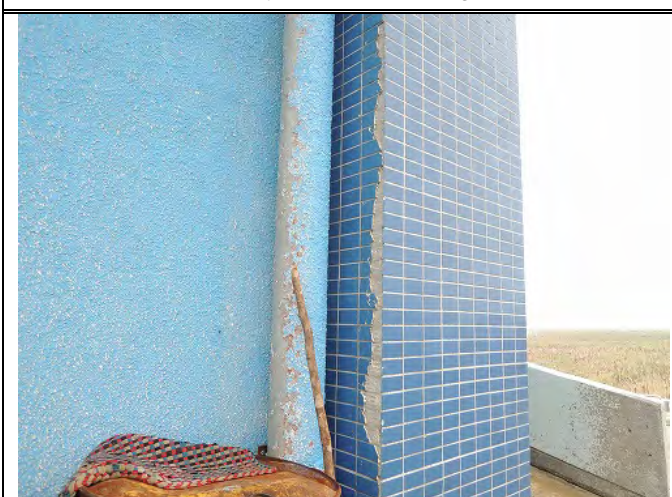
Exterior Wall, Gutter and Pillar with Peeling Finishing Materials
(By Stepping Stones of the Strong Wind)

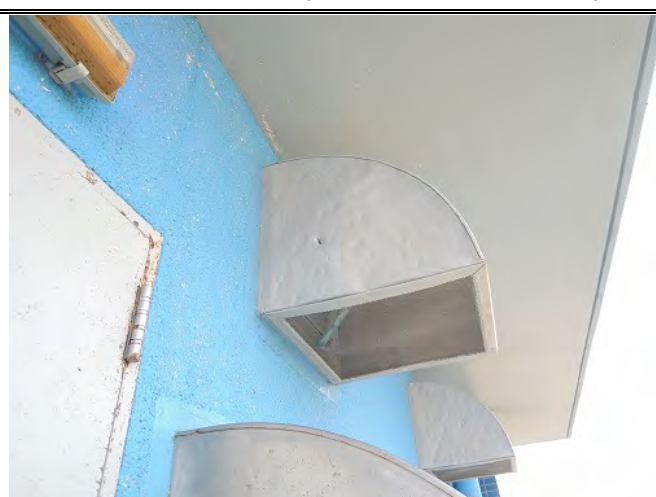
Exterior Stainless Hood
(By Stepping Stones of the Strong Wind)

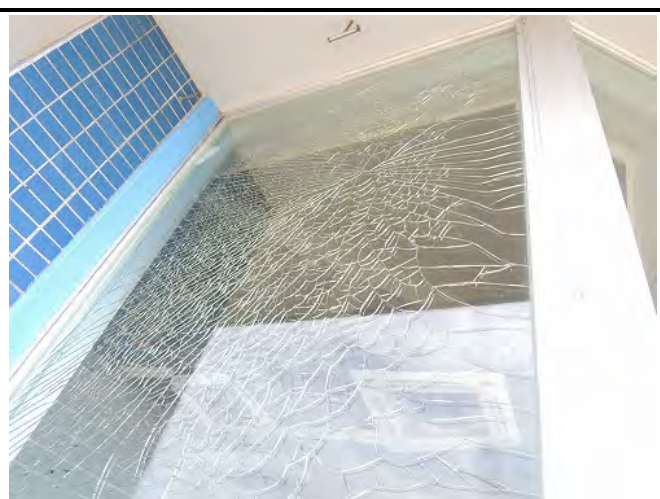
1F Observation Room
(Window Glass Broken by Stepping Stones)

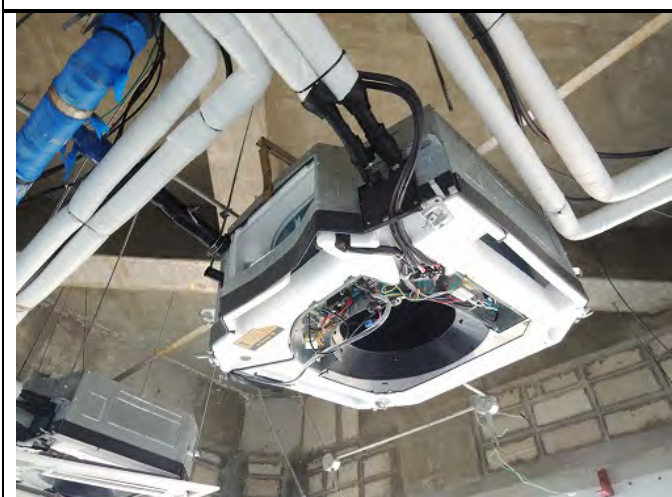
1F Observation Room (Air Conditioning Indoor Unit)

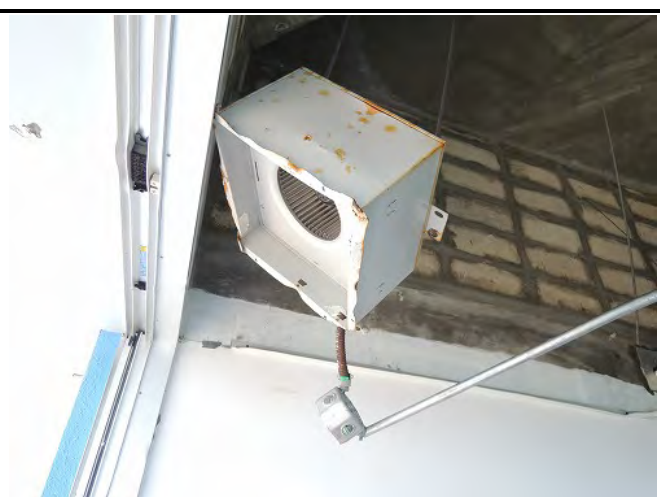
1F Data Analysis Room (Ceiling Exhaust Fan)

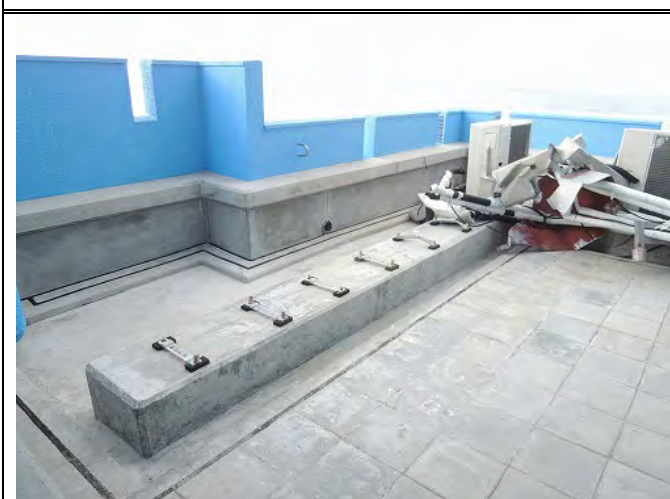
Roof
 Three of the seven air conditioning outdoor units disappeared due to the strong winds while four were damaged.

2F Roof (Air Conditioning Outdoor Unit Yard)

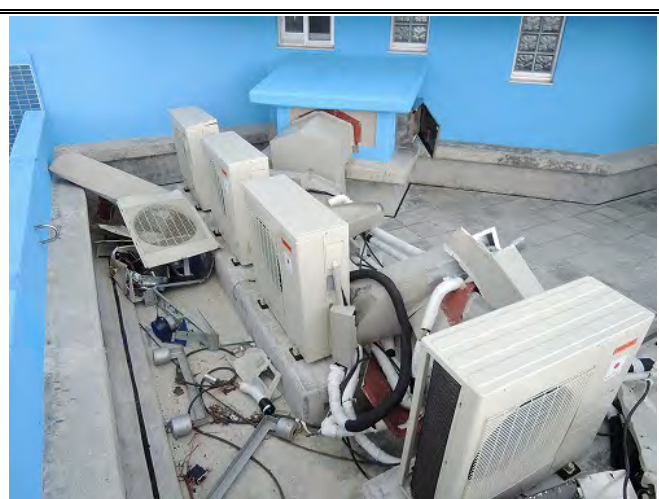
2F Roof (Air Conditioning Outdoor Unit Yard)

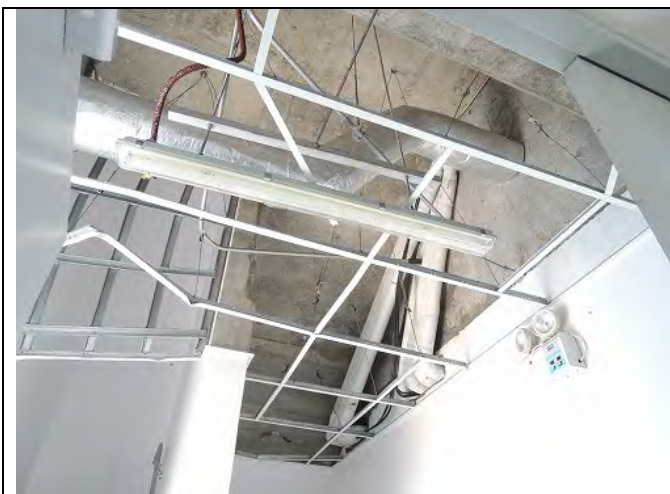
M4F Staircase (Ceiling)

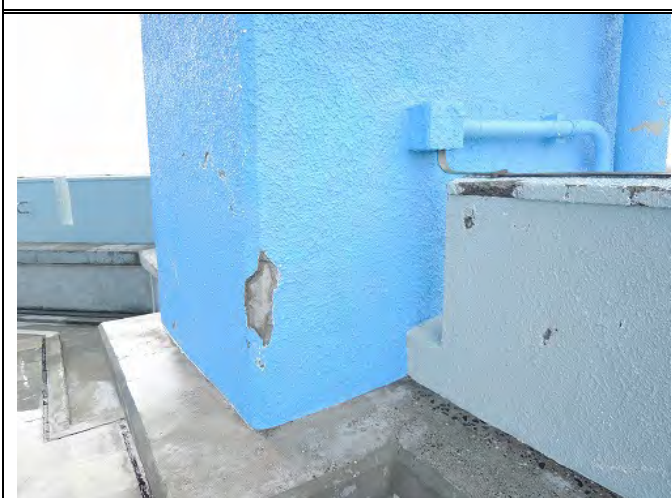
5F Observation Deck
(Collision Mark of the Air Conditioning Outdoor Unit)

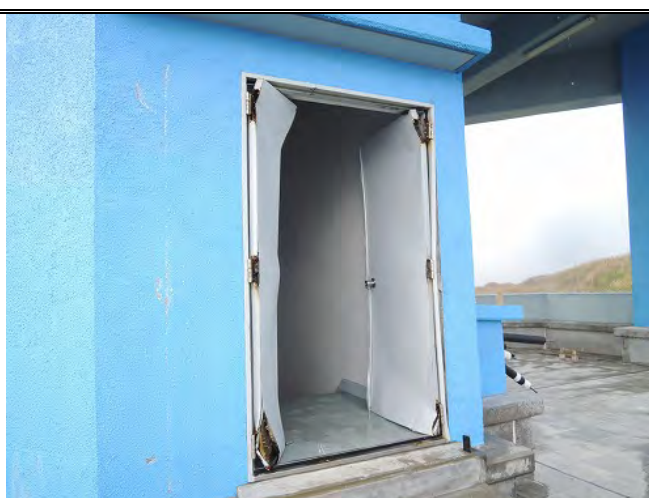
5F Observation Deck
(Steel Door)

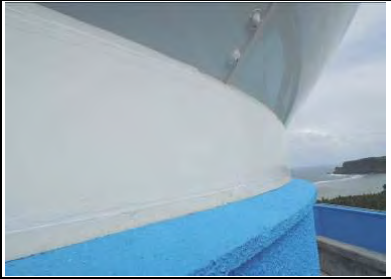
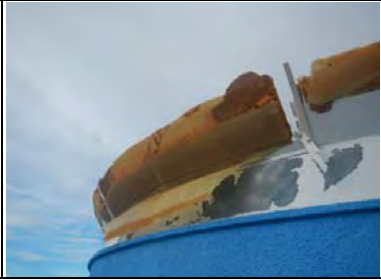
Radome (Base Ring)	Damaged	Replacement	Equivalent to the existing one

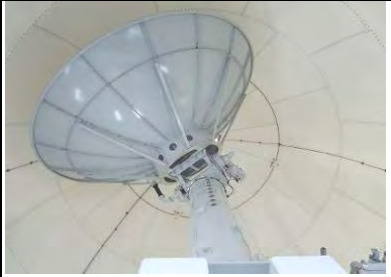
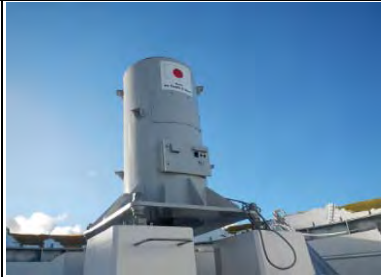
Radar Antenna (Meteorological Radar Antenna)	Missing	Replacement	Equivalent to the existing one

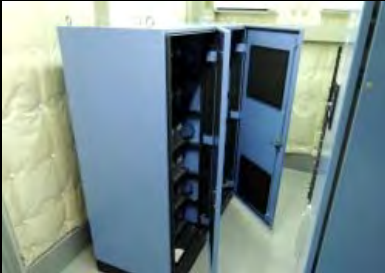
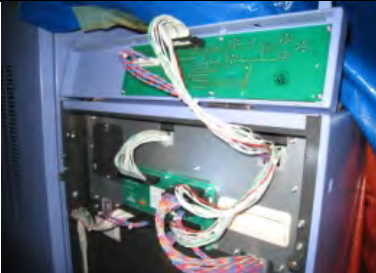
Power Supply Capacitor	Damaged	Replacement	Equivalent to the existing one (Replaced one to be utilized as spare parts)

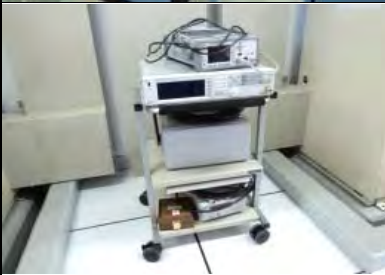
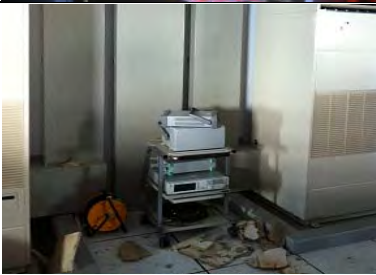
Measurement Equipment, etc.	Damaged	Replacement	Equivalent to the existing one

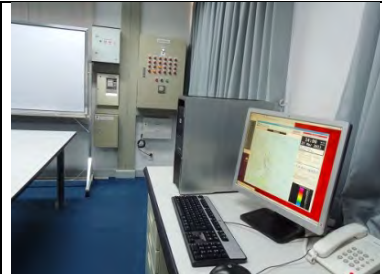
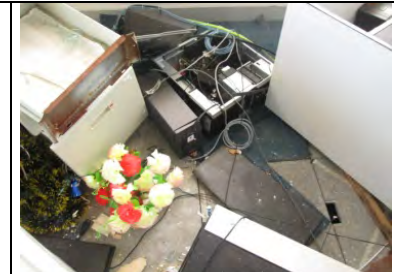
Meteorological Radar Data Display System					
Severe Storm and Doppler Velocity Indicator, Cyclone Tracking Monitor, Data Analysis Unit and Off-line Maintenance Computer	Destroyed	Replacement	Equivalent to the existing one

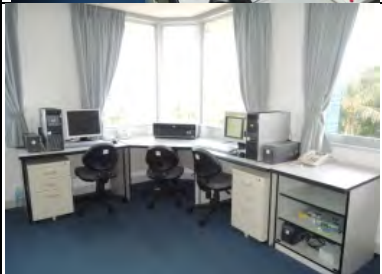
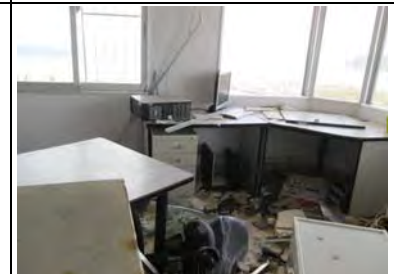
Compact UPS, Printer and Peripherals	Destroyed/ Damaged	Replacement	Equivalent to the existing one

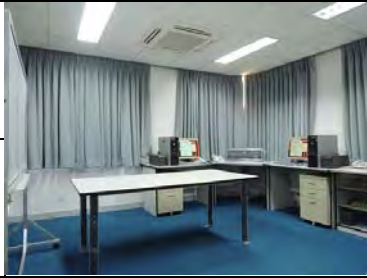
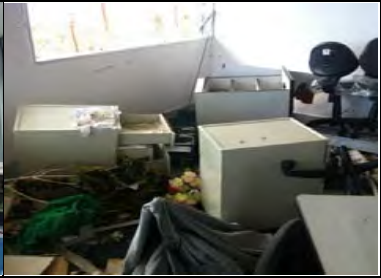
Access Floor (1F Observation Room)	Damaged	Replacement	Equivalent to the existing one

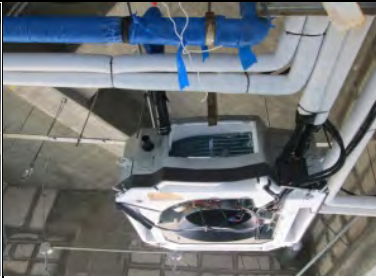
Air Conditioning Indoor Unit (1F Observation Room and Data Analysis Room)	Destroyed/ Damaged	Replacement	Equivalent to the existing one

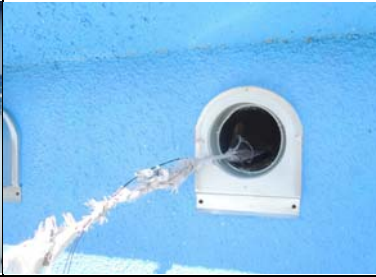
Bent Cap for Exhaust of Fan (1F and M4F)	Missing/Destroyed	Replacement/ Reinforcement	<ul style="list-style-type: none"> ■ Missing and destroyed bent cap will be replaced with a new one. ■ Reinforcement fixing with bolt.

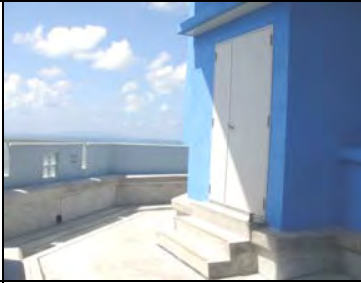
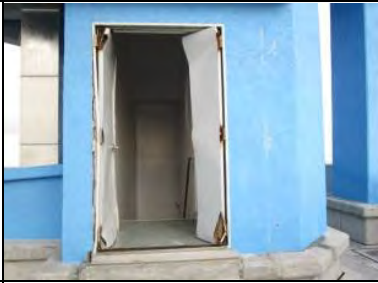
Exterior Door (5F)	Destroyed	Replacement/ Reinforcement	<ul style="list-style-type: none"> ■ To allow for a wider cover width between the door and the door frame to be strengthened by steel angles in the indoor side. ■ To add internal reinforcement and replace with a steel door which has a thick surface panel.
