**SIB 51 24 20**

**SERVICE ACTION: RENEW INTERIOR MIRROR HOLDER**

<b>E-Series</b>	<b>Model Description</b>	<b>Production Date</b>
I01	i3	July 8, 2020-August 6, 2020

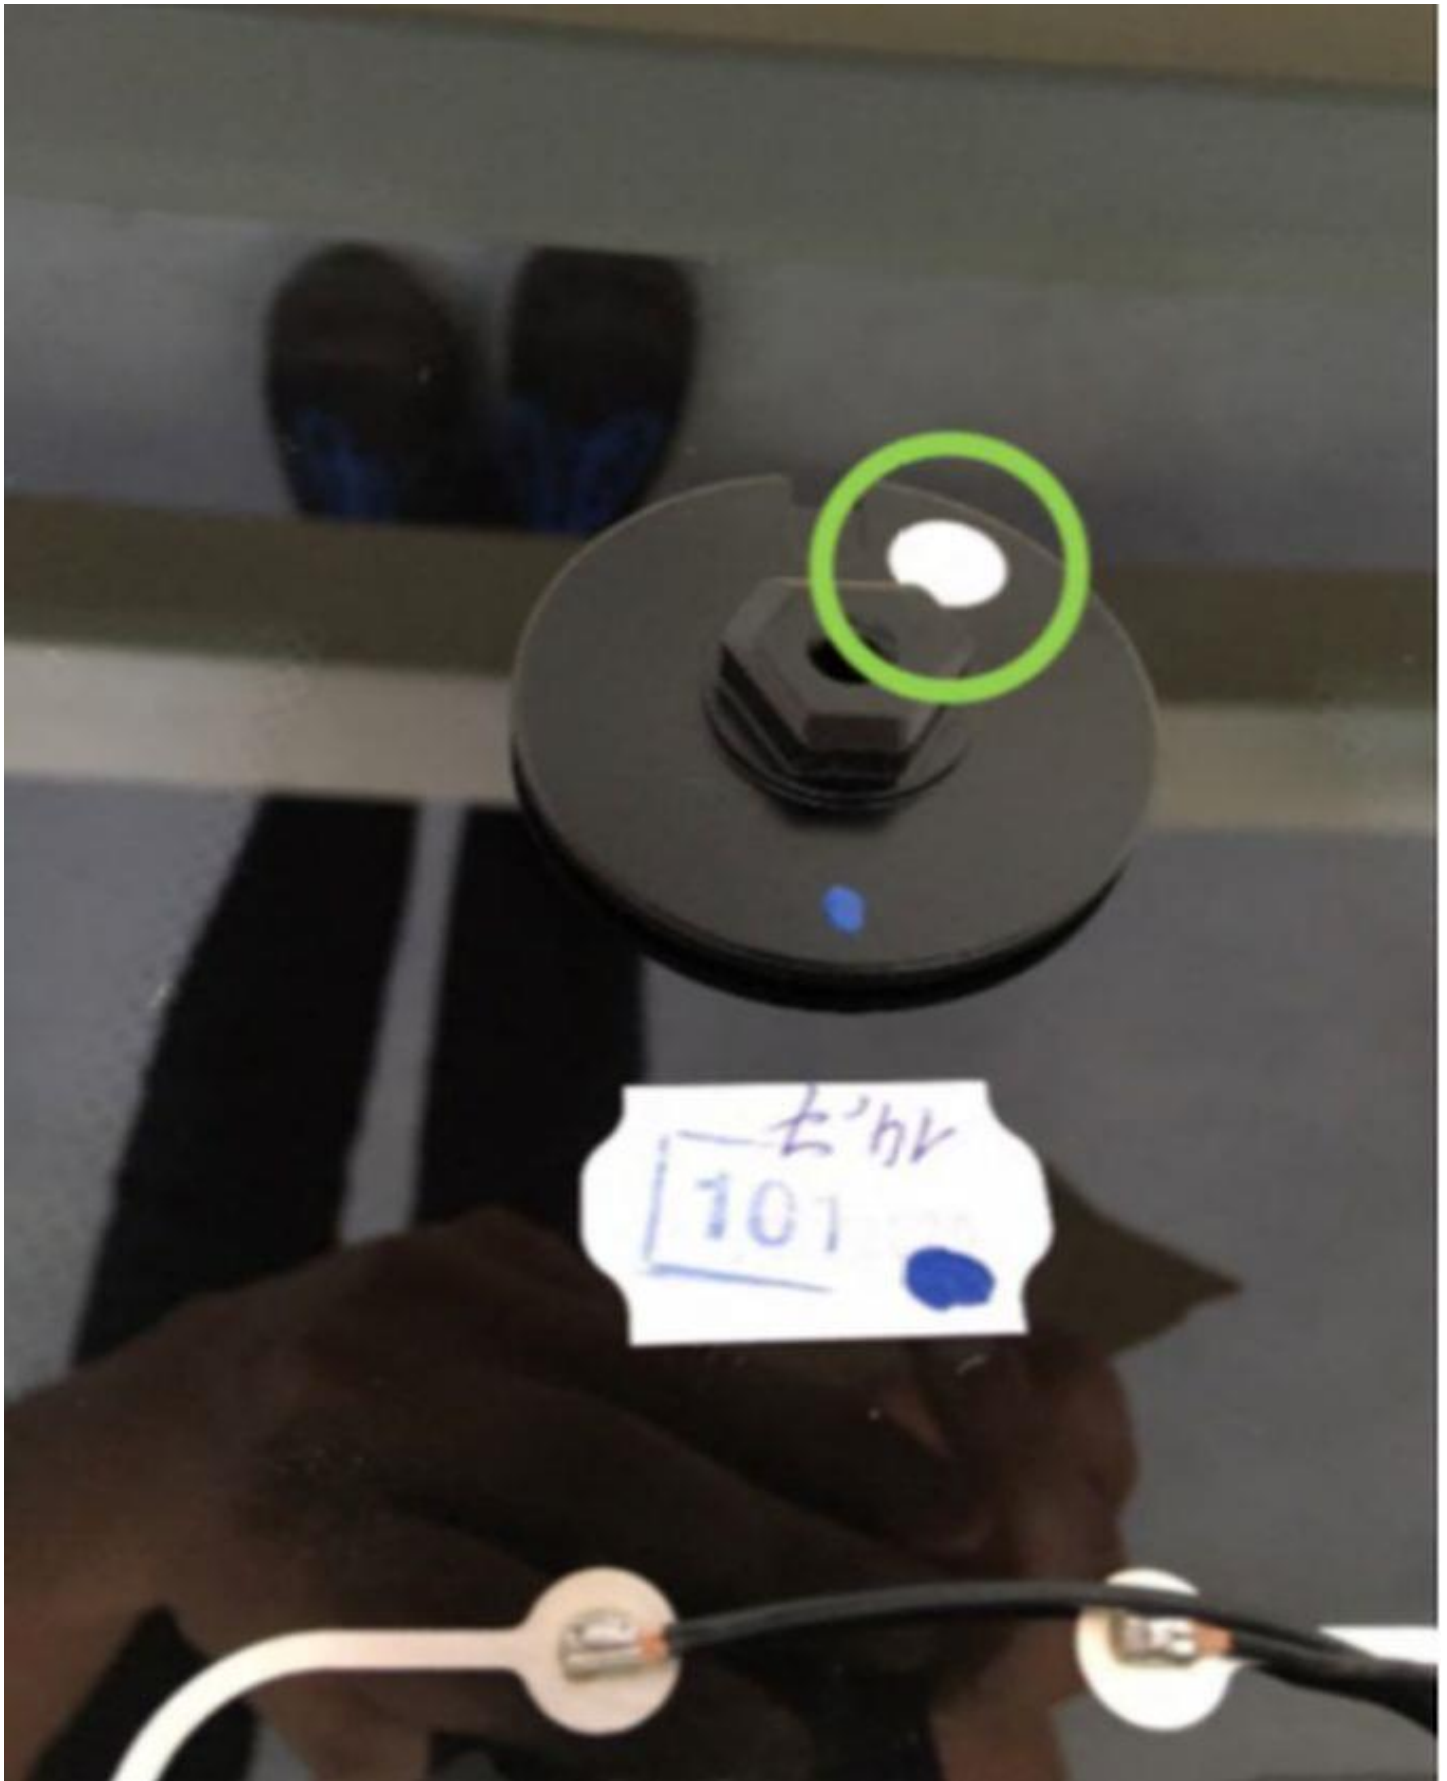
Check whether the mirror base is marked with a white dot as shown below:

2. Is the white dot present?

**Yes:** No further correction required. The mirror holder was correctly installed. Reassemble vehicle.  
**No:** Continue to step 3.
