# Product Safety Recall

## 18015 Front Passenger Air Bag Inflator

Reference Number: N161644424

Release Date: December 2018  
Revision: 00

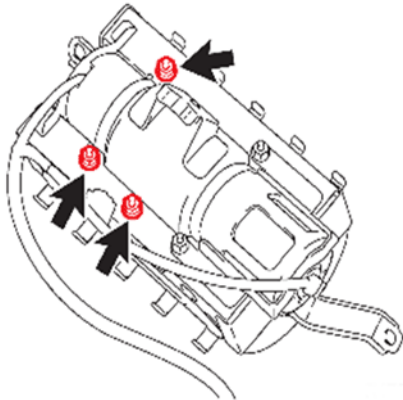
4751083

**Important:** If any gap exists, the aligned flats may move apart, resulting in failure in normal deployment of the air bag.

8. Remove the 3 remaining old self-locking nuts and install temporarily 3 NEW self-locking nuts by hand. Store the removed self-locking nuts in a replacement part box or the like.
9. Push the inflator and plate towards the position determining plate to eliminate any gap.

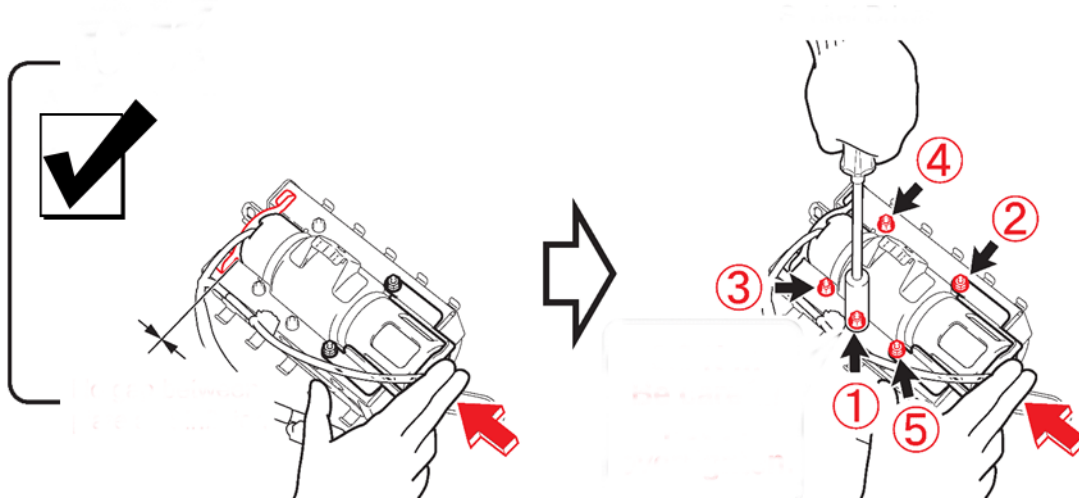
4751085

**Important:** The tightening torque is low (3.9 N·m). Use of an air ratchet wrench or tightening strongly with a T-handle wrench or a ratchet handle may cause deformation of the stud bolt.

10. Tighten 5 nuts evenly in several increments in the order shown above using a socket driver while pushing the inflator and plate. You will encounter some resistance during tightening because these nuts are self-locking nuts. Torque: 3.9 N\*m (40 kgf\*cm, 35 in.\*lbf).
11. Install the harness clip to the center stud after all 5 nuts have been torqued.
