Put Your Report Title Here

Infra-Red Imaging Documentation

Infrared Moisture Survey Report

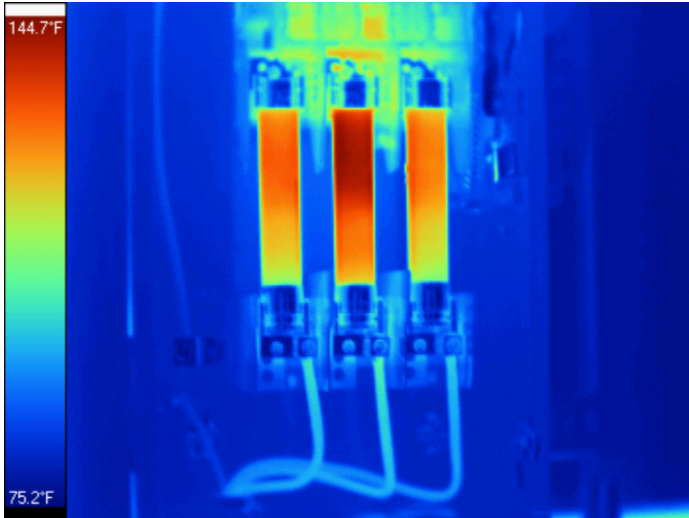
Location: Utility Room A-27 Panel B7		
Temperature Information		
High	Low	Average
144.7°F	75.2°F	86.5°F
Calibration Range	BkGround Temp	Emmissivity
32.0°F .. 212.0°F	68.0°F	94
Image Time Stamp: -		
Observations / Comments		
-

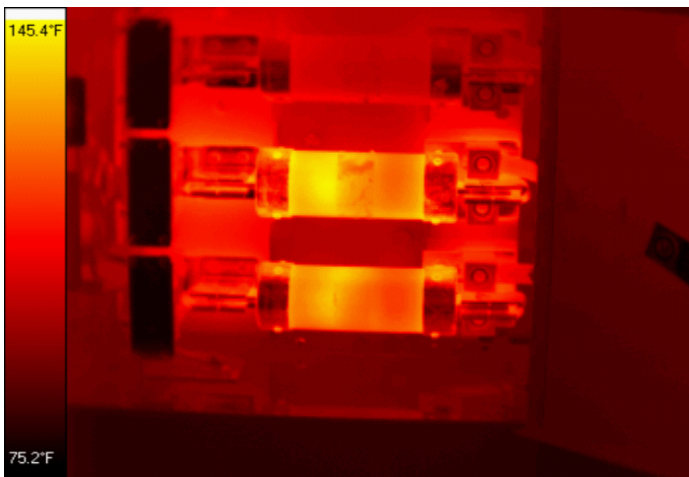
Location: Elevator Control Room - Panel 3		
Temperature Information		
High	Low	Average
145.4°F	75.2°F	99.3°F
Calibration Range	BkGround Temp	Emmissivity
32.0°F .. 212.0°F	68.0°F	94
Image Time Stamp: -		
Observations / Comments		
-

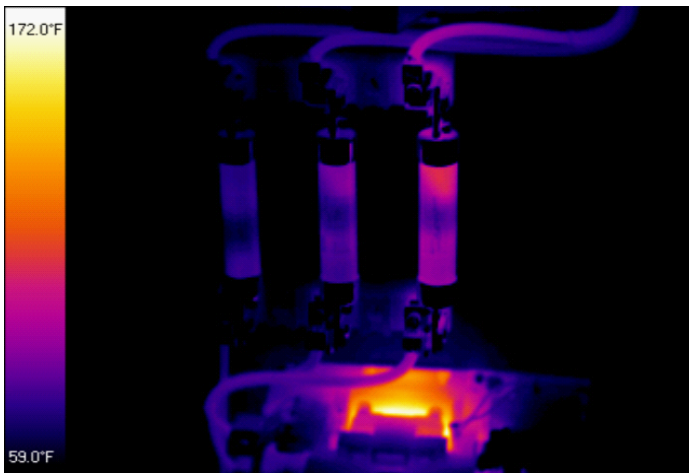
Location: Rm A-245 Main Sub Panel		
Temperature Information		
High	Low	Average
172.0°F	59.0°F	81.9°F
Calibration Range	BkGround Temp	Emmissivity
32.0°F .. 212.0°F	68.0°F	94
Image Time Stamp: -		
Observations / Comments		
-

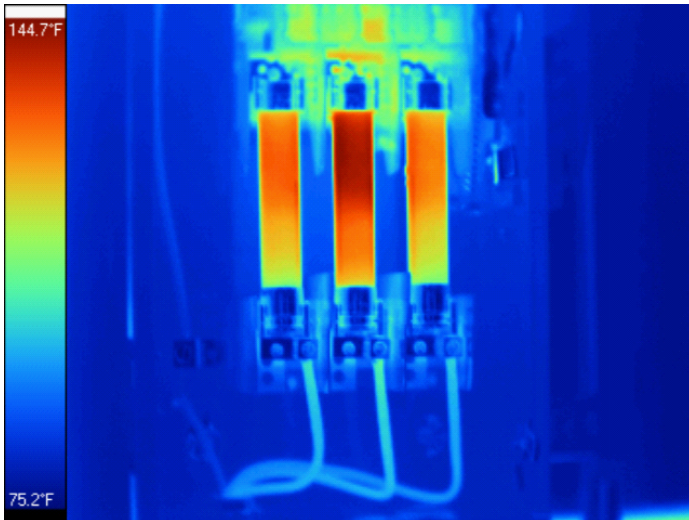
Location: Utility Room A-27 Panel B7		
<u>Temperature Information</u>		
High	Low	Average
144.7°F	75.2°F	86.5°F
Calibration Range	BkGround Temp	Emmissivity
32.0°F .. 212.0°F	68.0°F	94
Image Time Stamp 8/31/2005 10:41:26 AM		
Camera Info	Lens Type	Sensor Size
Model: FLXP320		320 X 240
Additional Image Comment:

Observation: There are no 'exact' industry level standards for these repairs as yet. The above suggestions are based on our experience with the systems and emerging repair practices. Stephen Advanced Technology, Inc. makes no warranty whatsoever for the suggested repair methods.

Suggestions: We suggest the appropriate professional be consulted for this condition and all repairs be made according to manufactures guidelines.

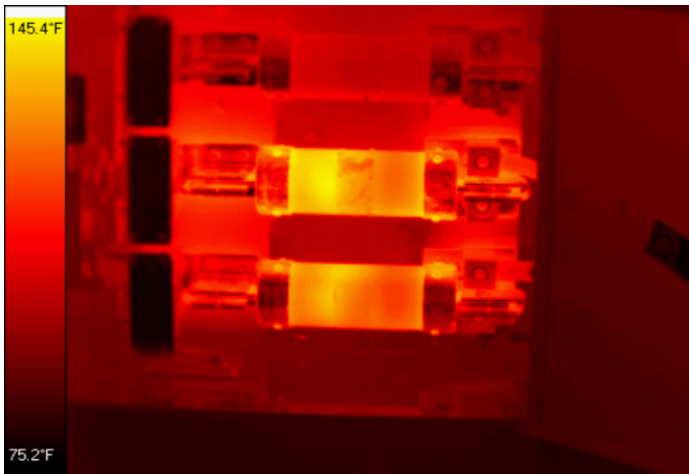
Location: Elevator Control Room - Panel 3		
<u>Temperature Information</u>		
High	Low	Average
145.4°F	75.2°F	99.3°F
Calibration Ran	BkGround Temp	Emmissivity
32.0°F .. 212.0°F	68.0°F	94
Image Time Stam 8/31/2005 11:01:12 AM		
Observations / Comments:

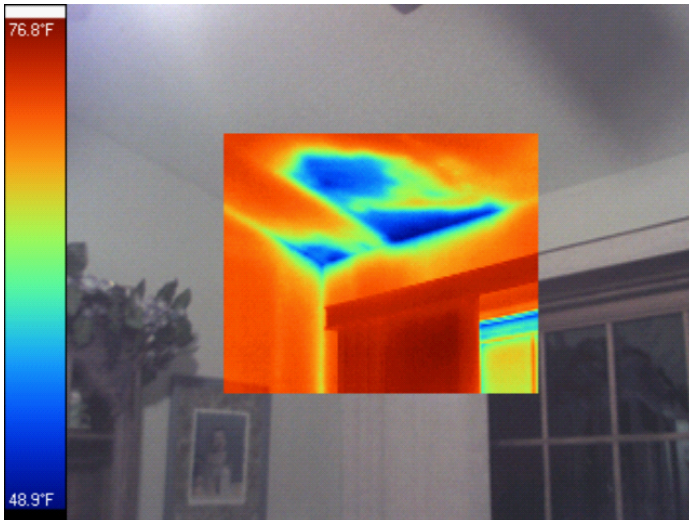
Location: South West Corner of Living Room (be		
<u>Temperature Information</u>		
High	Low	Average
76.8°F	48.9°F	68.9°F
Calibration Range	BkGround Temp	Emmissivity
-4.0°F .. 212.0°F	68.0°F	94
Image Time Stamp 12/23/2005 9:27:30 PM		
Camera Info	Lens Type	Sensor Size
Model: FLXP320F		320 X 240
Additional Image Comment:

Observation: Both InfraRed Thermal Imaging & Moisture Scan Meter confirmed water intrusion in corner / ceiling & walls directly below the improper deck termination. We feel this is the primary source of the report after intrusion

Suggestions: Deck termination needs to be properly repaired and reflashed. Suggest follow-up scans 2-3 months after repairs are complete to be sure area is drying out.

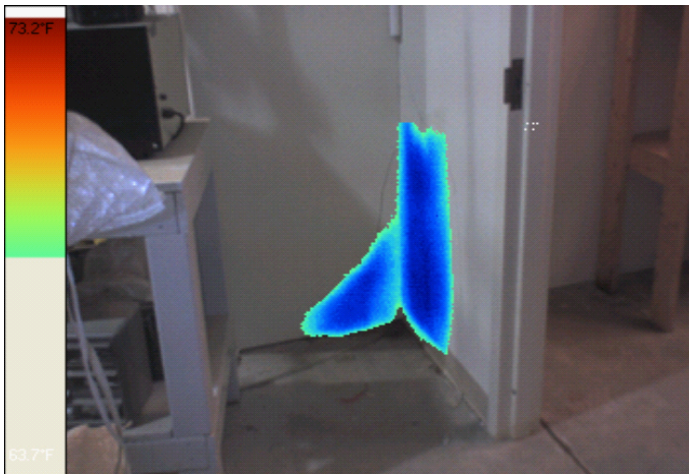
Location: Utility Room directly below Kickou		
<u>Temperature Information</u>		
High	Low	Average
73.2°F	63.7°F	67.1°F
Calibration Ran	BkGround Temp	Emmissivity
-4.0°F .. 212.0°F	70.0°F	89
Image Time Stam 8/29/2006 12:38:44 PM		
Observations / Comments:

Infra Red scan confirmed water intrusion in wall directly below missing Kickout detail. The improper kick-out / roof terminations need to have a proper flashing installed or the current flashing modified or replaced and sealed to prevent water intrusion through the system at these areas. During the installation of any flashing the immediate area can be inspected for wood rot or damage. Any other roof flashing in the area should also be checked as they sometimes can be a contributing cause. We suggest that the sidewall flashings of the roof be set in roof cement in the areas of kickouts as a preventative measures. These areas need to be addressed as discussed in Cpt 3.4.
