PV Module and System Fault Analysis

VijyantMahajan

Thesis Supervisor: Dr. David Parlevliet

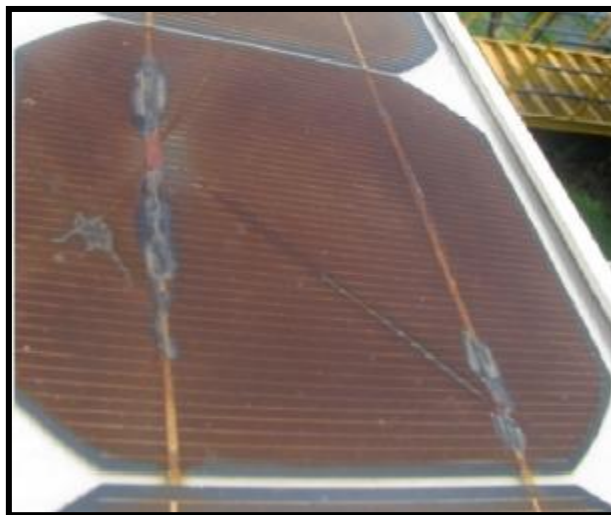
Metallization refers to the fingers and bus bars that criss-crosses the surface of the solar cell and gather the charge carriers for exporting outside of the module. It occurs on the metal and other parts of the photovoltaic module, except the glass or the actual cell. Corrosion of metallization can be easily seen at the fingers, interconnects and at the bus bars as shown in Figure 28 but sometimes it is not easily visible if the encapsulant is discoloured due to corrosion as well. (Rajiv Dubey, 2014).

Figure 28: Corrosion marks on Bush bars and interconnects (Source: (Rajiv Dubey, 2014))

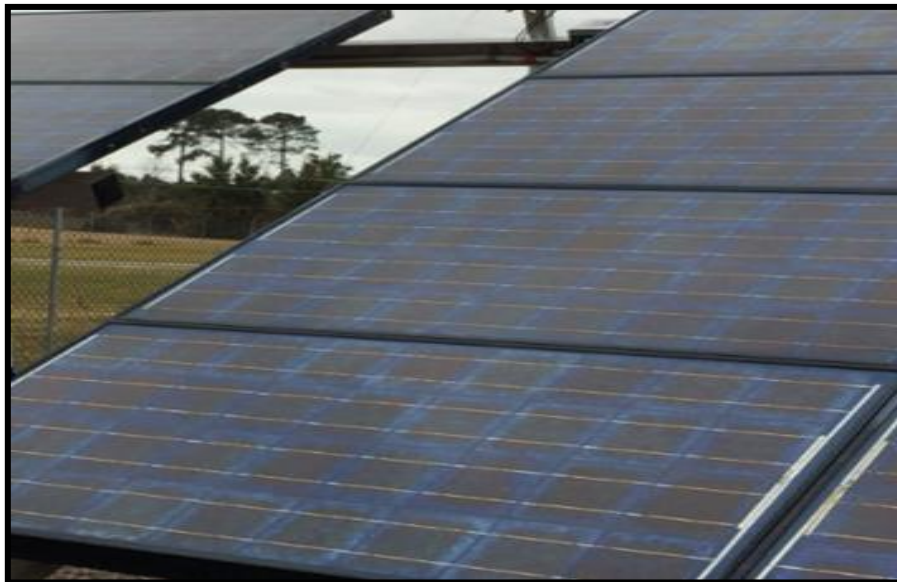
Figure 29: Discoloration shown in the solar cell of the PV module. (Source: Photo taken at Murdoch University, Perth on October 2014)

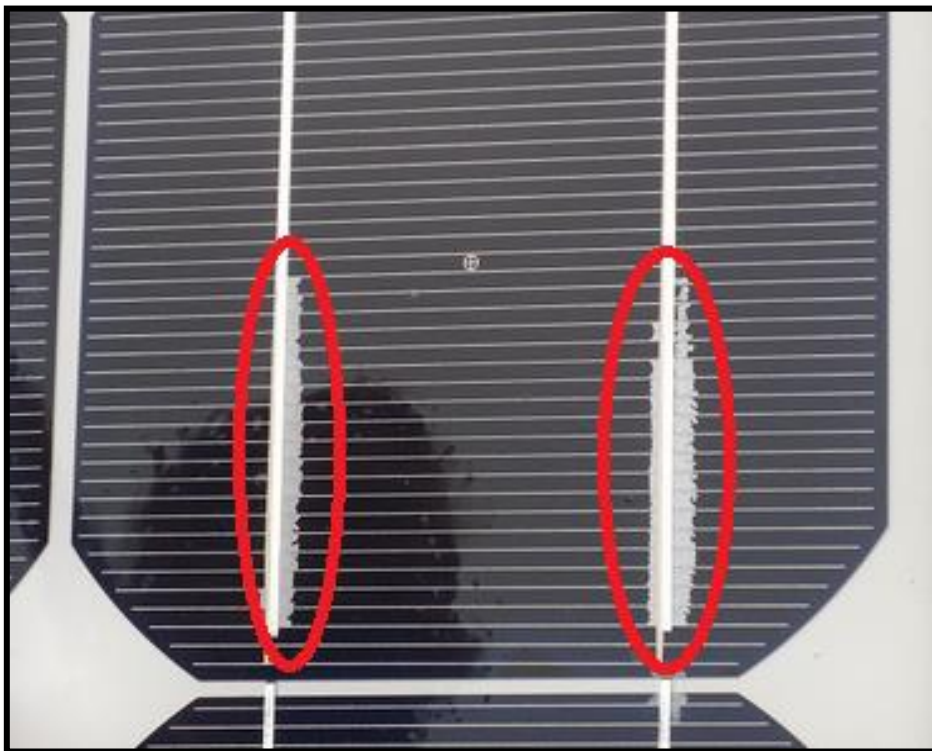
During manufacturing, this process is to be done at its mentioned temperature and pressure conditions for specific time. If the process is not performed properly or in the case of cheap or unsuitable material being used for this process, EVA will delaminate later during the operation of the PV module in the field. The layer of EVA gets dissolved or reacted with moisture to form white milky colour.

This will affect the performance of the cell. If the cell is used continuously after its delamination, moisture may get into the cells causing corrosion and other on-going damage to the module. (Clean Energy Investment, 2014)

Figure 32- Delaminated PV module (Source: (Clean Energy Investment, 2014))

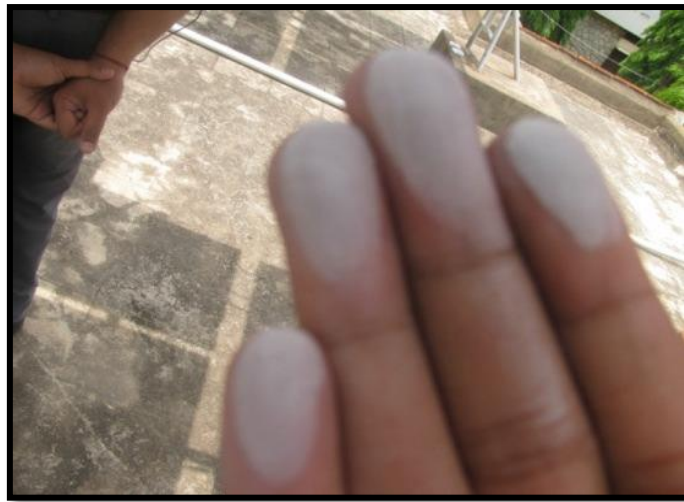
Degradation of adhesion strength also leads to delamination of back sheet and encapsulant. Adhesion performance is directly dependent on the moisture and temperature of the site. Photo-thermal degradation of the back sheet polymer results in the chalking of the back sheet as shown in Figure 34. This is caused by the heat from the environment which causes the back sheet polymer to degrade. (Rajiv Dubey, 2014)

Figure 34: Chalking of the Back sheet of PV module (Source: (Rajiv Dubey, 2014))

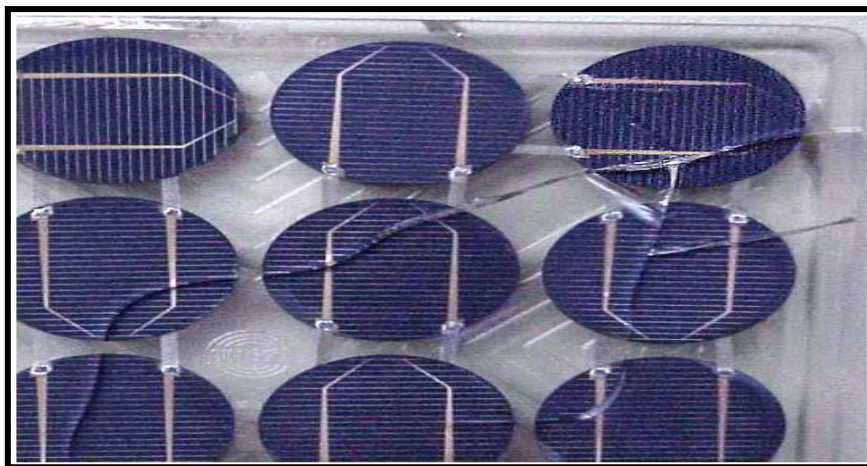
Most common cause of hot spot is the resistive heating of the shaded cells. This usually happens in the case of faulty bypass diode and defective soldier joints. (Daniel W. Cunningham, 2011)

Figure 38- Cracked module due to the heat dissipated in the shaded module (Christiana Honsberg, 2014)

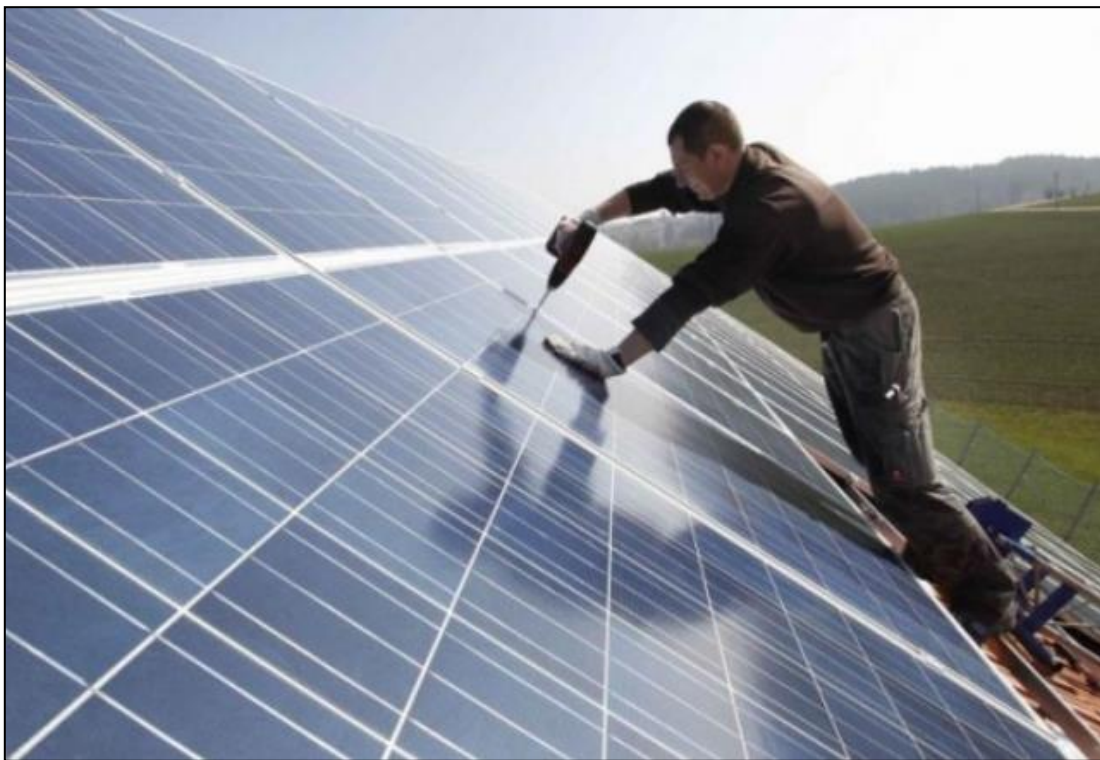
From manufacturing to installation, PV module needs proper care while it gets transported from the manufacturer to the end user. Micro cracks are often caused due to poor handling and improper care during installation as shown in Figure 40. (Roest, 3 quality issues in solar panels, 2013)

Figure 40: Installer leaning on PV module may cause module to crack (source: (Roest, 3 quality issues in solar panels, 2013))

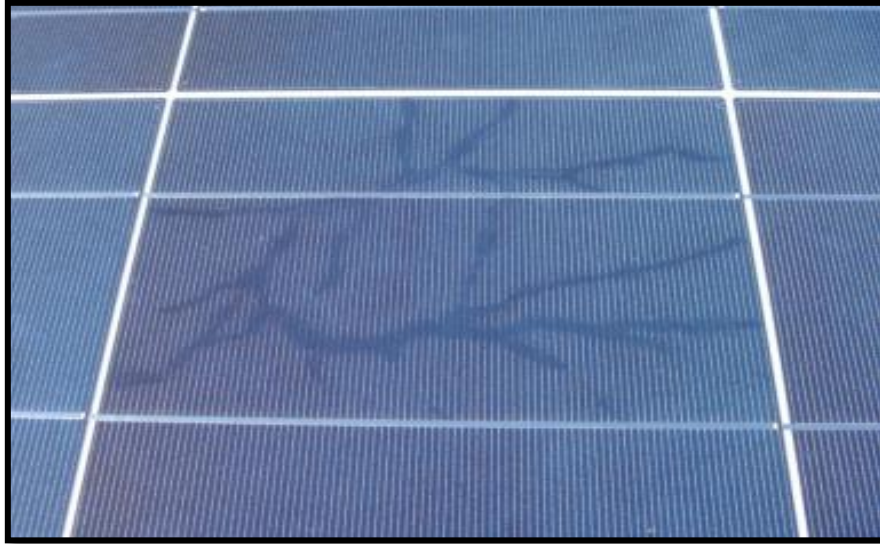
Snail trails are also originated due to the presence of Ag_2CO_3 nanoparticles. These particles absorb and scatter the light which results in the discoloration of the module which are visible on the surface. (Vashishtha, 2014)

Figure 41: Snail Trails on PV module (Source: (Vashishtha, 2014))

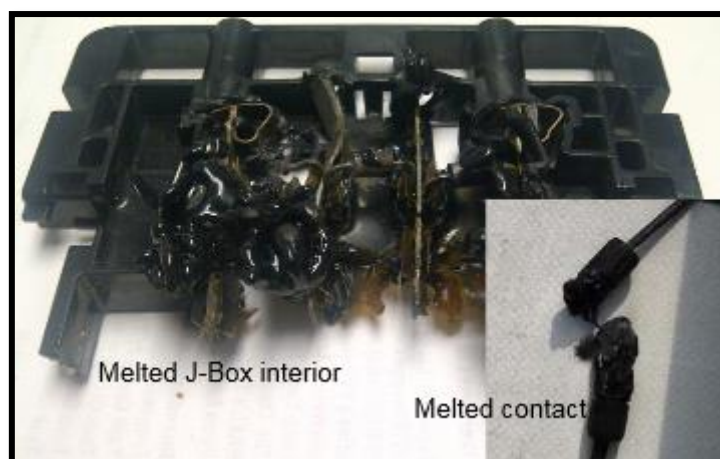
Figure 42: Damaged Junction Box (Source: (Kalejs, 2012))

example of a junction box which is melted from inside due to the overheating effect within 2-3 years in the field. Melting of Junction boxes with non-soldering contacts is often experienced in 2-3 years of its operation in the field. There are other common faults which can be found in the junction box including plastic cracking of the connectors, cracking of the Junction box due to fatigue and melted connectors due to the poor installation. Corrosion is often experienced and lead to the damage to the junction box as shown in Figure 43 in very humid areas. In very hot regions, high temperature may lead to the burning of the diode. (Kalejs, 2012)

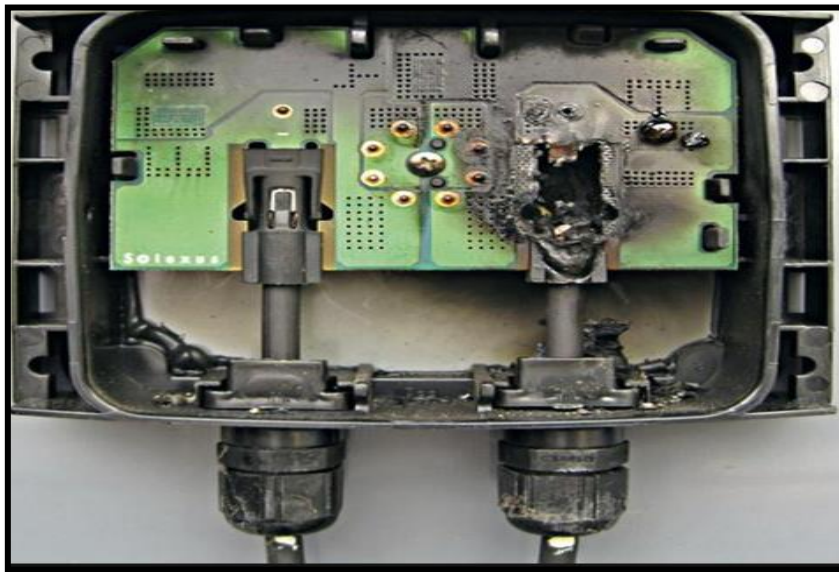
Figure 43: Corrosion in the Junction Box led to increase in contact resistance (source: (Ali-Oettinger, 2013))

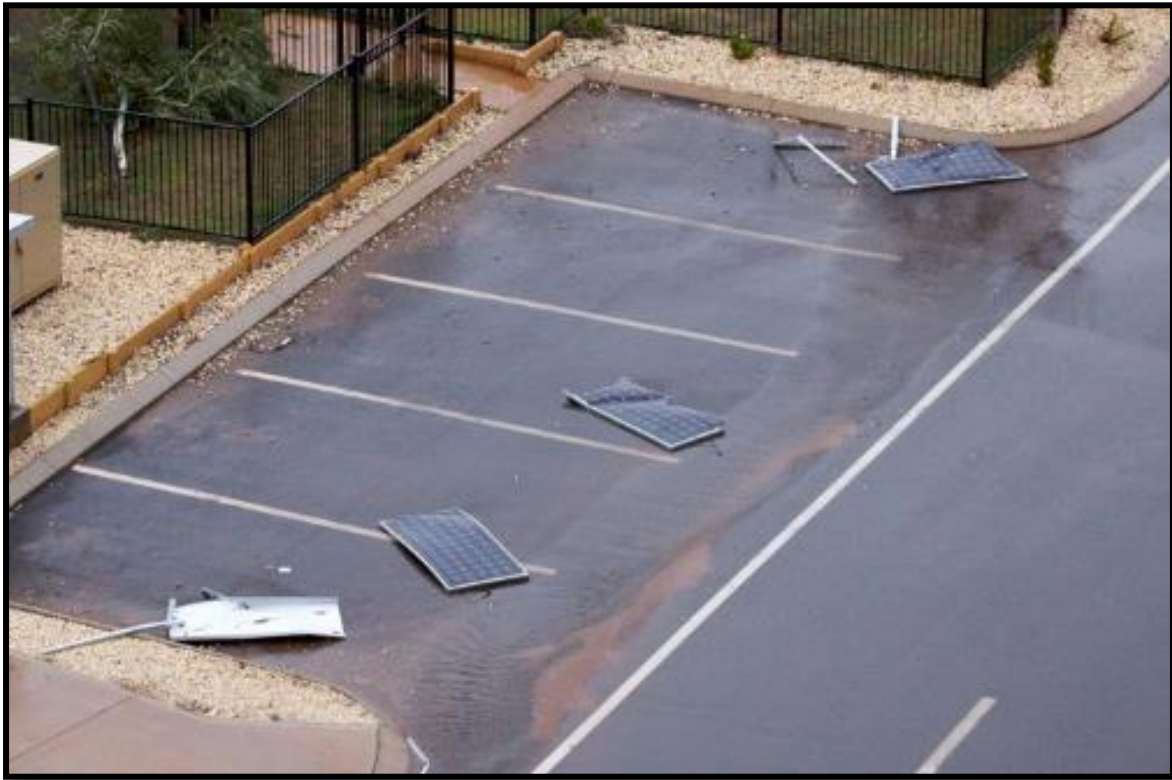
Figure 45 shows the solar panel debris on the streets of Pilbara region after been hit by the cyclone Christine in December 2013. (Coasts Down Under, 2013)

Figure 45: Damaged Solar panel debris on the street after cyclone. (Source: (Coasts Down Under, 2013))

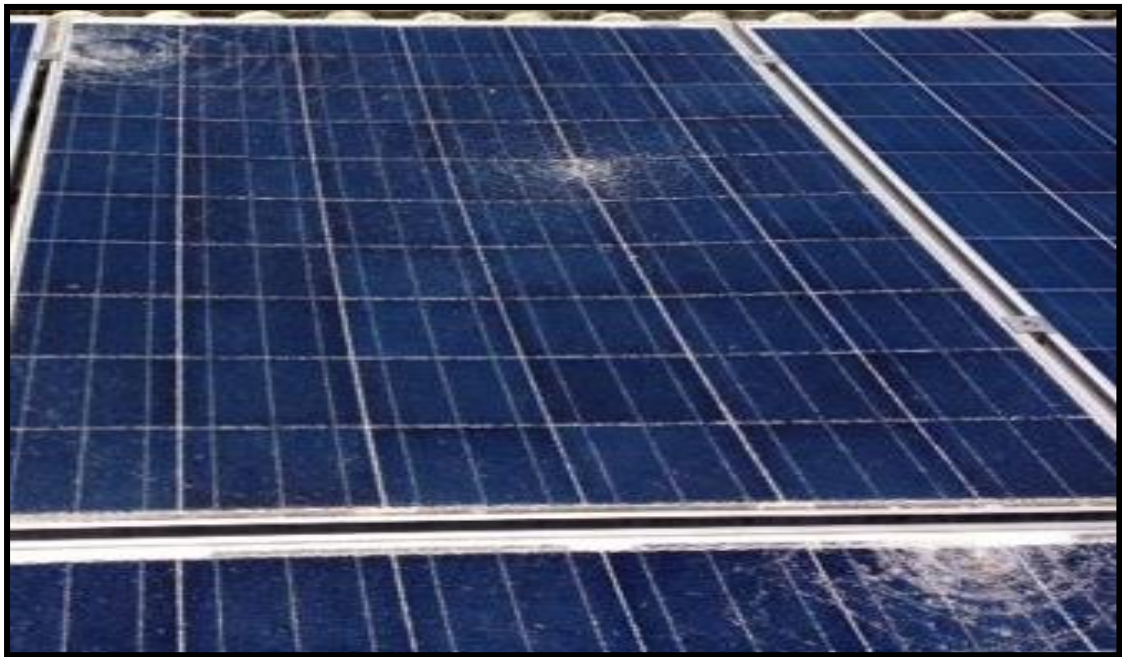
Sometimes, hail storms bring extremely large size hail stones which are large enough to produce the damage on PV modules as shown in the Figure 46.

Figure 46: Hail damaged PV module (Source: (Gold Coast Solar Power Solutions, 2014))

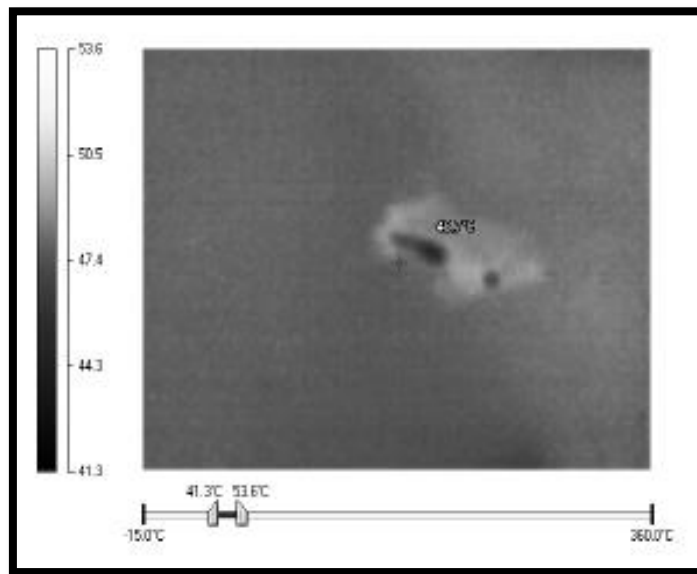
Figure 73- Hot spot resulted as dirt and impurities got stuck to the panel (Source: (F. Ancuta, 2011))
