Recall Information Bulletin -

No: C1007710 Issued: 5/15/2015

Transport Canada No: 2015-138 **Re:** 4P10 Lower Timing Chain Bolt

Safety Recall C1007710 - 4P10 Lower Timing Chain Bolt

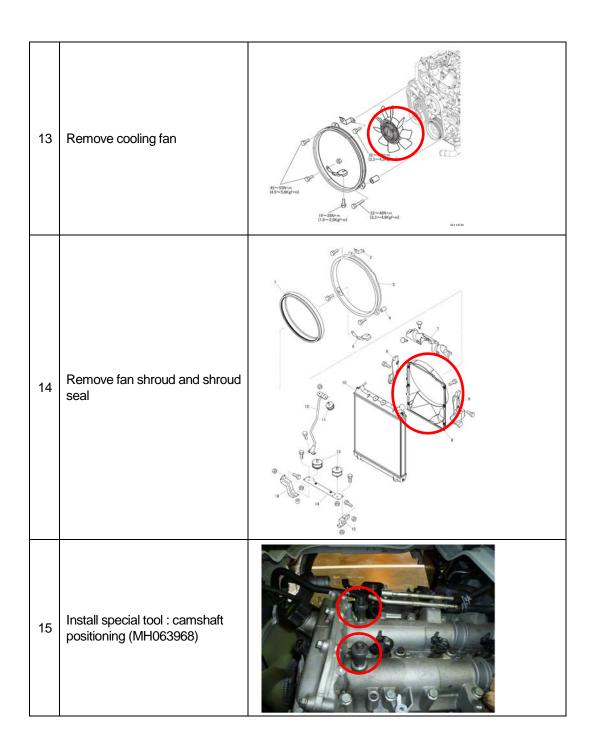
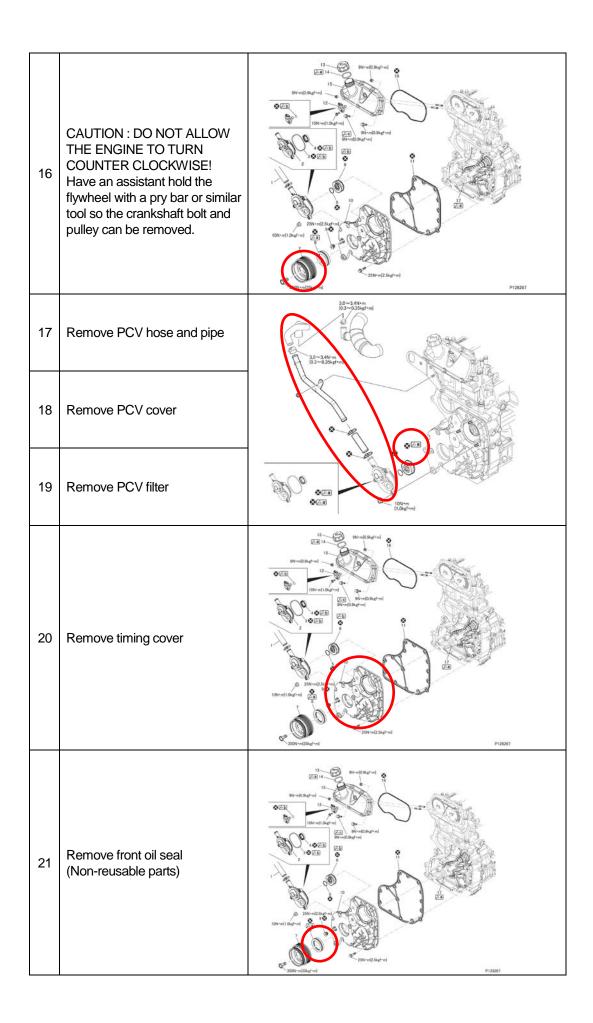
Mitsubishi Fuso Truck of America, Inc. has decided that a defect which relates to motor vehicle safety exists in certain 2012-2015 FEC72 and FEC92 vehicles equipped with the 4P10 engine lower timing chain bolt. On certain affected vehicles, the lower engine timing chain bolt may have been insufficiently tightened during assembly. Normal operation in this condition may cause an engine oil leak. In the worst case, the engine could become inoperative, increasing the risk of a crash.

7	Remove fan belt.	25N+m 2.5kgf+m 12 25N+m 2.5kgf+m 25N+m 2.5kgf+m 25N+m 2.5kgf+m M3.25N+m 2.5kgf+m M10.50N+m 5kgf+m 6	
8	Remove automatic belt tensioner.		
9	Remove alternator/generator	255N-m 8 10 350N-m (35kgf-m) P116710-1	
10	Remove air conditioner compressor	DI1	
11	Remove alternator bracket	25N+m (2.5kgf+m) 25N+m (2.5kgf+m) M3 25N-m (2.5kgf+m) P116710-1	
12	Remove radiator upper hose

22	Install special tool : Crank positioning (MH063969)	O. S. Tan
23	Remove cover.	9N-m(0.9kg*m) 9N-m(0.9kg*m) 15 9N-m(0.9kg*m) 17 28 17 28 17 28 17 28 17 28 17 28 17 28 18 19 19 10 10 10 10 10 10 10 10
24	Replace upper chain stretcher with new [37 ft.lbs. / 50 Nm]	
25	Replace lower chain stretcher with new [37 ft.lbs. / 50 Nm]	
26	Remove upper mobile skid and lower mobile skid.	
27	Remove camshaft timing gear (Intake/Exhaust)	
28	Remove timing chain upper	
29	Tighten upper skid and the upper side skid mounting bolts with standard torque [7.4 ft.lbs. / 10 Nm]	Camshaft control gear Single chain Upper skid Upper skid Upper skid Upper skid Drive gear Double chain
30	Tighten upper side skid and the upper side skid mounting bolts with standard torque [7.4 ft.lbs. / 10 Nm]	Lower chain stretcher Timing control gear Lower skid J10843E
31	Reassemble in the reverse order	er of disassembly.
