RECAPP Facility Evaluation Report

Mary Immaculate Hospital

B1130A
Mundare

Evaluation Company: Genivar / Sherri Turpin - Architect
Evaluation Date: October 26 2011
Evaluator Name: Len O'Connor

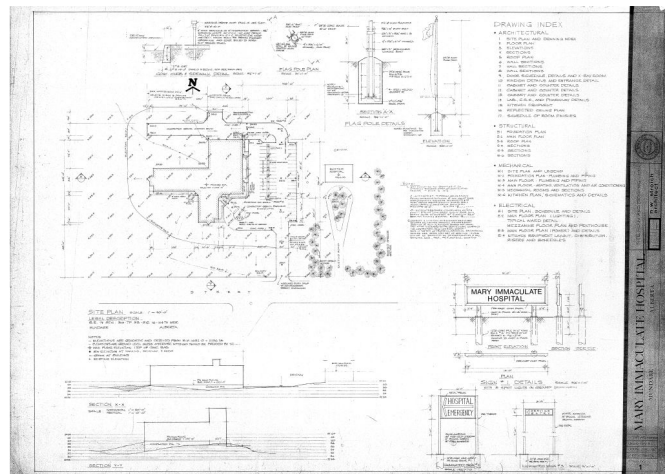
B1130A_444-001-201-0-5R.jpg

Site Summary: This building site has both hard and soft landscaping, The hard surfaces include concrete sidewalks, and asphalt paved parking areas. The soft areas are covered with grass, landscaping beds and shale transition areas. There are mature trees, and shrubs. There are 4 service and storage buildings on site. There is an enclosed patio assembly.

<u>Rating</u>	<u>Installed</u>	<u>Design Life</u>	<u>Updated</u>
4 - Acceptable	1979	0	MAR-12

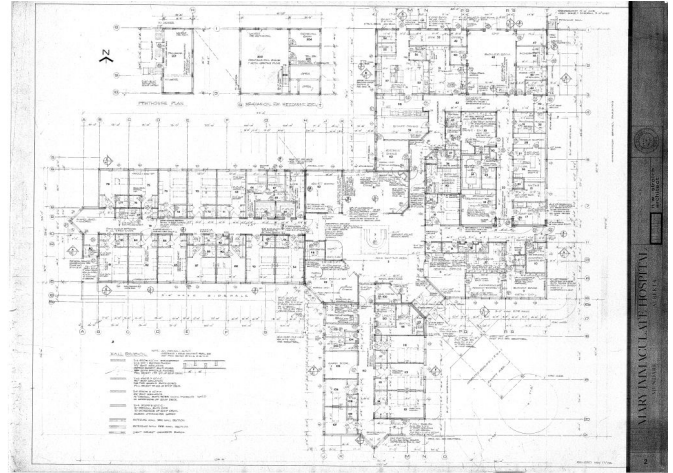
B1130A_444-001-202-0-5R.jpg

Services: This is a continuing care facility with 30 beds offering additional services in laboratory, x-ray, a group home and mental health day program.

<u>Rating</u>	<u>Installed</u>	<u>Design Life</u>	<u>Updated</u>
4 - Acceptable	1979	0	MAR-12
