Relocation of Narikoso, Ono Kadavu Island Group

NARIKOSO RELOCATION WORK UPDATES MRD GEOLOGICAL & AND GEOTECHNICAL FINDINGS & RECOMMENDATIONS

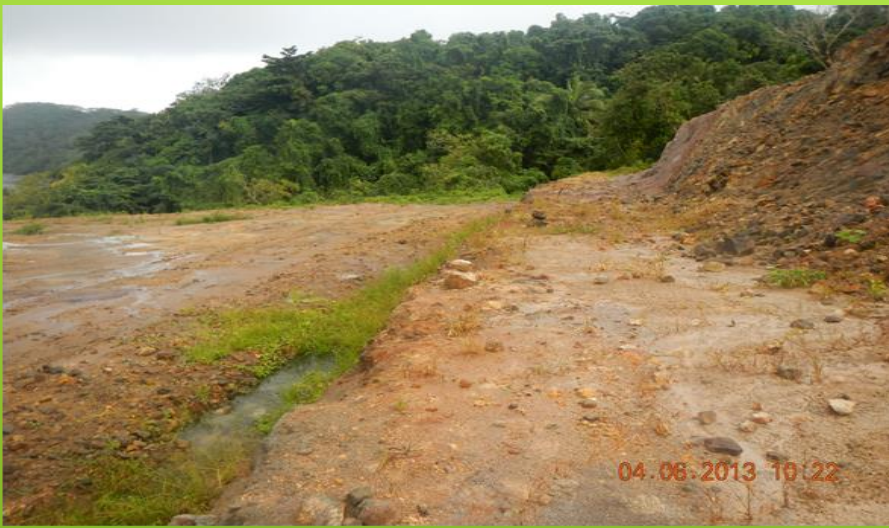
Impact of improper drainage designs

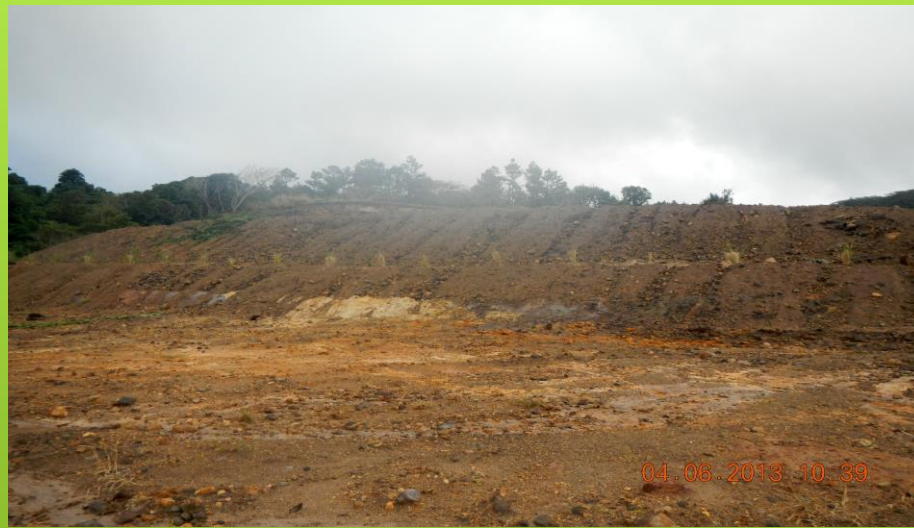
Heavy siltation and deposition on near shore

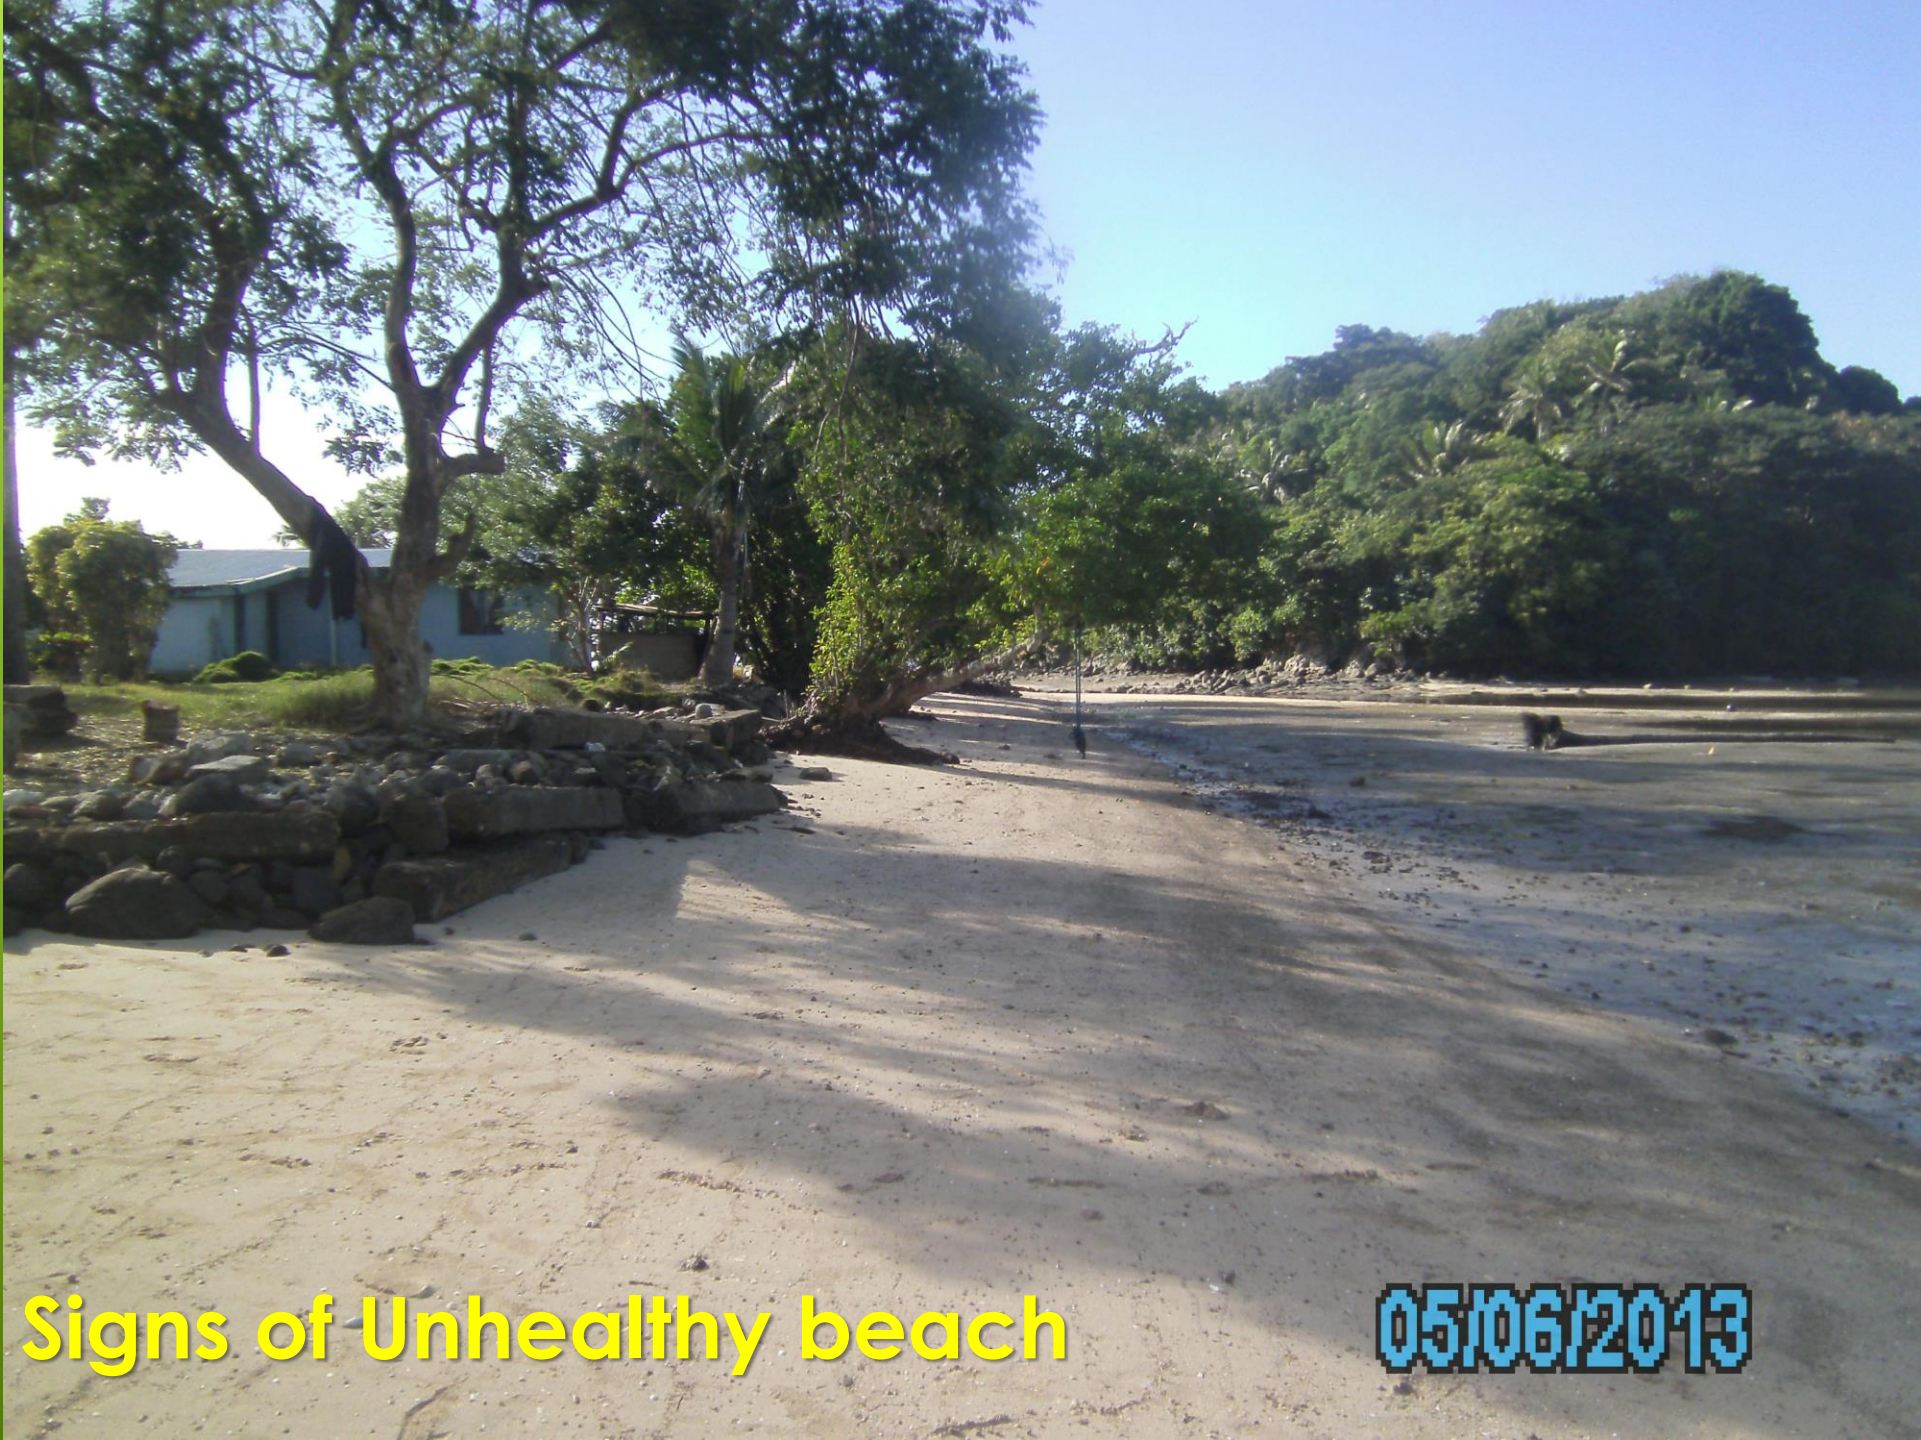
Signs of Unhealthy beach

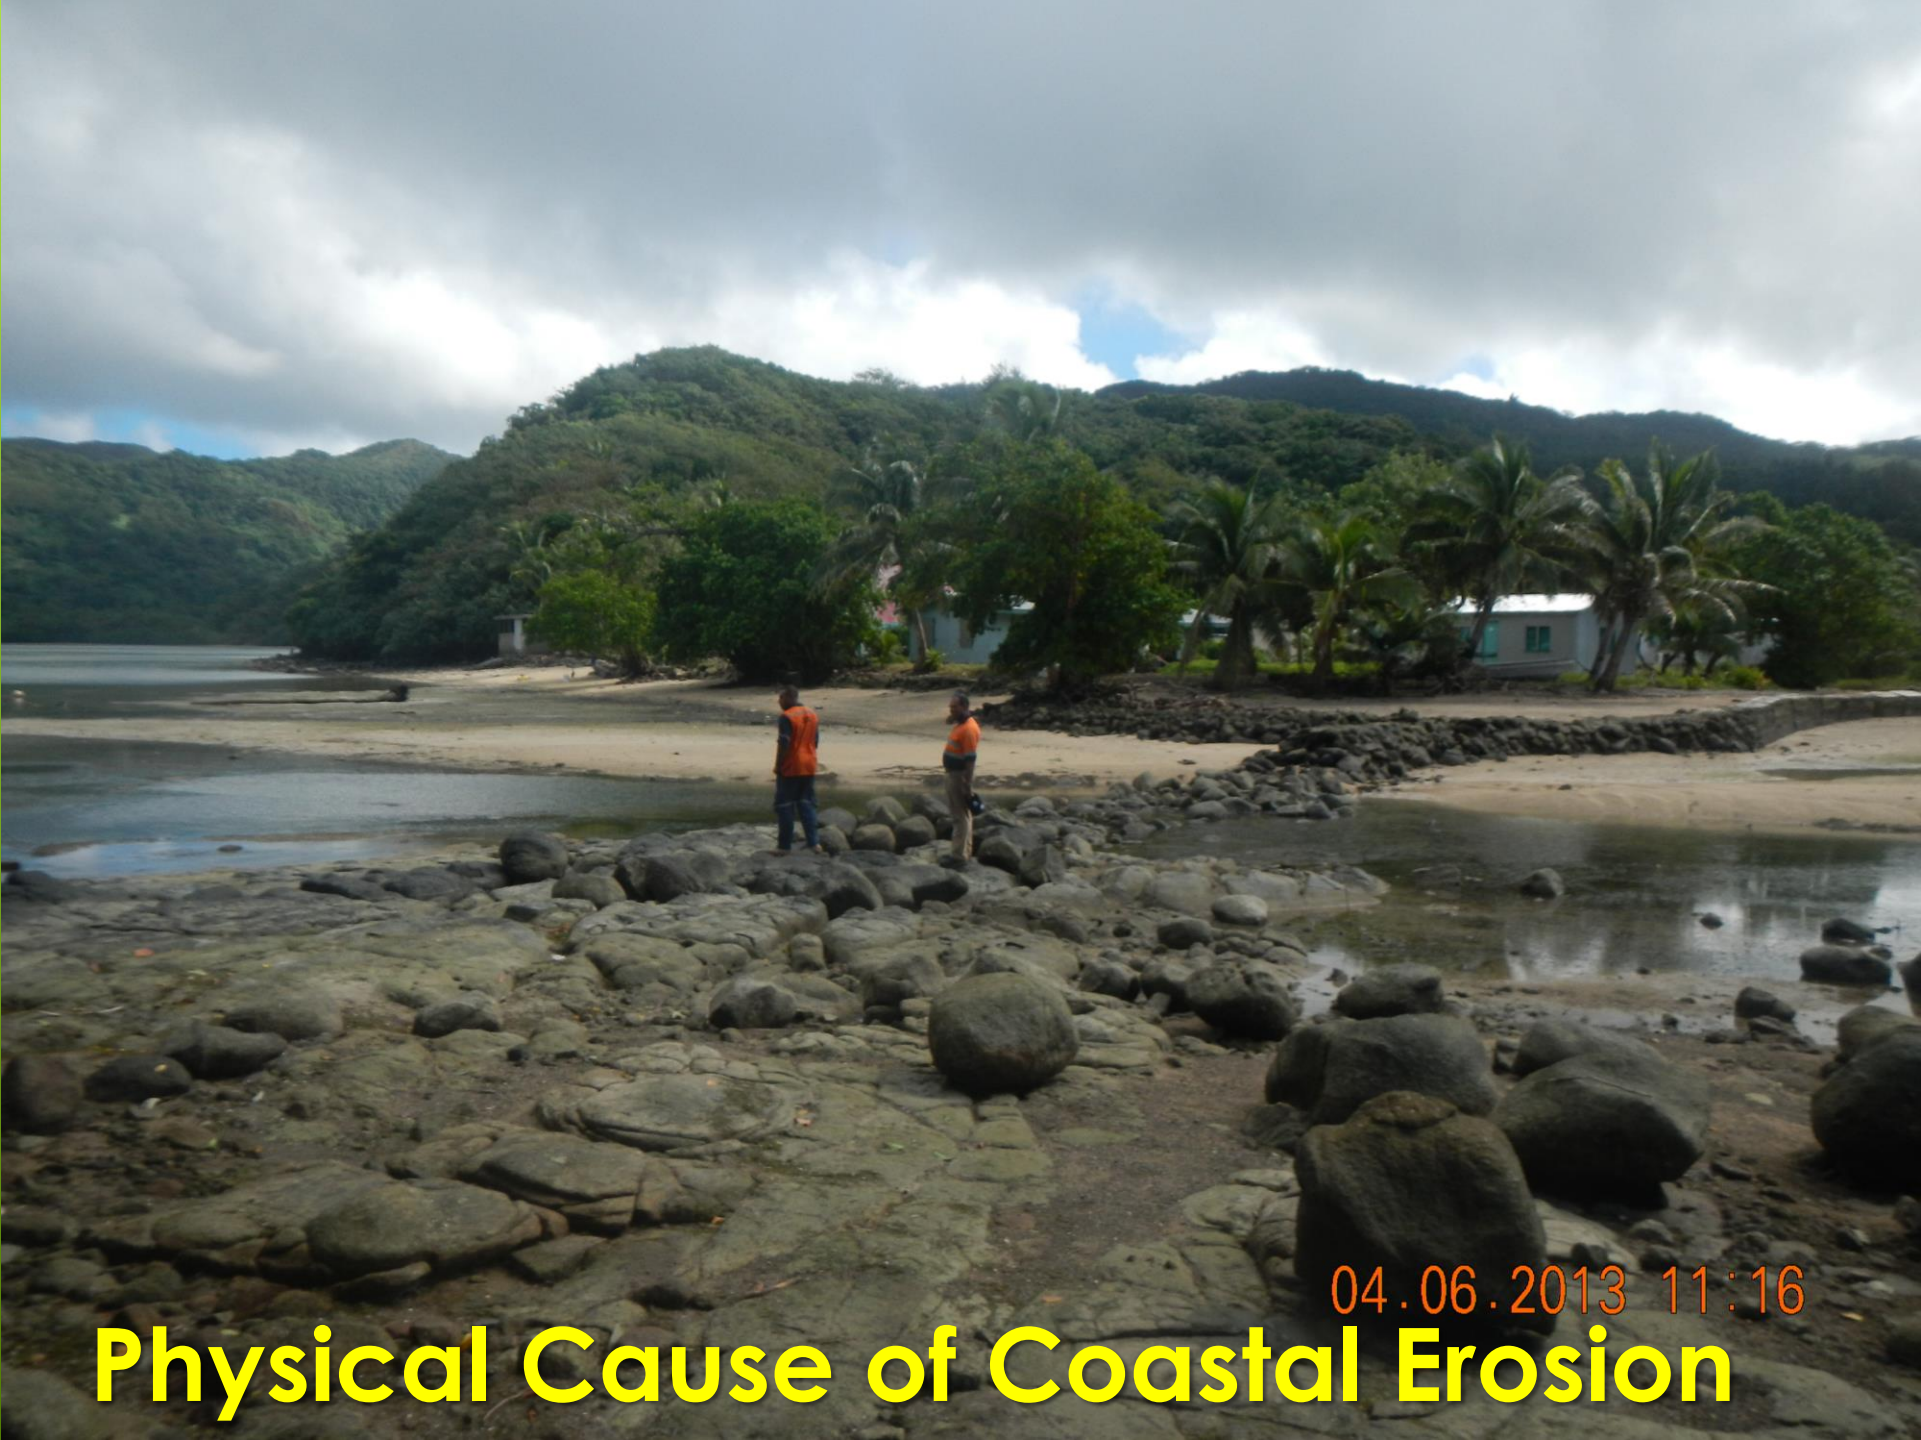
Physical Cause of Coastal Erosion

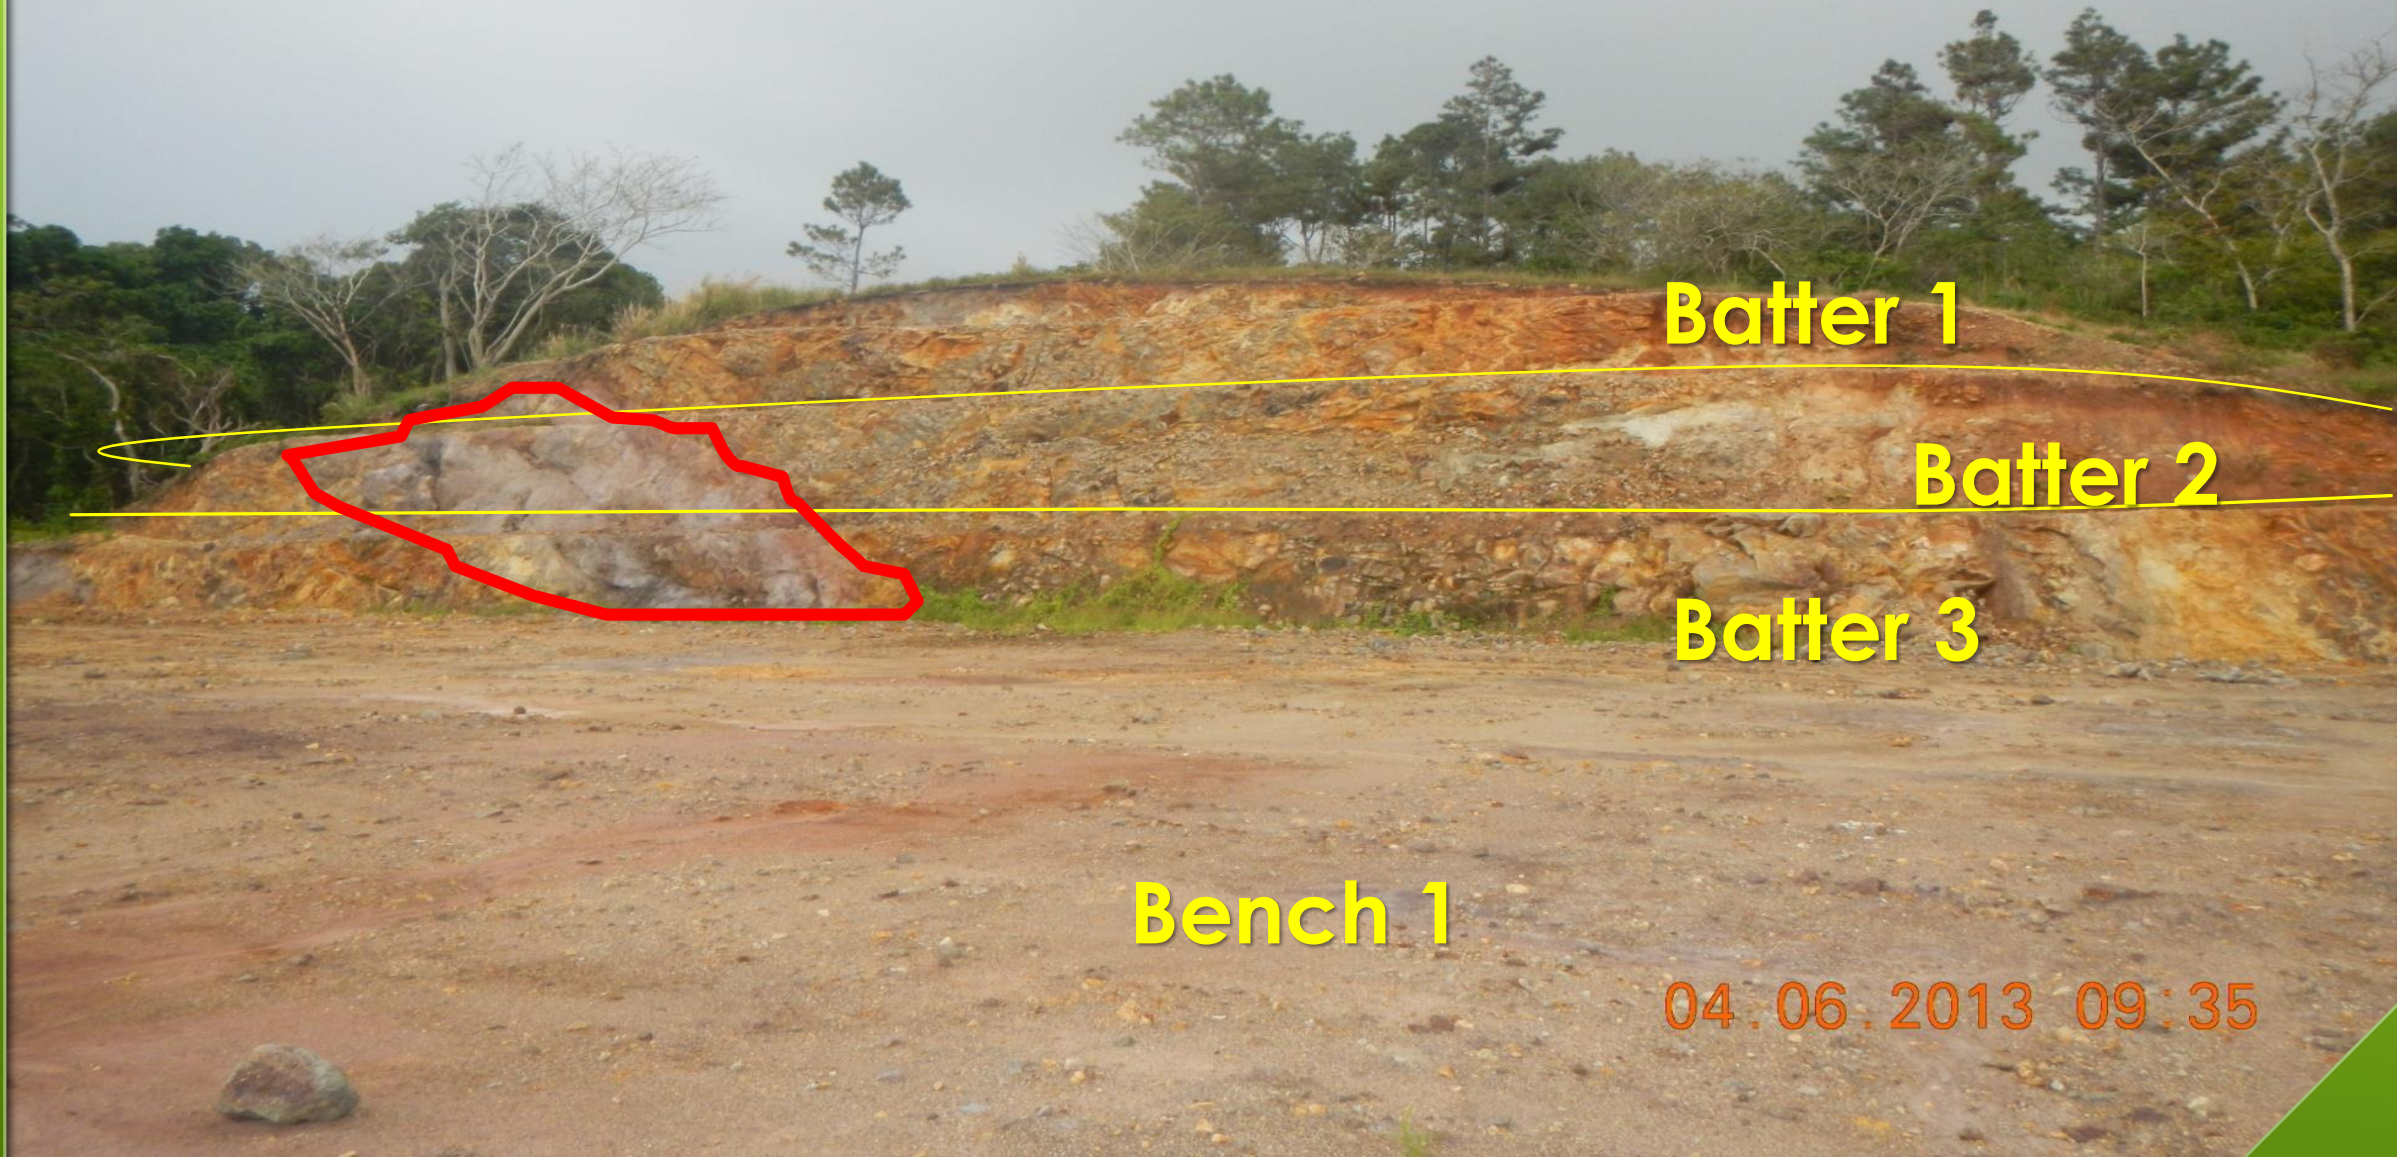
Geological outcrop exposed after excavation

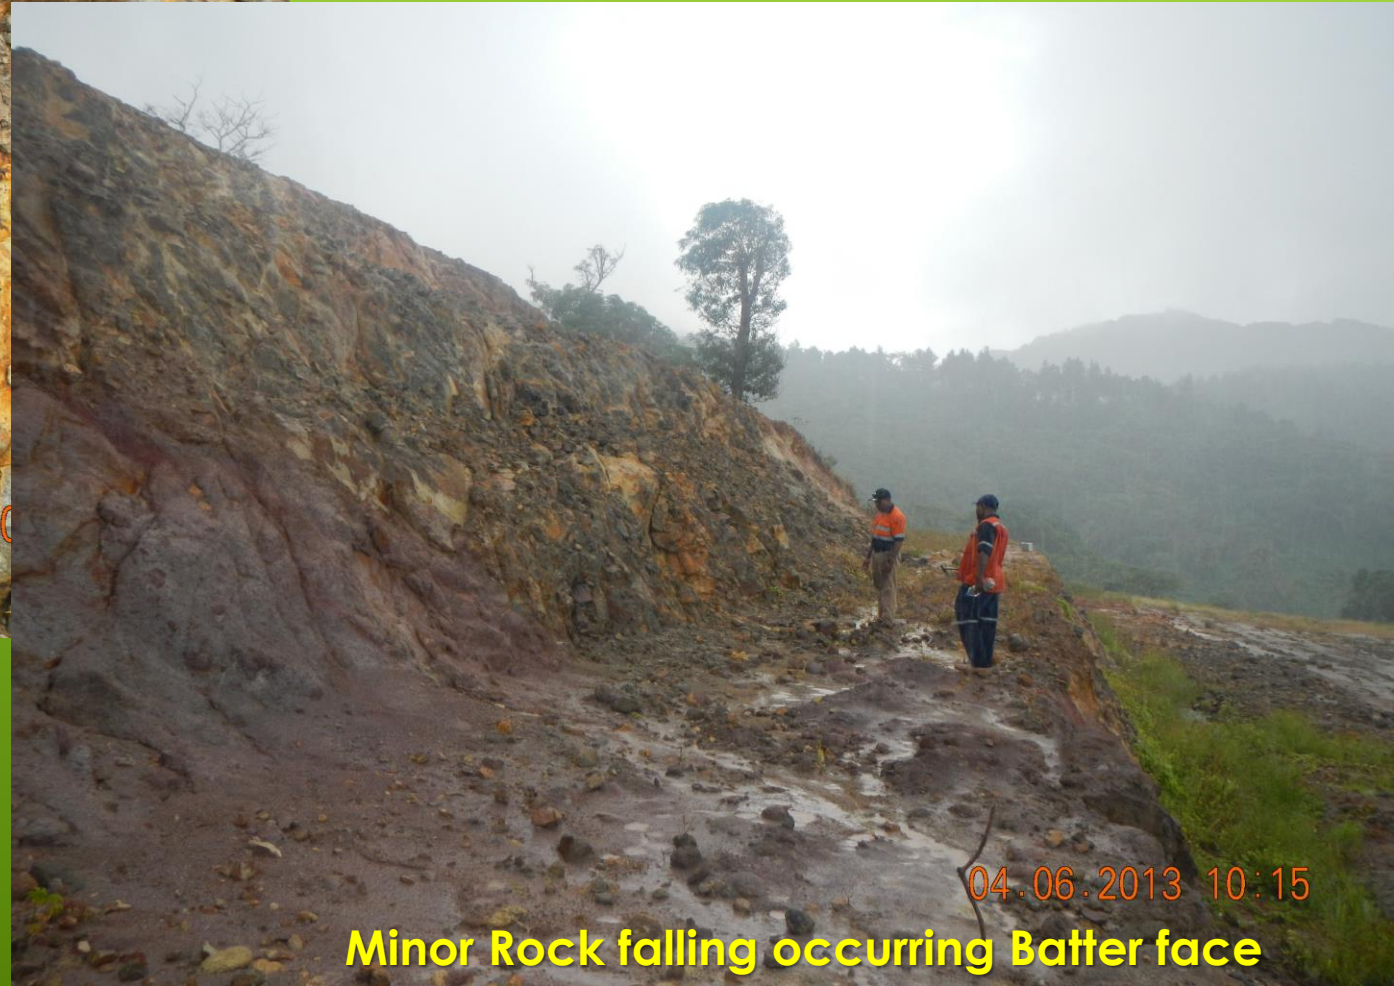
Minor Rock falling occurring Batter face

- SITE IS NECESSARILY STABLE DUE TO DIPPING DIRECTIONS OF LITHOLOGICAL UNITS
- IMPROVE DRAINAGE SYSTEM ON TOE OF BATTER.
- MINOR ROCKFALLS & MINOR TRAJECTORIES.

- TO CATER FOR ROCKFALLS & TRAJECTORIES ON WEAKENING STRUCTURES – ENGINEERING BRACE TO BE ERECTED ALONG THE TOE OF THE BATTER
- DRAINAGE SYSTEMS NEED TO HAVE SHALLOW DEPTHS & DEEPER DEPTHS ON OUTLETS
- WEED MAT TO COVER SURFACE OF BENCHES & SLOPE ON THE SOUTHERN SIDE OF SITE
- FURTHER GEOTECHNICAL TESTS TO BE DONE TO GAUGE SUBSIDENCE & TOTAL LOAD ON THE BENCHES & EXTENDED BOUNDARY
- BUFFER ZONE ON BENCH 1 : 5m FROM TOE OF BATTER AND 5m FROM EDGE OF BENCH. FOR BENCH 2 : 4m FROM TOE OF BATTER AND 3m FROM EDGE OF THE BENCH

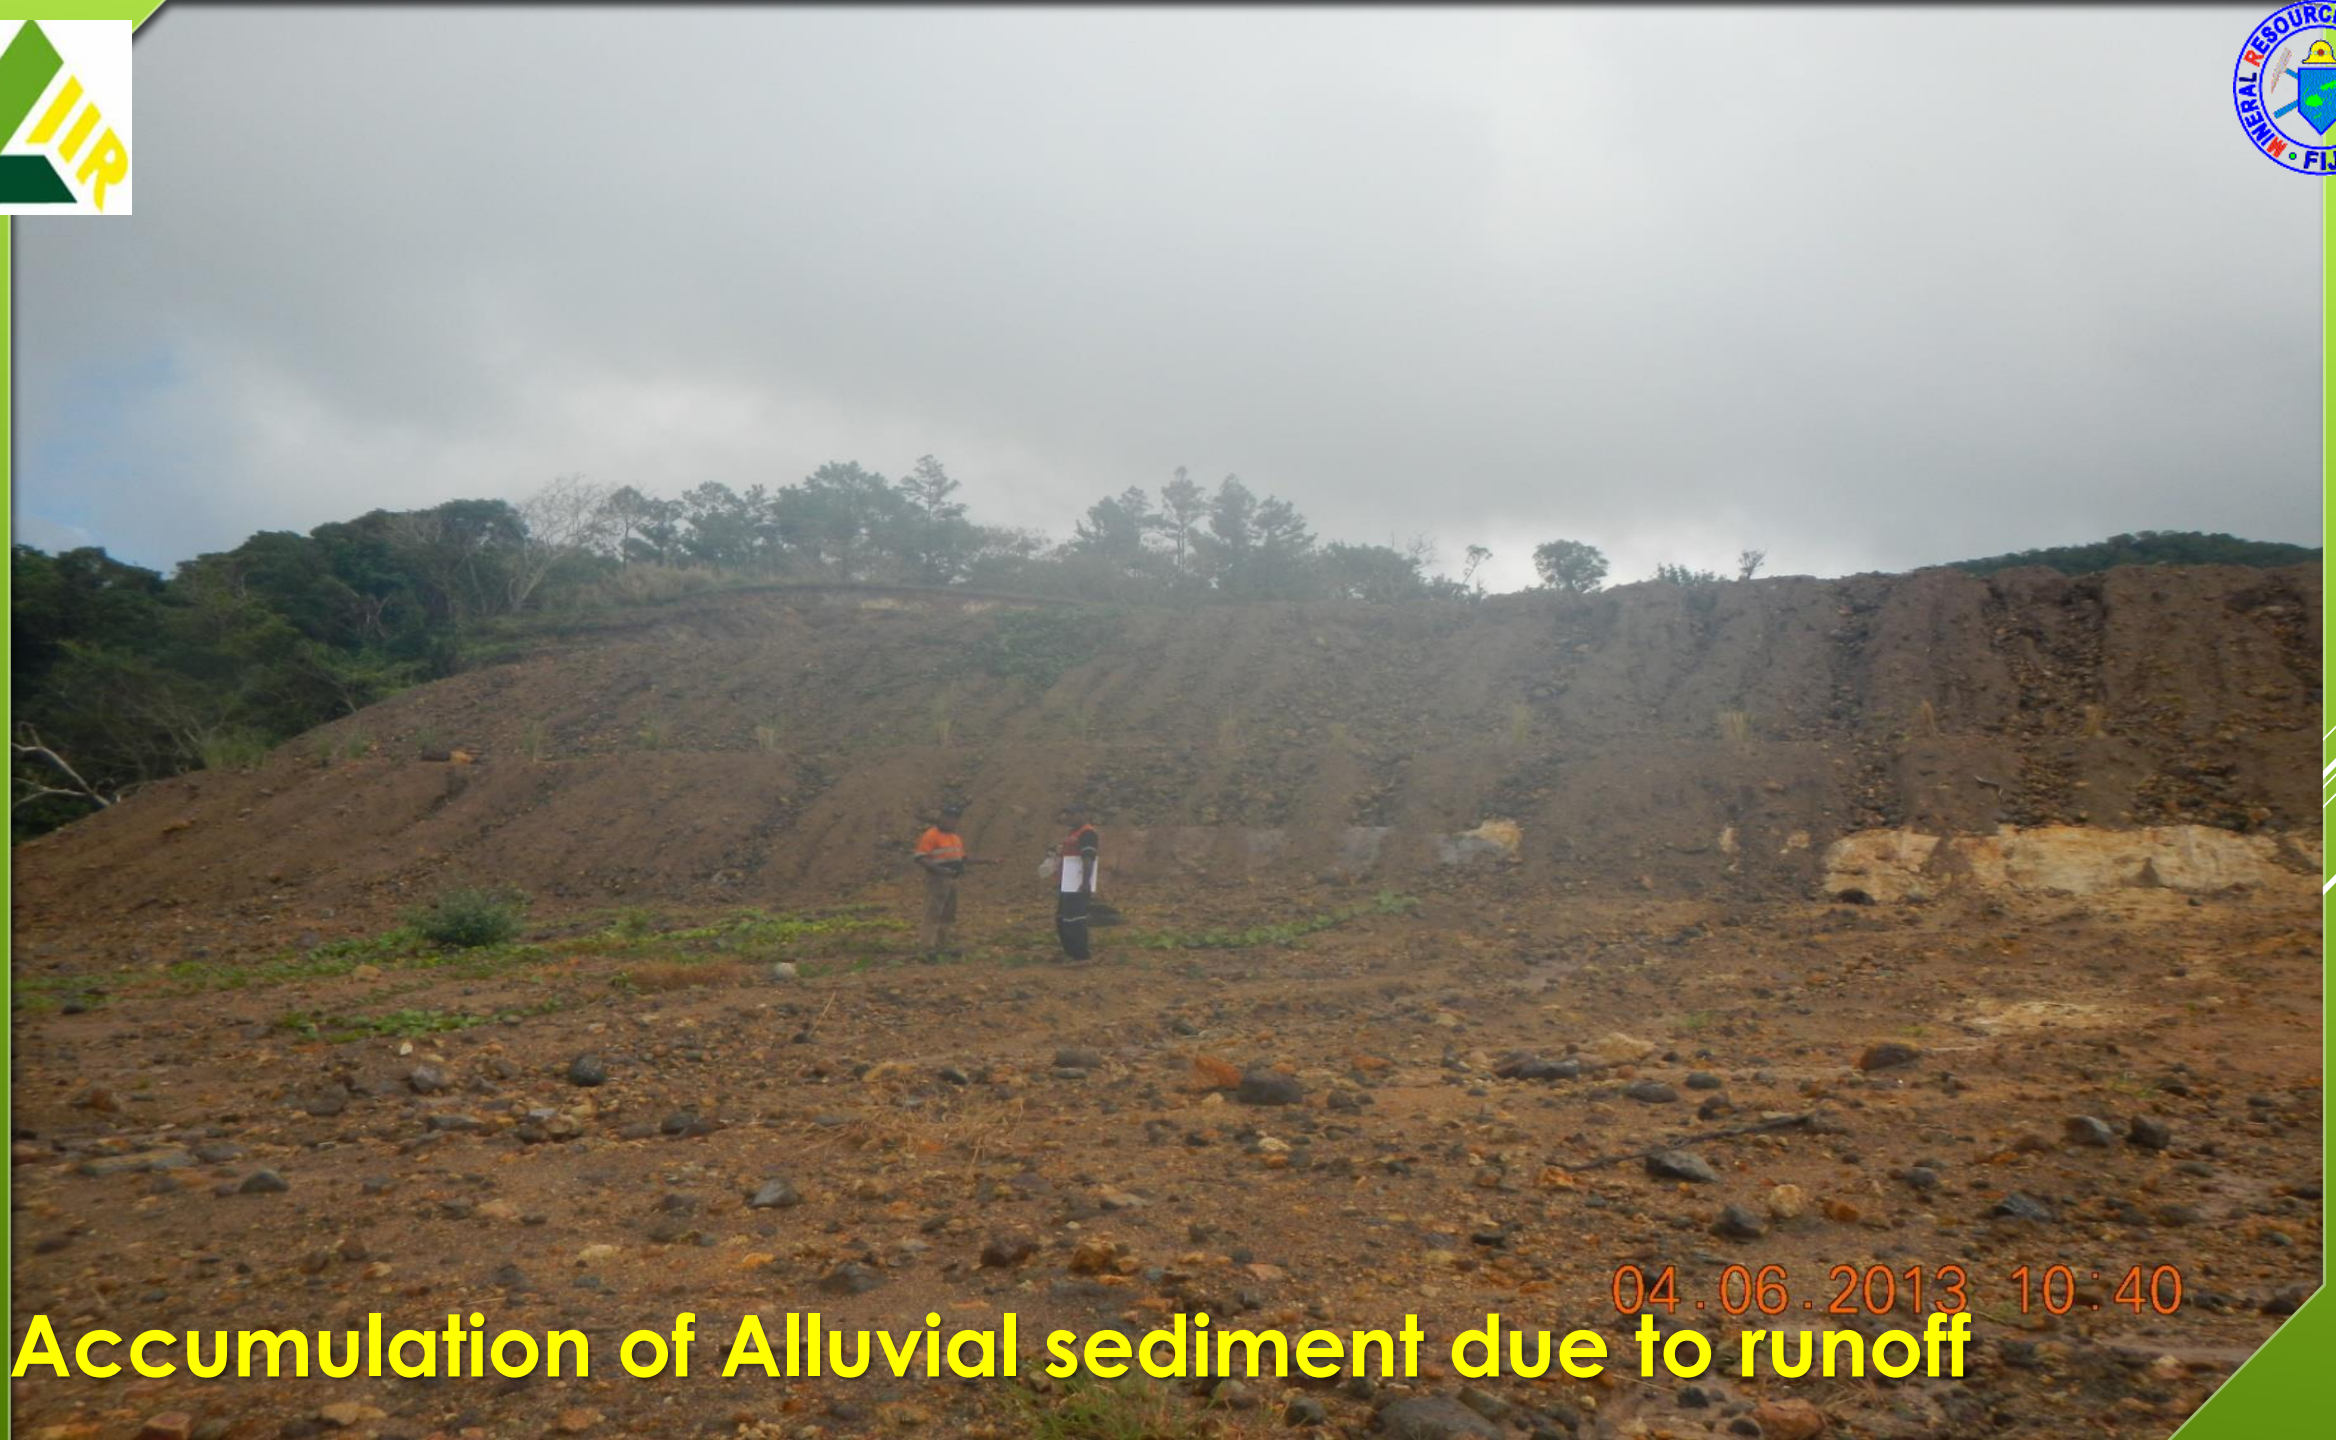
Accumulation of Alluvial sediment due to runoff

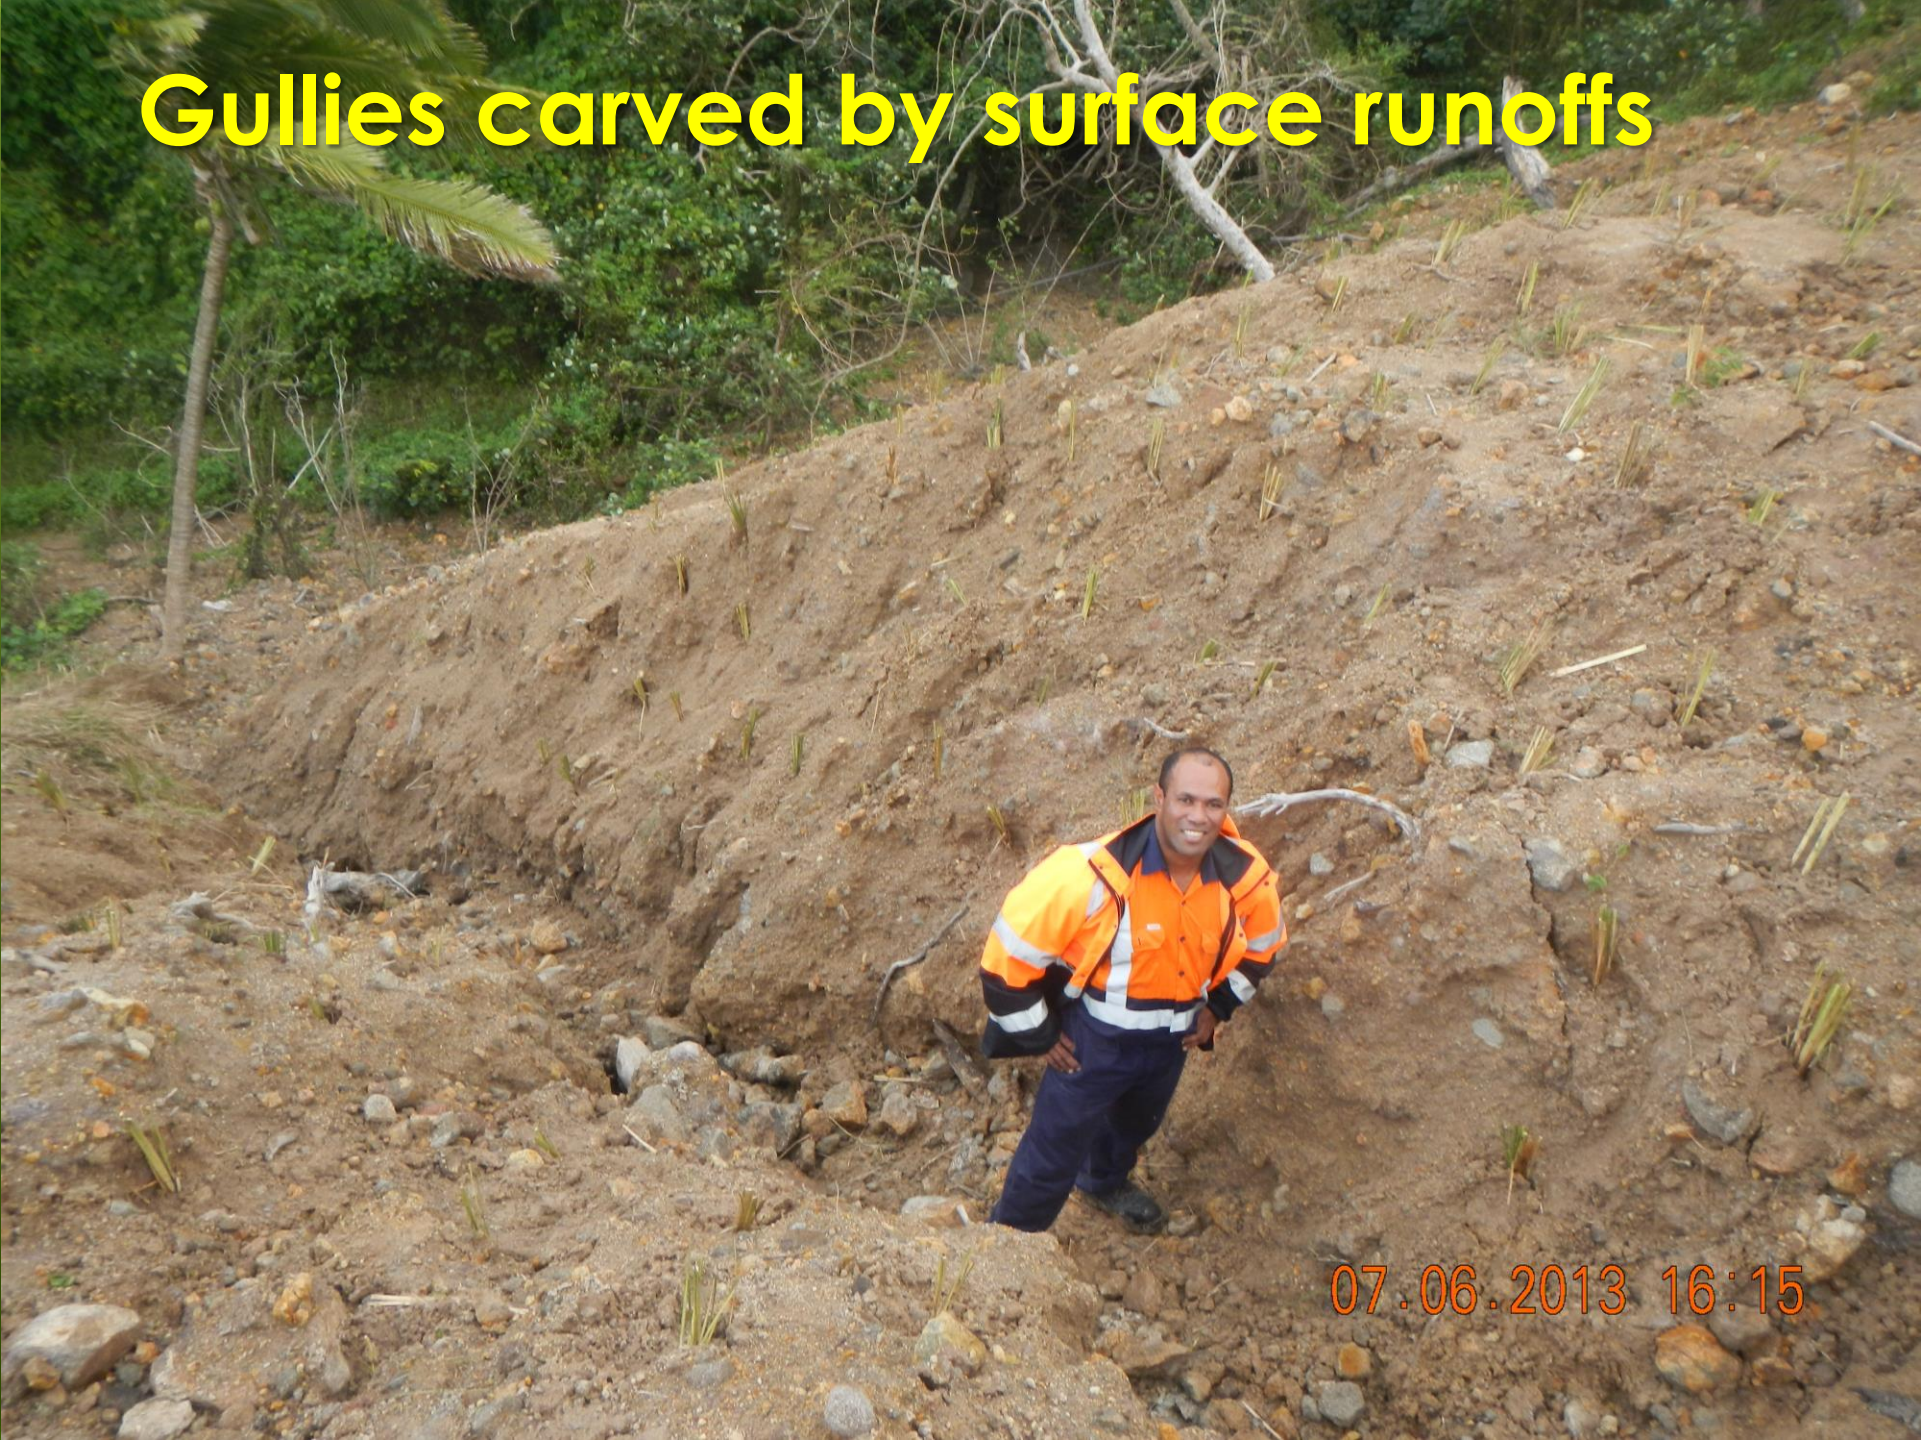
Gullies carved by surface runoffs

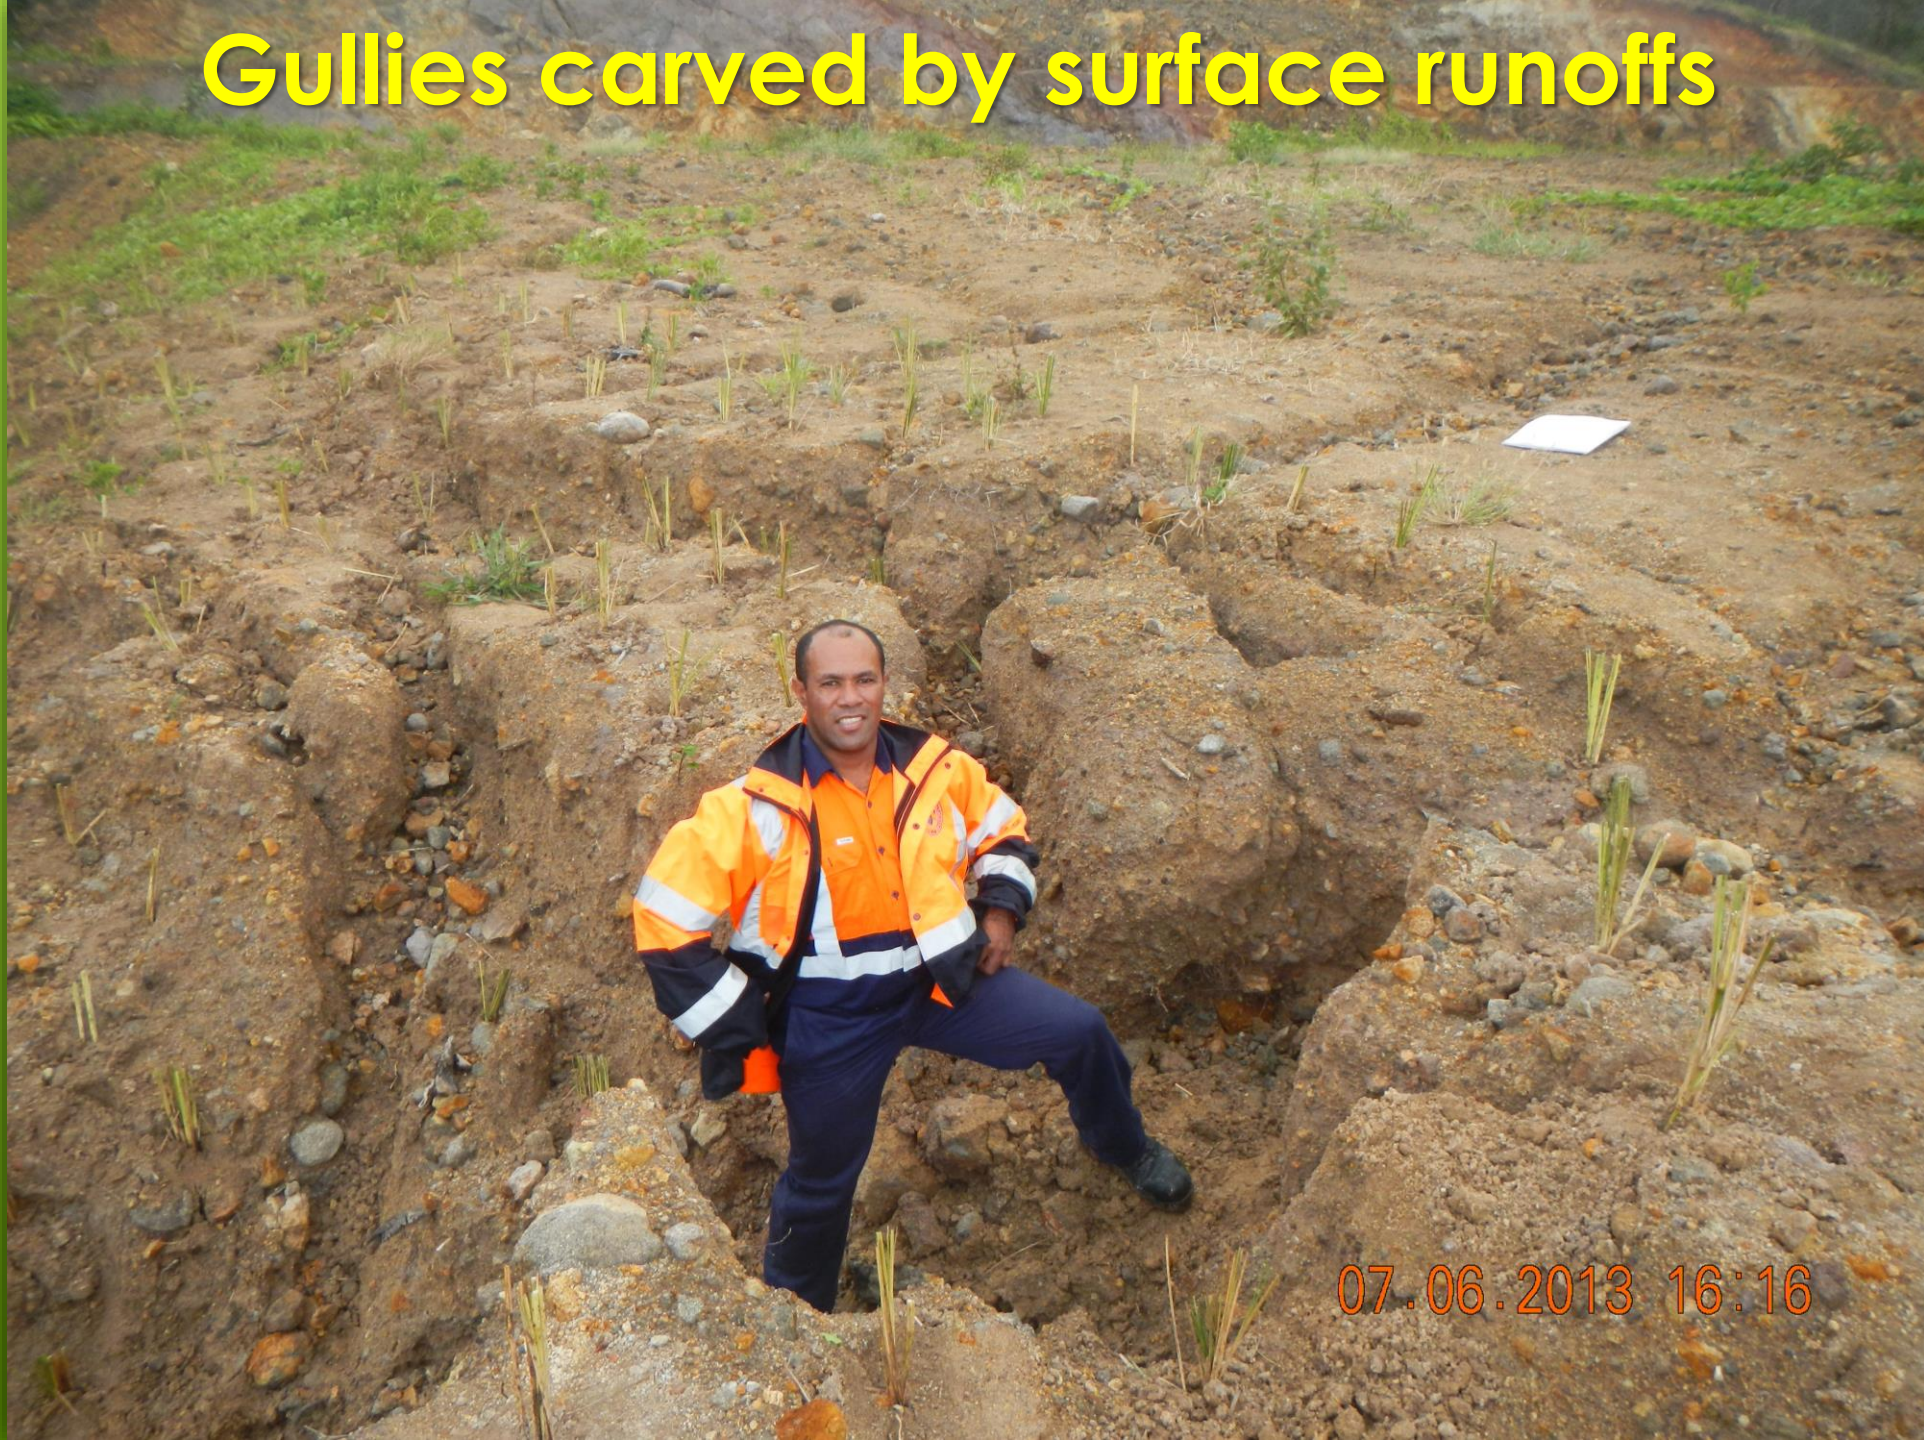
Gullies carved by surface runoffs
