**Report 07-003, Piper PA32S-300 Cherokee 6, ZK-DOJ, departed grass
airstrip on landing, Elfin Bay, Lake Wakatipu, 5 April 2007**

Report 07-003

Piper PA32S-300 Cherokee 6

ZK-DOJ

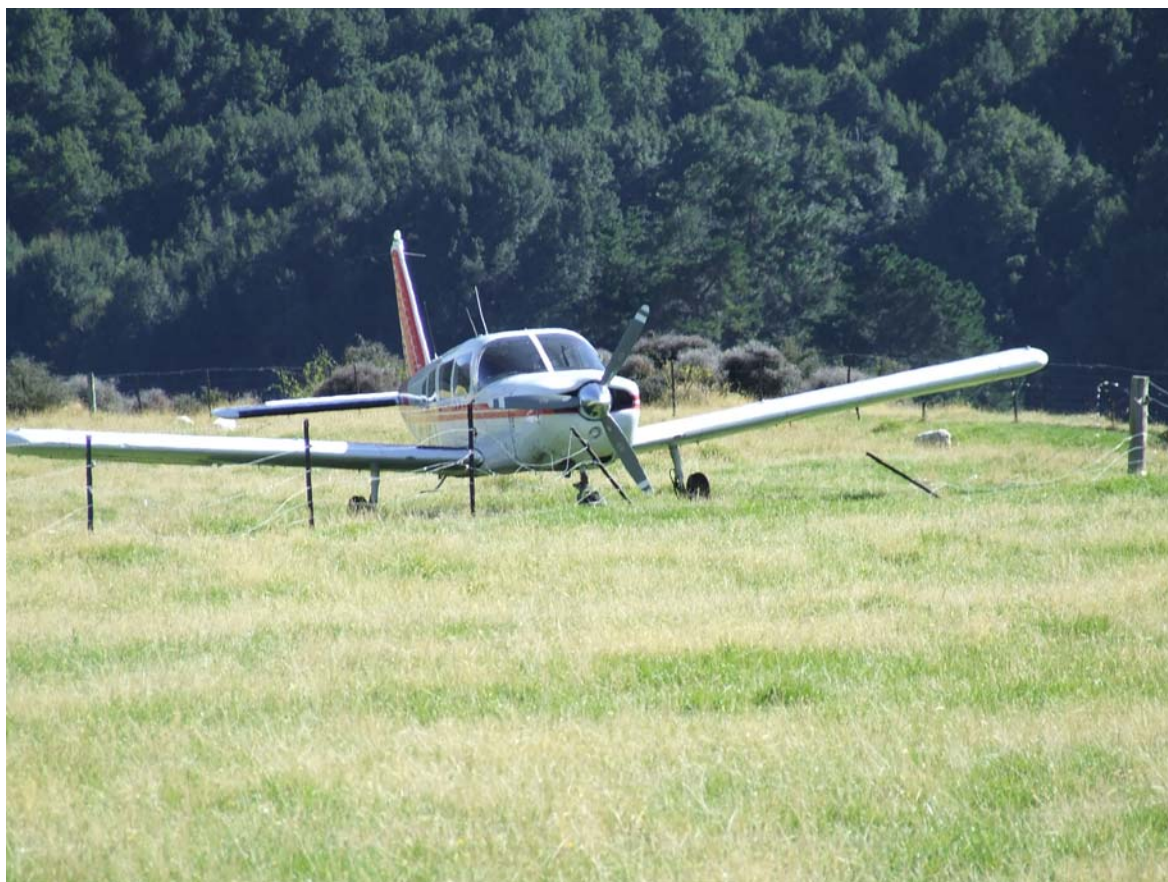
**Piper PA32S Cherokee ZK-DOJ
after landing at Elfin Bay**

1.3.1 The damage consisted mainly of scrapes and dents to the right wing and propeller. The nose landing gear, engine firewall and engine mounting frame were twisted, probably by side loads on the nose wheel.

1.11.1 ZK-DOJ had struck the fence on the left side of the airstrip about 25 m short of the end marker posts. The aircraft was on a heading of about 100° magnetic. The aircraft had sustained damage, primarily to its right side. The damage included scraping on the leading edge and underside of the right wing. The nose wheel was bent to the left and there was some buckling to the firewall and engine mounting area. The propeller had scrape marks and chips in the leading edges of 2 of the 3 blades.

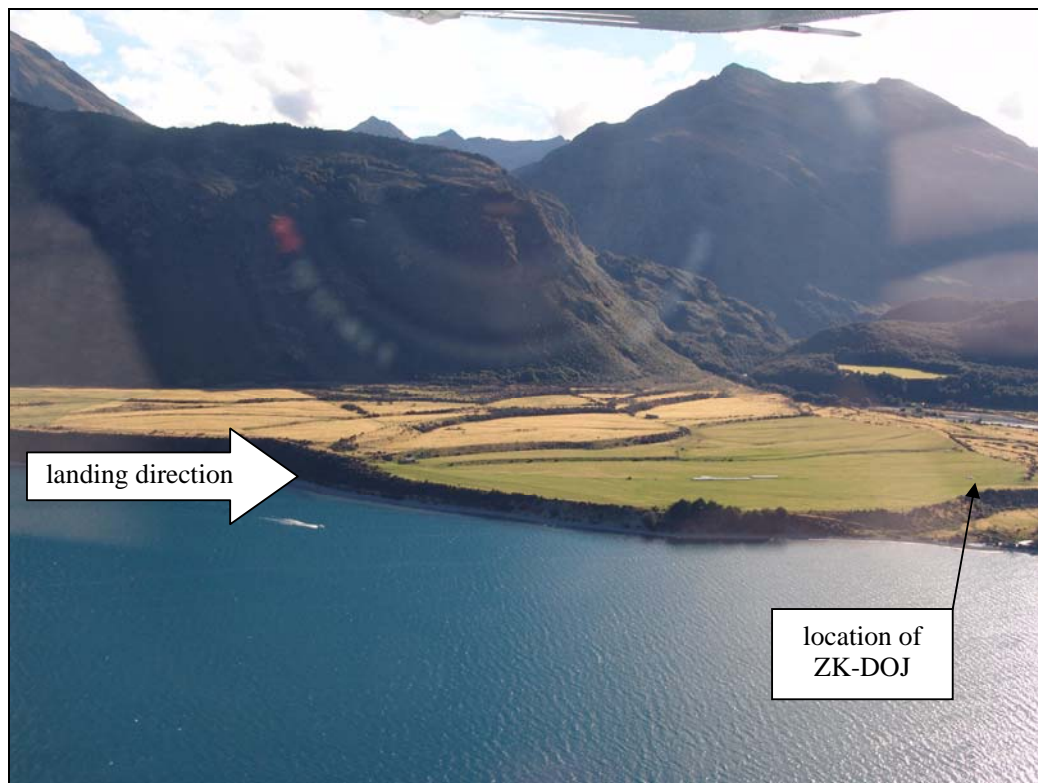
Figure 2
Elfin Bay airstrip – aerial view

- 1.1.3 After circling Mount Aspiring the flight continued down Rees Valley, descending as it flew past Paradise and Glenorchy to Lake Wakatipu. The pilot noted that the lake surface appeared calm, with no indications of any wind in the area. At about 1100, the pilot positioned ZK-DOJ to overfly the airstrip at Elfin Bay so he could check the landing area and conditions. The pilot noted that "everything seemed fine – there was no wind at all". The pilot then positioned ZK-DOJ on a left base to land towards the north (see Figure 2).

- 1.9.2 The single grass airstrip was orientated 320° magnetic and had a 0.5° upslope when landing to the north – the direction ZK-DOJ was landed. It had an elevation of 1160 feet above sea level. Unobstructed approaches allowed take-offs and landings in both directions.

- 1.9.3 The airstrip was contained within a larger paddock and was marked by white painted tyres along the eastern side and bounded by a stock fence on the western side. Two white painted posts lay on the ground marking the northern end, about 30 m before a drop-off down to the river fan area. The start of the southern end of the airstrip was marked by a tyre positioned about 35 m in from the fence. The airstrip length from this tyre to the white posts was measured as about 480 m (about 1575 feet).

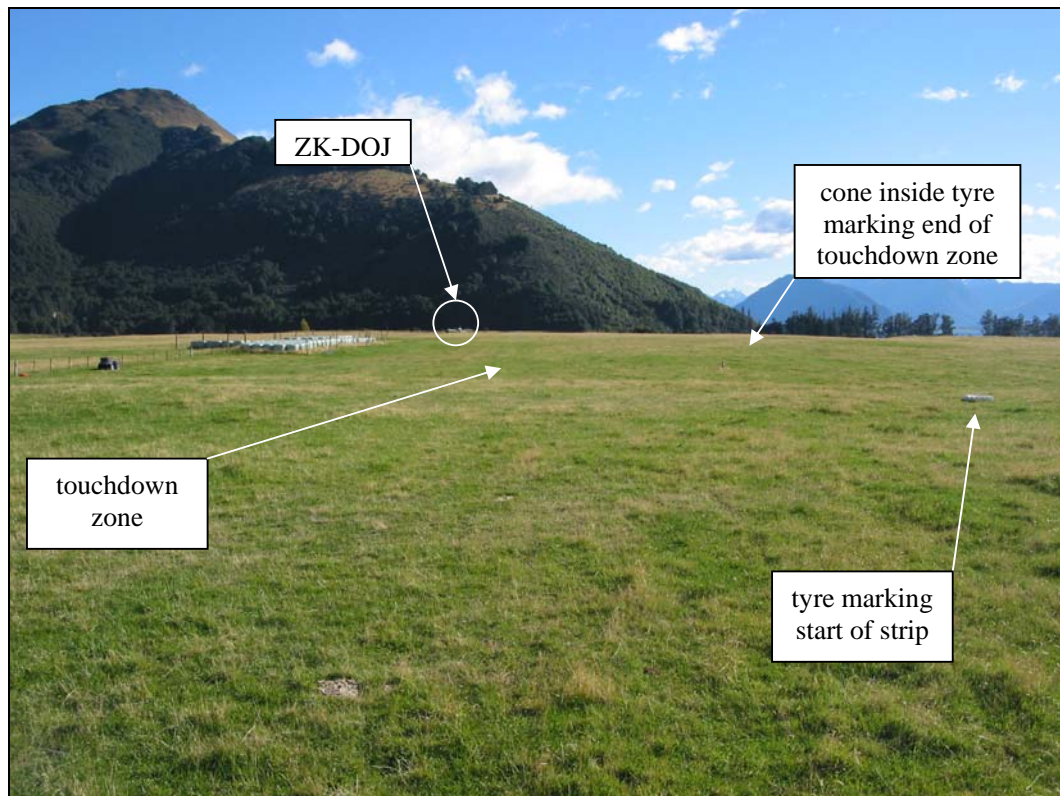
Figure 3
Elfin Bay airstrip – looking north

- 1.9.4 A cone set inside a second tyre about 50 m along from the first tyre helped identify the touchdown area. The area between the first 2 tyres was undulating with 1 to 1.5 m rise and falls, but generally flat near the centre of the airstrip (see Figure 3).

- 1.9.5 A windsock was located along the stock fence, about midway down the airstrip. However, the fabric had frayed to the extent that the sock was ineffective as a wind indicator.

054/07 require operators to provide an approved serviceable wind indicating device at remote airstrips used frequently for commercial operations, to allow pilots to accurately assess wind conditions for take-off and landing.

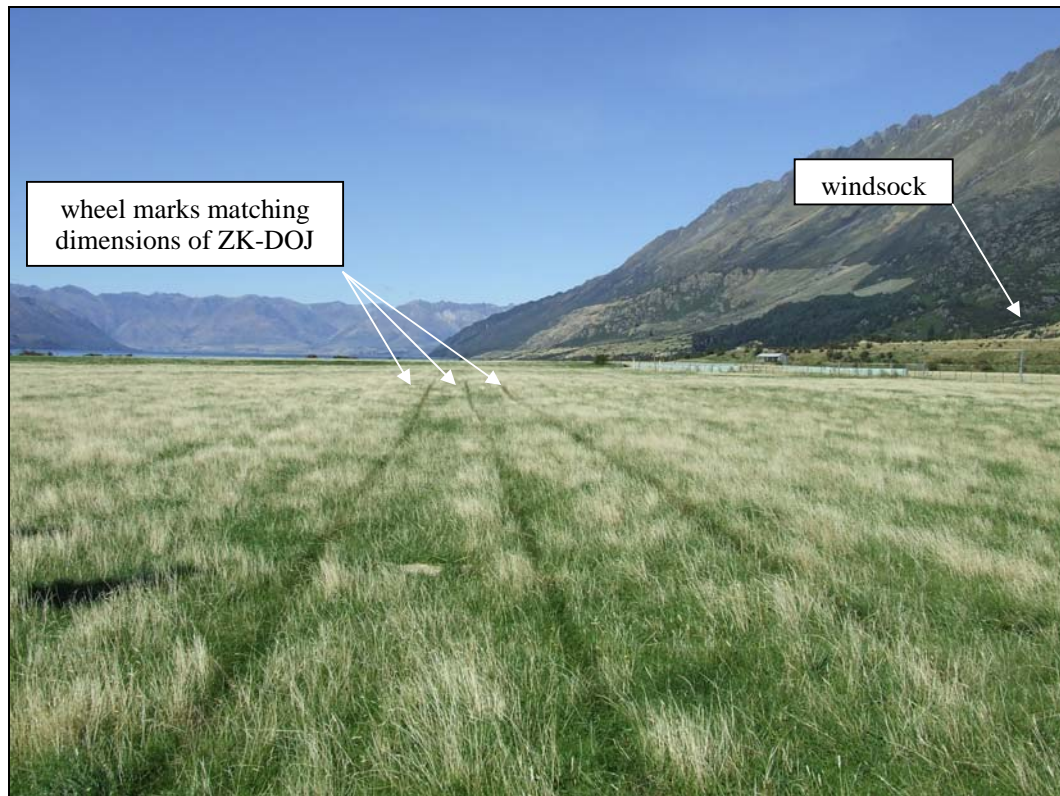
Figure 4
Elfin Bay airstrip – looking south

1.11.3 Photographs taken using the passengers' camera, about one hour after the landing and before the second aircraft had landed, showed 3 wheel tracks running along the airstrip and terminating at the aircraft. The measurements of the tracks matched the landing gear dimensions of ZK-DOJ, and commenced about abeam the touchdown cone and initially ran along the centre of the airstrip. At about 290 m along the airstrip, the tracks started veering to the left (see Figure 4).

1.11.4 Closer examination of the tracks showed a distinct change in the characteristics of the ground marks after about 40 m. For the first 40 m the grass was rolled over; after that point it was also bruised or burnt-like. This later characteristic continued as the tracks veered left and became crossed up as the aircraft started rotating.

- 2.8 The wheel marks showed that the pilot started braking shortly after landing. The change in characteristics of the wheel marks also showed that the wheels locked up about 40 m after braking had started and remained locked until exiting the side of the airstrip. Though the grass was dry on top, the damp foliage underneath, combined with the hard surface, would have created a slick contact surface for the wheels. This significantly reduced the effectiveness of the brakes.

- 2.9 To have mitigated the effects of the moisture and poor braking action, the pilot should have released pressure on the brakes to ensure the wheels were able to rotate, and then reapplied braking pressure. By repeating this action as the aircraft slowed he could have ensured that the maximum braking effect possible was achieved. The pilot was aware of this technique, but he appeared to have focused on the fast approaching end of the strip and subconsciously applied continuous full braking pressure, thereby keeping the wheels locked up until it was too late.

053/07 use this accident to educate pilots on appropriate landing and braking techniques, especially for remote and restricted length aerodromes.
